# ALASKA TRUCKING SPILL MANAGEMENT WORKSHOP

Bob Whittier  
Matt Carr  
EPA

## MP 48 RICHARDSON HIGHWAY DIESEL DISCHARGE

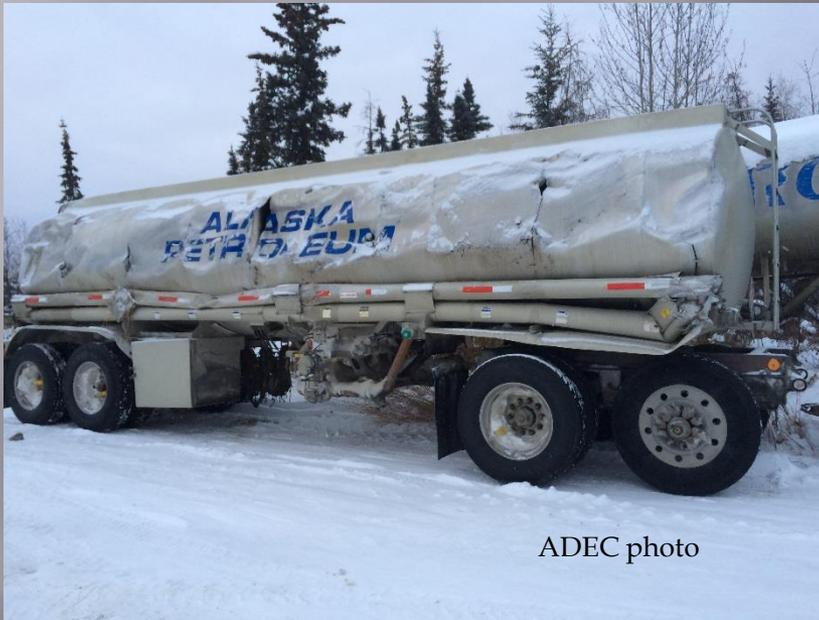
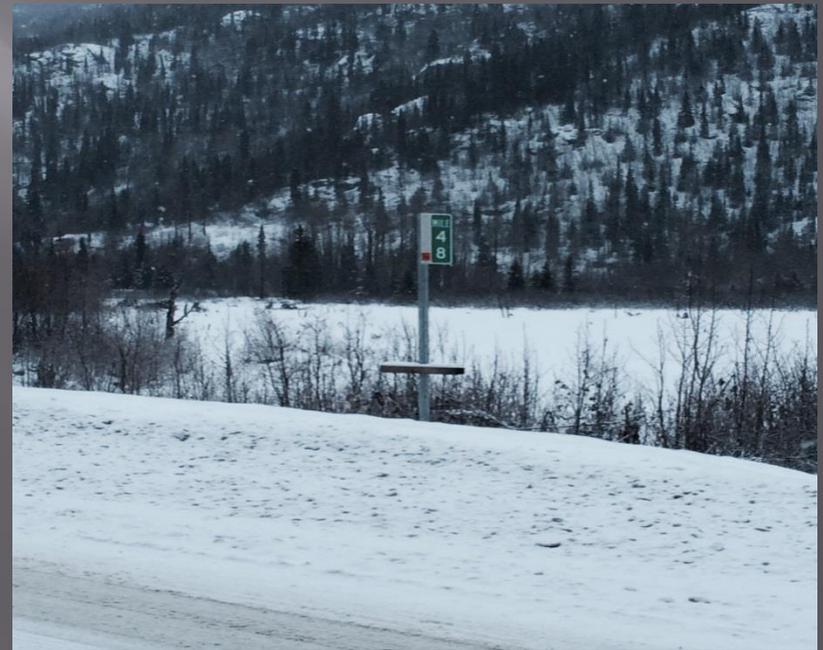
On December 09, 2014 a “pup” tanker rolled over on the Richardson Highway at MP 48 discharging its contents.

- 4400 gallons of low sulfur diesel fuel
- Discharged directly to a frozen creek bed
- **Why EPA?**
- Large quantity directly to a Navigable Waterway of the US
- PRP's inability to pay
- Sensitivity of the area; salmon habitat, tributary to the Copper River, subsistence use, etc.

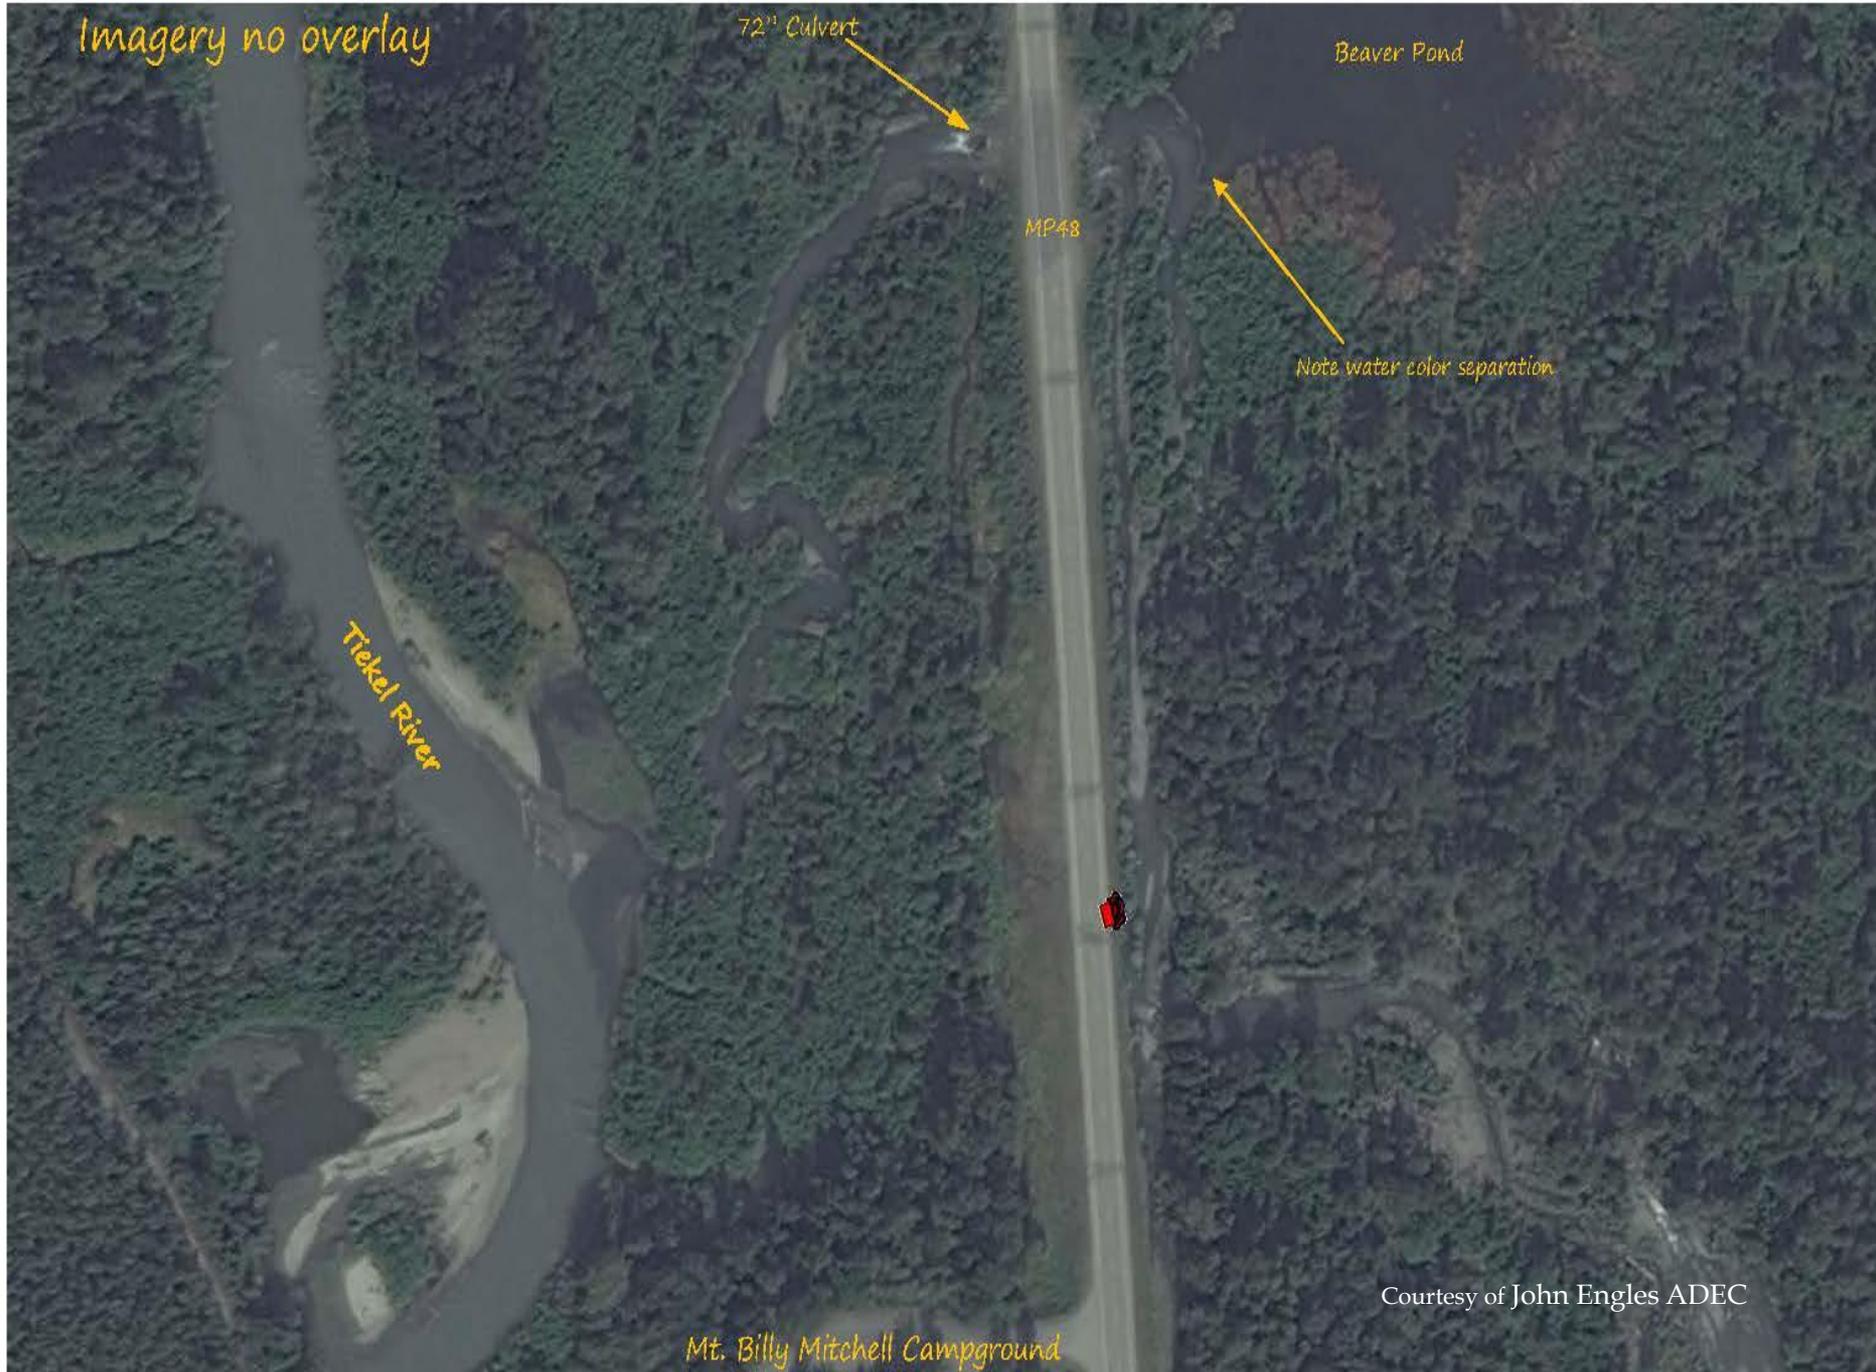
Imagery no overlay

72" Culvert

Beaver Pond

MP48

Note water color separation.

Tikel River

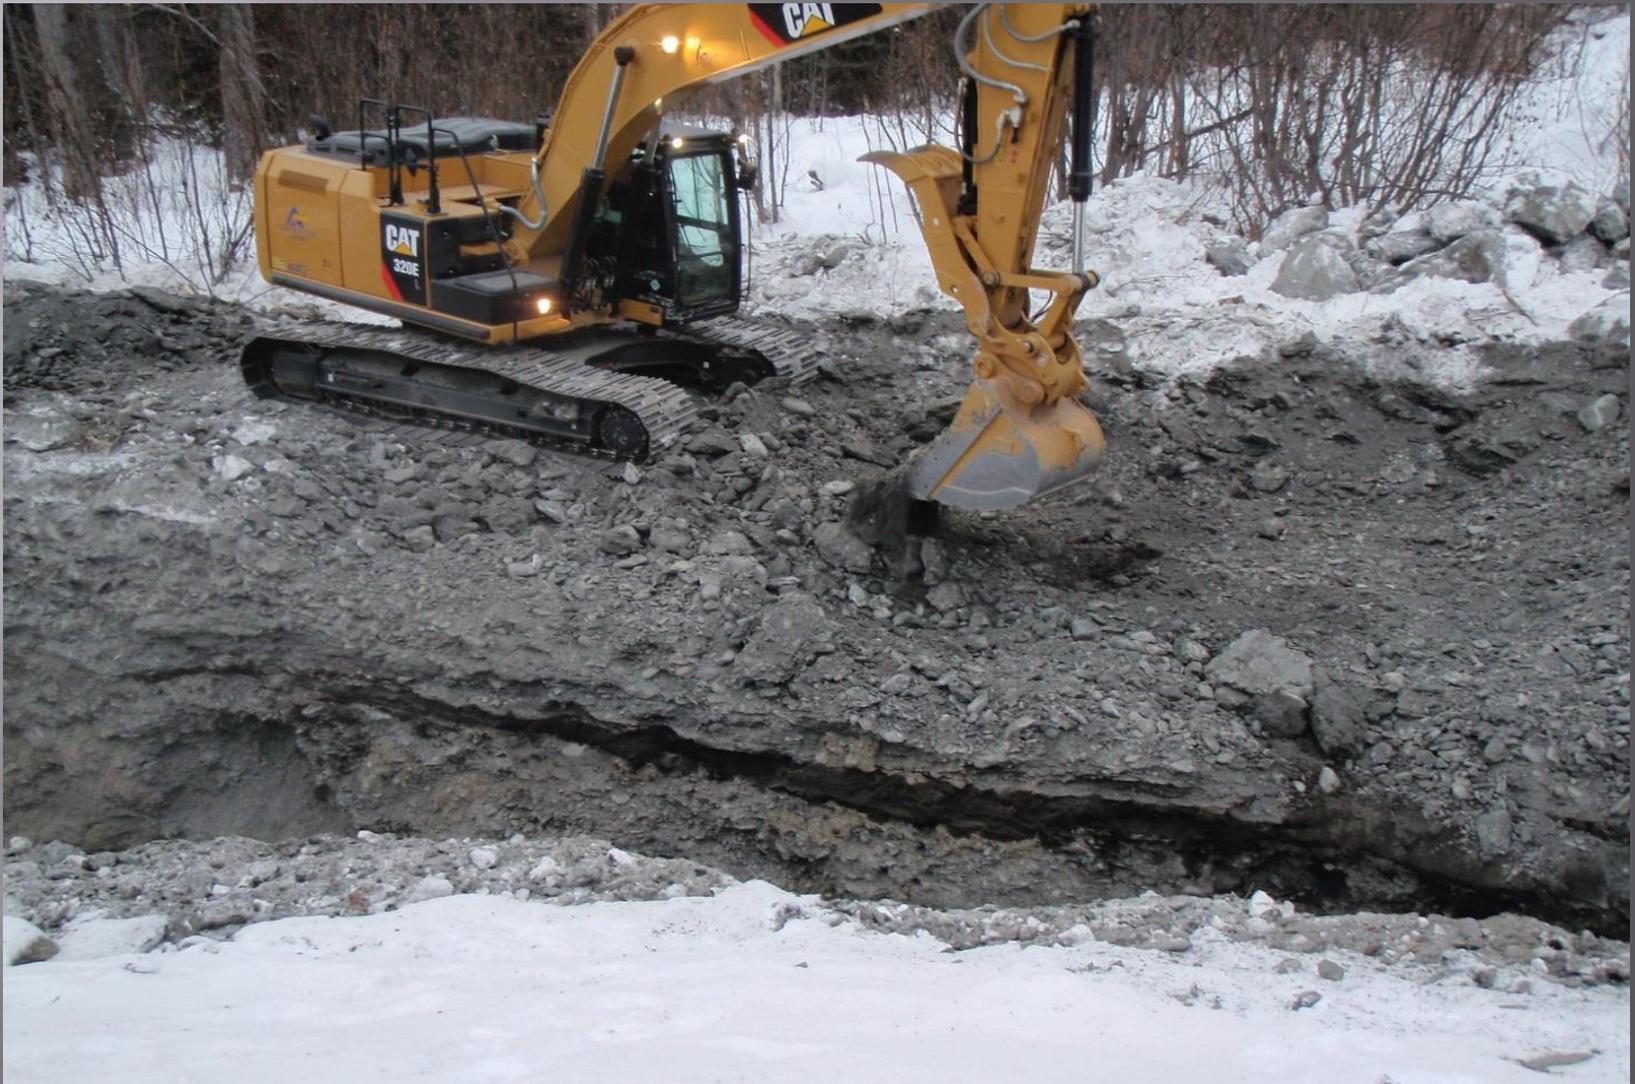
## Excavation Operations *"Note contaminated silt"*

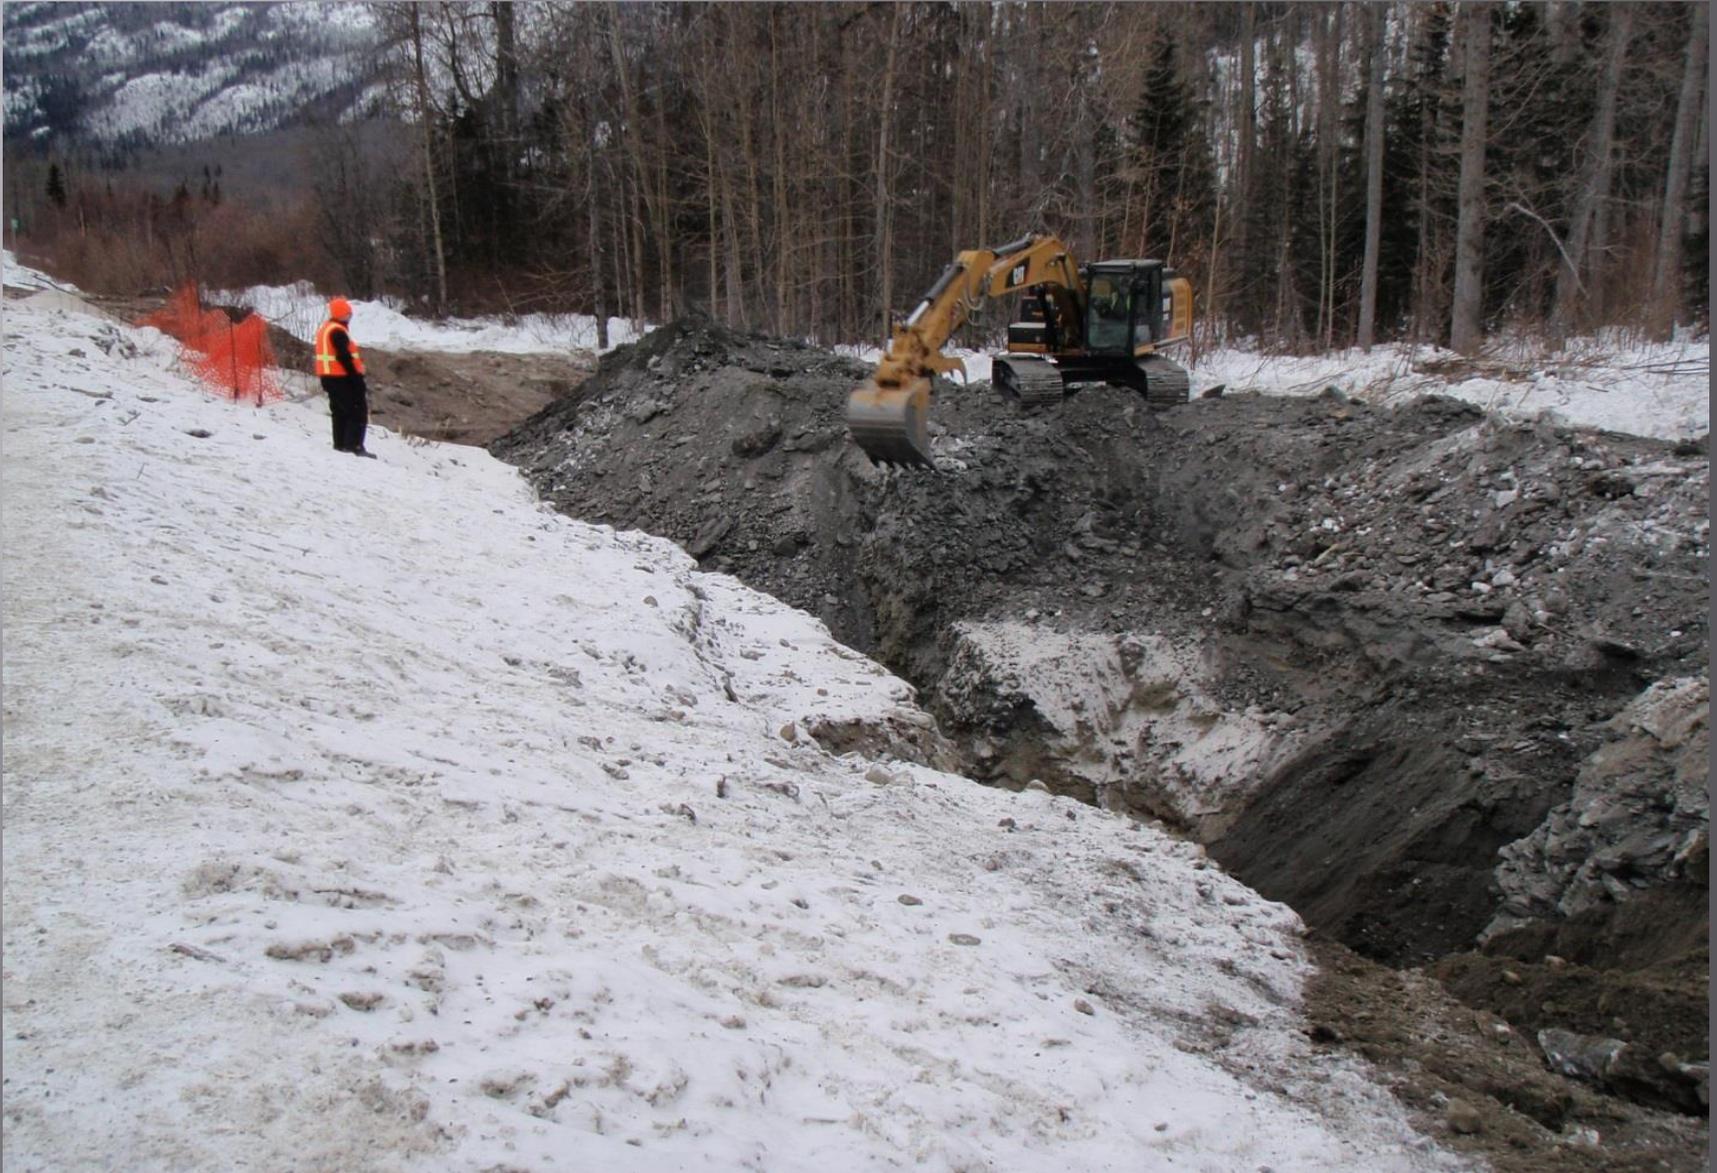
## “Benching” to Access Contamination at Depth

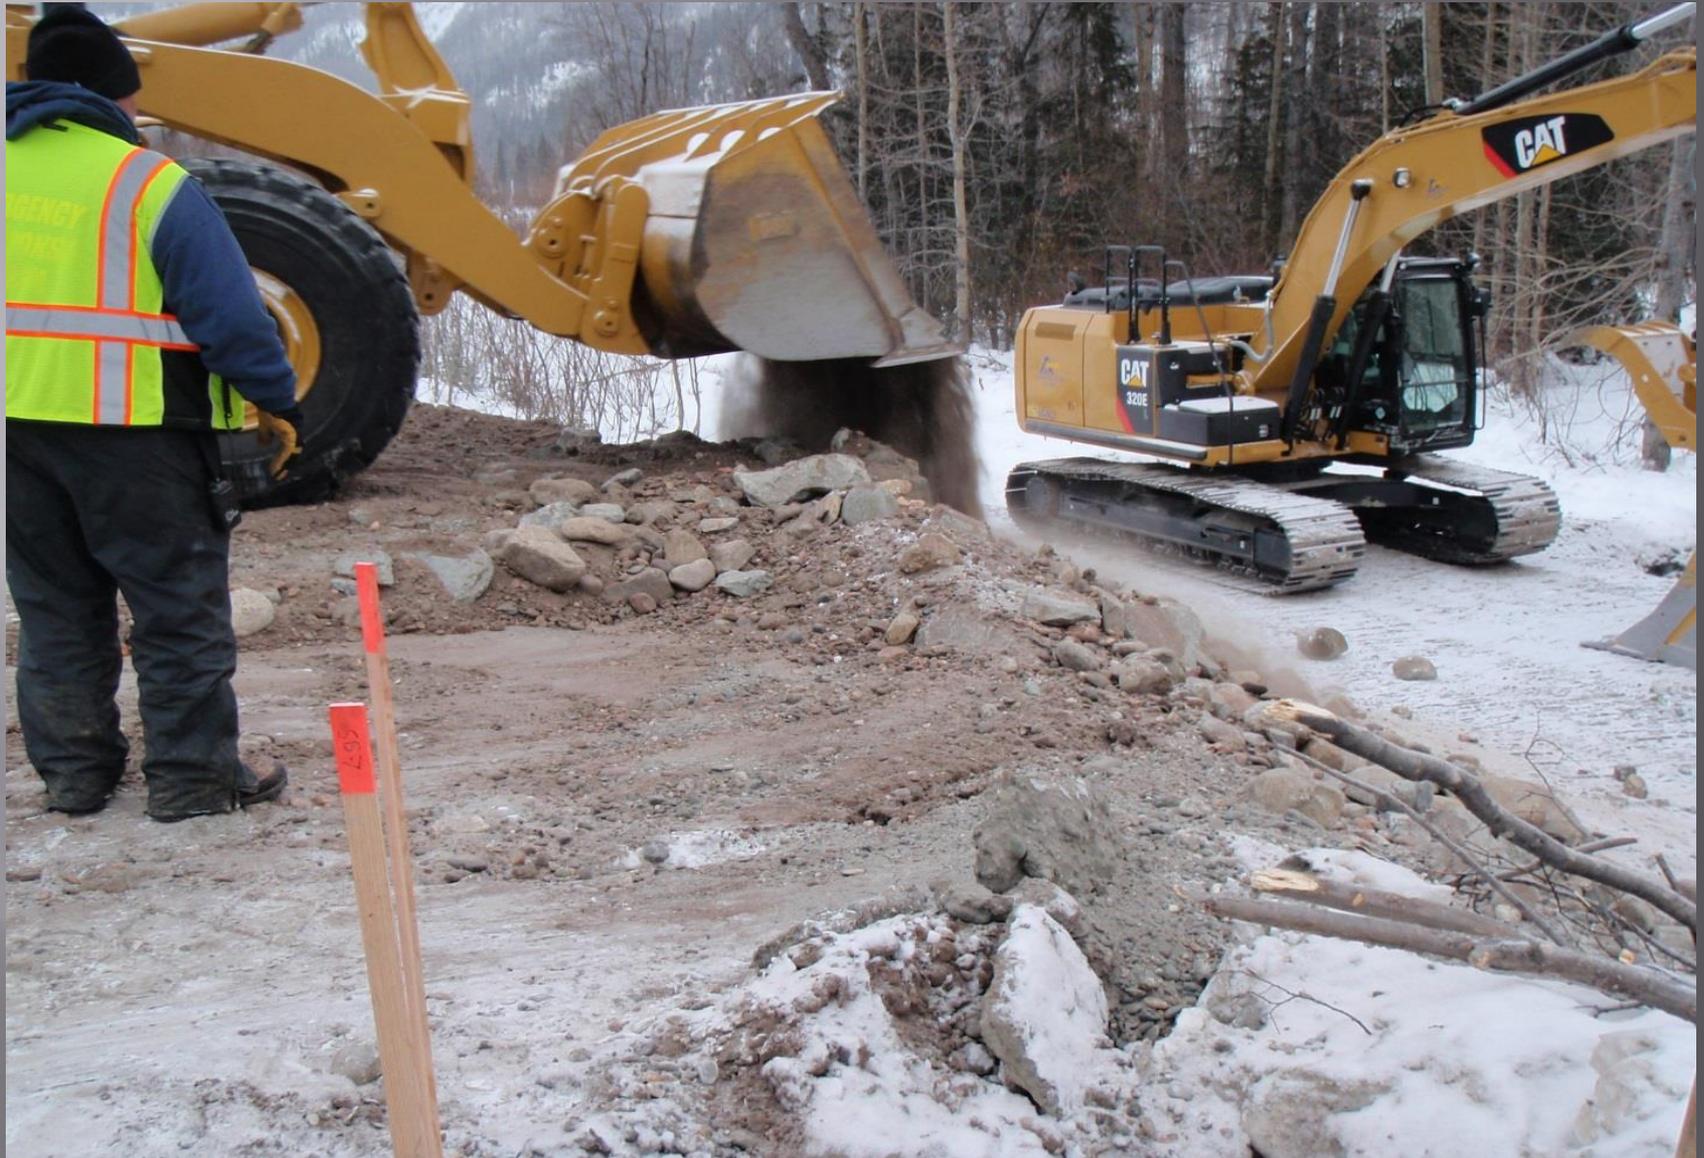
## Backfilling with Comparable Materials

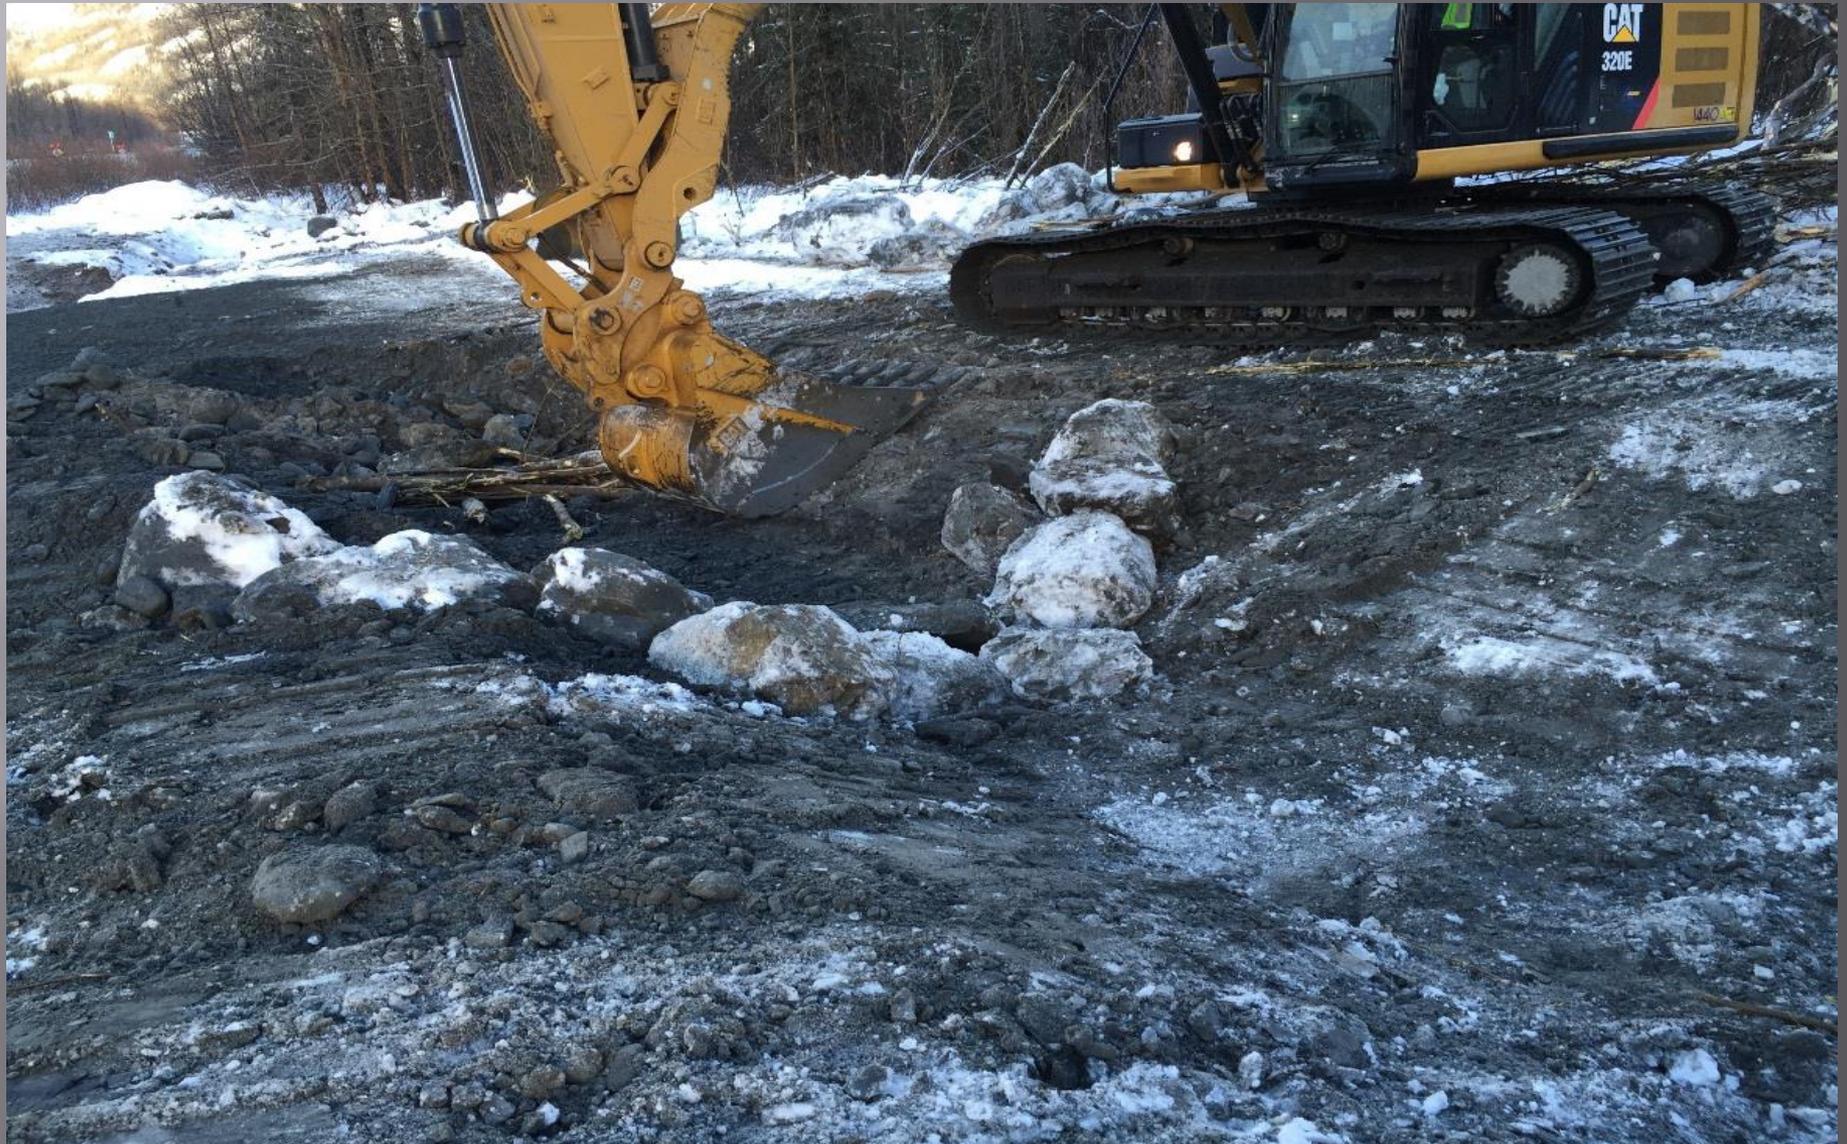
# Creek Bed Reconstruction
