**ALASKA DEPARTMENT OF ENVIRONMENTAL CONSERVATION**  
**Division of Spill Prevention and Response**  
**Prevention and Emergency Response Program**

**SITUATION REPORT**

**INCIDENT NAME:** Lisburne Common Line Release

**SITREP #:** 6

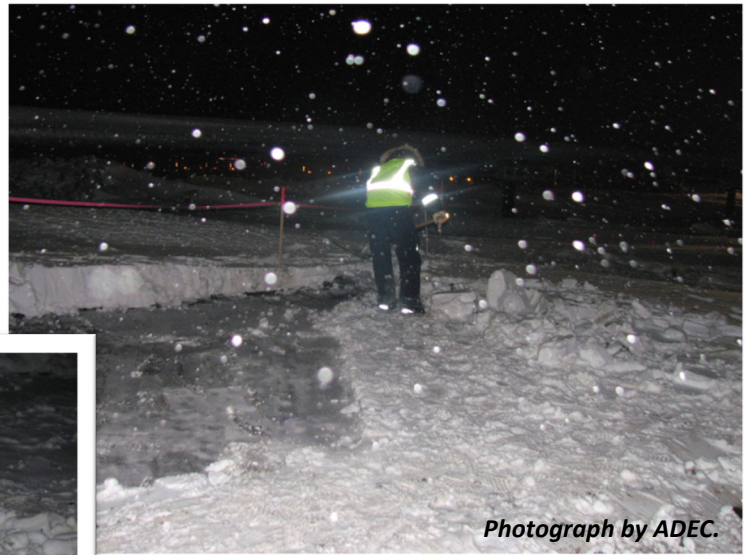
Crews collected approximately 40 cubic yards of contaminated snow from the heavily contaminated area in the South Division.

As of 6:30 AM on December 4, approximately 40 cubic yards of contaminated material was manually removed from the south side. BPXA also discovered standing liquid product under the snow during cleanup operations. There is no indication from the Forward Looking Infrared Radar (FLIR) overflights that the size of the affected area has increased. BPXA is developing new cleanup tactics for collecting standing liquid product for UC approval.

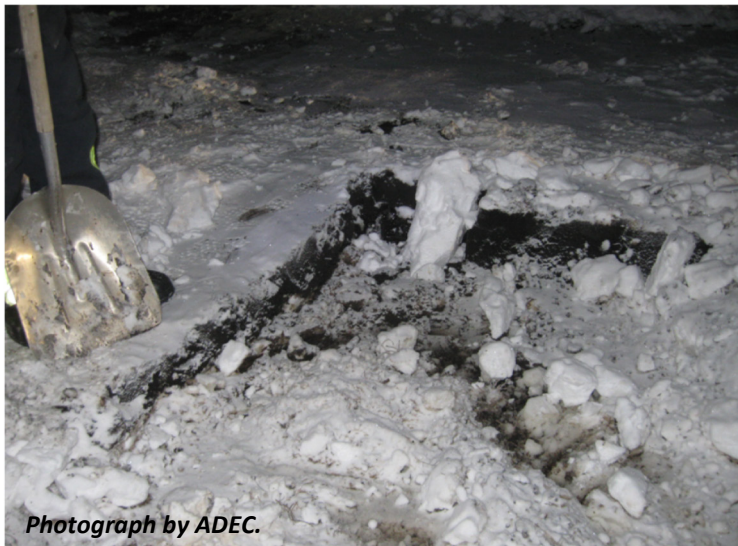
Liquid product found during cleanup operations.
