ALASKA DEPARTMENT OF ENVIRONMENTAL CONSERVATION
Division of Spill Prevention and Response
Prevention and Emergency Response Program
SITUATION REPORT (*sitrep*)

BPXA H Pad Well 8 Three-Phase Flowline Spill

SITREP #: 5

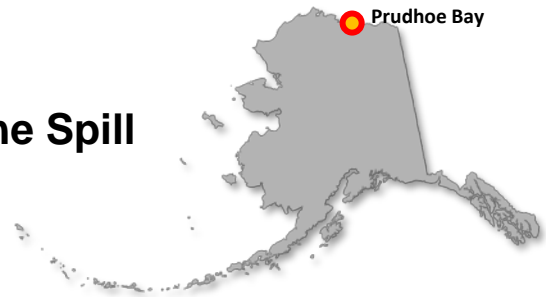
Personnel from Environmental Resource Management obtained legal sampling from within the delineated zone of impacted snow before crews completed recovery of the oil contaminated snow.

RESOURCES AFFECTED: Approximately 33 acres of snow-covered tundra and two acres of gravel pad have been sprayed with an oily mist to varying degrees of coverage. Snow buntings have been observed at the site. No other wildlife observations reported. BPXA continues to maintain passive hazing tactics to discourage bird visitation.

Management of melt water will continue. Crews will deploy river containment boom in areas of natural drainage in an attempt to collect any runoff that might be contaminated. The number of cleanup personnel for today's crew is back to 33, with 22 scheduled again for tonight; additional staff provide support to each of these crews.

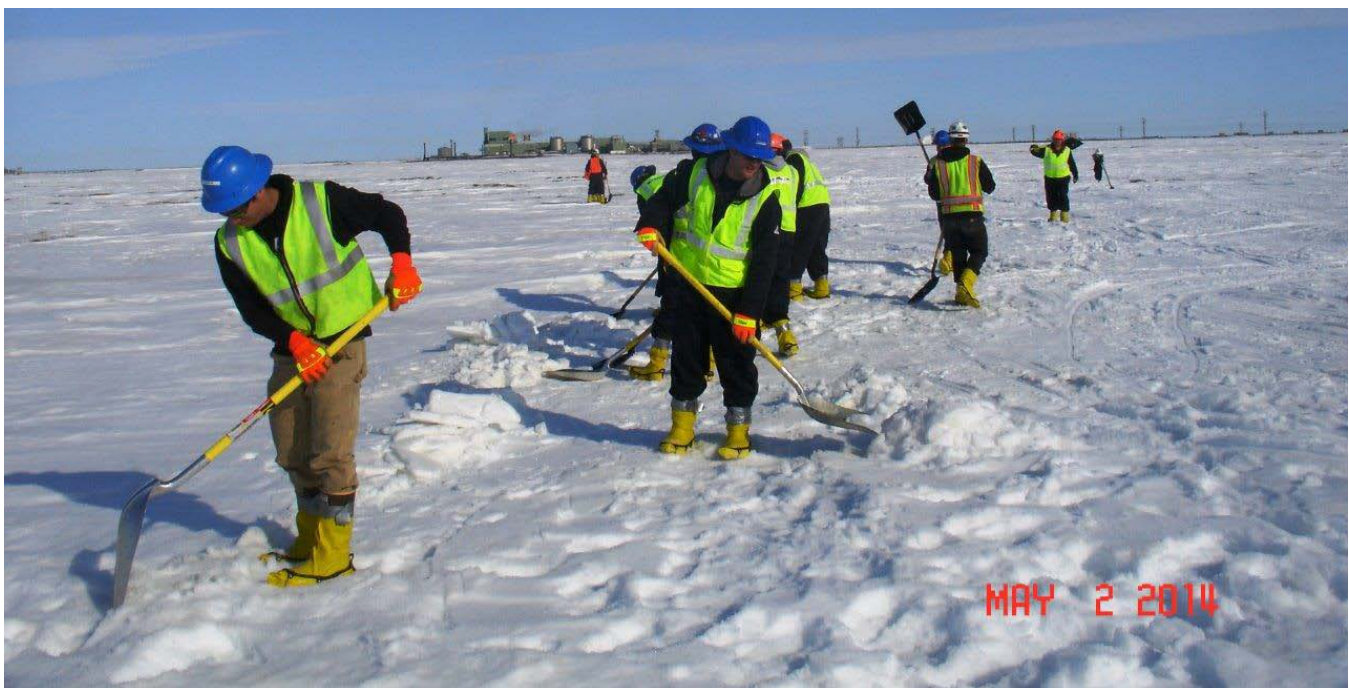
Cleanup workers searching the area for additional oil-contaminated snow. May 2, 2014 (photo: Ebel, ADEC)

Areas of snow showing oil contamination have been located outside the original zone, and work crews will be addressing those spots today, as well as searching for other areas that may have been missed. It appears that strong winds occurring after the original demarcation of the impacted area transported contaminated snow outside the delineated zone.
