# Lake Lucile Sediment Quality Sampling: Spatial Extent of Impaired Sediment due to Outfall Stormwater Inputs

Prepared for: Alaska Department of Environmental Conservation

Jeffrey C. Davis, Gay A. Davis, and Rachel J. Burns  
Aquatic Restoration and Research Institute  
P.O. Box 923, Talkeetna, AK, 99676  
[arri@arrialaska.org](mailto:arri@arrialaska.org) 907.733.5432

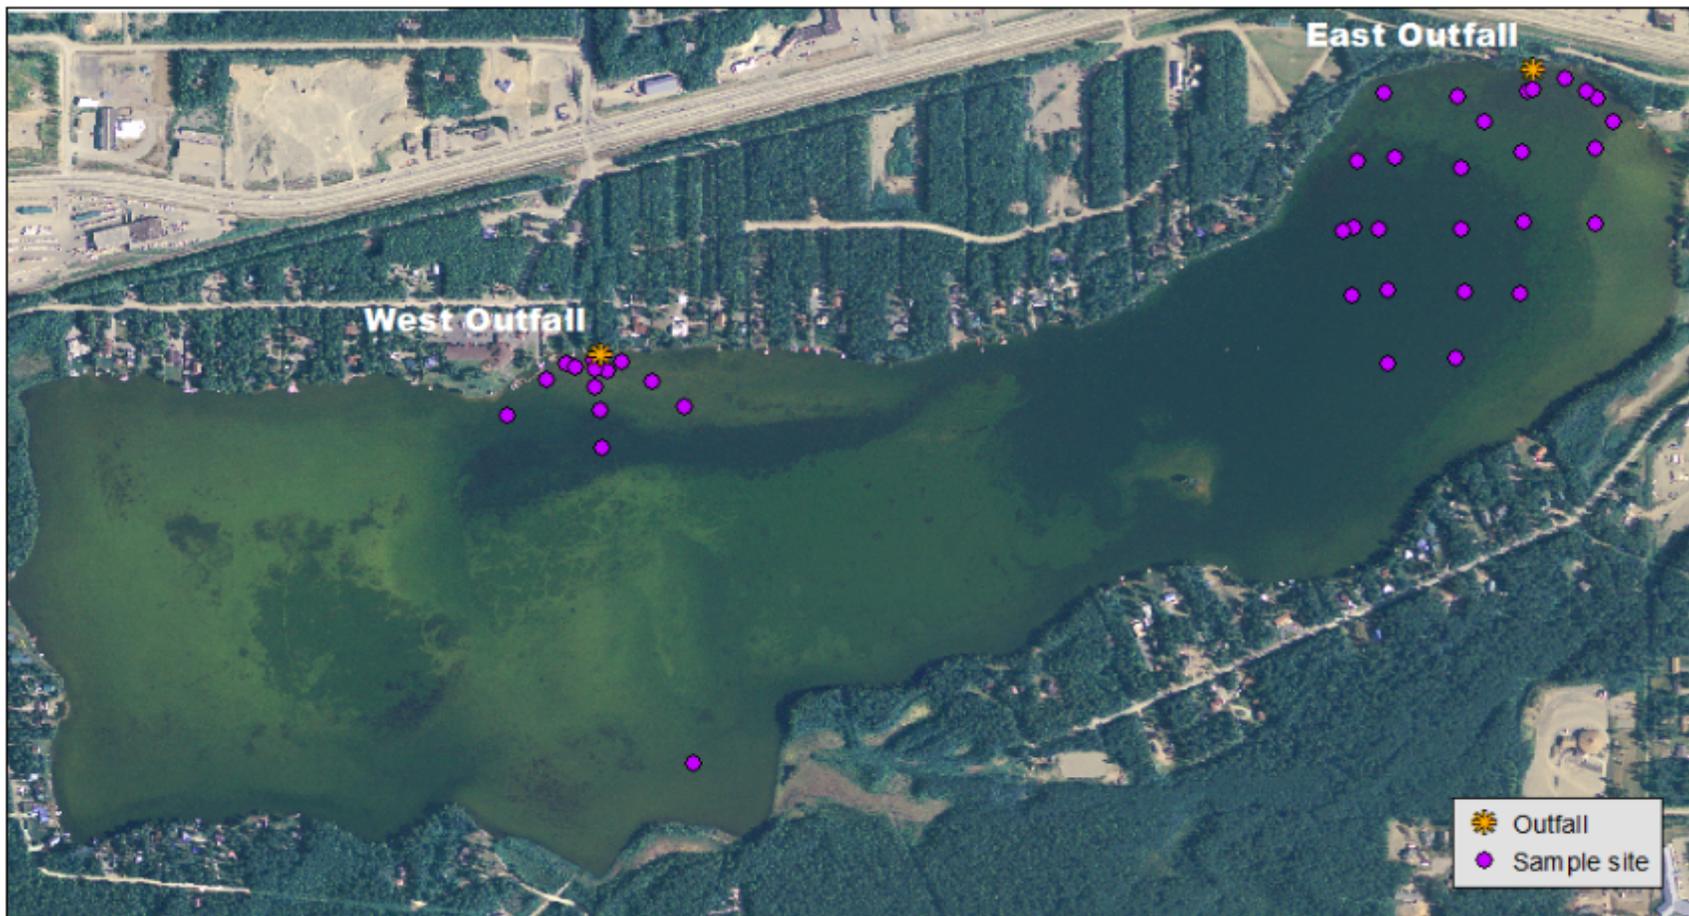
Figure 2. Aerial photograph of Lucile Lake showing east and west outfall and grid sampling locations. Initial sampling points around the east outfall were on a 100 m grid. Samples around the west outfall were collected 25, 50, 100, and 150 m from the outfall.

Initial sediment sampling was conducted on June 4, 2013. 27 samples were collected during the first sampling event. Results from this sampling were used to determine sampling locations for the second sampling event which occurred on June 20 and 21, 2013. 17 samples were collected during the second sampling event (Figure 2).

Initial sampling locations were distributed on a 100 m interval grid from the east outfall in order to determine the extent of contaminated sediments. Sampling locations were mapped in ArcGIS and were accessed by boat. Exact sampling locations were recorded with a handheld GPS receiver and triangulated to two points on the shore.

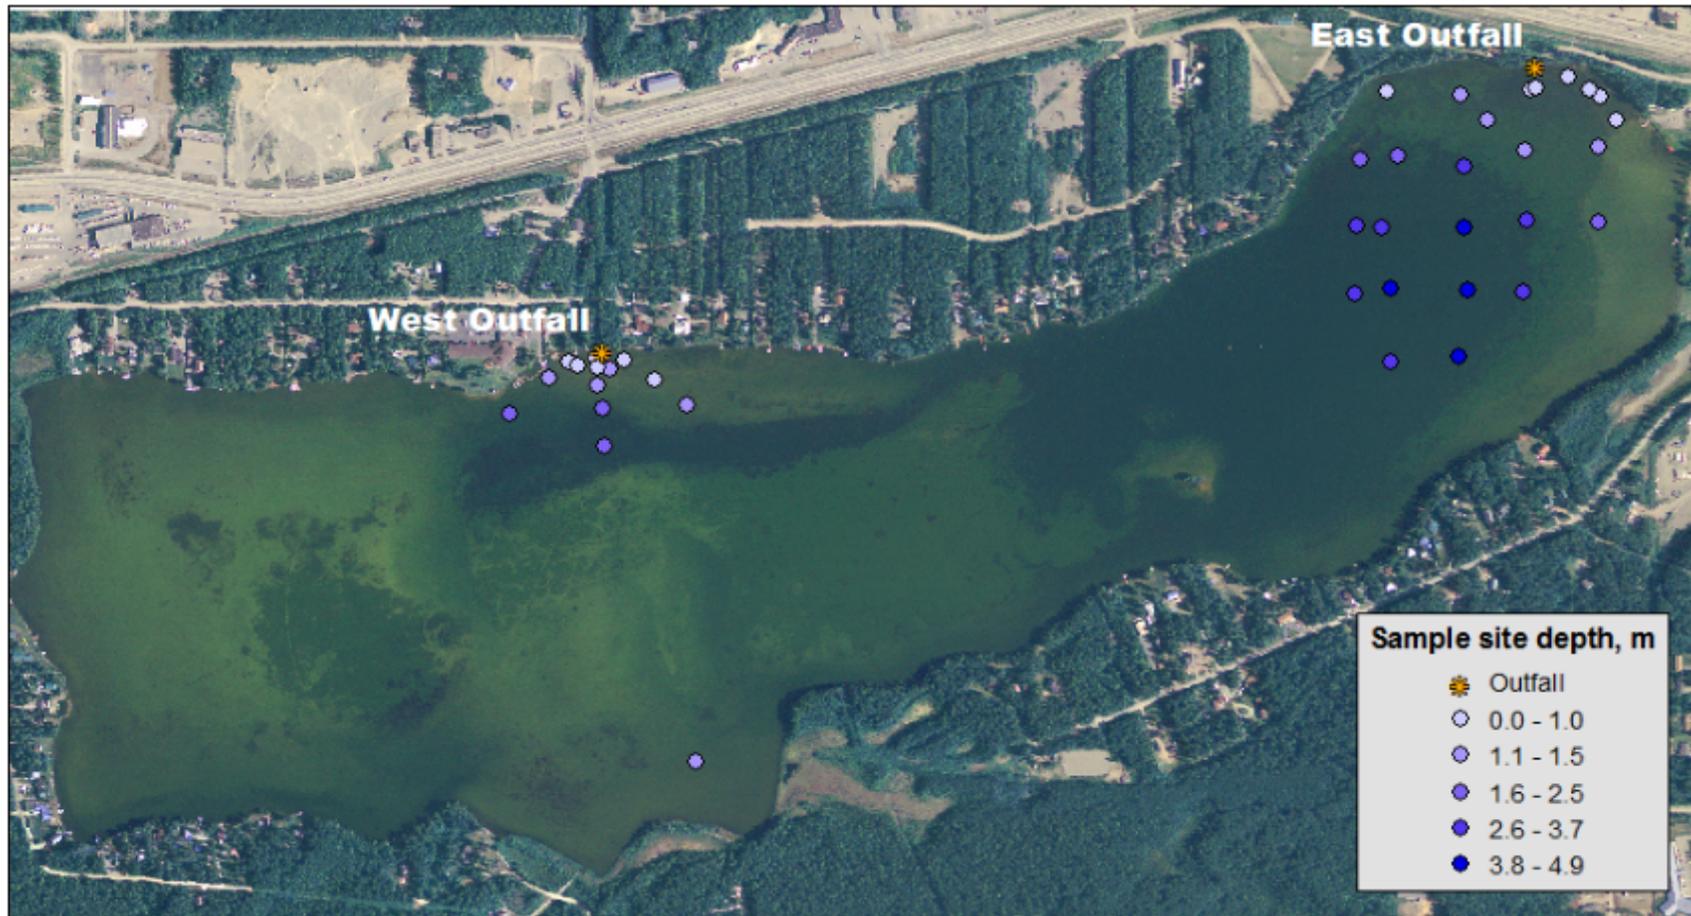
Figure 3. Distribution of water depths at sampling locations.

Water physical and chemical characteristics are reported in Table 3. Water depth at sampling locations ranged from 0.6 to approximately 5 m (Figure 3). Water temperatures were warm,

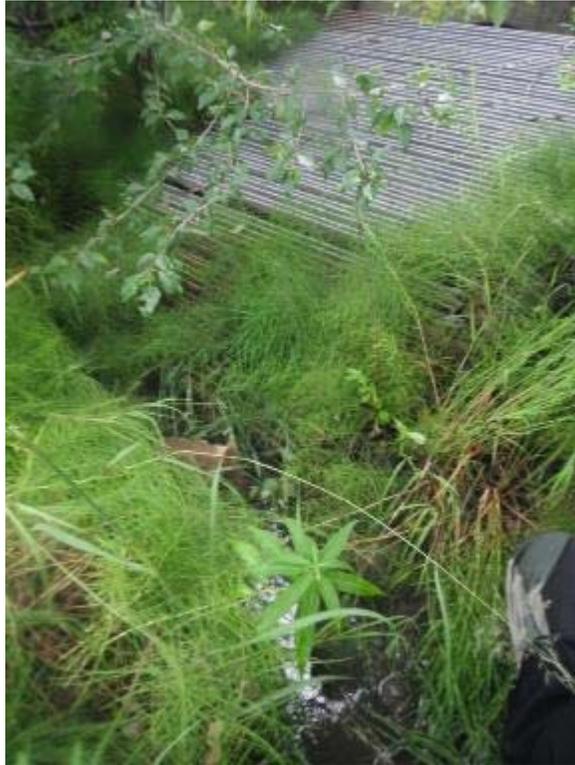
Photograph 1. Lake Lucile east outfall.

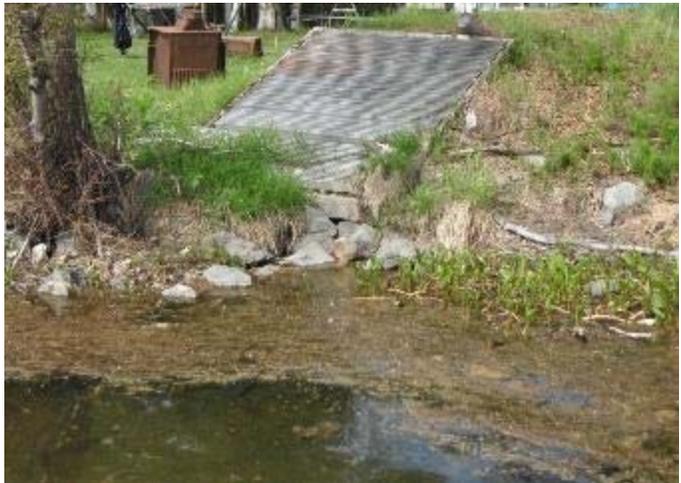
Photograph 2. Lake Lucile west outfall.

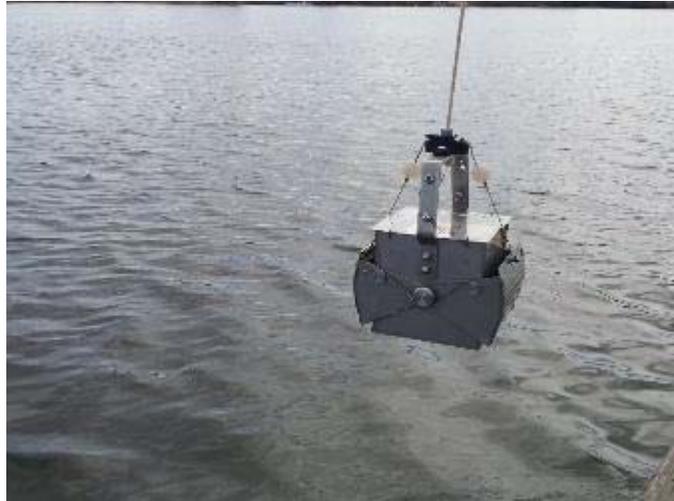
Photograph 3. Ponar dredge sampler.

Sediment samples were collected using a Ponar dredge sampler. The sampler was rinsed in the lake three times at each sampling location prior to deployment. The sampler was released into the water column to submerge 15 cm into bottom sediments under the force of gravity. Once the sampler had settled into the bottom sediments, the messenger was released to trip the spring mechanism and close the dredge. The sampler was retrieved and the top opened to allow access to the sampler contents, which were observed for hydrocarbon sheen or odor. Clean, gloved hands collected sediment from the top 10 cm of the sample in a 250 ml glass bottle for metal and PAH analyses.

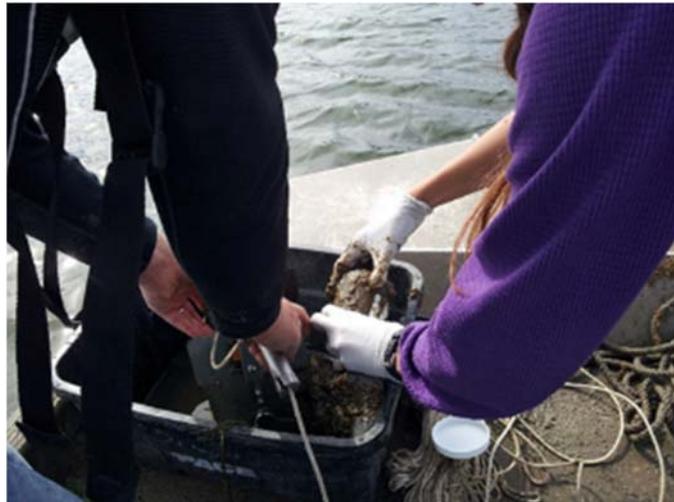
Photograph 4. Sediment collection from dredge sampler.

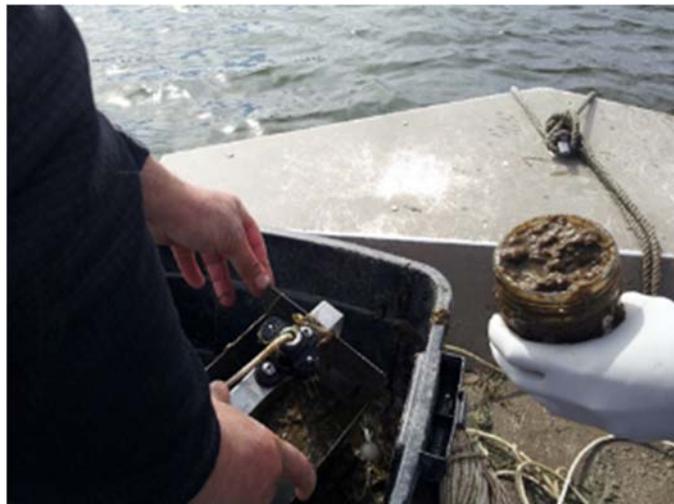
Photograph 5. Full sediment sample container.
