PORT HEIDEN RRS
ALASKA

FINAL
PRELIMINARY ASSESSMENT/SITE INSPECTION
PORT HEIDEN RADIO RELAY STATION
PORT HEIDEN, ALASKA

MARCH 1996

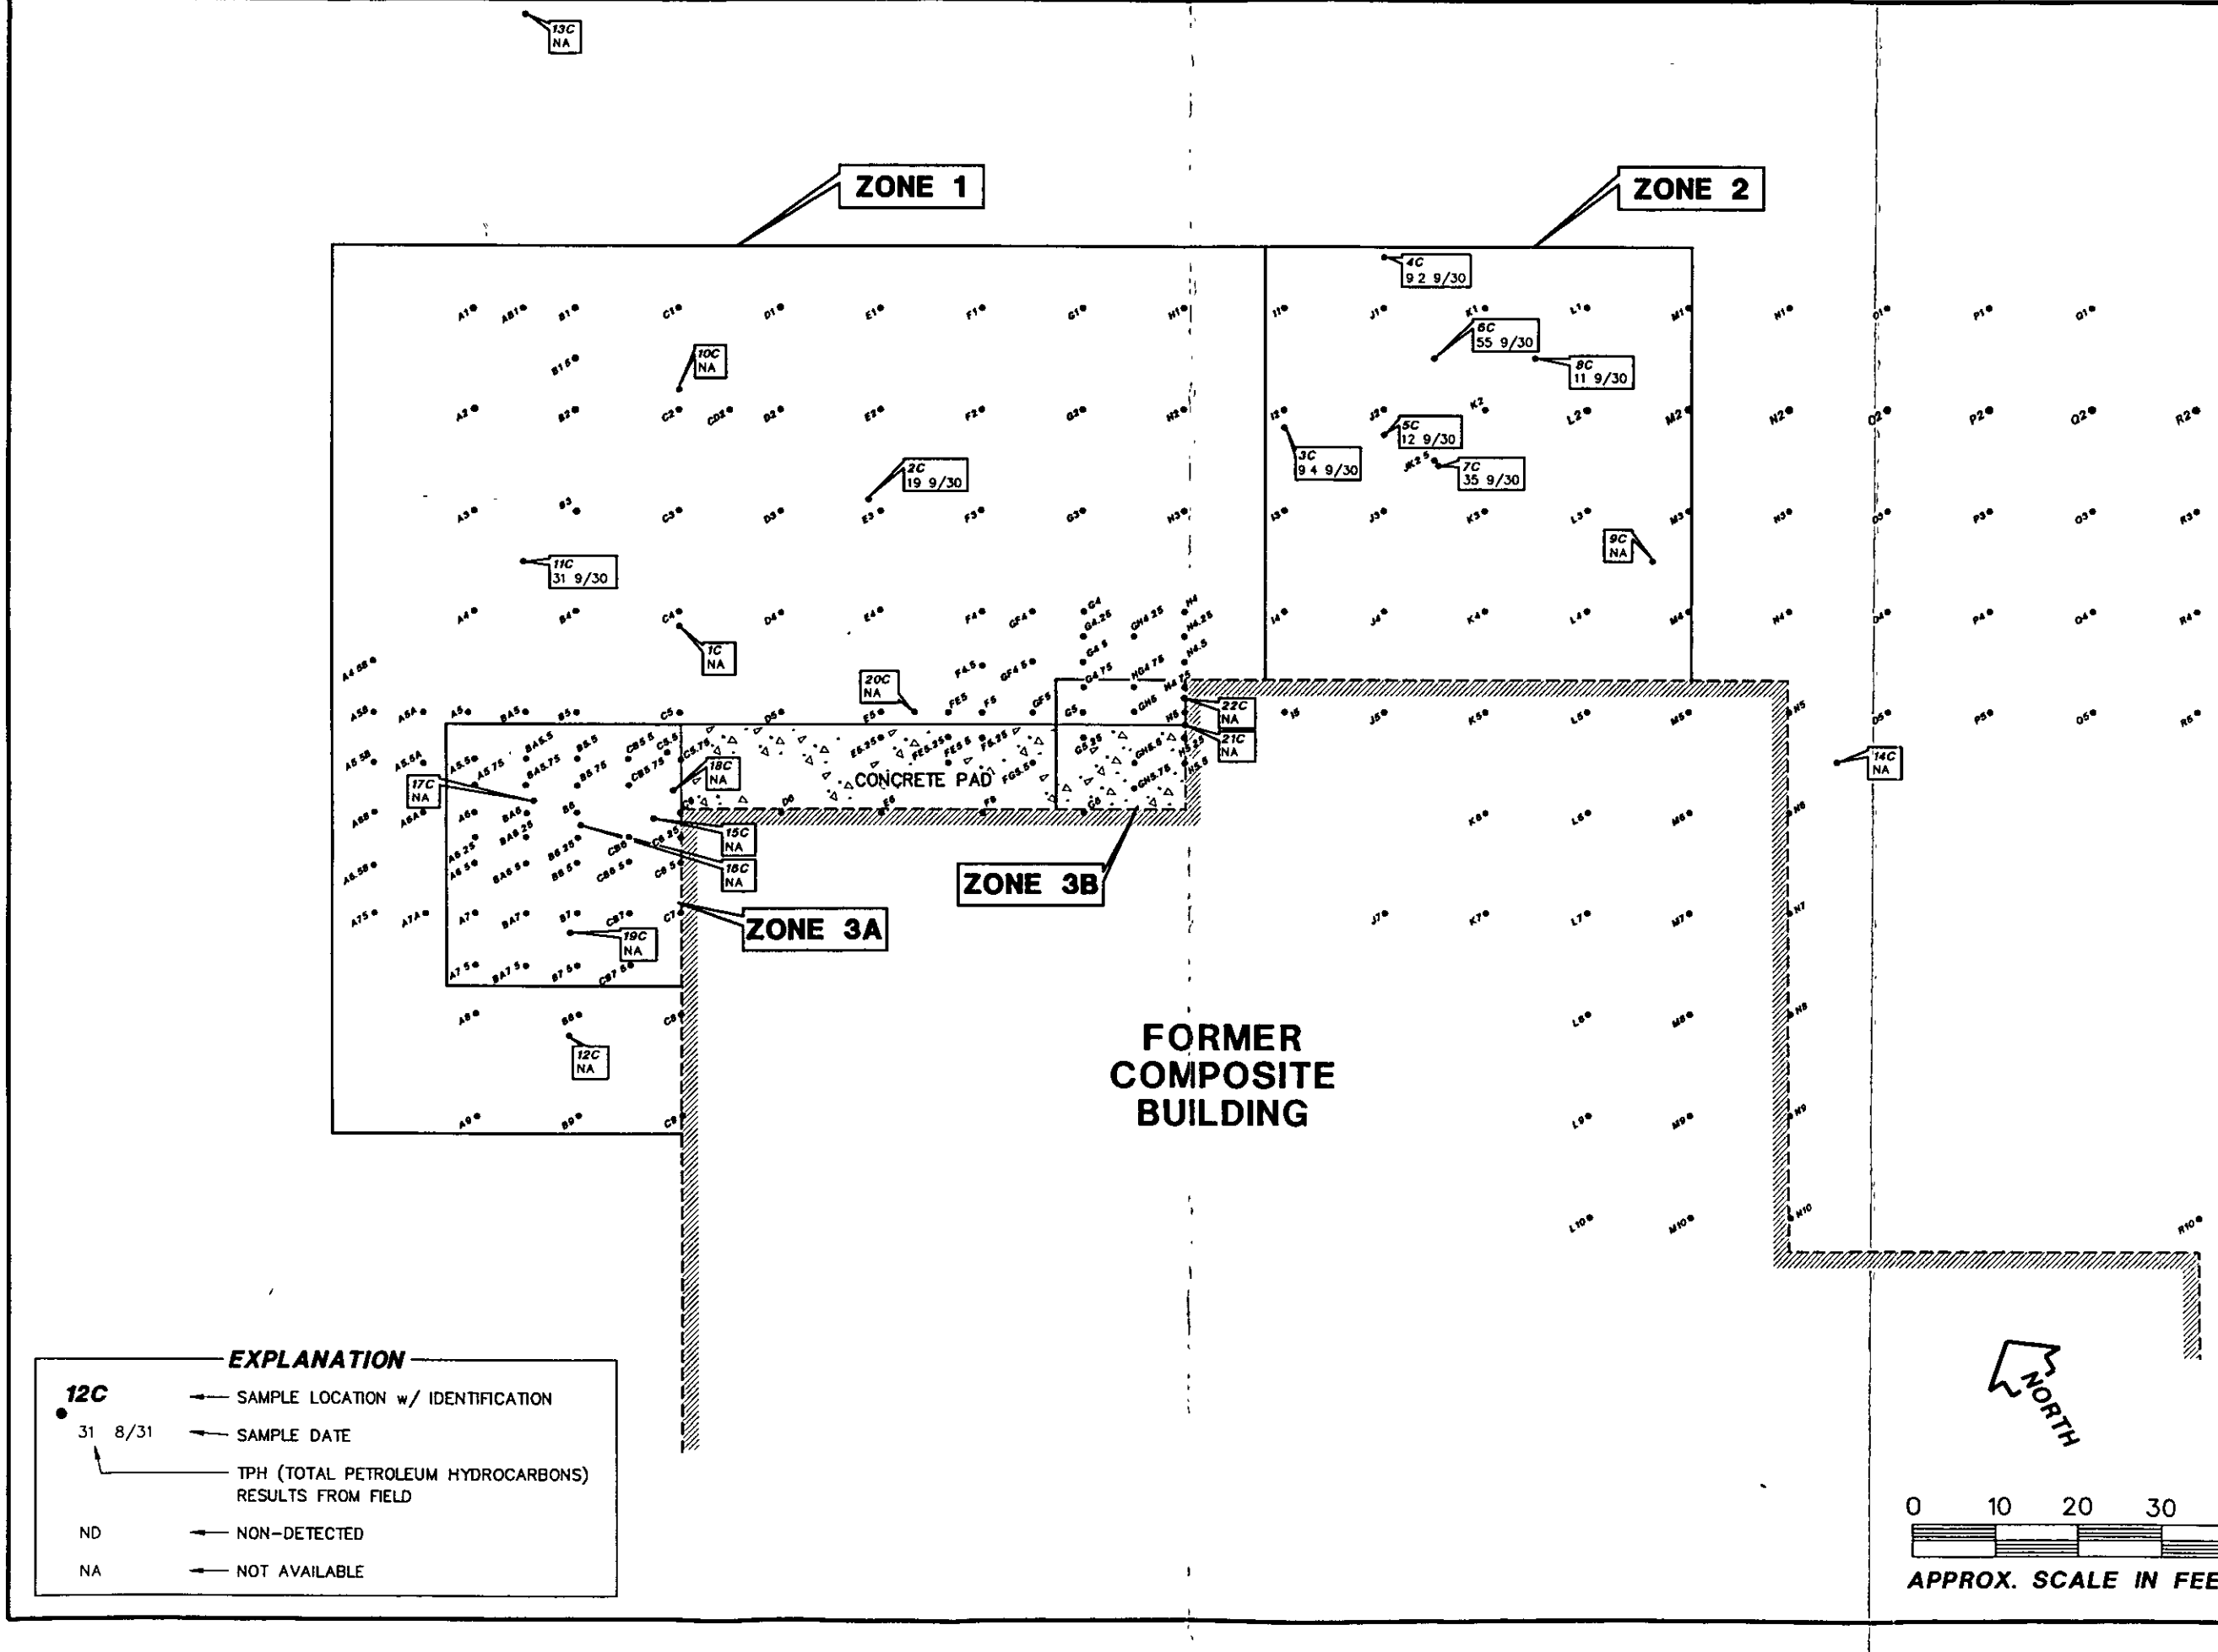
1990 SOIL SAMPLE LOCATIONS TPH RESULTS FORMER COMPOSITE BUILDING

Surface soil with TPH concentrations above 5,000 mg/kg on the north side of the composite building was removed in 1-foot thick intervals and then retested by UC&AI laboratory and NWES The goal in 1990 was to achieve TPH concentrations below 100 ppm throughout the grid area This cleanup goal was not achieved In 1991, ADEC agreed to a 5,000 mg/kg TPH cleanup concentration Figure 7 presents the final analytical results Table 1 lists TPH results for the confirmation samples collected in 1990 All field laboratory and confirmation TPH results are shown in Appendix B Soil with TPH concentrations below 5,000 ppm and having PCB concentrations below 10 ppm was placed into the soil caps of Landfills A and B (Figure 1) Soil with analytical results above 5,000 ppm TPH and PCB concentrations below 25 ppm was stockpiled on site for remediation

Overall IRP site recommendation No further action recommended for PCBs or TPH-impacted soil

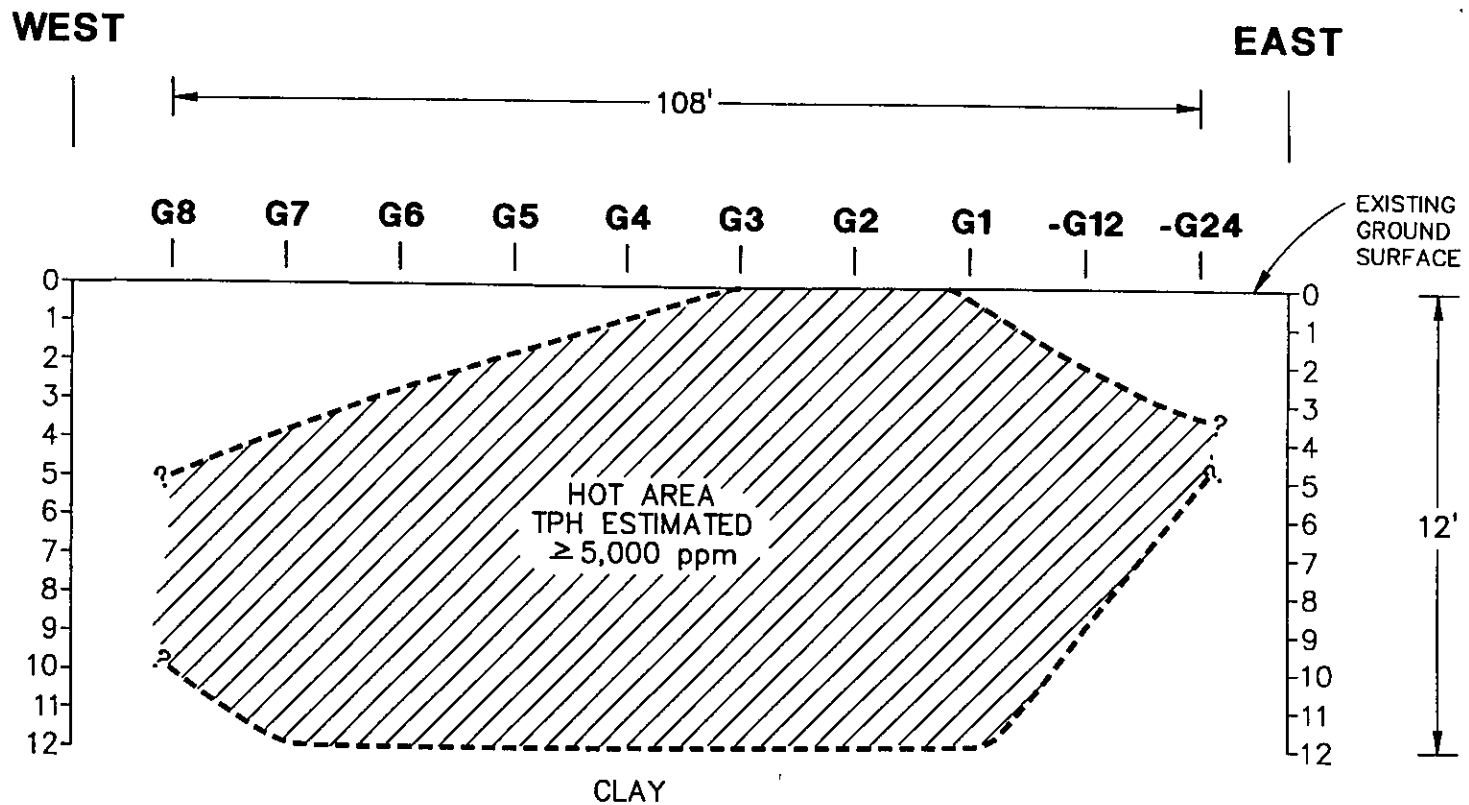
BLACK LAGOON CUT 1
CROSS SECTION

Table 2 lists the 1990 analytical results from the black lagoon Analytical results varied from ND to 67,000 mg/kg TPH Samples analyzed for PCBs were ND The extent of impacted soil with greater than 5,000 mg/kg TPH was estimated in each trench Impacted soil with greater than 5,000 mg/kg TPH was found locally at the surface and to a depth of 12 feet Approximately 4,000 cy of impacted soil with TPH concentrations above 5,000 mg/kg remain in the black lagoon vicinity

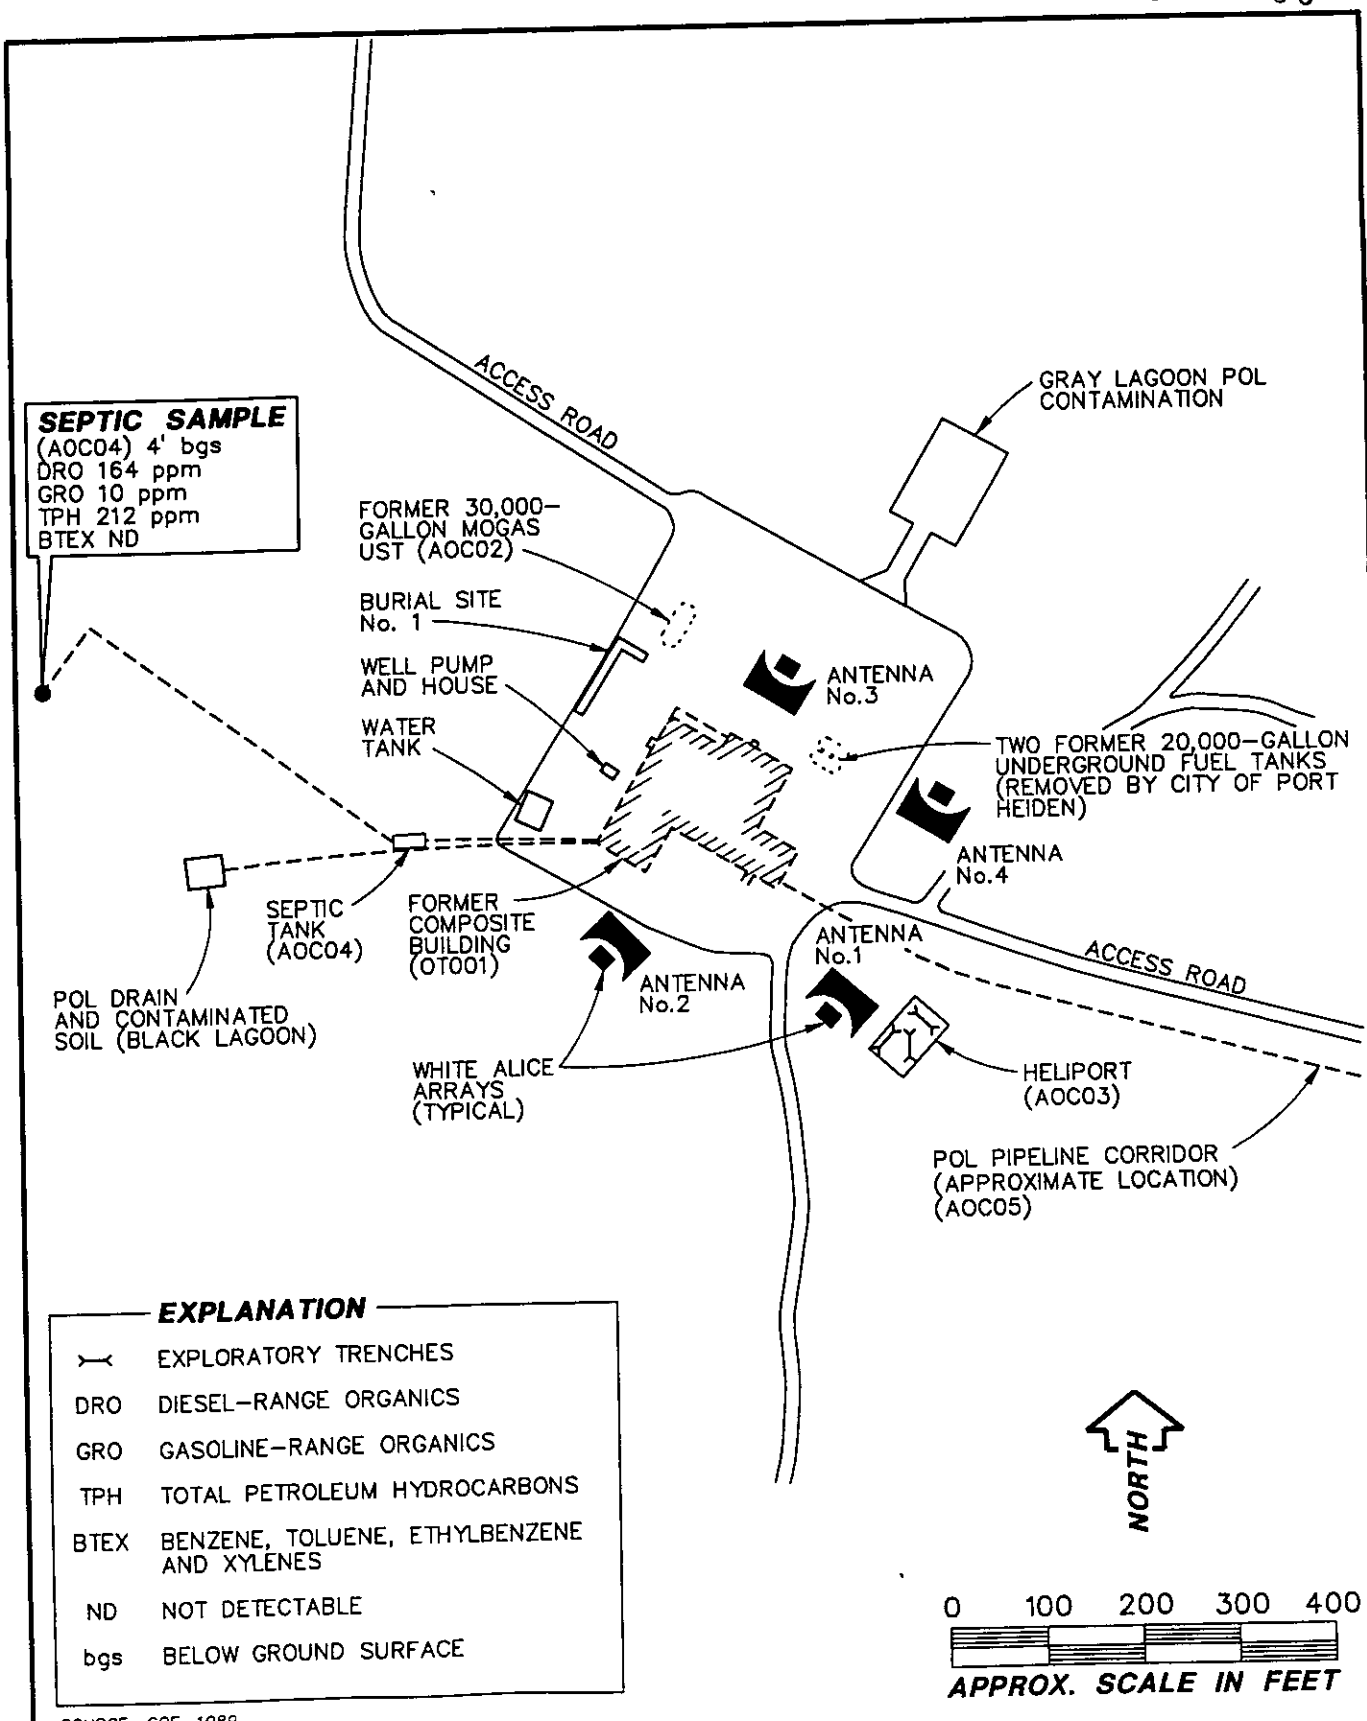
FIGURE 14

Exploratory trenching was conducted north of the composite building near Antenna No 3, in the vicinity of the former 20,000-gallon USTs excavation, and into the gray lagoon (Figure 14)

Field laboratory TPH results for samples collected from the gray lagoon varied from 5,700 mg/kg to 8,600 mg/kg TPH Samples collected from the other trenches varied from 8 9 mg/kg up to 8,600 mg/kg TPH Soil removed from the trenches was used to backfill them, except for about 3 cy of soil in the vicinity of the former 20,000-gallon UST excavation (Ed Erickson, NWES, personal communication) Figure 14 shows the field sample locations and laboratory TPH analytical results Table 3 presents the field laboratory data Soil from trenches T and S may have been removed during excavation of TPH soil in the composite building area after this exploratory trenching, as discussed in Section 2 1 6 Impacted soil from the other trenches was not removed

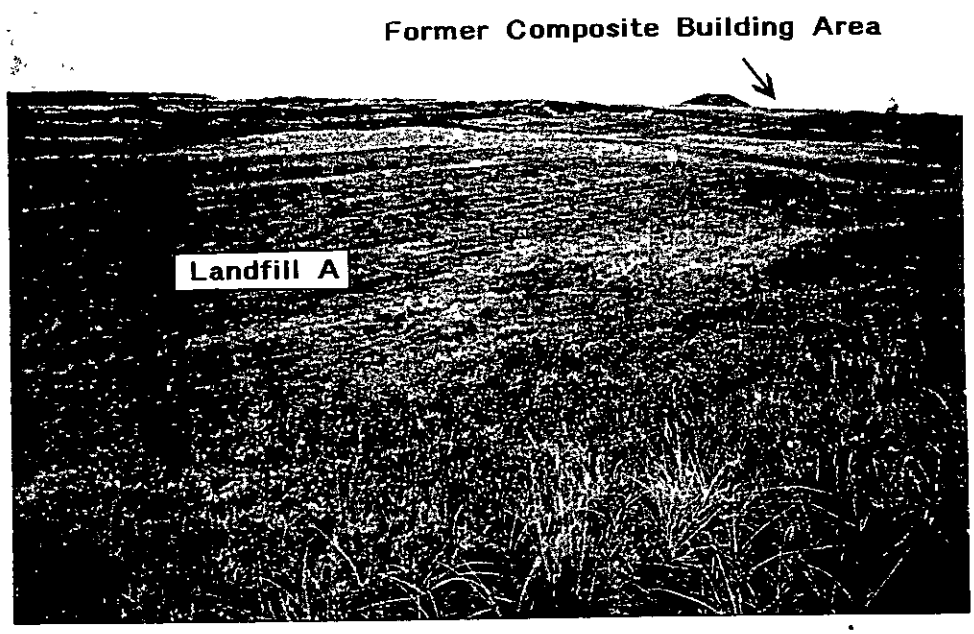
Photograph #2
Landfill A Soil Cap

The landfill cap is intact, and there does not appear to be any threat of potential breaching It is recommended that closure documentation be submitted to ADEC, and an asbestos sign be posted

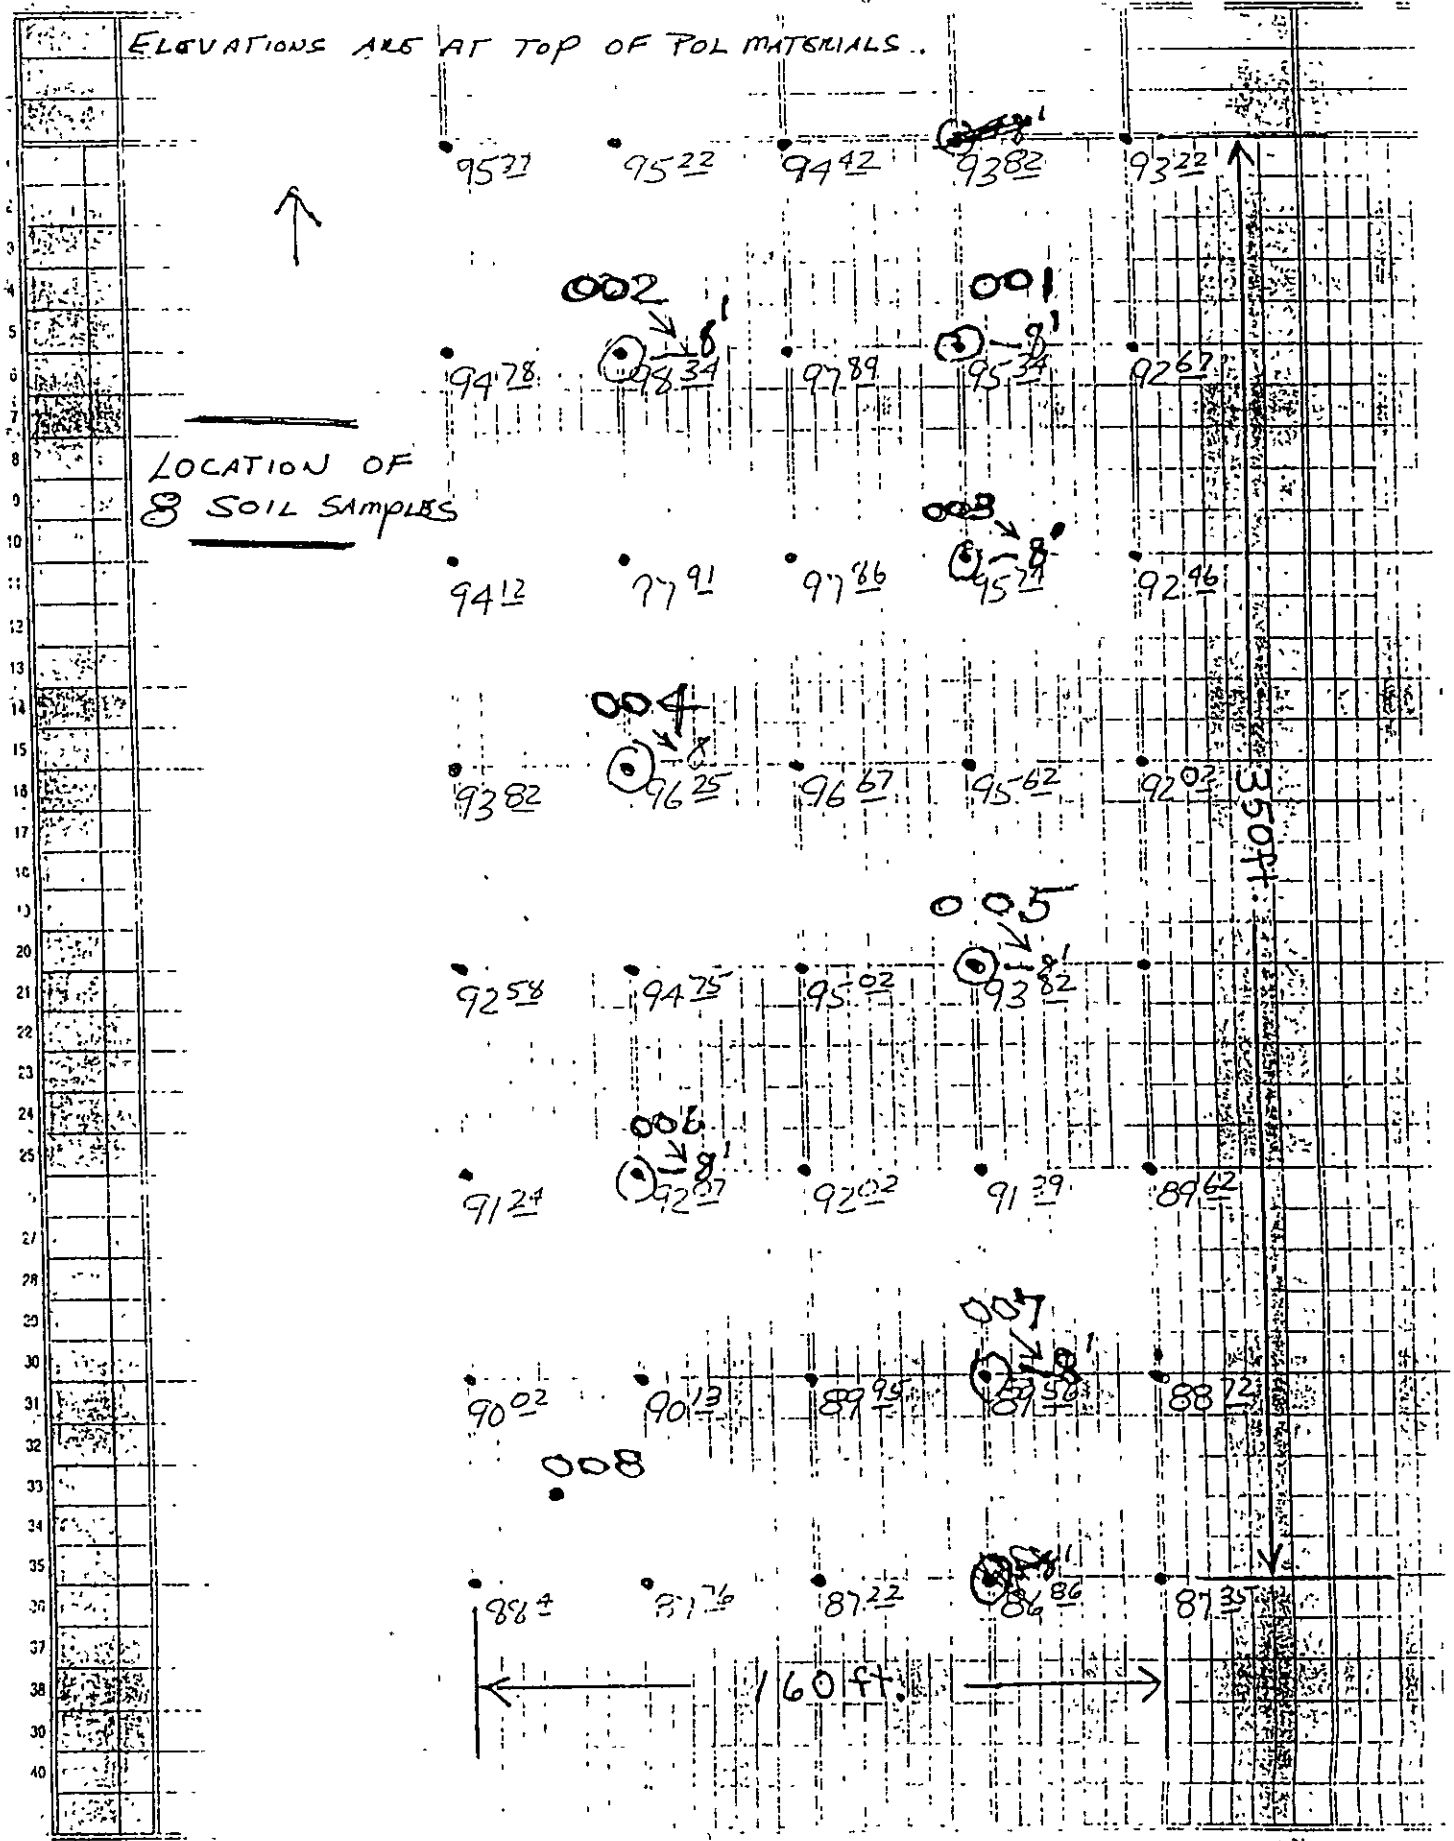
"LANDFILL "A" - ASBUILT OF PIT COVER

Landfill A was filled with non-toxic demolition debris from the RRS, POL tanks, FAA site, and the Fort Morrow area ADEC issued solid waste disposal permit 8721-BA012 for Landfill A (Figure 1) Landfill A is approximately 300 feet east of the RRS composite building (Photograph 2, Appendix C) Asbestos from the RRS and Fort Morrow buildings were placed into an asbestos cell within Landfill A POL-impacted soil with less than 5,000 mg/kg TPH, and with PCB concentrations less than 10 mg/kg was placed in 6-inch lifts within the landfill cap Appendix D shows very rough as-builts of Landfill A The landfill was seeded after the cap was in place

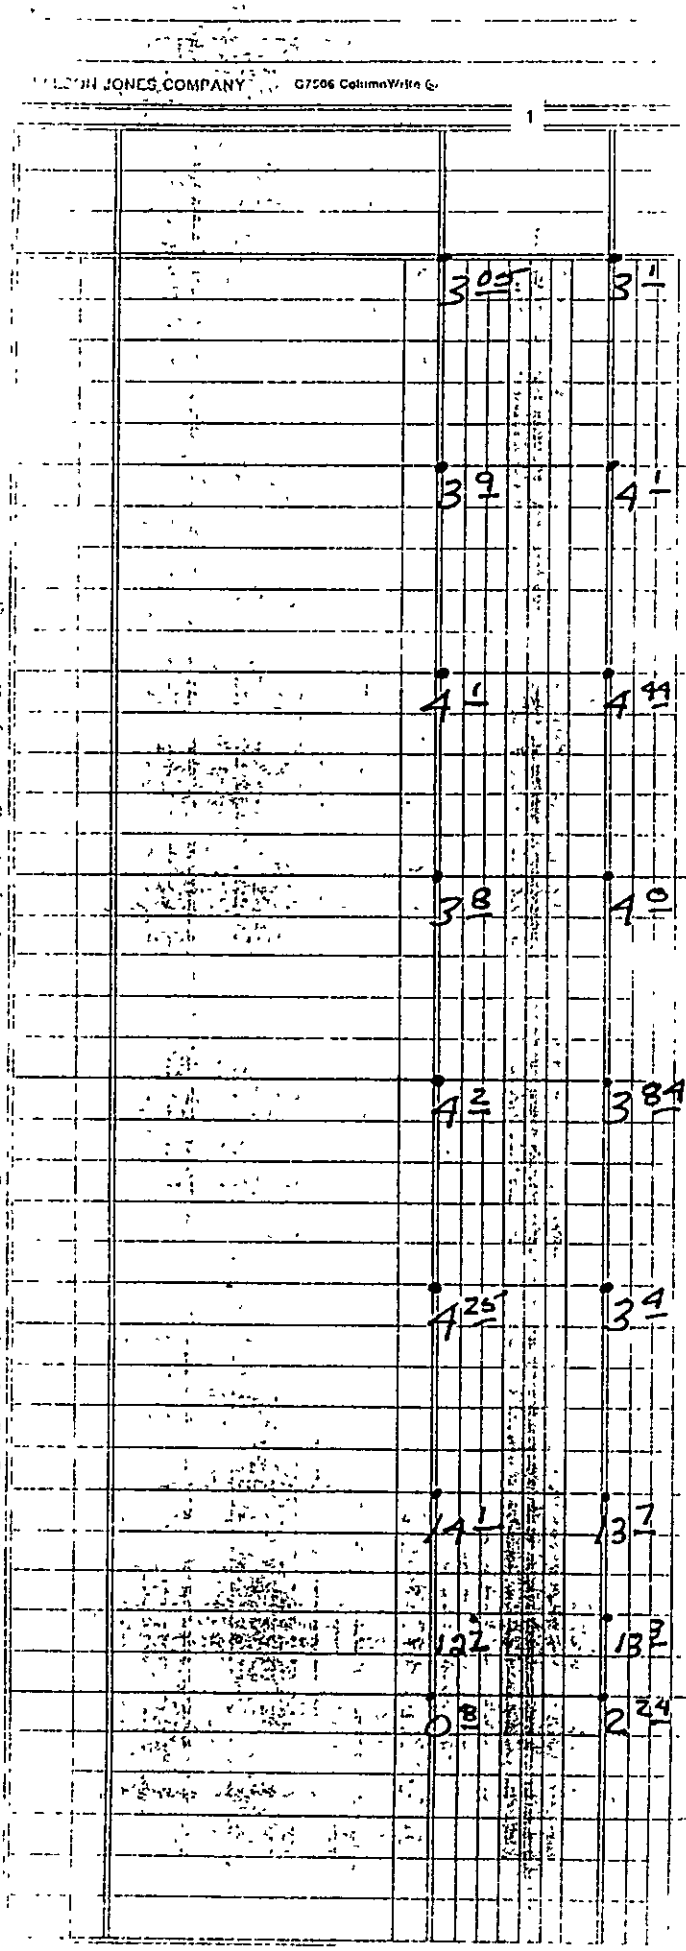
LANDFILL, "B" DIMENSIONS

Landfill B was filled with non-toxic demolition debris from the RRS, POL tanks, FAA site, and the Fort Morrow area ADEC issued solid waste disposal permit 87211-BA013 for Landfill B (Figure 1) Landfill B is approximately ½ mile south of the west end of the runway (Photograph 3, Appendix C) POL-impacted soil with less than 5,000 mg/kg TPH, and with PCB concentrations less than 10 mg/kg were placed in 6-inch lifts within the landfill cap Appendix D shows very rough as-builts of Landfill B The landfill was seeded after the cap was in place
