Final 2017
Sampling Report
Two-Party Site

Former Building 3564
HQAES No. 02871.1076
ADEC Hazard ID. 25015, File No. 108.26.028
Fort Wainwright, Alaska

FINAL 2017 SAMPLING REPORT

FORT WAINWRIGHT
GROUNDWATER SAMPLING PROGRAM

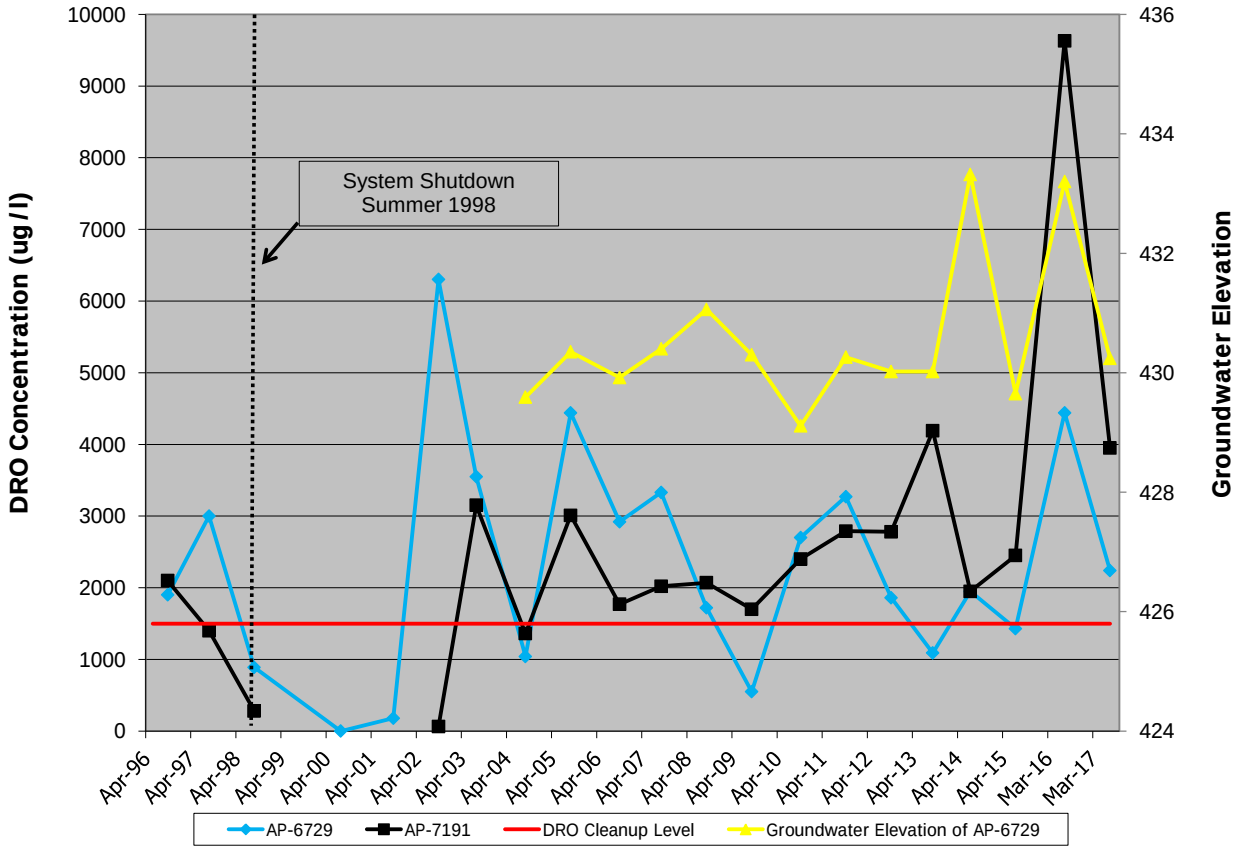
Figure 3-3. DRO Concentrations in Downgradient Wells AP-6729 and AP-7191

- DRO in downgradient well AP-7191 had remained at typical concentrations historically observed in this well throughout 2014; however, DRO in this well increased during the 2015 sampling event to 9,630 µg/L, which is the highest concentration seen since sampling began in this well in 1996. The DRO concentration in 2017 is 4,850 µg/L and is similar to the 2016 concentration of 3,950 µg/L, and is comparable to previous years DRO results.

Two additional downgradient wells, AP-6729 and AP-7191, have exhibited DRO at concentrations that exceed the cleanup level. DRO concentrations in AP-6729 increased during 2015 and then decreased in 2016 and rose slightly in 2017. However, overall data from this well has been variable and the 2017 trend analysis using MAROS software indicated "Stable" in this well. DRO in AP-7191 had been relatively stable for many years; however, a recent increase in the DRO concentration has been observed and the trend analysis indicated an "Increasing" trend in this well. The DRO concentration detected in 2015 was the highest concentration detected since sampling this well began in 1996. DRO slightly increased in 2017 to a concentration comparable to previous years.

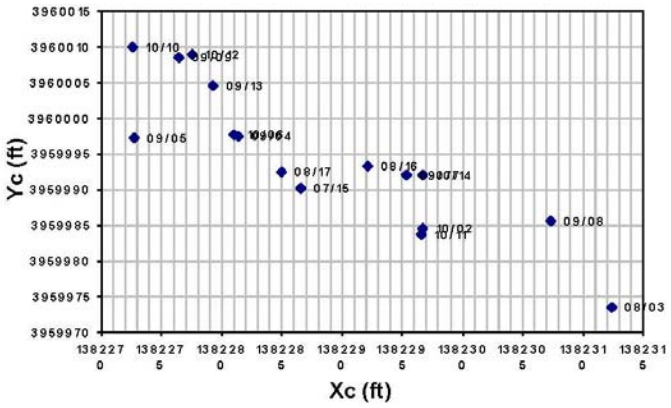
Change in Location of Center of Mass Over Time

Effective Date	Constituent	Xc (ft)	Yc (ft)	Distance from Source (ft)	Number of Wells
10/1/2002	PHC as DIESEL FUEL	1,382,297	3,959,985	84	6
8/1/2003	PHC as DIESEL FUEL	1,382,312	3,959,974	67	6
9/1/2004	PHC as DIESEL FUEL	1,382,281	3,959,997	102	7
9/1/2005	PHC as DIESEL FUEL	1,382,273	3,959,997	107	6
10/1/2006	PHC as DIESEL FUEL	1,382,281	3,959,998	102	7
9/1/2007	PHC as DIESEL FUEL	1,382,295	3,959,992	91	7
9/1/2008	PHC as DIESEL FUEL	1,382,307	3,959,986	80	7
9/1/2009	PHC as DIESEL FUEL	1,382,276	3,960,009	114	7
10/1/2010	PHC as DIESEL FUEL	1,382,273	3,960,010	117	7
10/1/2011	PHC as DIESEL FUEL	1,382,297	3,959,984	83	7
10/1/2012	PHC as DIESEL FUEL	1,382,278	3,960,009	114	7
9/25/2013	PHC as DIESEL FUEL	1,382,279	3,960,004	109	7
7/7/2014	PHC as DIESEL FUEL	1,382,297	3,959,992	90	7
7/21/2015	PHC as DIESEL FUEL	1,382,287	3,959,990	93	7
8/19/2016	PHC as DIESEL FUEL	1,382,292	3,959,993	93	7
8/3/2017	PHC as DIESEL FUEL	1,382,285	3,959,993	96	7
