NOTICE OF INTENT

to be covered under
APDES GENERAL PERMIT AK-G52-0000
for
SEAFOOD PROCESSORS IN ALASKA
(See Part IV.C. of the Permit, reissued 2001)

NORTON SOUND SEAFOODS
NORTON SOUND, ALASKA

DIVE SURVEY REPORT

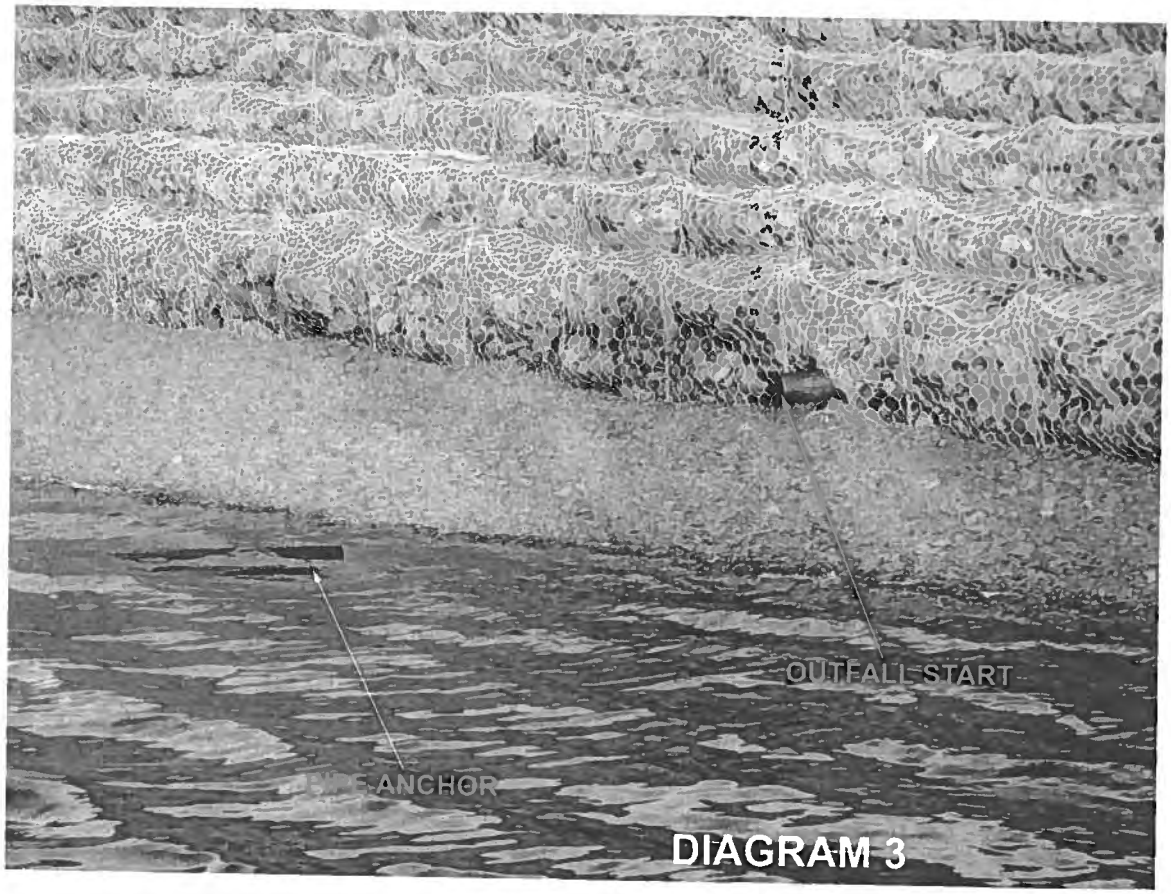
DIAGRAM 3

The outfall line from the NSEDC Unalakleet plant extends from the base of the gabion basket wall to the east of the processing plant (Diagram 3, p.xx xx). The pipe is removed every fall to prevent damage due to ice in the river. The 40 ' outfall is soft coupled to this pipe and extended in a due East direction.
