SITE CHARACTERIZATION AND CORRECTIVE ACTION REPORT

**NAPA FACILITY
1937 VAN HORN ROAD
FAIRBANKS, ALASKA**

JANUARY 22, 2013

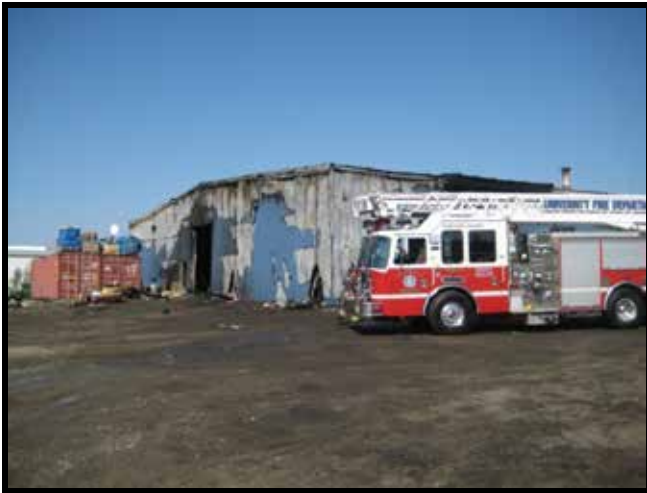
Photo 1: 5/27/2011 - South side of NAPA facility during initial visit.

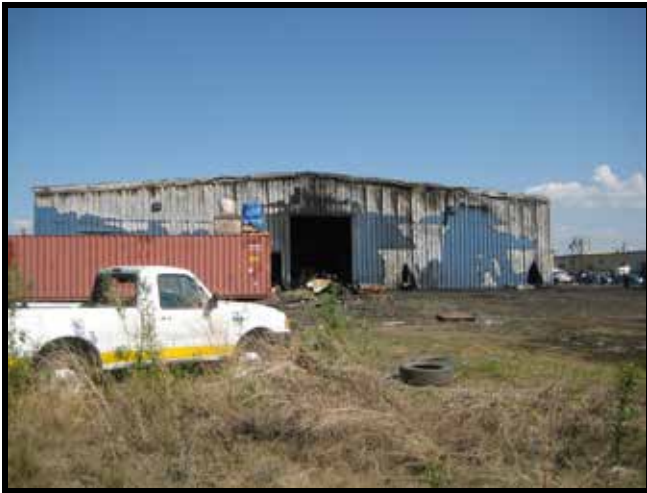
Photo 7: 5/27/2011 – Impacted ground from firefighting water release on the south side of the property.

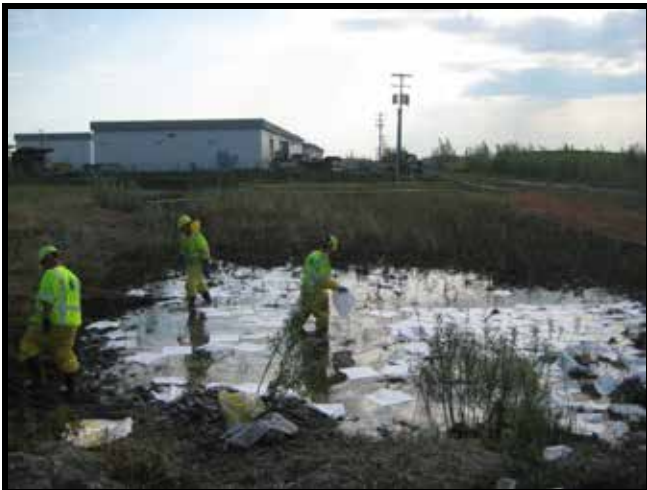
Photo 11: 5/29/2011 – Southeast perimeter Ditch surface contaminant absorption.

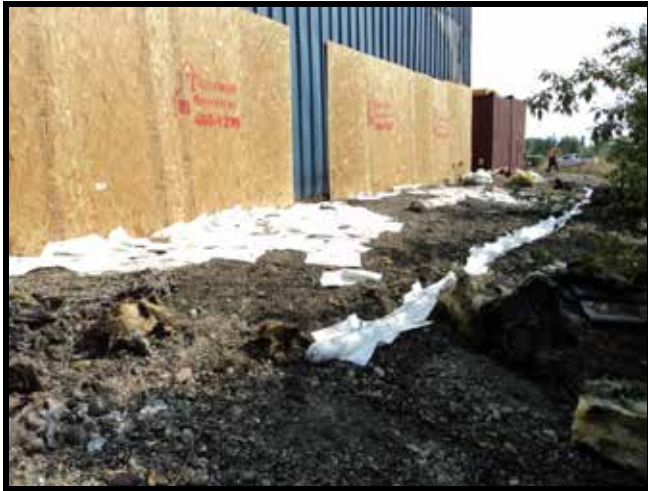
Photo 13: 5/29/2011 – West building perimeter sludge and surface migration control.

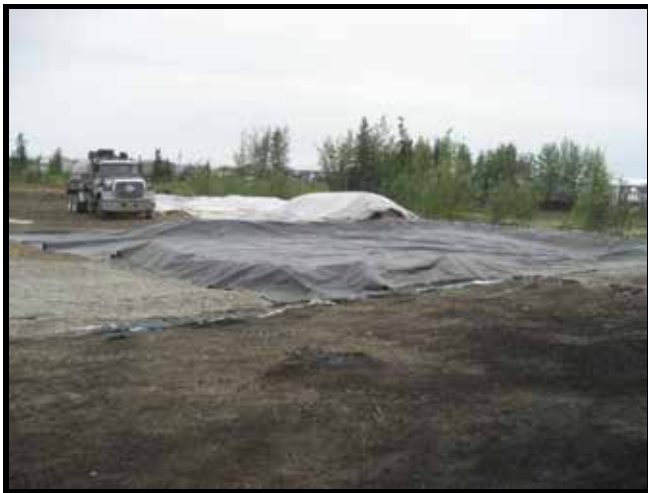
Photo 15: 6/2/2011 – Southern soil stockpile construction.

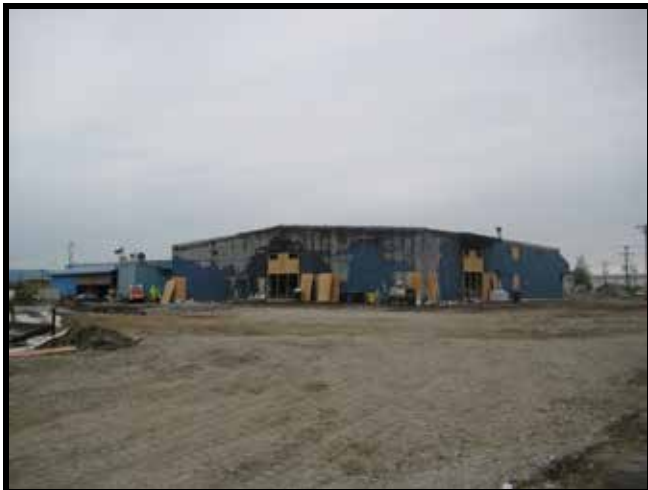
Photo 17: 6/2/2011 – South driveway and southern waste storage areas after initial surface scraping.

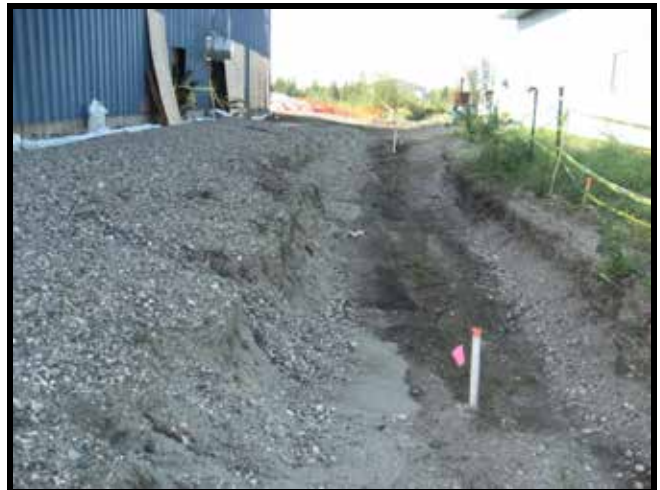
Photo 18: 7/6/2011 – West Ditch after initial excavation and installation of monitoring wells (MW2 in foreground).

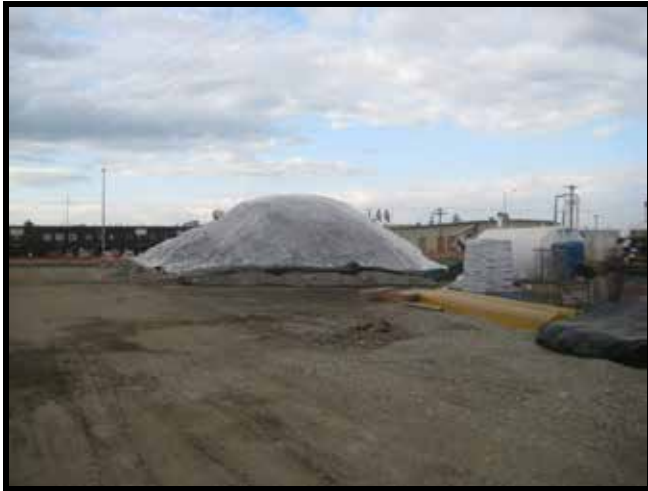
Photo 19: 6/3/2011 - Eastern stockpile excavated from perimeter ditches.

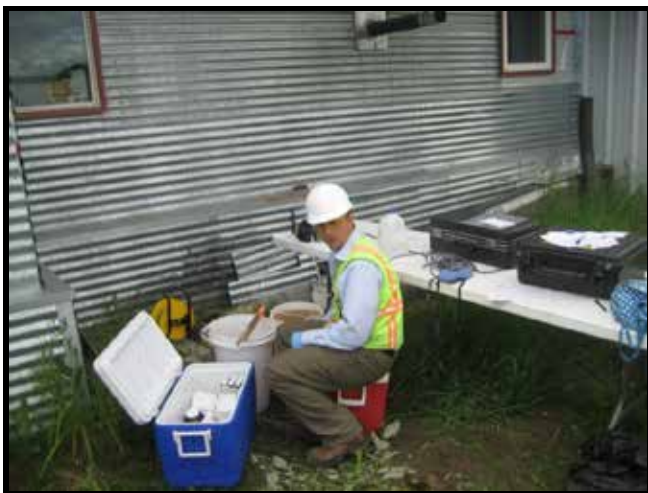
Photo 21: 6/20/2011 - Interim groundwater collection efforts two lots away.

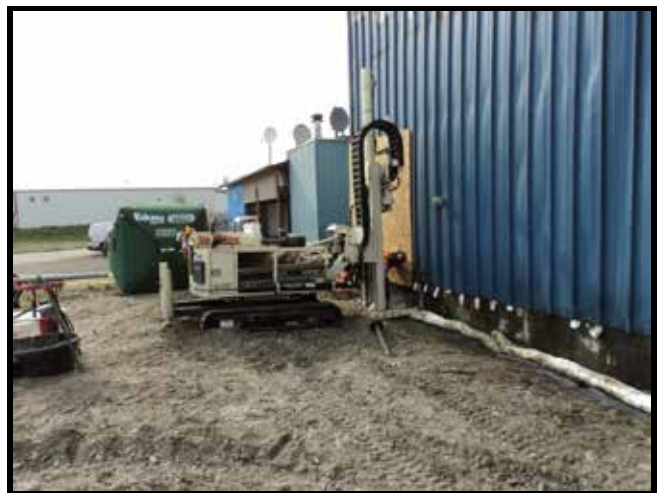
Photo 22: 6/9/2011 – Initial building perimeter soil boring.

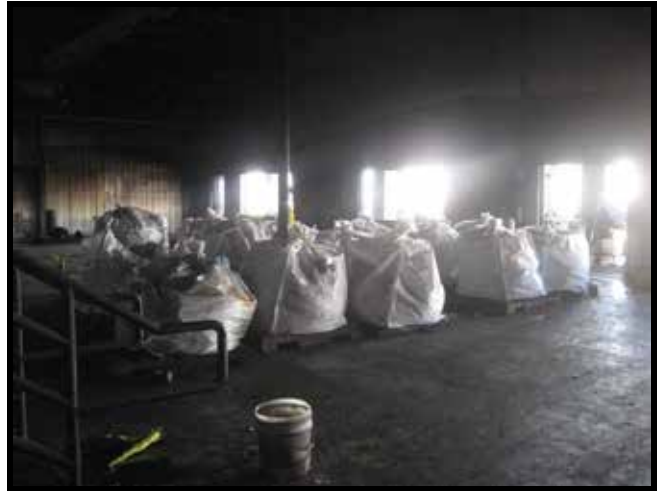
Photo 26: 7/9/2011 - Interior supersack storage area with interior building waster.

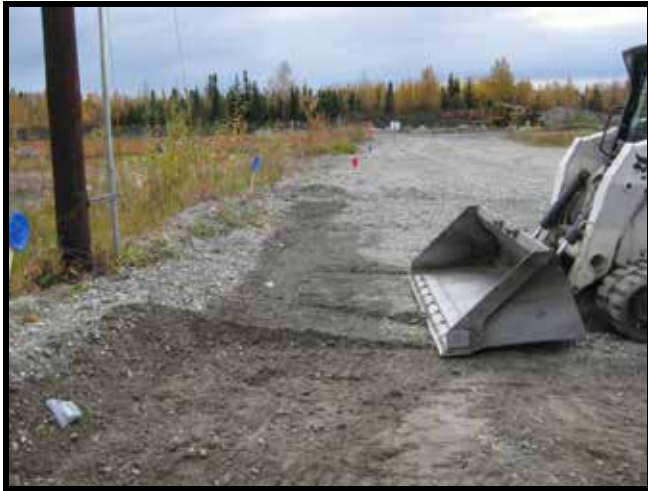
Photo 31: 9/22/2011 – Typical surface stain corrective action.

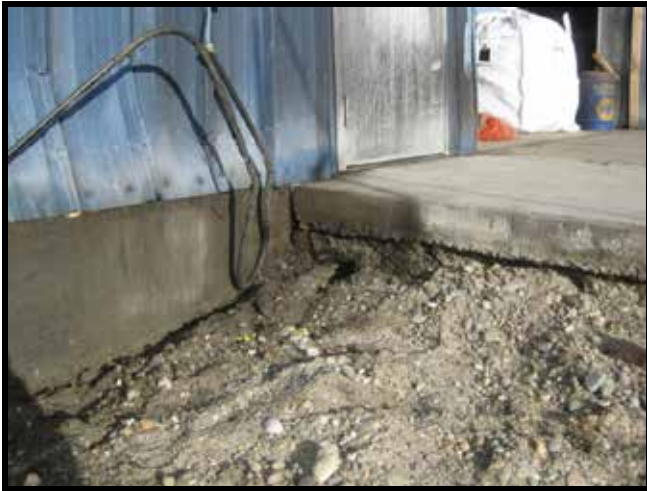
Photo 37: 10/6/2011 – Surface impacts from oily sludge at southern overhead door.

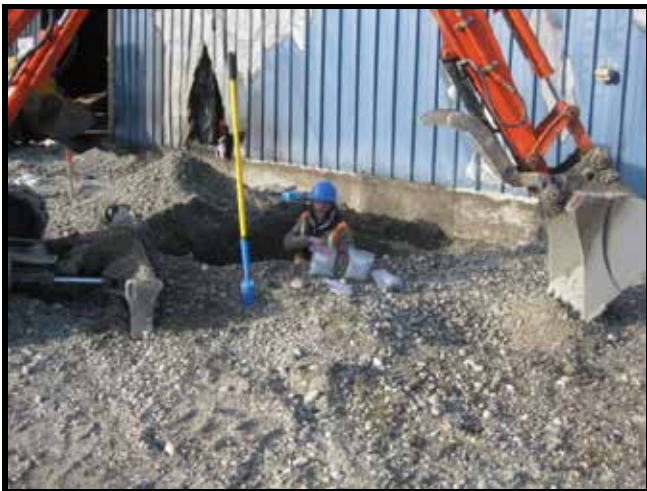
Photo 39: 10/12/2011 – Typical excavation for building perimeter profile characterization.

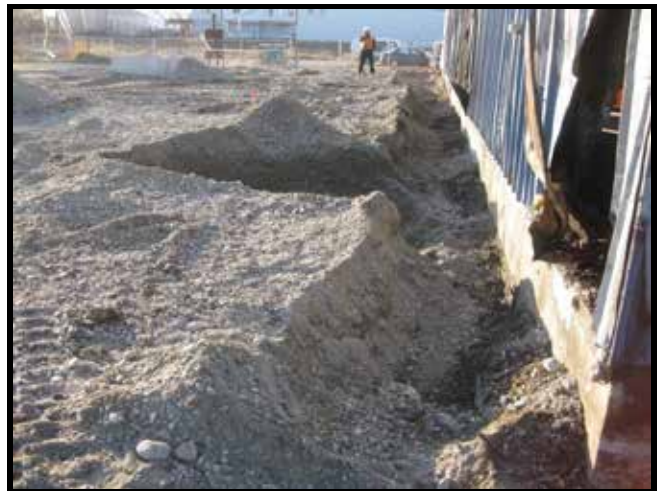
Photo 40: 10/12/2011 - Build perimeter corrective action on south side of building.

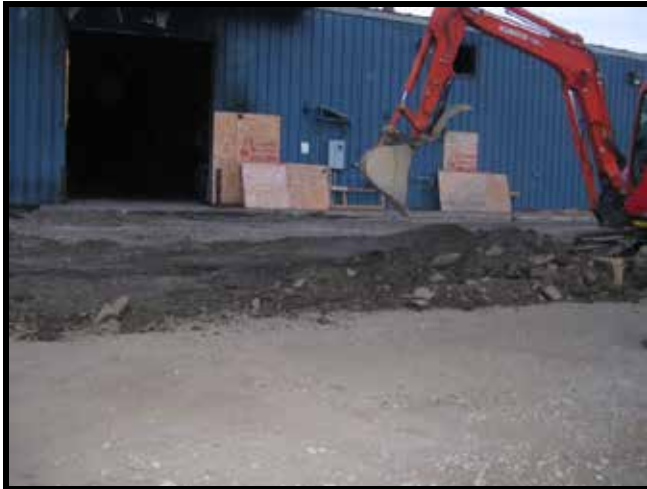
Photo 43: 10/4/2011 – Removal of East Driveway RAP.

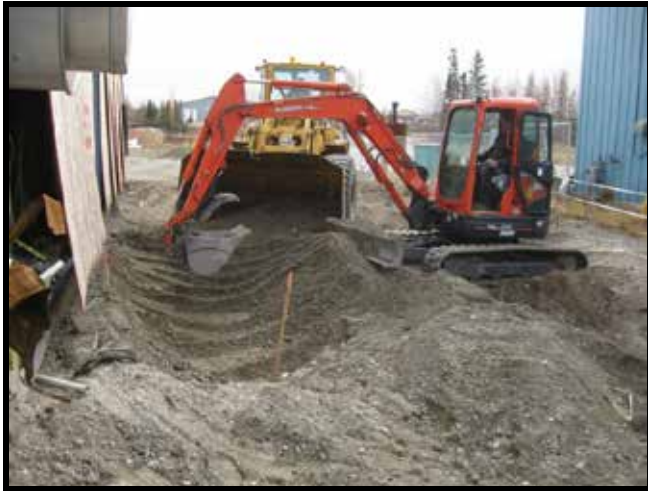
Photo 49: 10/11/2011 – Corrective action at 1:1 slope toward the West Ditch.

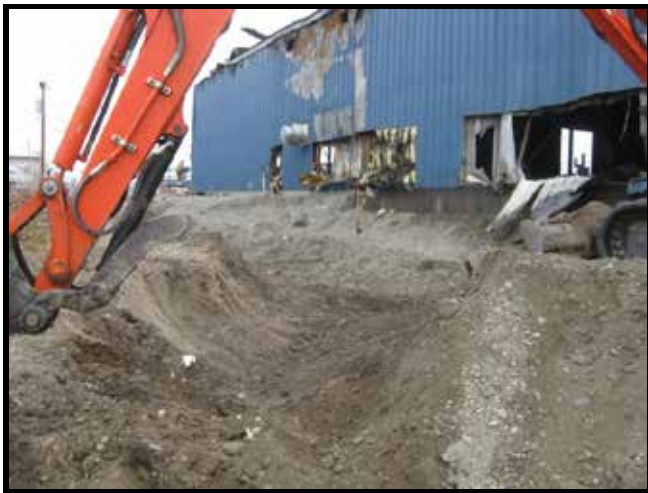
Photo 51: 10/13/2011 – Corrective action near the south end of the West Ditch.

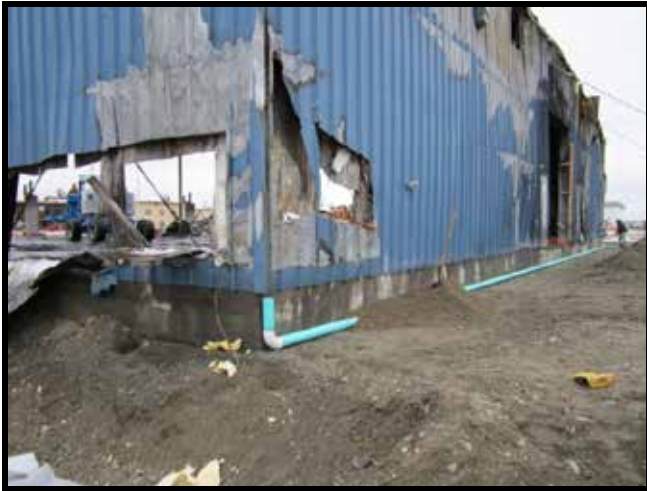
Photo 55: 10/17/2011 – Vapor extraction and bedding gravel across the south end of the building.

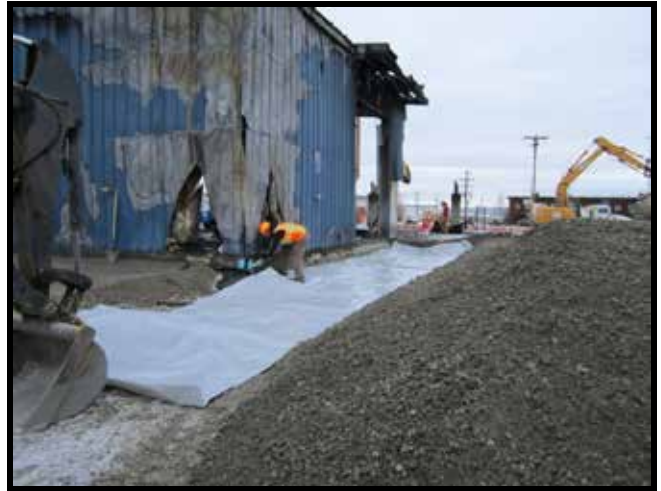
Photo 56: 10/18/2011 - Typical vapor barrier installation above piping on the eastern side of the building.

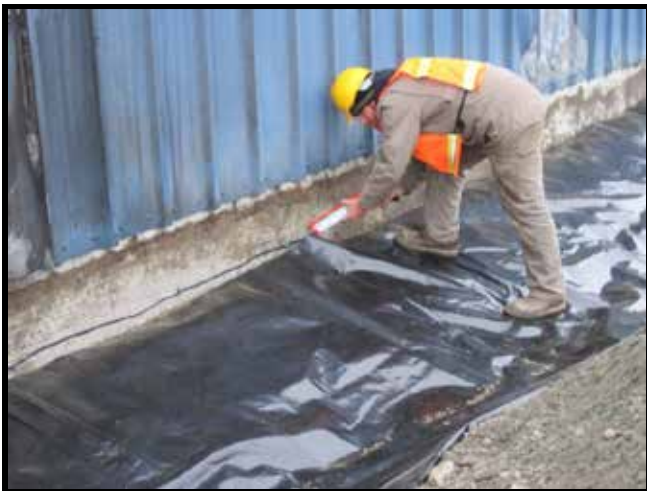
Photo 57: 10/17/2011 – Typical sealing of vapor barrier onto concrete pad.

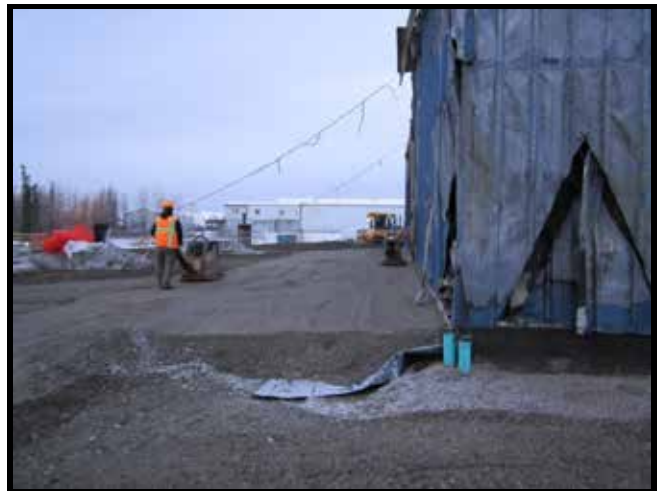
Photo 58: 10/18/2011 – Backfill and 95% compaction above the vapor barrier on the south side of the building.
