Building Condition Assessment/Materials Investigation

Torpedo Bombsight and Utility Shop, Unalaska Airport, Dutch Harbor, Alaska

**Alaska Department of Transportation
& Public Facilities
Anchorage, Alaska**

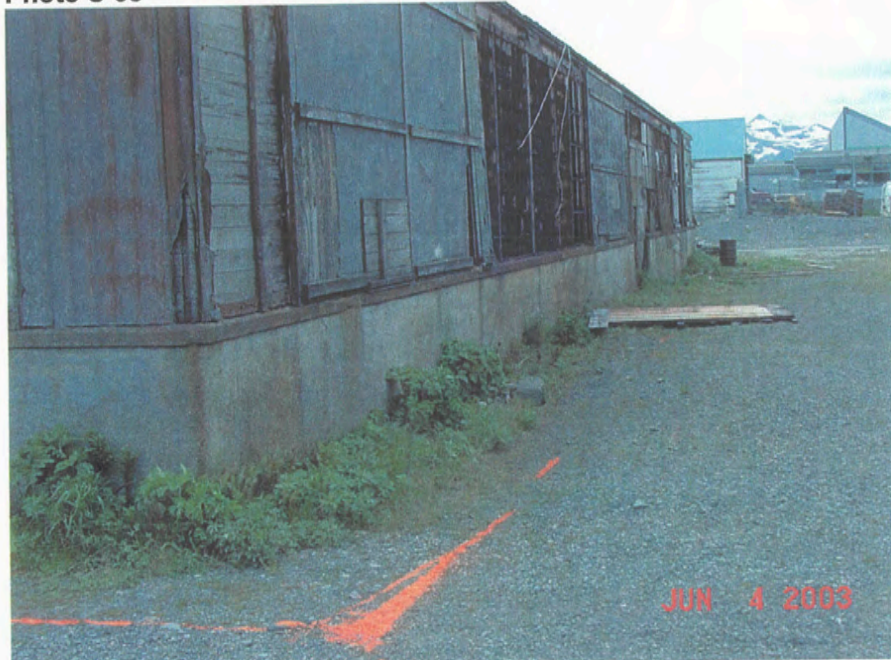
Photo S-03

Grid D – typical exterior concrete wall, June 2003

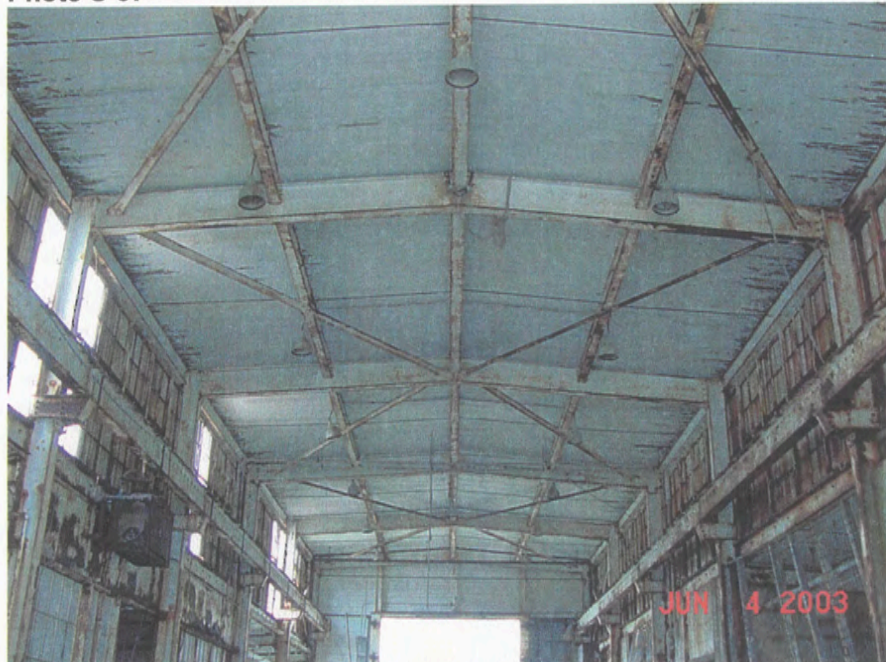
Photo S-07

Grid 1-7/B-C – interior elevation high central roof, horizontal roof bracing looking west, June 2003

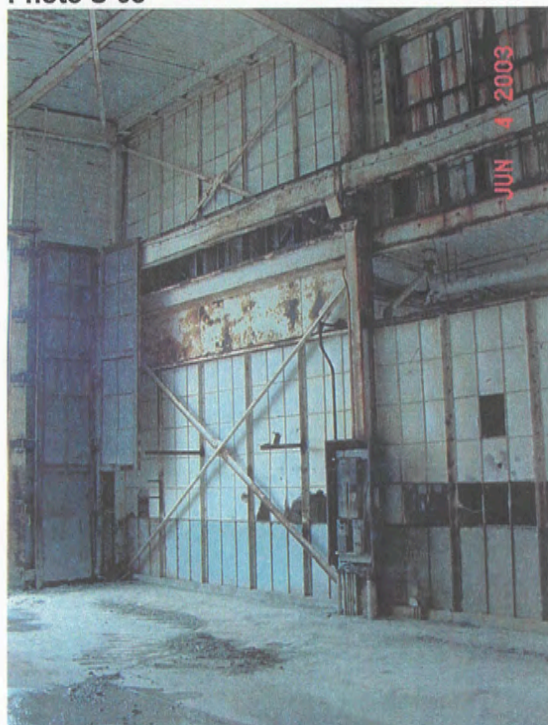
Photo S-08

Grid 6-7/B – interior elevation, vertical cross bracing high central roof to SOG , June 2003

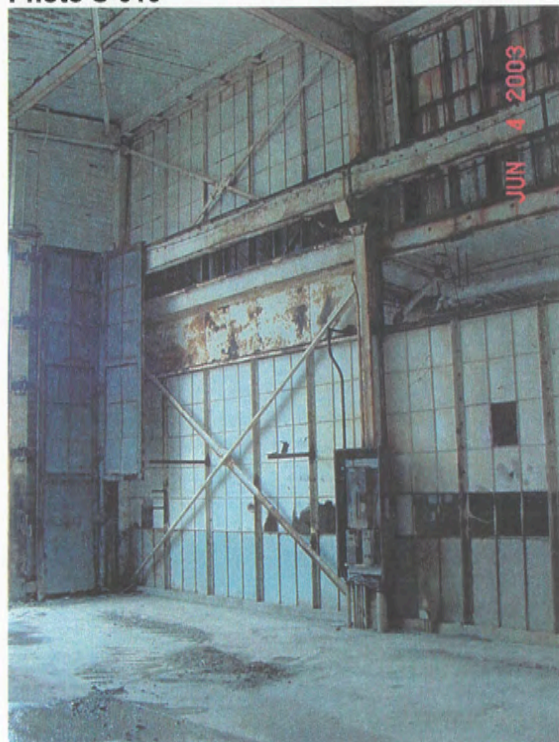
Photo S-010

Grid 1-2/C – interior elevation, cross bracing high central roof to low side shed roof, June 2003

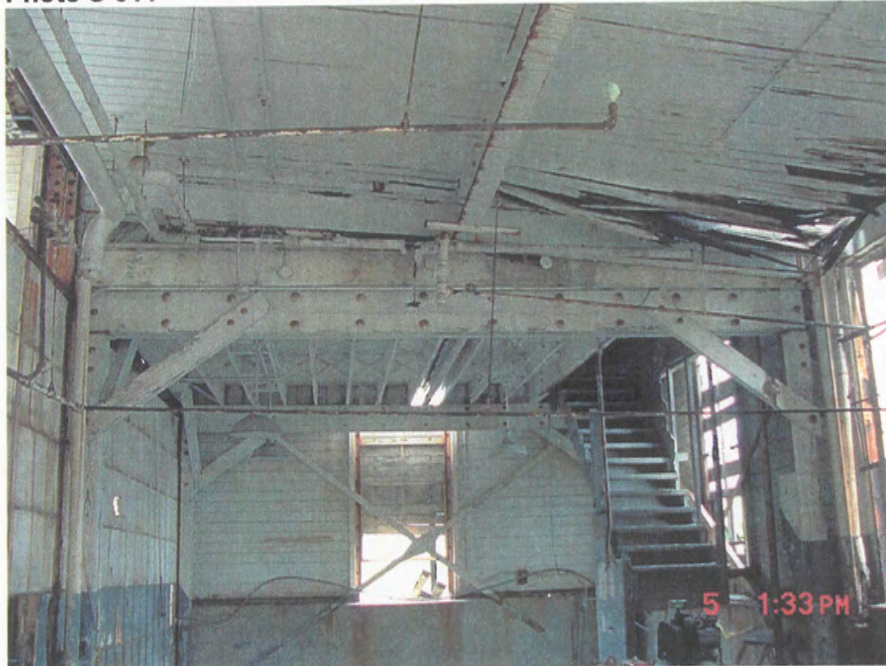
Photo S-011

Grid 7/A-B – interior elevation, vertical cross bracing parachute loft below intermediate floor, June 2003

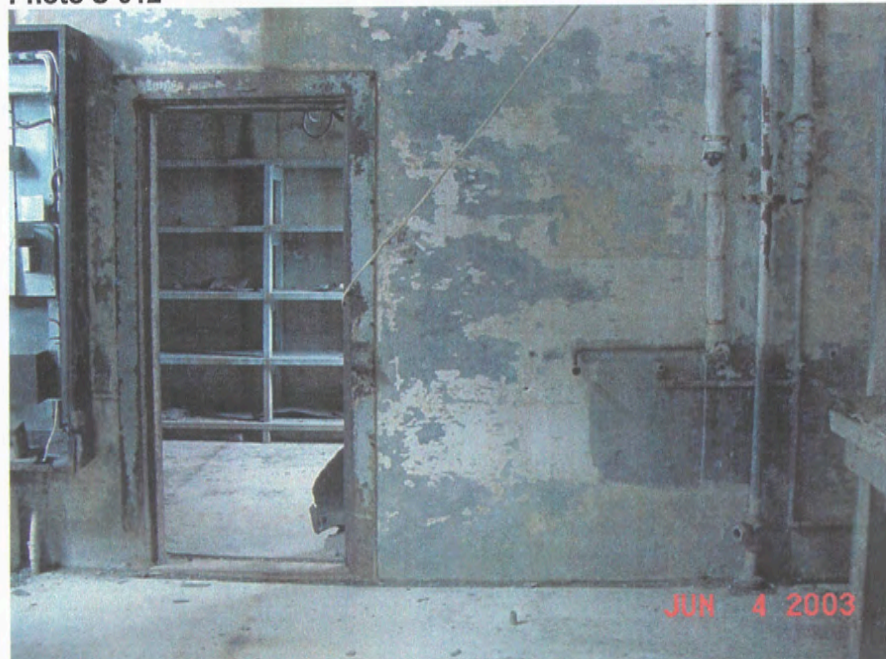
Photo S-012

Grid 6/C – interior elevation, south side of concrete shear wall, June 2003

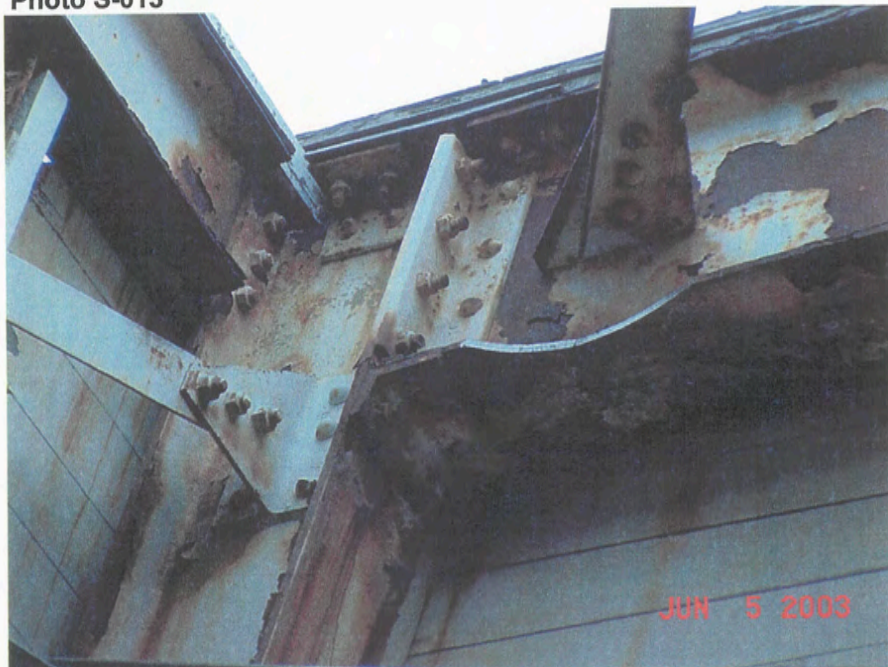
Photo S-013

Grid 7/C – Northeast corner of central H roof, June 2003

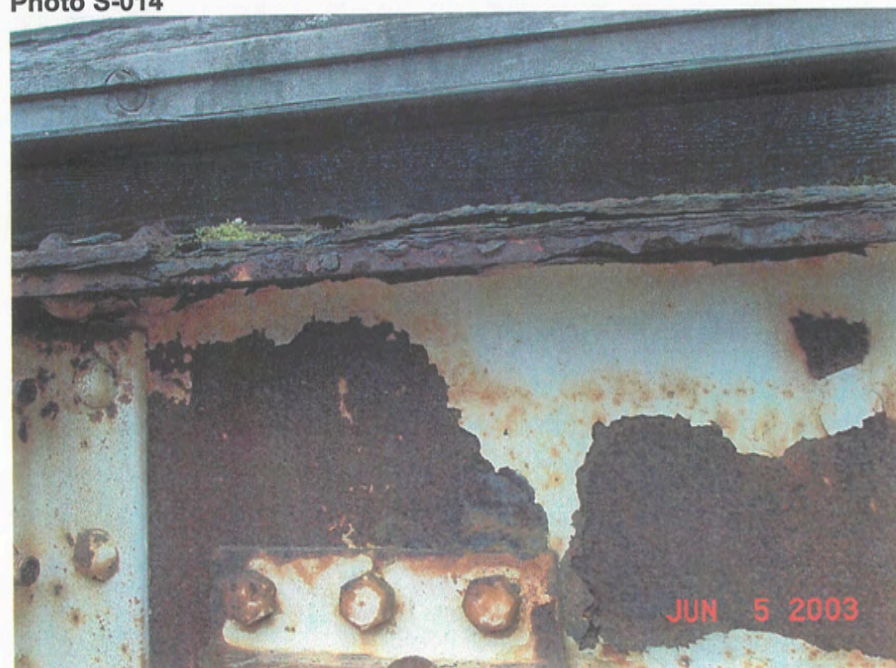
Photo S-014

Grid 7/C – top of east girder, misc. steel between girder and roof deck, June 2003

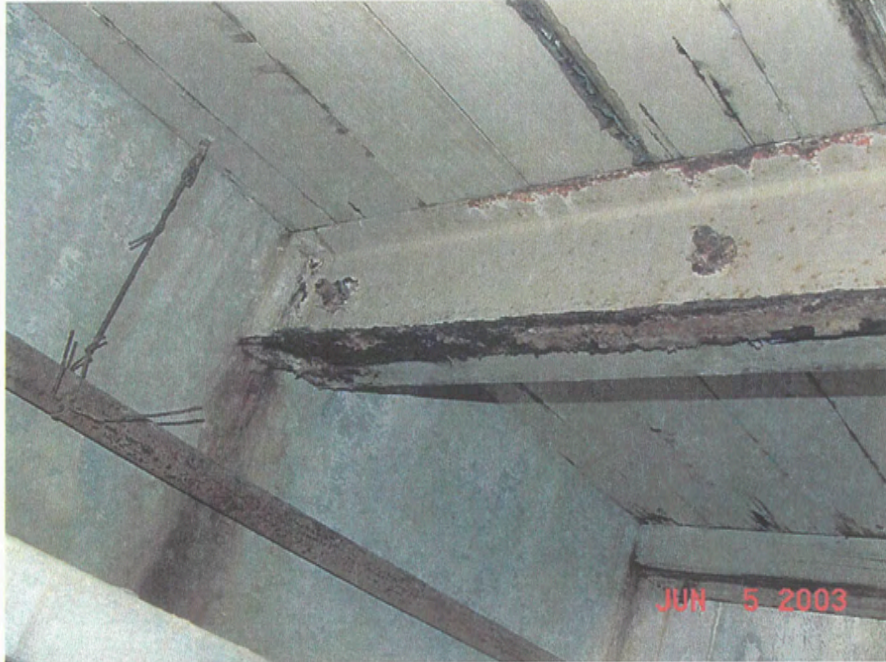
Photo S-015

Grid 5.75/C.25 – Mechanical floor, wood beam bolted to steel channel, June 2003

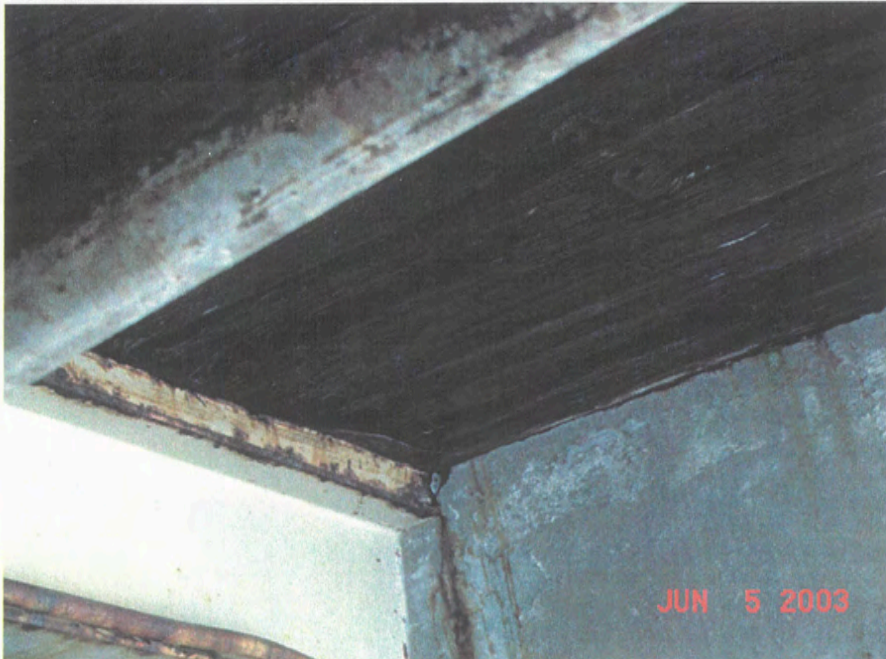
Photo S-016

Grid 5.5/C.5 – W-beam through concrete wall, June 2003

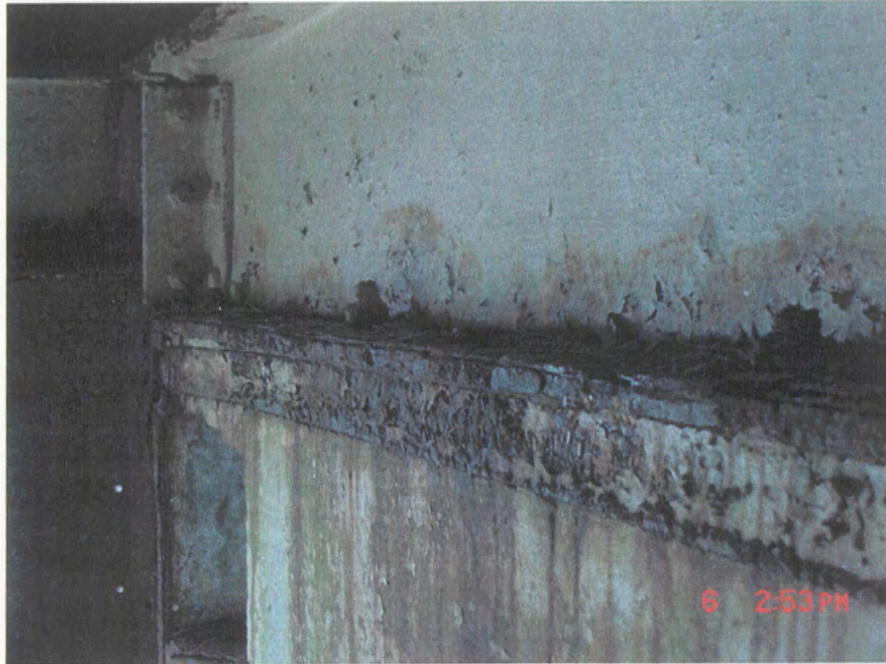
Photo S-017

Grid 6/D – Channel over top of interior concrete wall, typical W girder above, June 2003

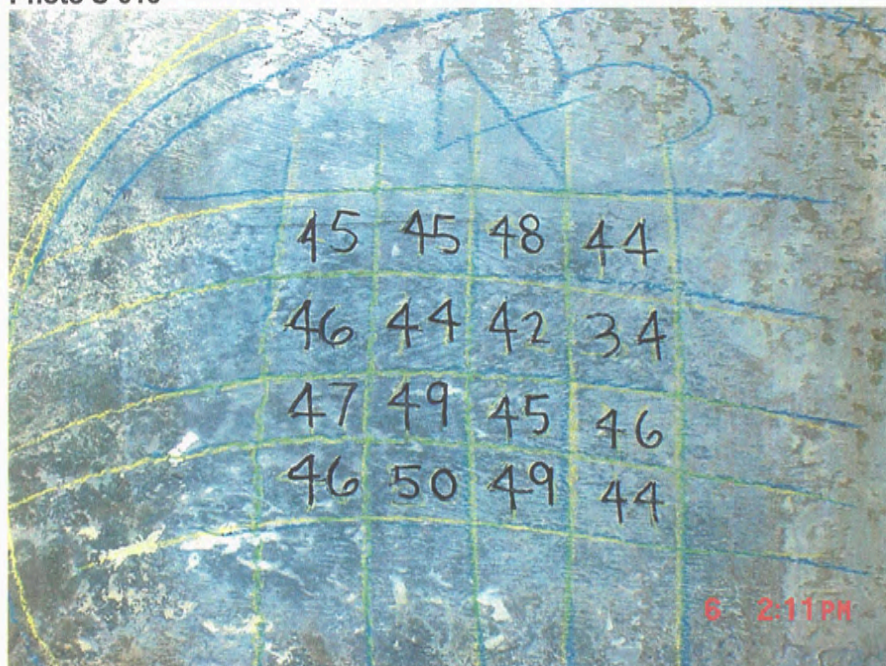
Photo S-019

Grid 5/D – concrete wall west face; reinforcing size and spa, June 2003

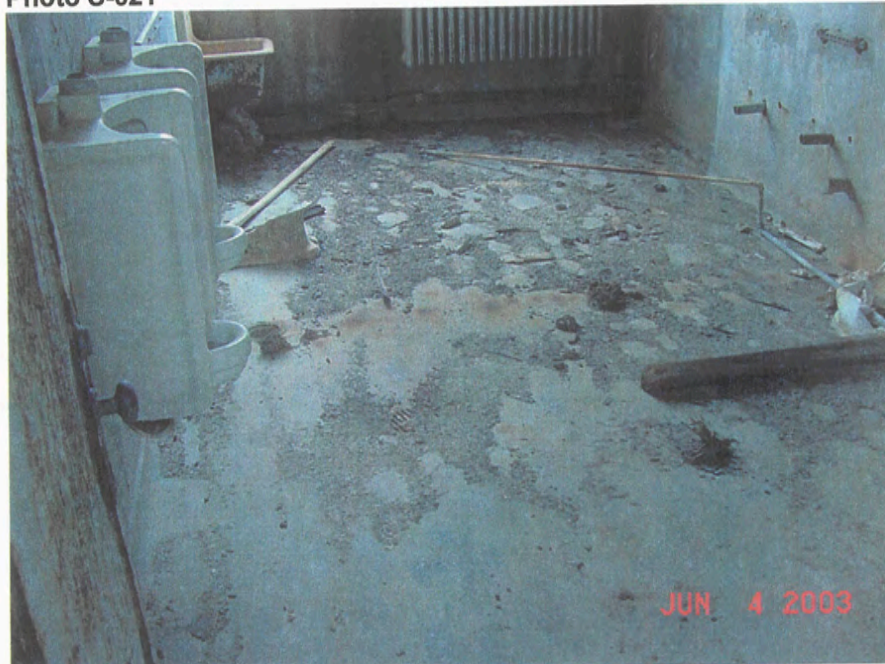
Photo S-021

Grid 2/C-D – slab on grade, toilet room, June 2003

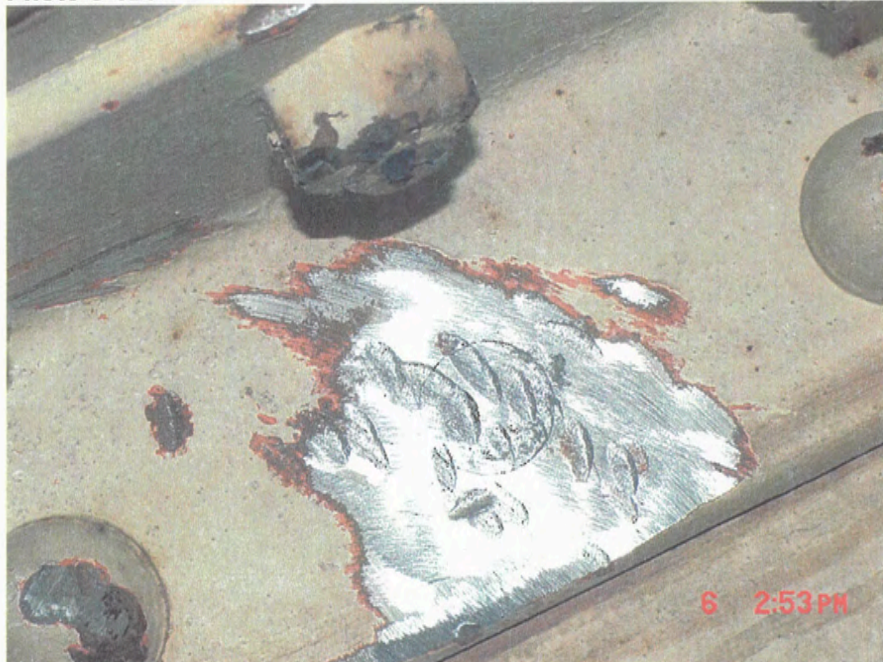
Photo S-025

Grid 6/C.6 – Head of rivet ground off to face of W beam web, June 2003

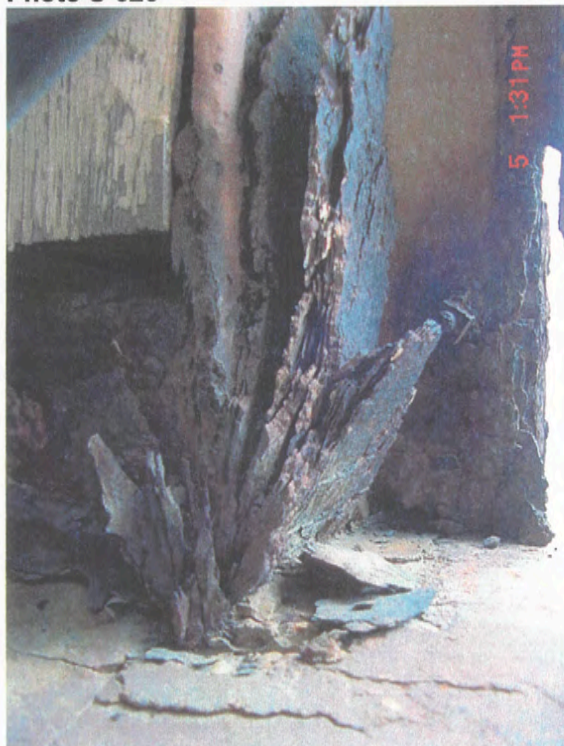
Photo S-026

Steel angles framing around windows, doors, and walls, including the jambs, sills and heads, are generally corroded beyond repair and require replacement.

Grid 7/A.5 – Steel angle, jamb north side of parachute loft, east windows, June 2003

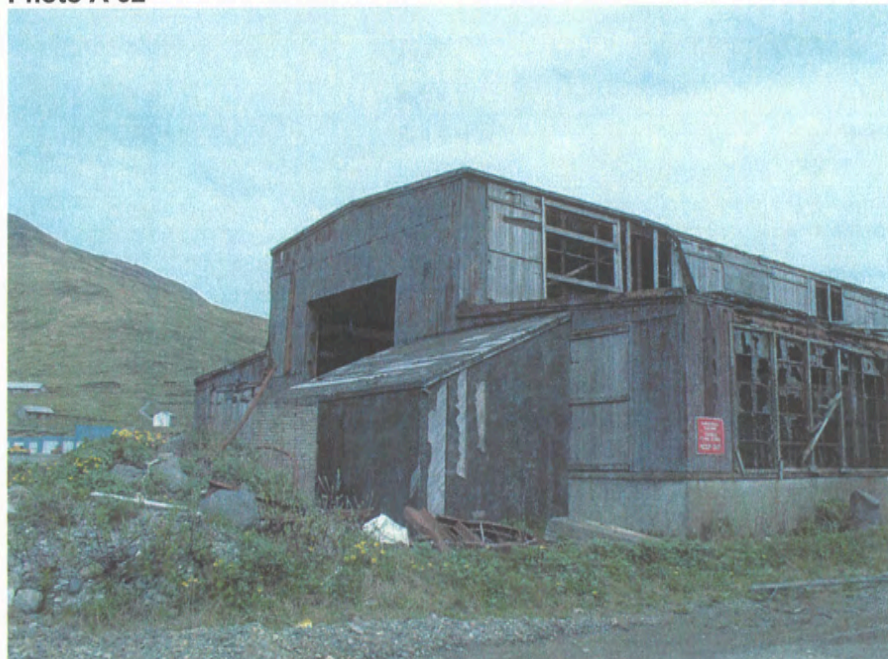
Photo A-02

Wood-frame addition to south elevation, June 2003

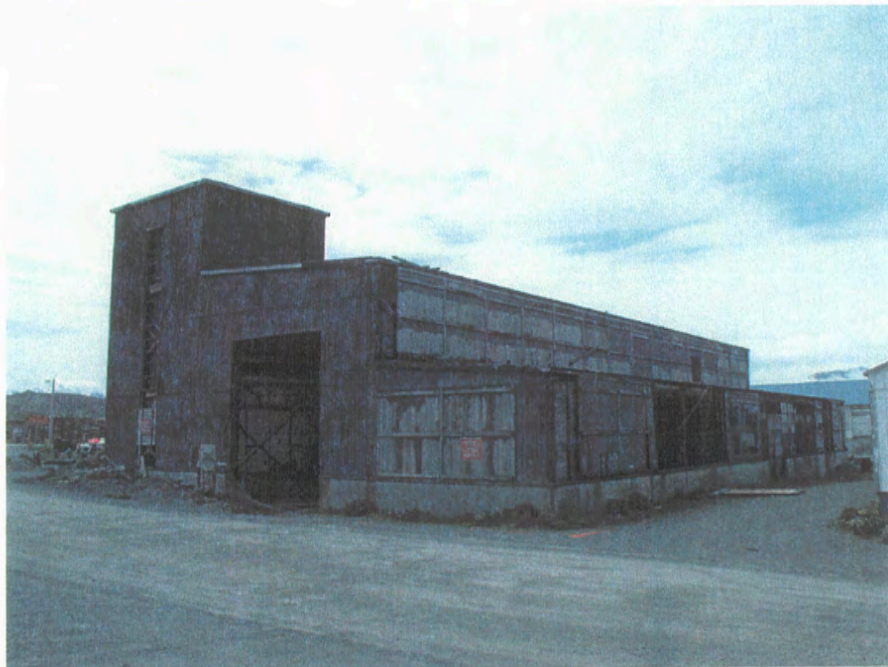
Photo A-03

Northeastern corner of building, June 2003

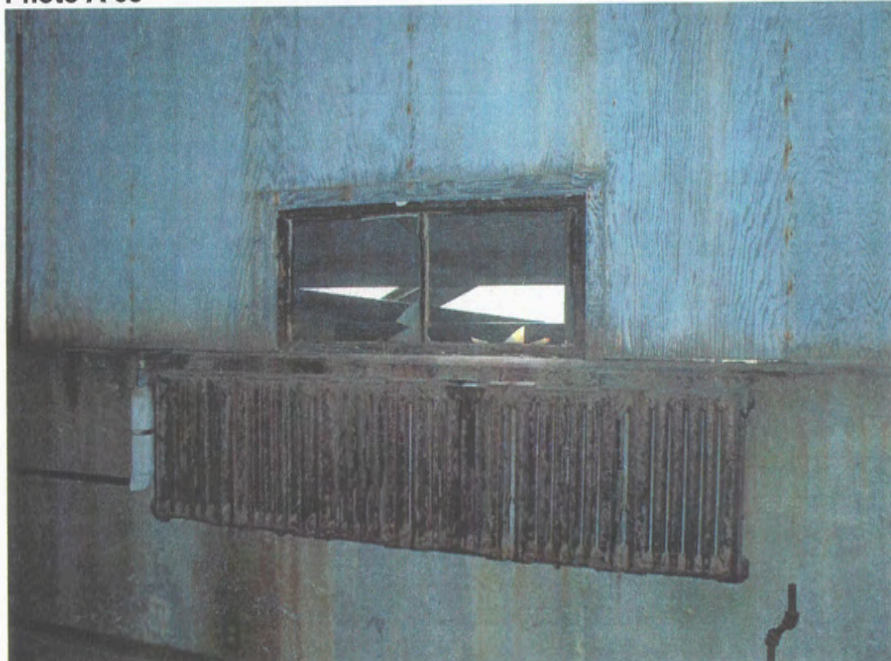
Photo A-08

North elevation of Room 100-Office, June 2003

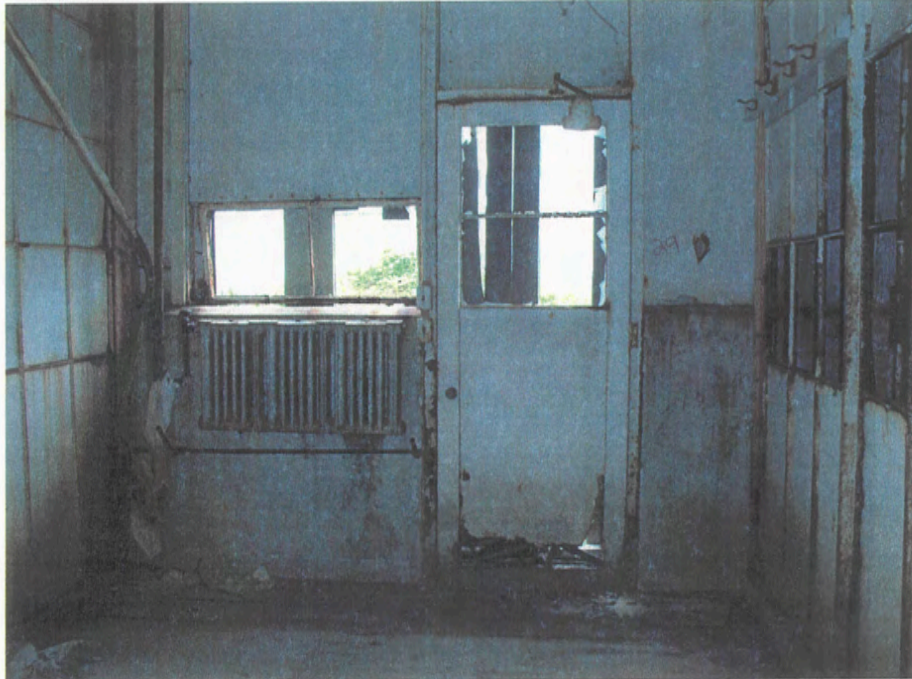
Photo A-09

West elevation of Room 101-Office, June 2003

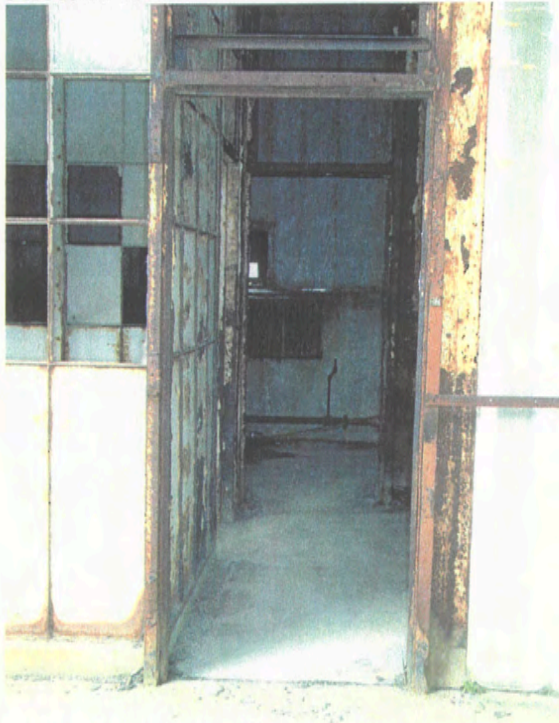
Photo A-10

North elevation of Room 102-Passage, June 2003

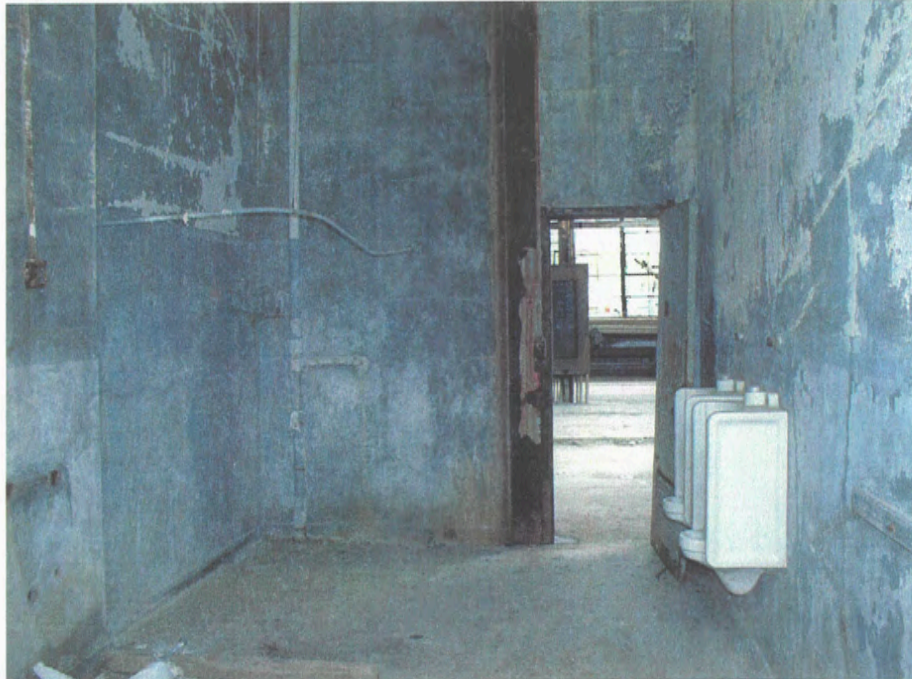
Photo A-11

South elevation of Room 103-Toilet, June 2003

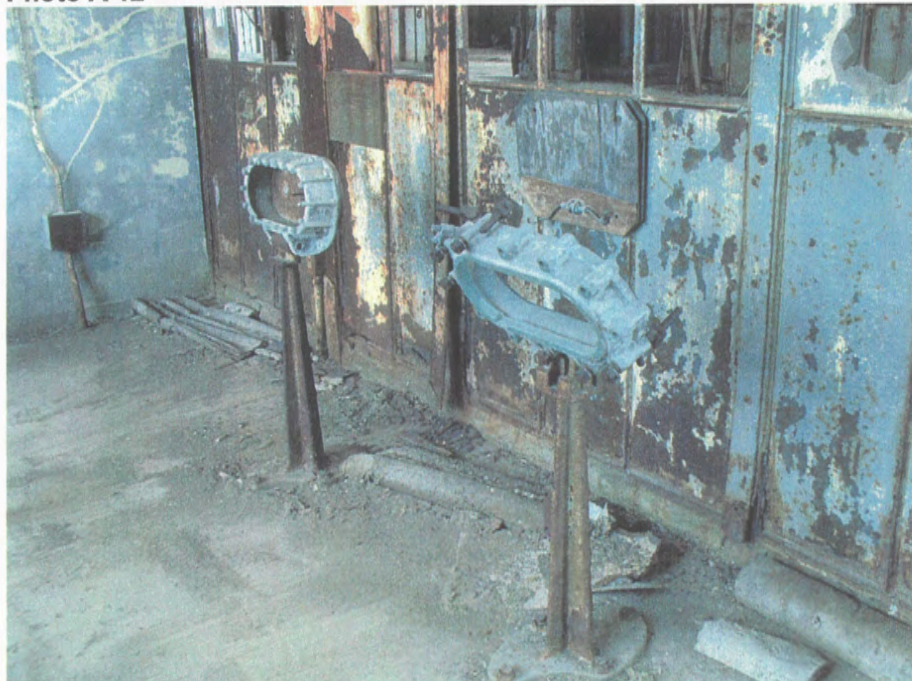
Photo A-12

Southwest corner of Room 104-Tool & Storage, June 2003

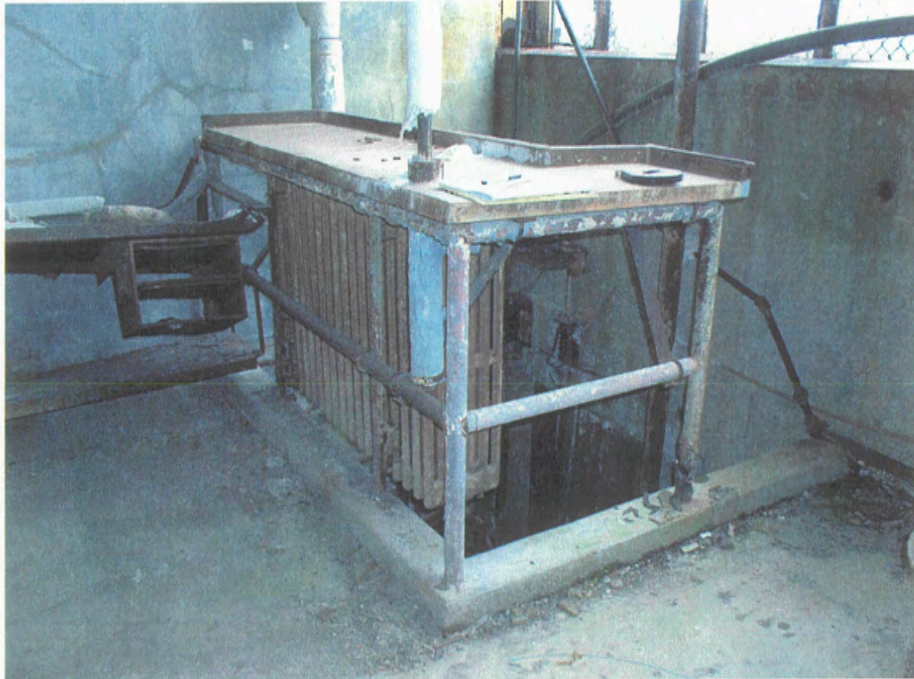
Photo A-13

Boiler Pit, Northwest corner of Room 104-Tool & Storage, June 2003
