Re: OMS 35-1.2 Reconnaissance Report

Reconnaissance of Operations Mining Site (OMS) 35-1.2 was completed on July 7, 2019 by SLR International Corporation (SLR) on behalf of Alyeska Pipeline Service Company (Alyeska). The reconnaissance was requested by the Alaska Department of Environmental Conservation (ADEC) to assess the area for the presence of petroleum stained gravel and to document the condition of the entrance gate. In addition, ADEC requested a review of mining records to evaluate whether mining activity has occurred since 2003. Alyeska retained SLR International Corporation (SLR) to complete this work. Site activities were conducted in accordance with the ADEC-approved work plan dated June 20, 2019 (SLR, 2019).

Report
 OMS 35-1.2 RECONNAISSANCE REPORT

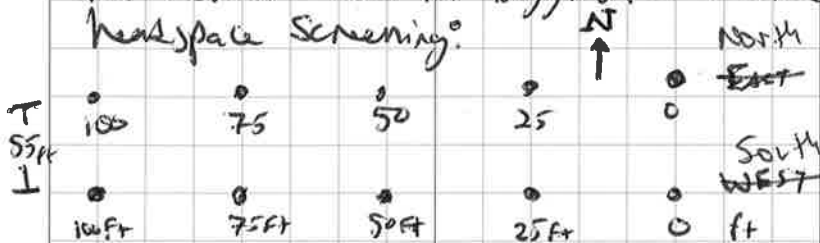
1100-arrive on site, layout four
100ft long transects, ^{one} across eachsuspected area. No obvious staining or signs of
contamination, debris, or excavations.1110-1200 dig 6" deep every 25ft
and collect soil in baggies for heated
headspace screening.

- Soil is very hard, sandy gravel pad. Cannot dig 76".
