TRIP REPORT

FORT MORROW

Site Reconnaissance and Geospatial Data Acquisition Port Heiden, Alaska

**Alaska District
Pacific Ocean Division
U.S. Army Corps of Engineers**

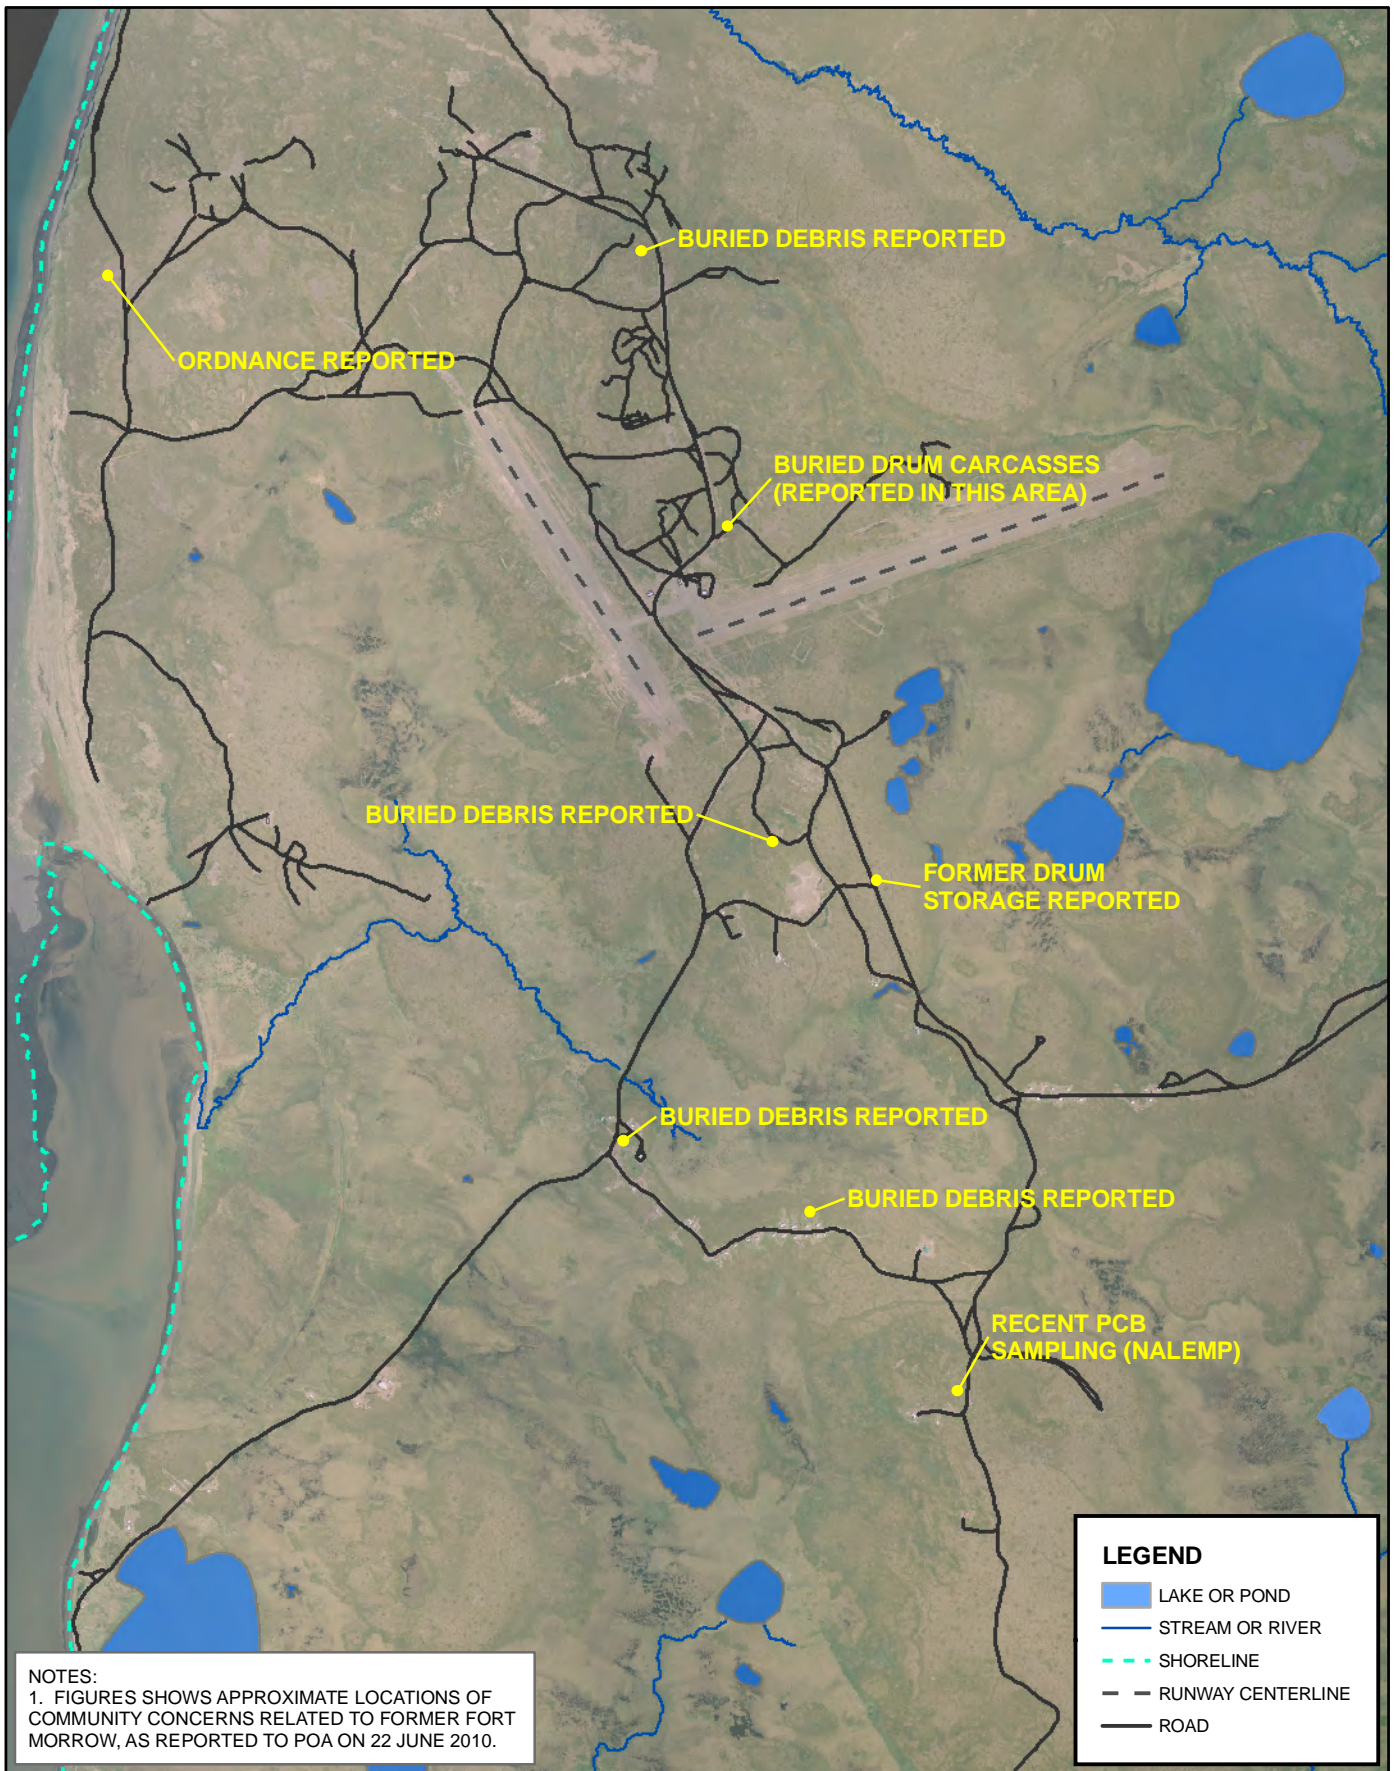
FIGURE 3

POA representatives met with community residents on the afternoon of 22 June 2010 to obtain information about potential contaminated areas associated with the former Fort Morrow facility and activities. Several residents communicated concerns and the approximate locations. These are shown on Figure 3. POA representatives visited the locations of community concerns during the site visit to identify if evidence of contamination or potential contamination is readily apparent.

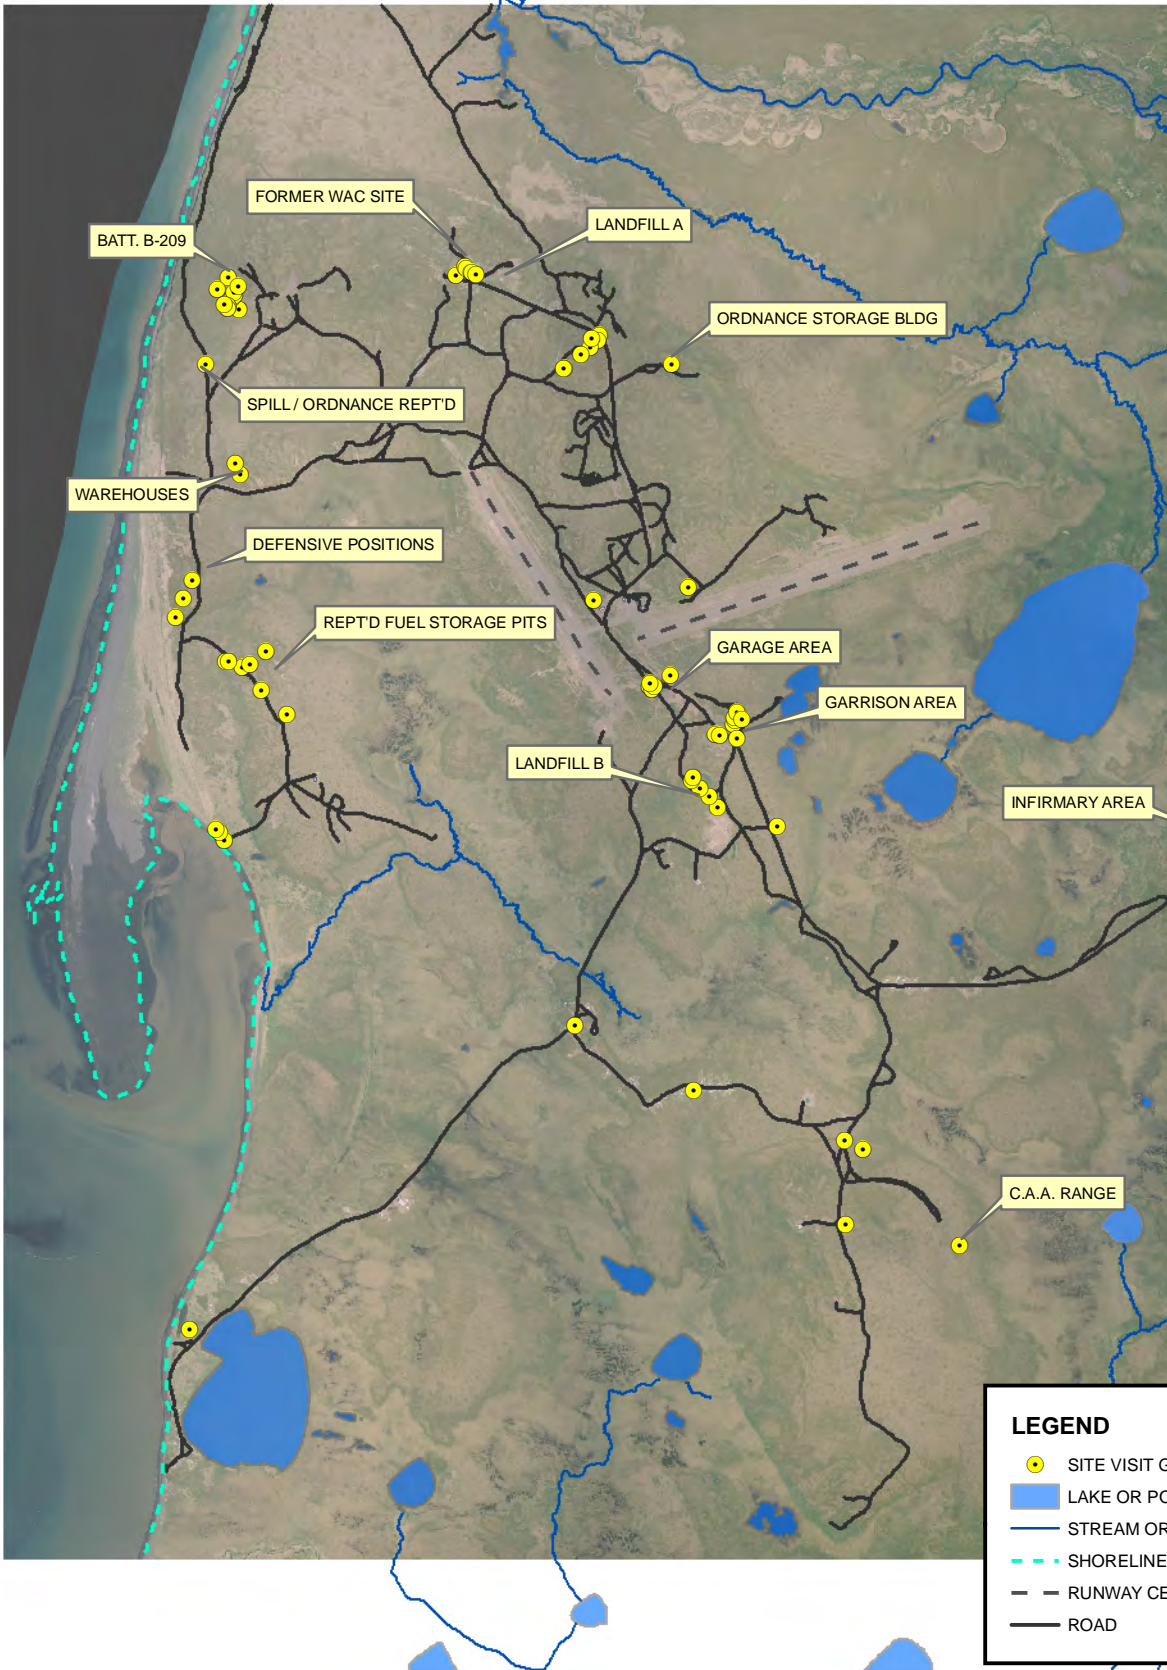
ROAD CONDITION 23 JUNE 2010

- GOOD, GRAVEL, 2WD
- TRAIL, 4WD OR ATV
- NOT DRIVEN, NOT OBSERVED
