**DRIFTWOOD BAY RRS
ALASKA**

FINAL
PRELIMINARY ASSESSMENT/SITE INSPECTION
RADIO RELAY STATION
DRIFTWOOD BAY
UNALASKA ISLAND, ALASKA

JANUARY 1996

EMCON Alaska, Inc
4701 Business Park Boulevard, Suite 36
Anchorage, Alaska 99503-7166

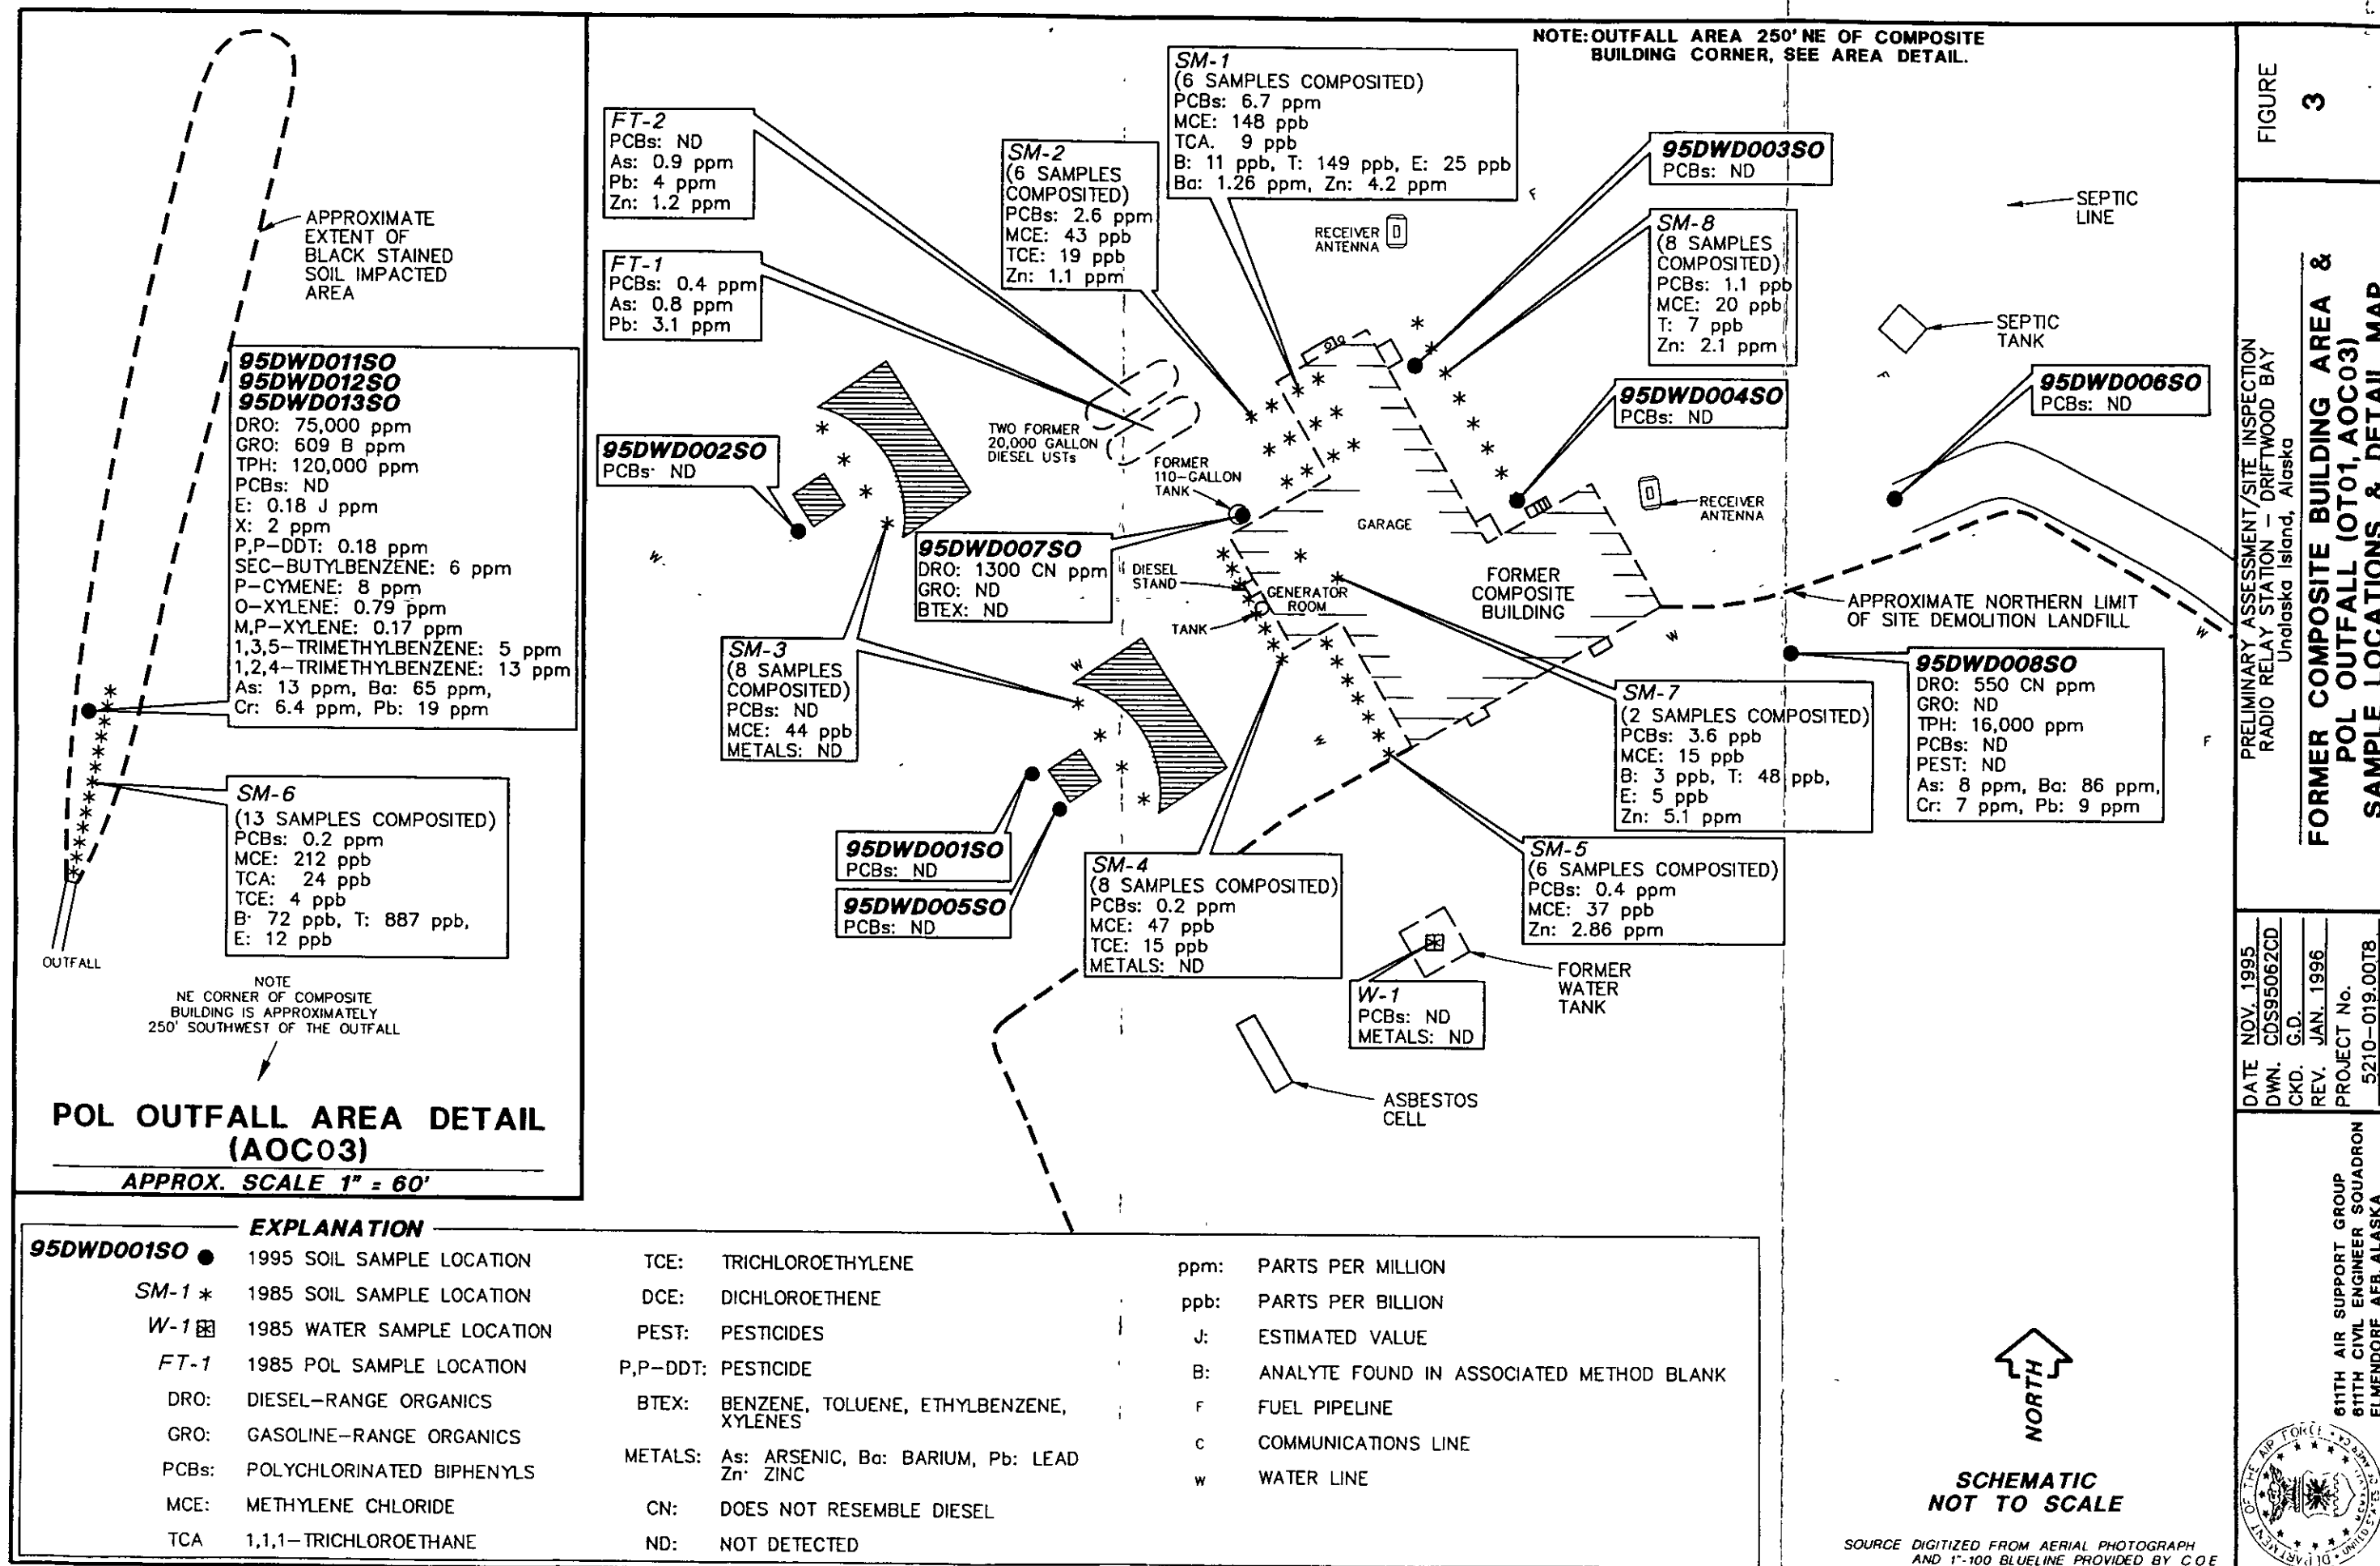
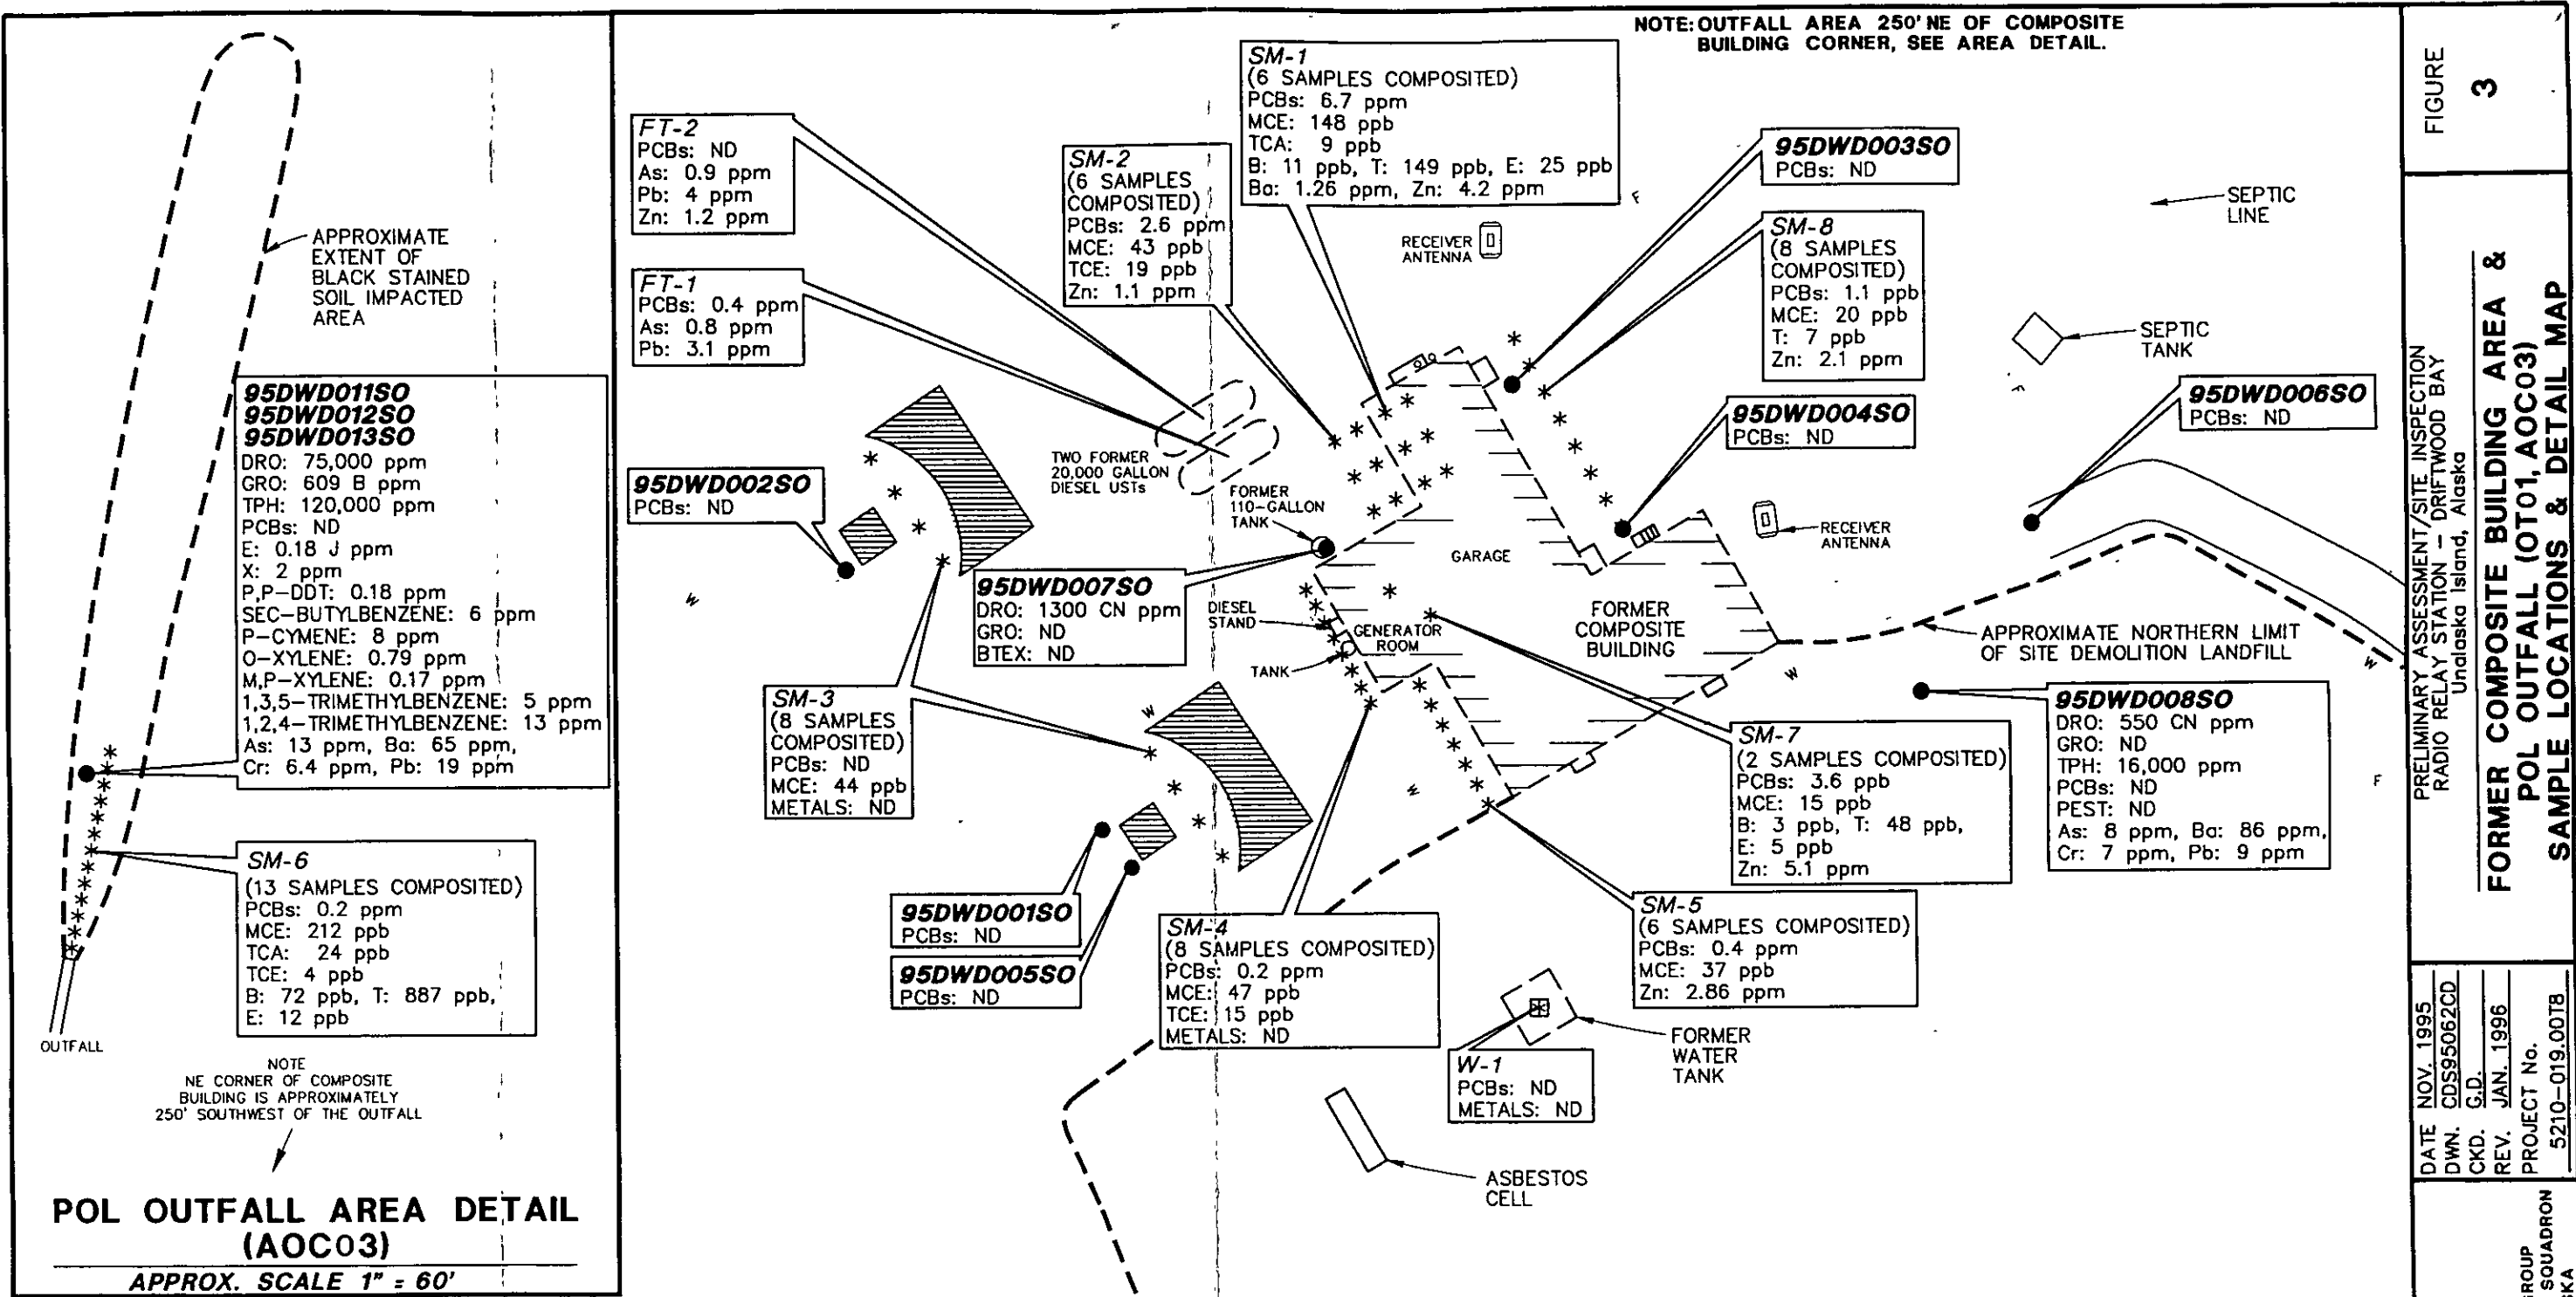
FIGURE 3

Data for analyses conducted in 1995 and recommendations are included in Table 3. Soil samples 95DWD001SO and 95DWD005SO were collected near the foundation of the former south feedhorn location (Photograph 3, Appendix C). Sample 95DWD002SO was collected near the location of the former north feedhorn location (Photograph 4 in Appendix C). Figure 3 shows the locations of each sample.

Soil samples 95DWD003SO and 95DWD004SO were collected along the east side of the former composite building near former doorways. Five attempts to collect soil samples along the southern edge of the composite building were unsuccessful due to buried debris within the landfill. Sample 95DWD006SO was collected in the road approximately 100 feet east of the composite building. Sample 95DWD007SO was collected in the approximate location of a former 110-gallon fuel tank on the west side of the foundation (Figure 3). No impact was apparent in the sample locations around the former composite building foundation.

Data for soil samples analyzed in 1995 are included in Table 7. Soil sample 95DWD011SO, split sample 95DWD012SO, and duplicate sample 95DWD013SO were collected from the impacted zone approximately 67 feet downslope of the discharge point (Figure 3). Samples were submitted for analysis of VOCs, PCBs, TPH, GRO, DRO, and metals. Samples for VOC analyses were collected first, and then the soil was homogenized prior to placing it into the sample jars for the other analyses.

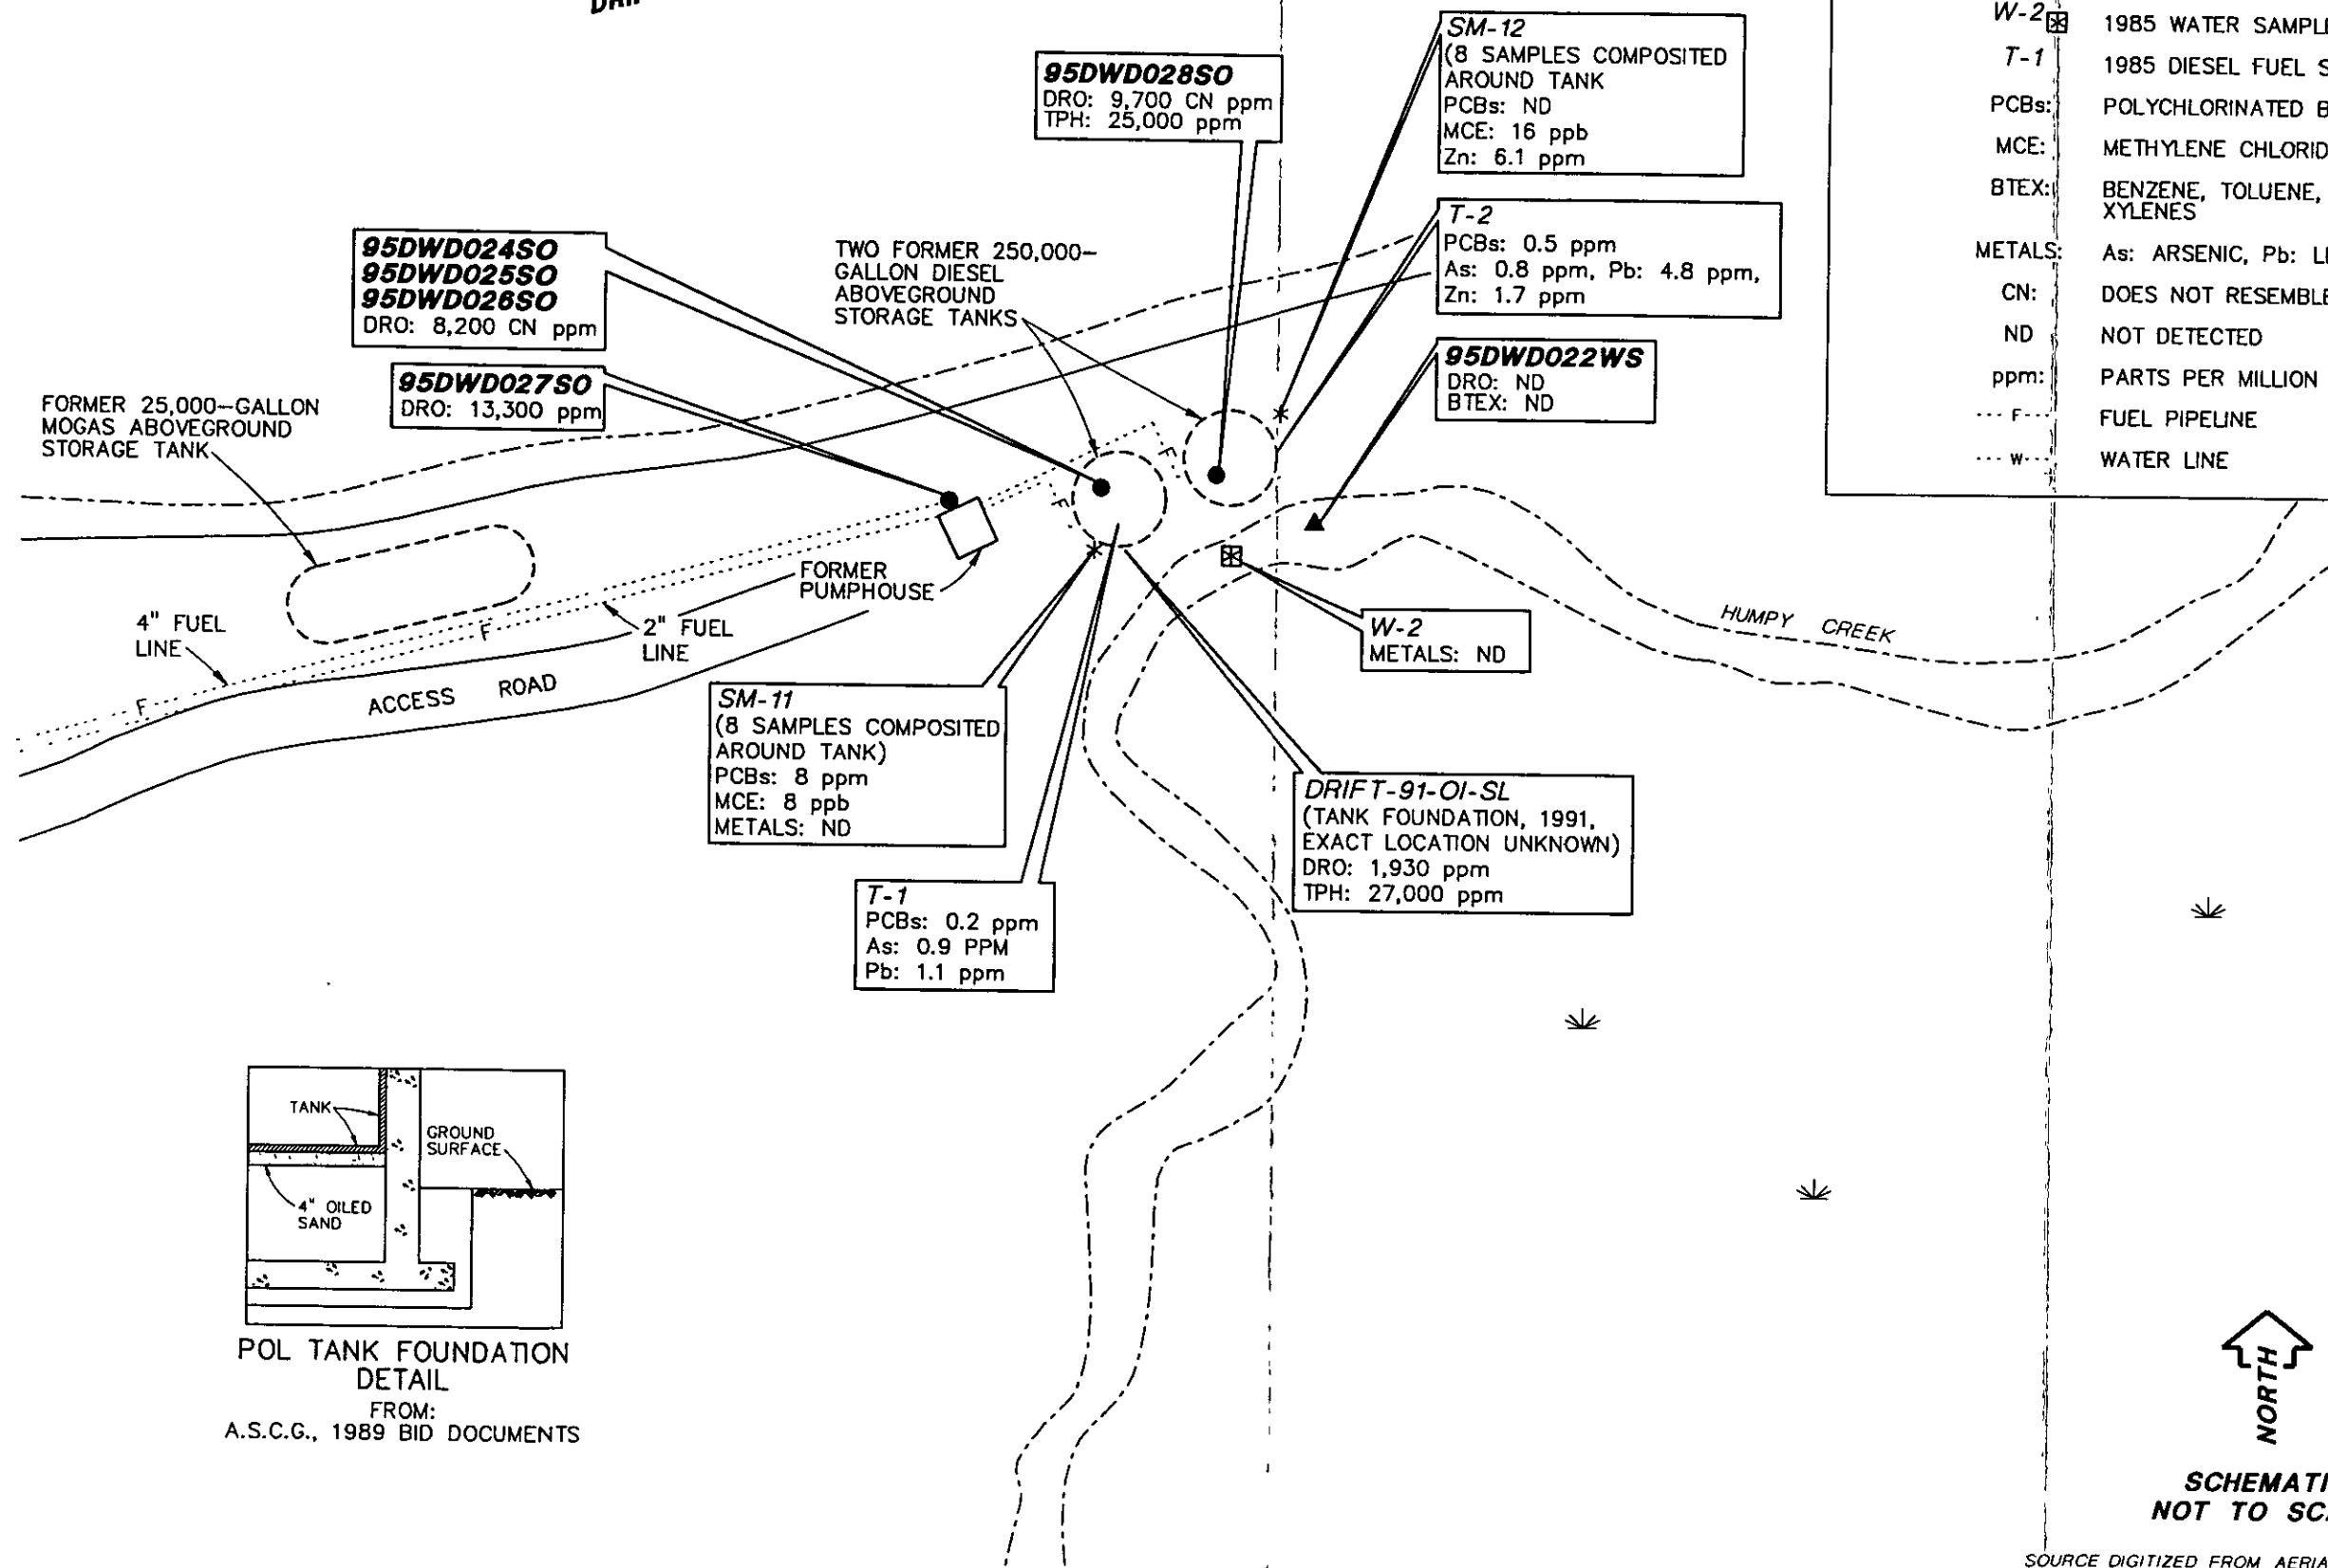
POL TANK FOUNDATION
DETAIL
FROM:
A.S.C.G., 1989 BID DOCUMENTS

The soil samples contained no detected concentrations of PCBs or pesticides. One VOC was detected, methylene chloride, which is a common laboratory contaminant. Metals

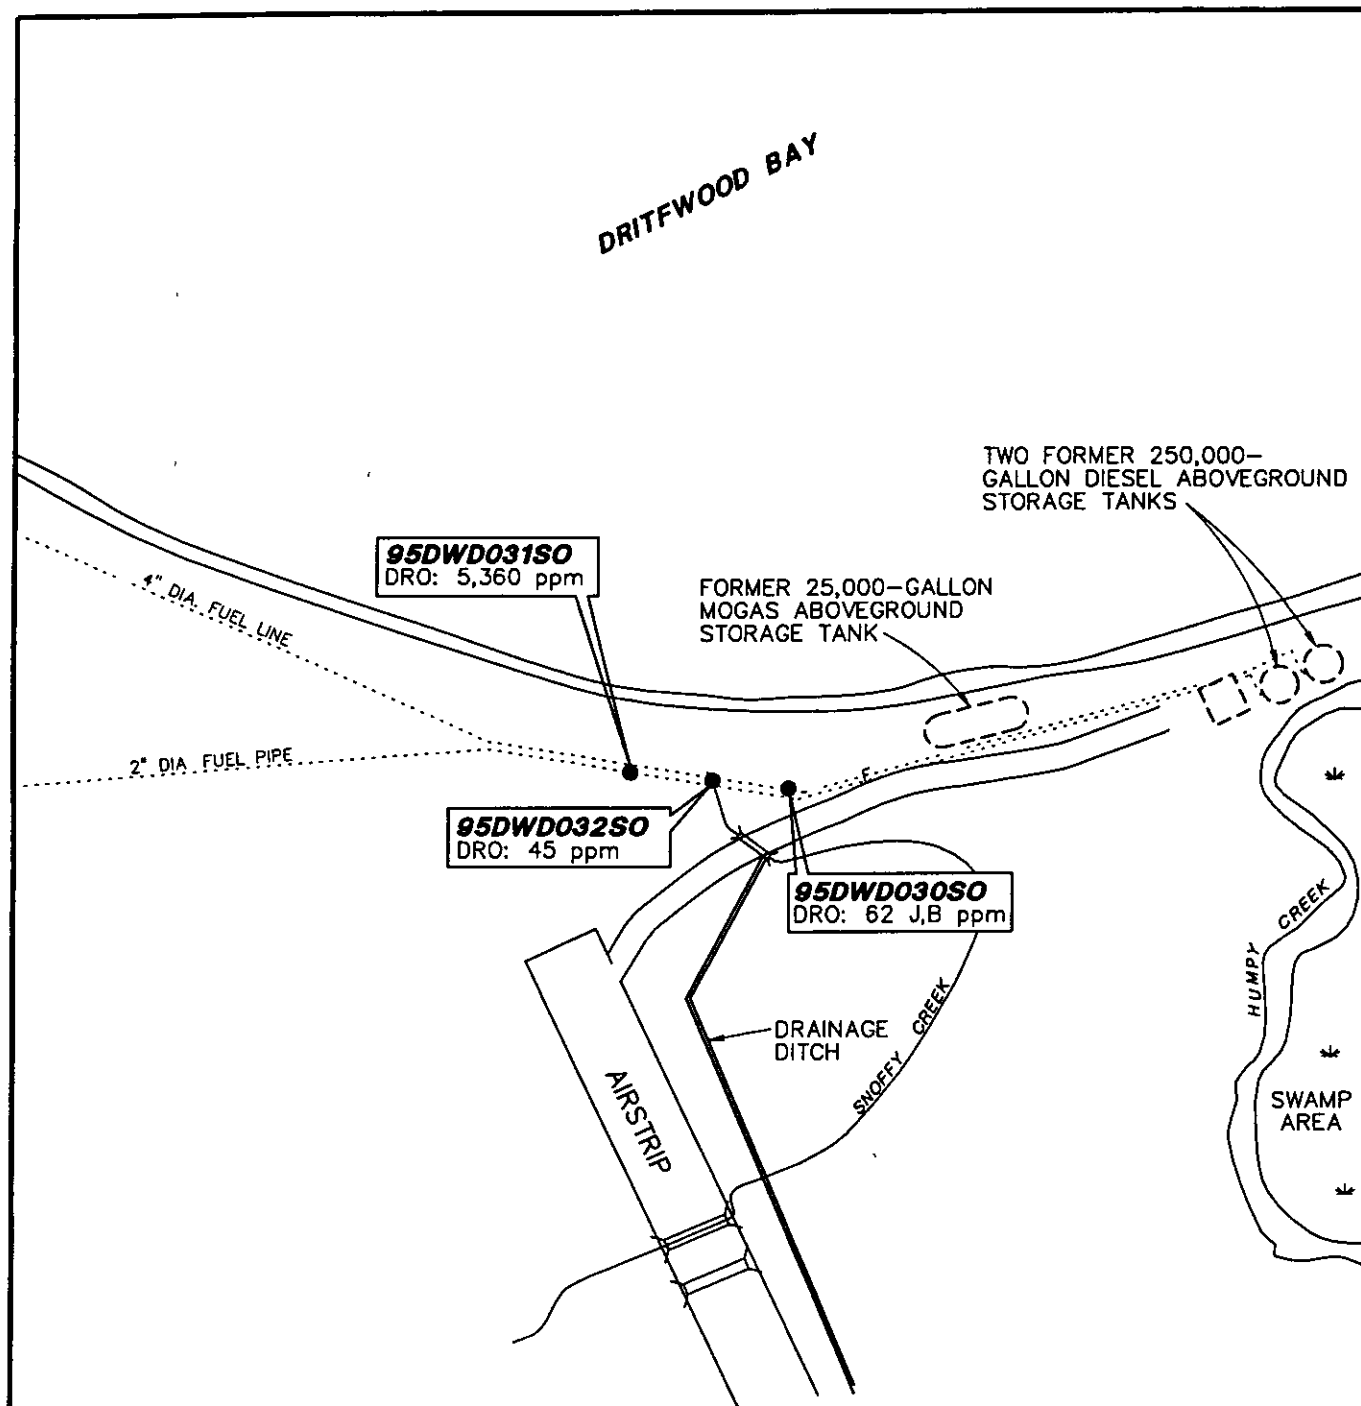
Sample ID	Matrix	DRO (ppm) 8100	Remarks	Recommendations
95DWD030SO	Soil	62 (10) J,B	Collected from area where 2" and 4" pipe are located	Additional sampling should be done along pipeline corridor
95DWD031SO	Soil	5,360 (10)	Collected along 2" pipe corridor west of Snoffy Creek	Additional sampling should be done along pipeline corridor.
95DWD032SO	Soil	45 (10) J,B	Collected from sediment of Snoffy Creek at crossing of 2" pipeline	Additional sampling should be done along pipeline corridor
