SITE CHARACTERIZATION

AIR NORTH / BEN LOMOND METRO FIELD PROPERTY BLOCK 6, METRO INDUSTRIAL PARK FAIRBANKS, ALASKA

SEPTEMBER 12, 2007

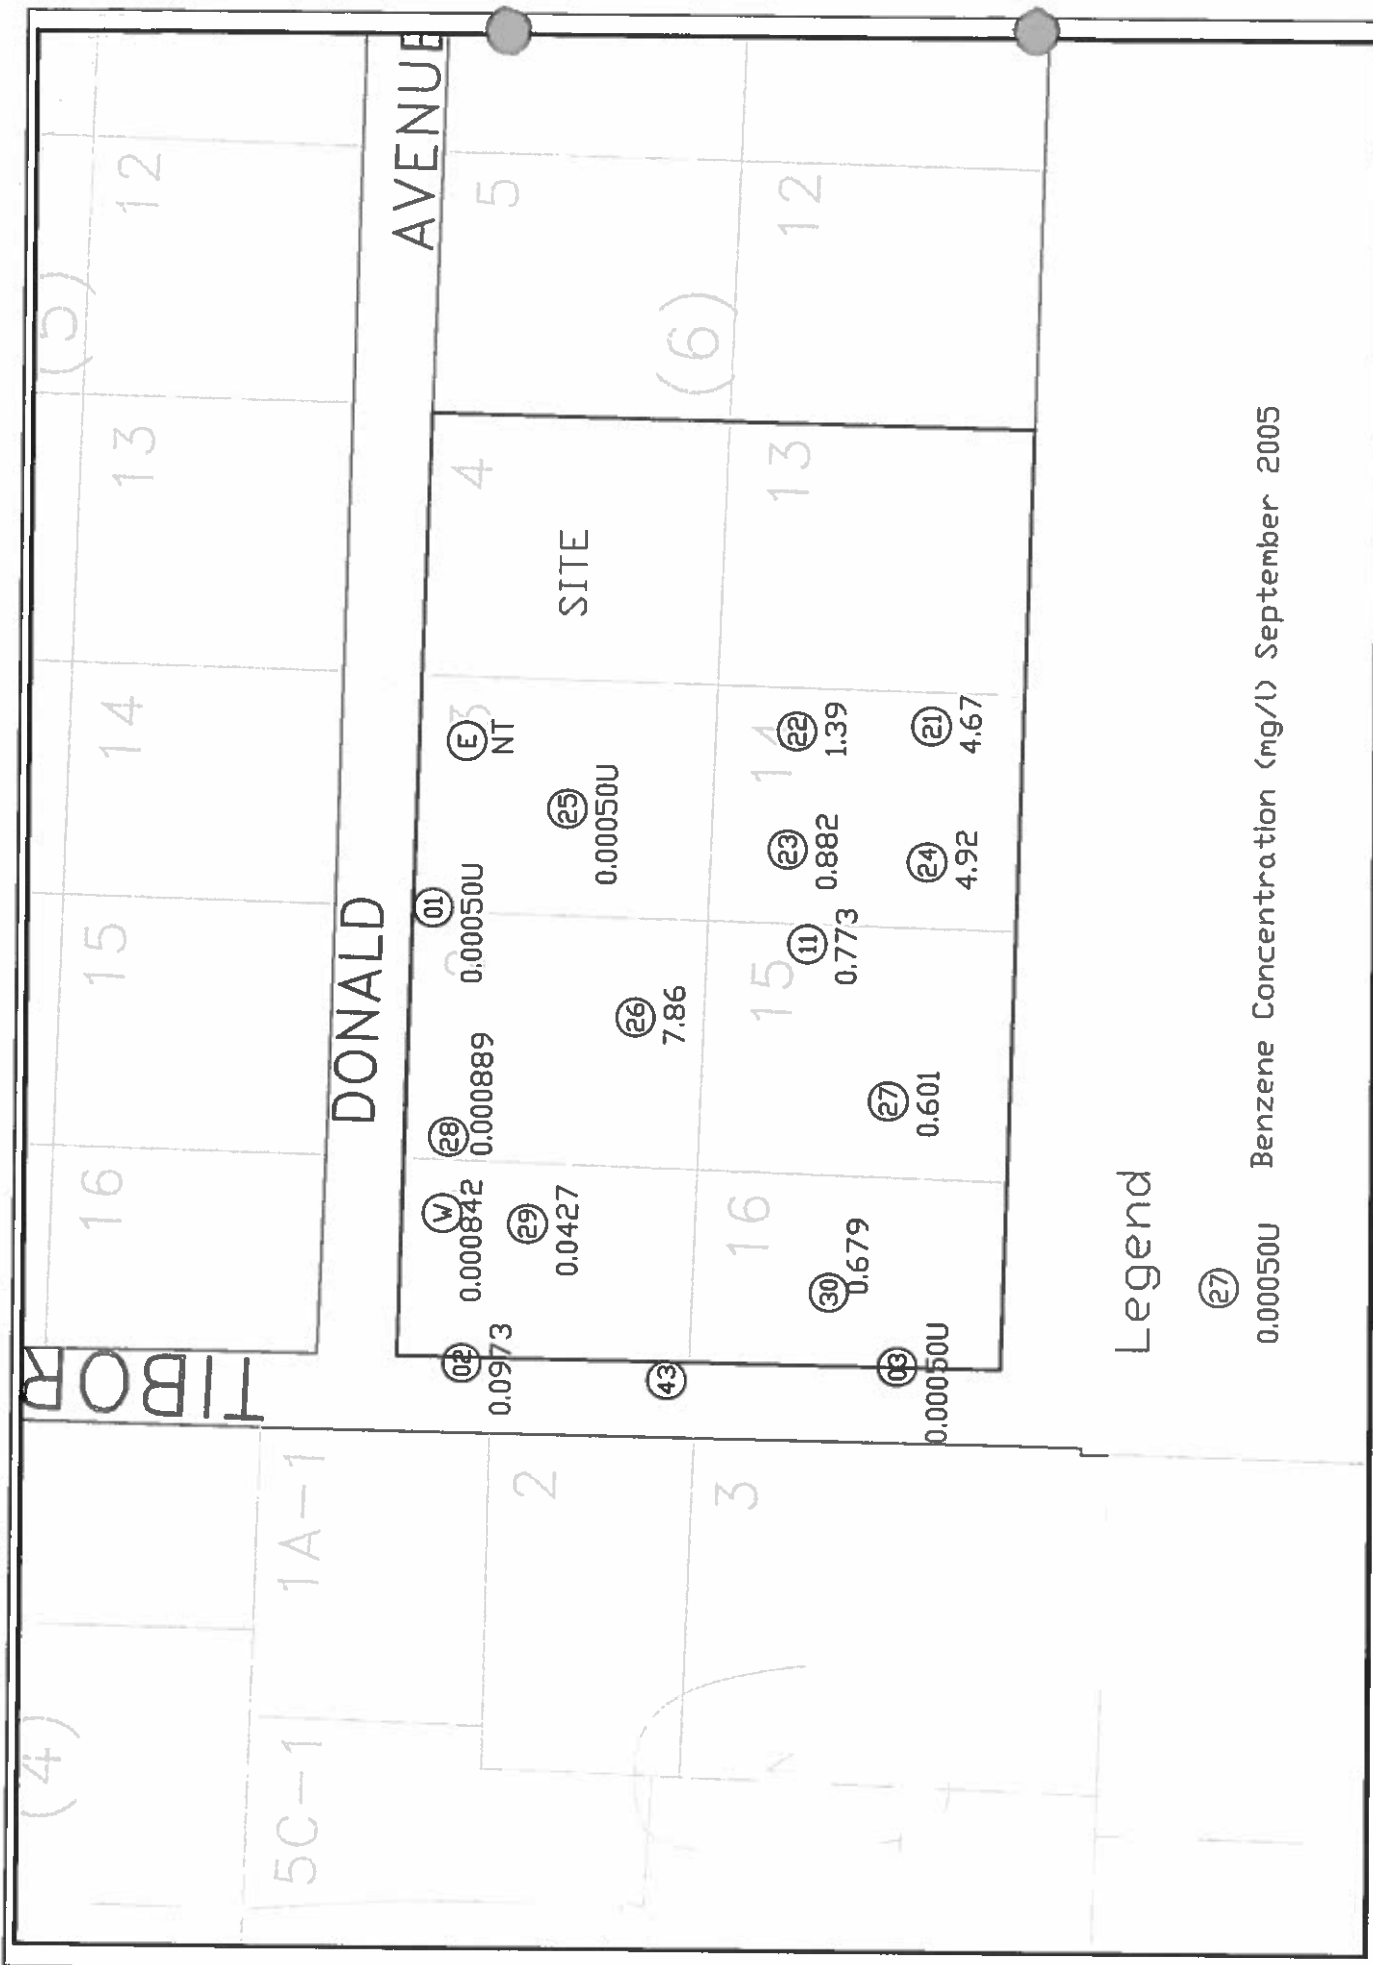
ENVIRONMENTAL & ENGINEERING CONSULTANTS 2400 College Road, Fairbanks, Alaska 99709 (907) 452-5888 FAX: (907) 452-5894	2005 Sample Locations and Benzene Results Ben Lomond Metro Field Property Fairbanks, Alaska			DATE: 09/12/07	SCALE: 1"=150'
				DESIGN: PLB	PROJECT: 051036	
				DRAWN: PLB	DWG: 051036b(05)	
FIGURE 5
