ROZAK ENGINEERING

Re: Report of Groundwater Sampling Events 5, 6, 7 & 8
Former Doyle's Fuel Storage Facility, Spill #1998230128901
SE ¼ B.L.M. Lot 51, S34, T6S, R11W, City of Kenai

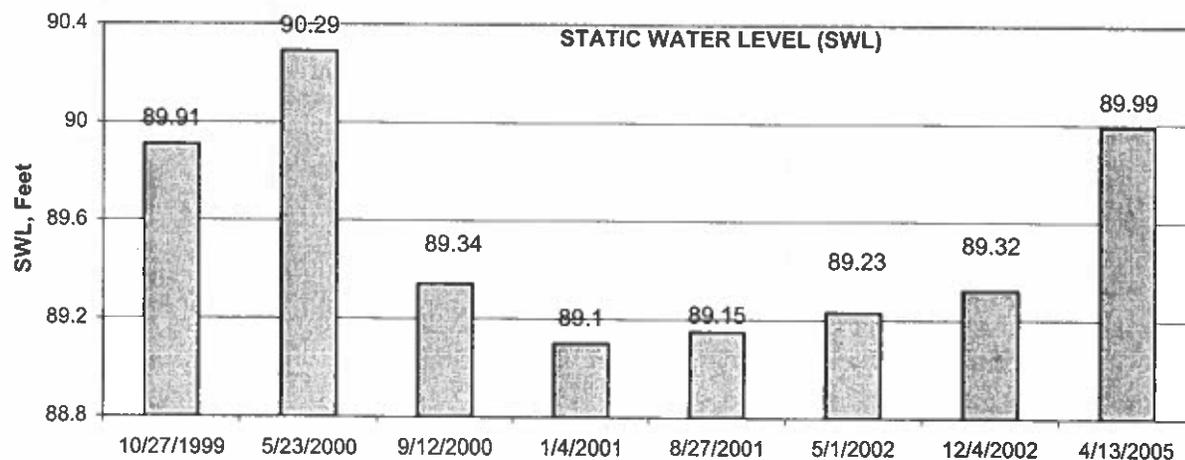
MW-3 This well is located near the southeast corner of the property, 120 feet south of the former storage tank site. Low levels of PHC concentrations, if any, were expected at this location. That has generally been the case except for an unexplained benzene and GRO spike in December 2002.

- GRO was detected twice: the sixth sampling event was below the cleanup level and the seventh event was 26 times the cleanup level.
- DRO was detected once, during the third sampling event, less than the cleanup level.
- Benzene was detected six sampling events. Benzene was relatively low except the sixth event (December 2002) was 87 times the second highest sampling event (May 2002) and 234 times the cleanup level.
- The difference from lowest to highest measured groundwater level is 1.19 feet.
- There is no apparent correlation between the PHC concentrations and the groundwater level.
