CORRECTIVE ACTION REPORT
TRAILSIDE GENERAL STORE
HOMER, ALASKA

PROJECT NO. 002-10
DECEMBER, 2002

Subject: Trailside General Store Corrective Action Report

ADEC Spill # 99-23-00-119-01

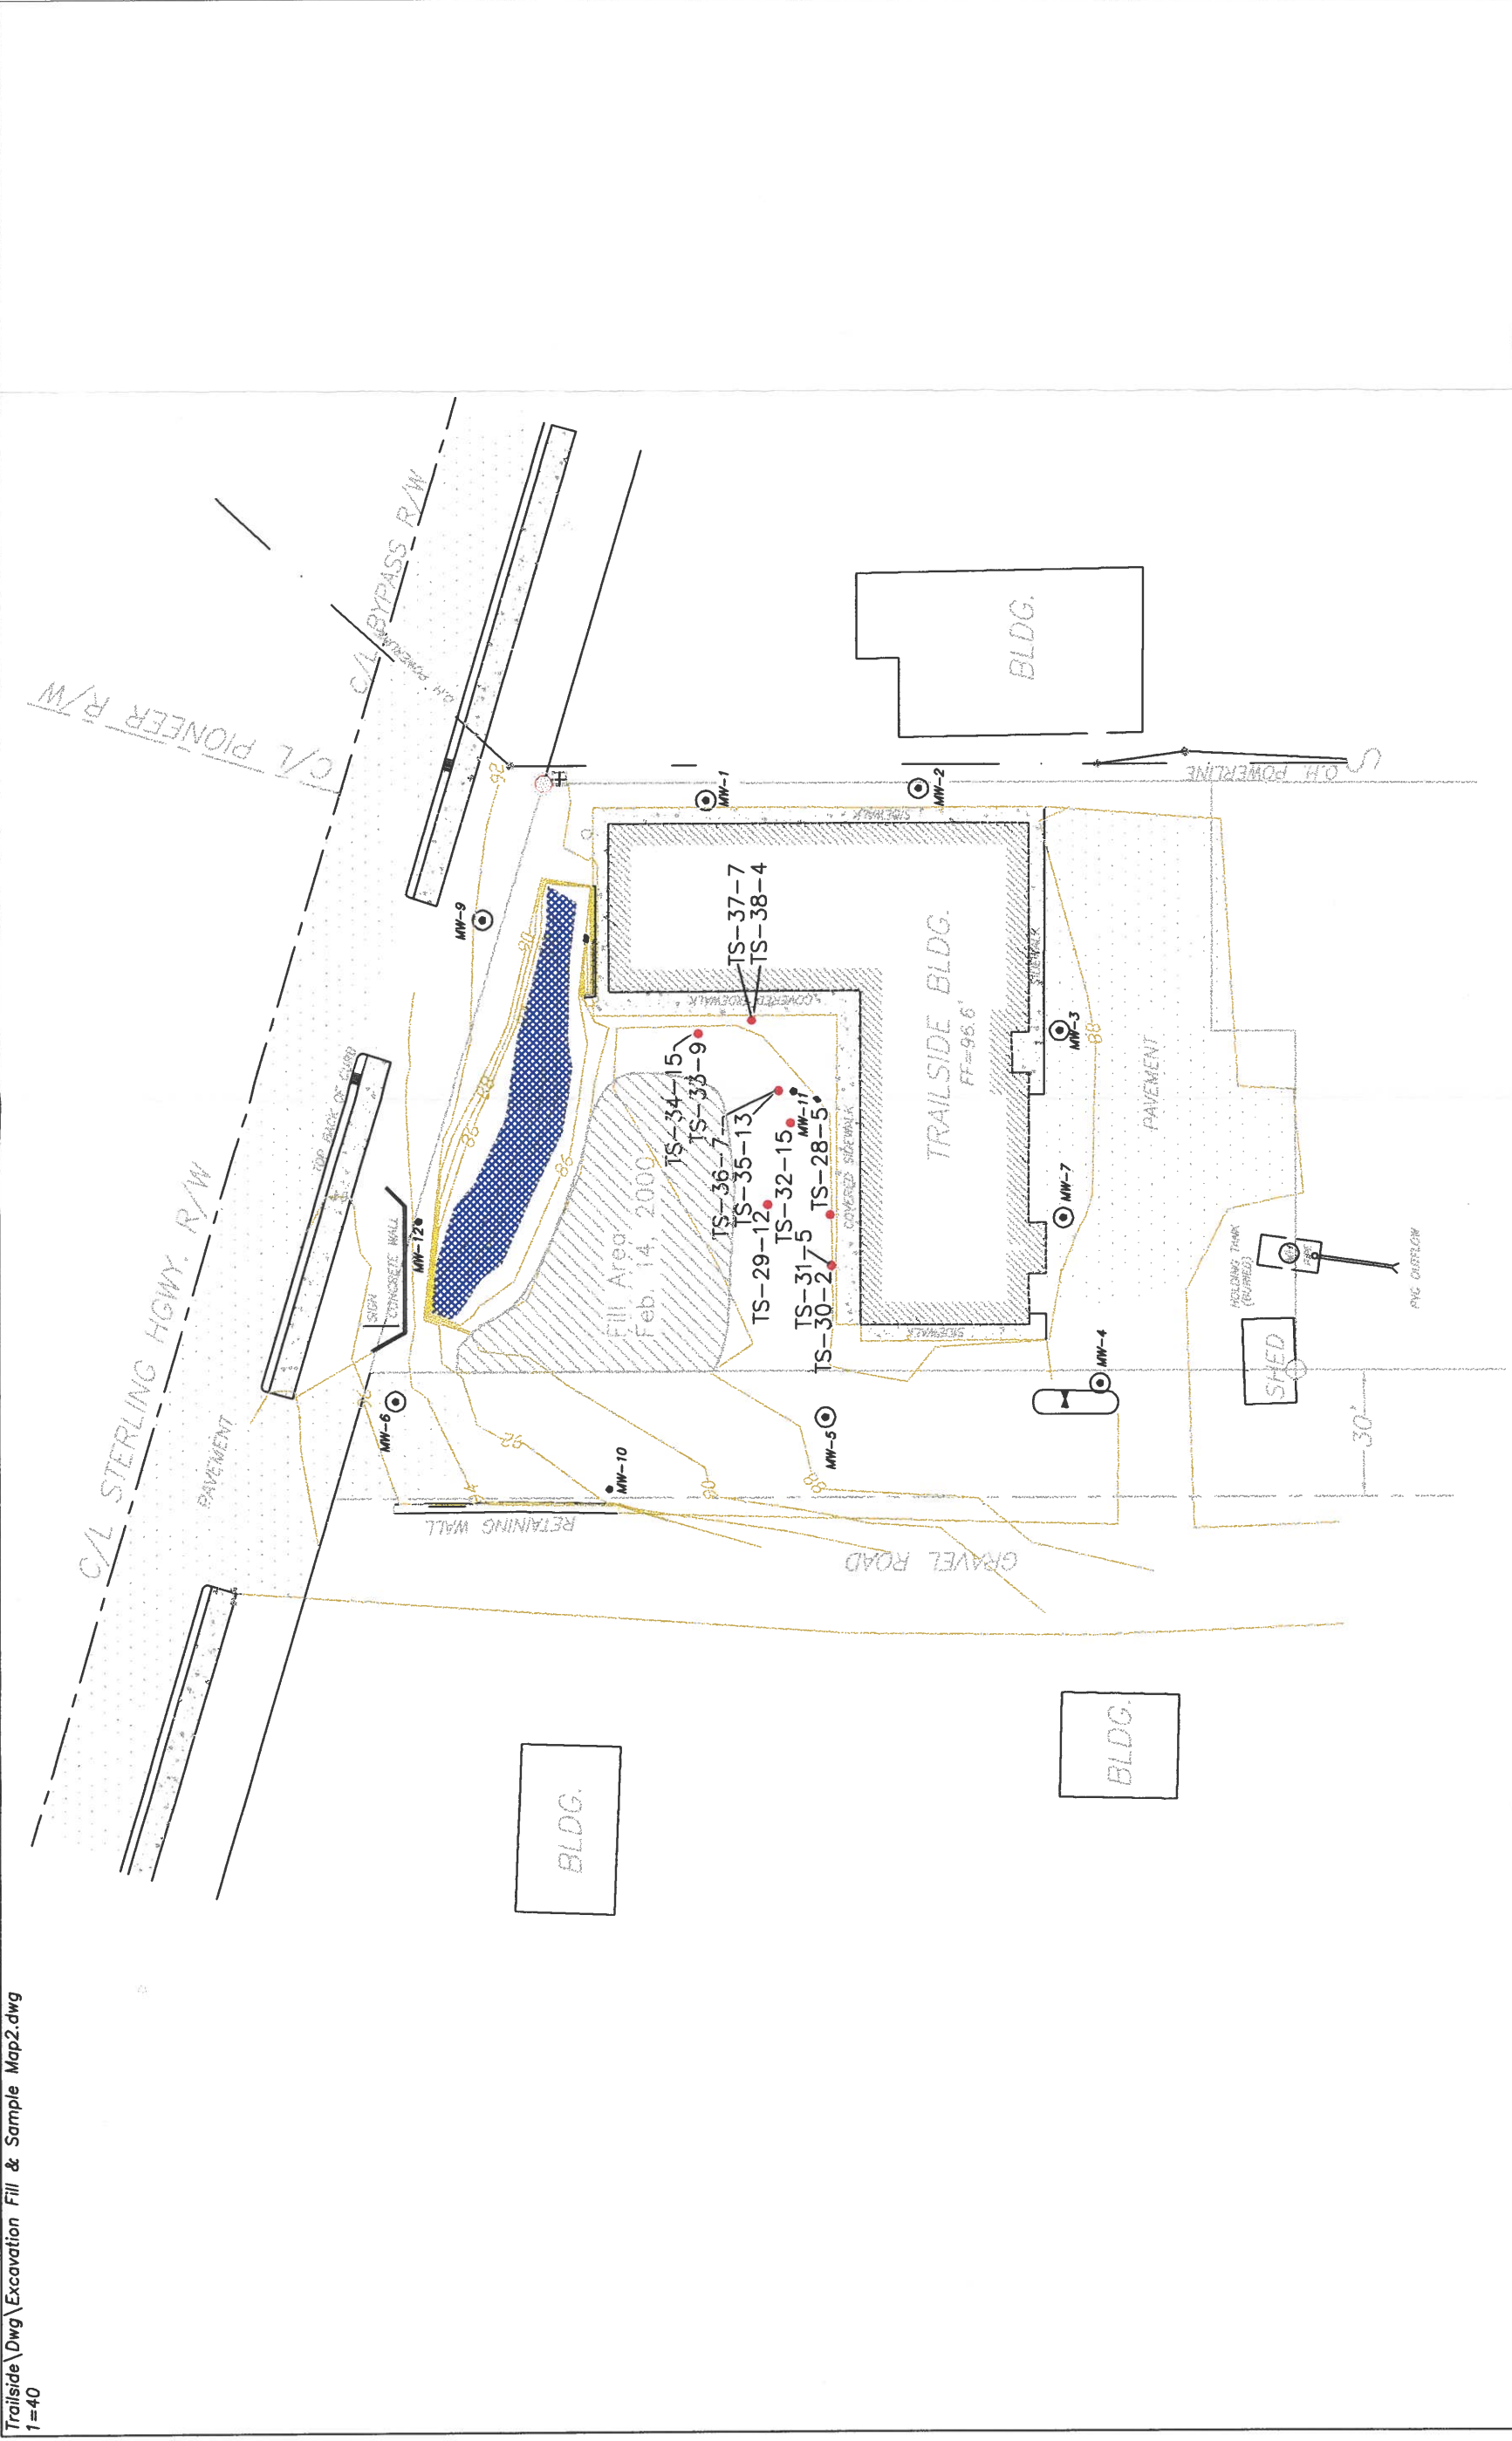
FIGURE
3

Significant backfilling of the excavation was initiated by Southeast Construction on this day. See Photo 5. The practical limits of the excavation had been reached on the north and west sides of the excavation. Further excavation on the west side would have disrupted access to the property and excavation to the north would have intruded into the highway right of way. It was decided to backfill the area beginning on the west side of the excavation. The excavation was filled to grade in the area depicted in Figure 3: Topographic Site, Sample and Monitoring Well Locations, February 2000.

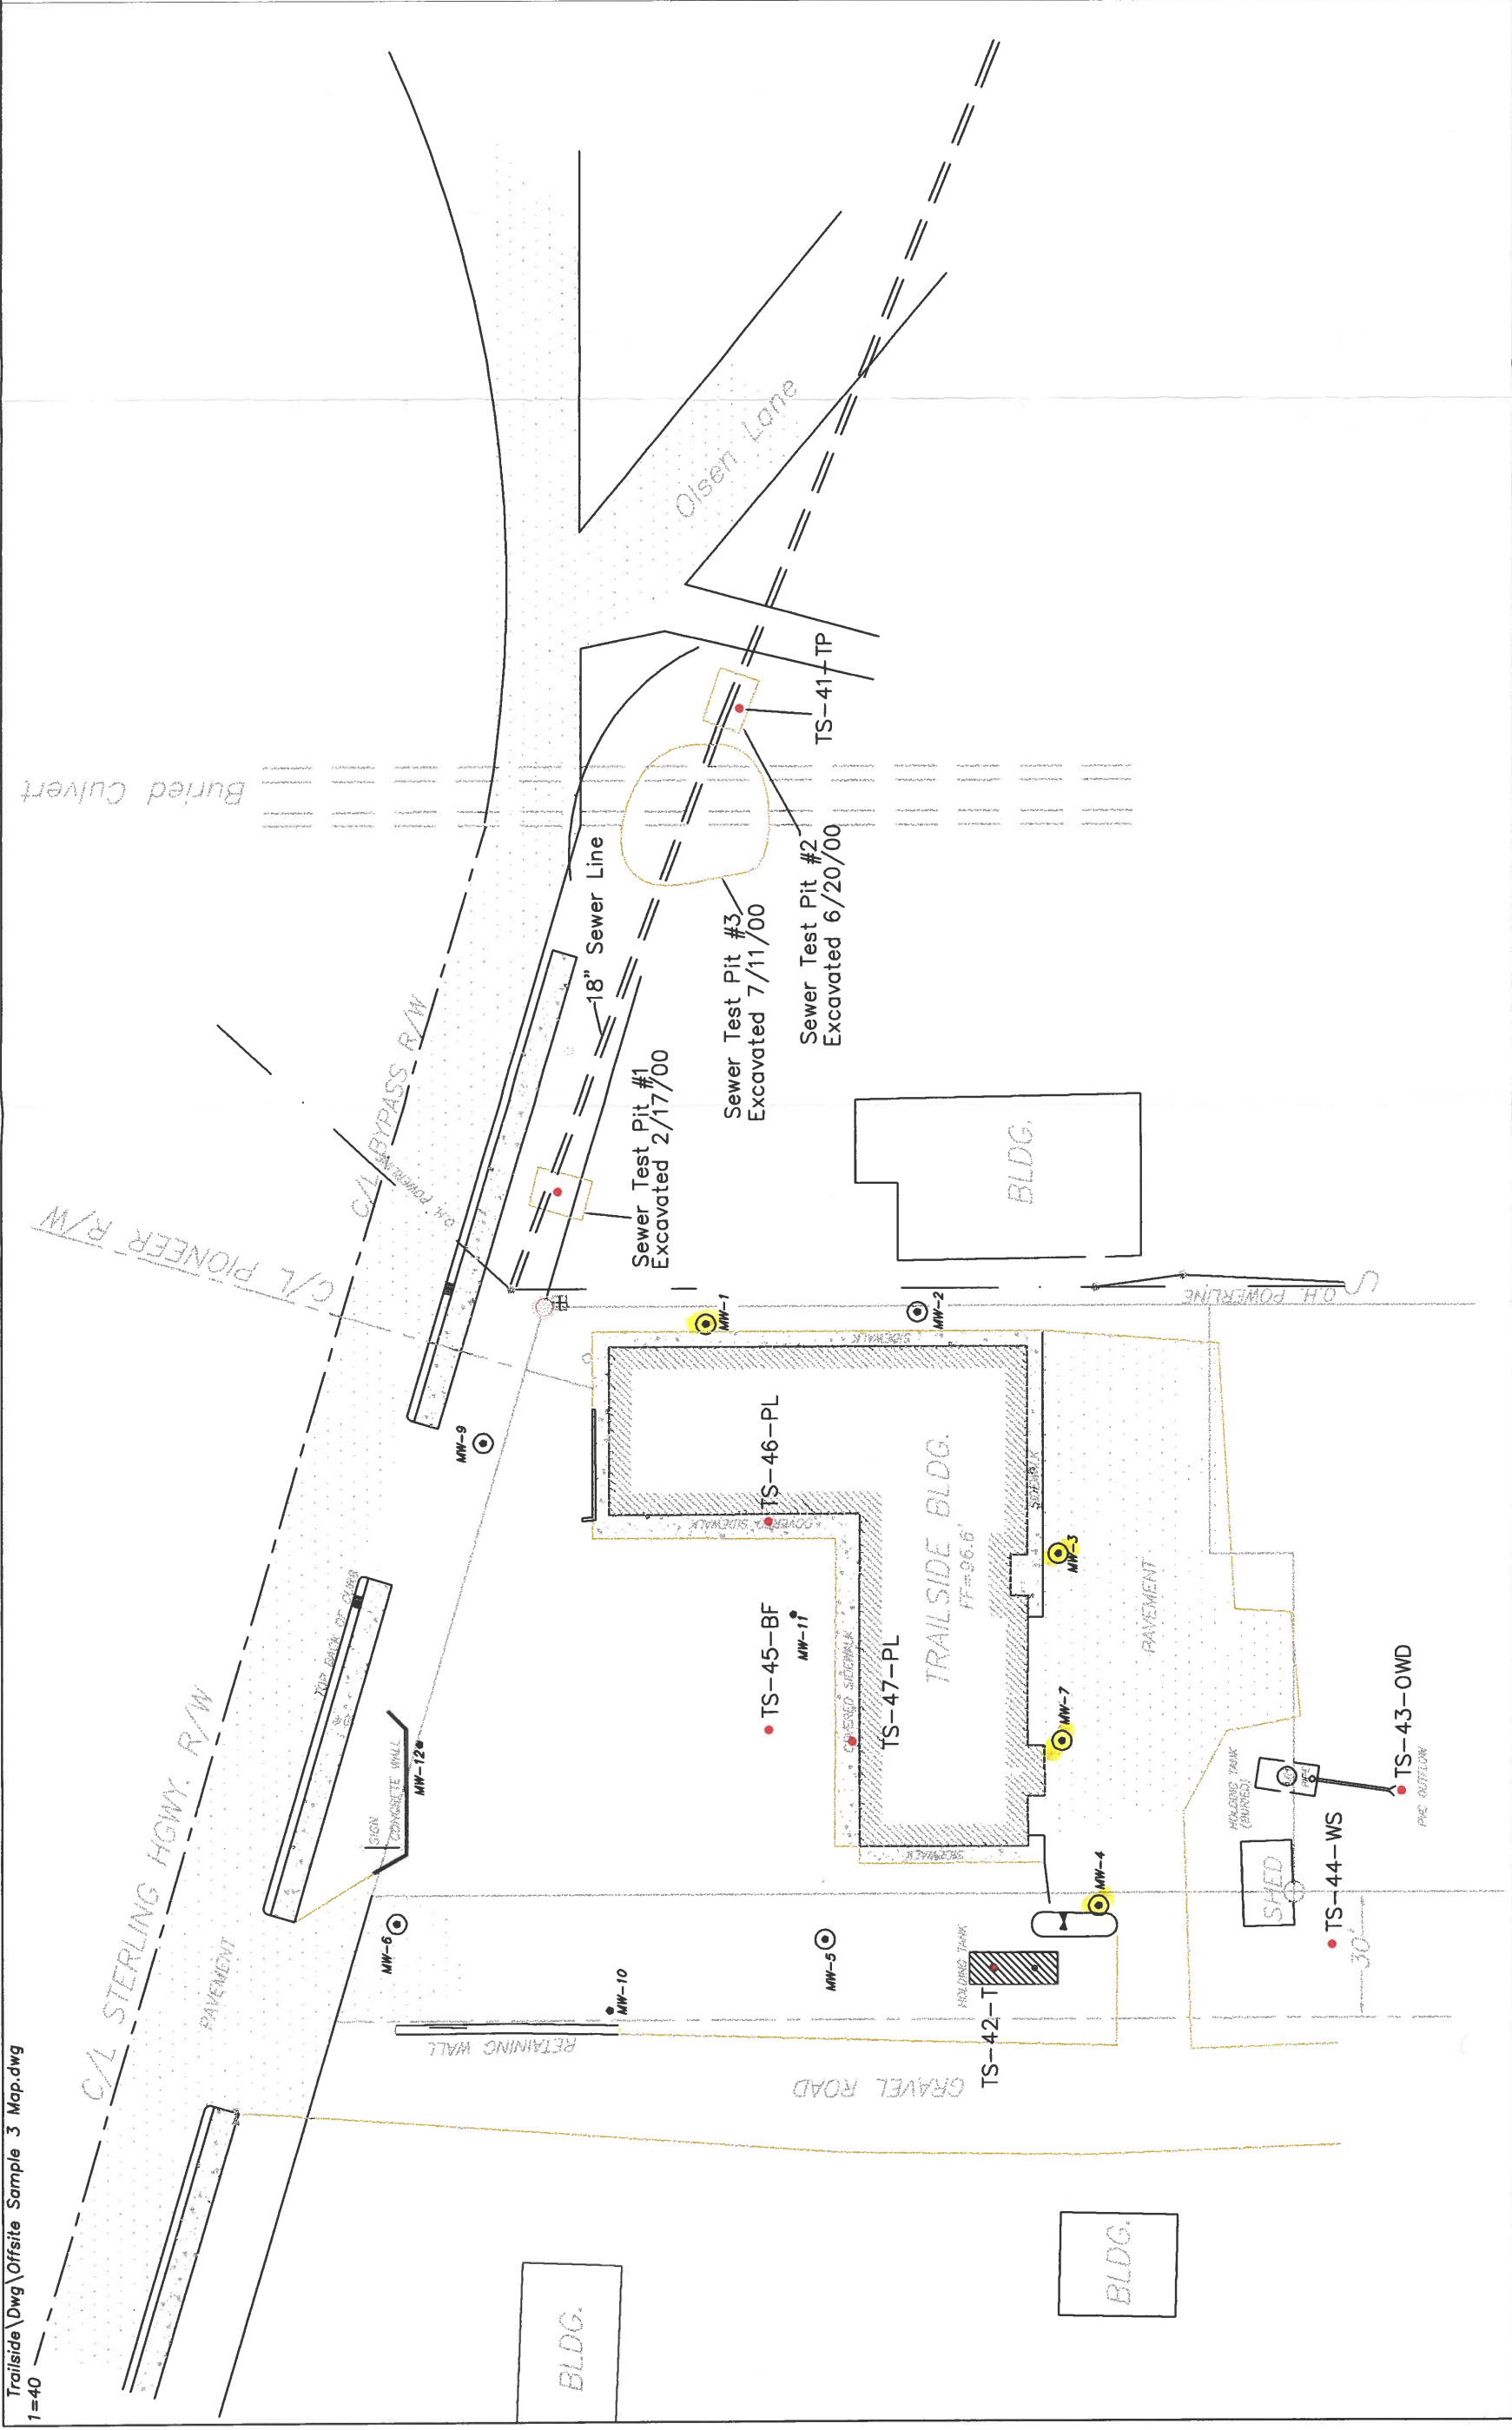
FIGURE 4

Off-site test pits were placed along the City of Homer sewer lines to determine if petroleum contamination had entered the sewer backfill along the sewer line that runs parallel to the property and in the Sterling Highway right-of-way. The test pit locations are shown on Figure 4: Surface and Test Pit Sample Locations. The decision to excavate this test pit was based on several factors. First, a significant amount of product was noted in MW-9, which was located in close proximity to the sewer line. The sewer line is bedded in a sand material, surrounded by dense silty soils of low permeability. Water levels measured in MW-9 also closely approximated the elevation of the buried sewer pipe backfill.

A soil sample was collected from the area where the excavator had been partially buried on July 13, 2000. The sample was collected to determine if the churning of the excavator had brought contaminated soils or water to the ground surface. Sample TS-45-BF (Figure 4, Table 4) indicated that no detectable hydrocarbons were present.

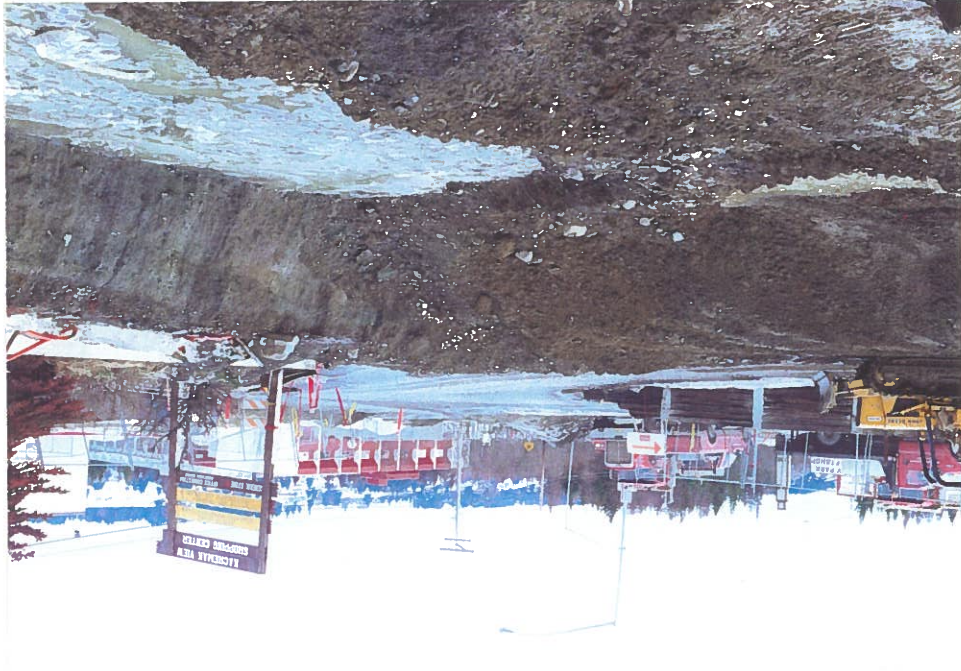
TG-19-12, TG-20-5 and TG-21-1 were collected from the northwest corner of the excavation to profile the vertical extent of contamination from bottom to top, at 12, 5 and 1 foot bgl. See Photo 4, Appendix F. Sample results indicated that GRO concentrations near the surface and at depth met the cleanup requirements, but benzene concentrations in each sample exceeded the cleanup levels. The sample collected from 5' bgl was still very high in the GRO range.

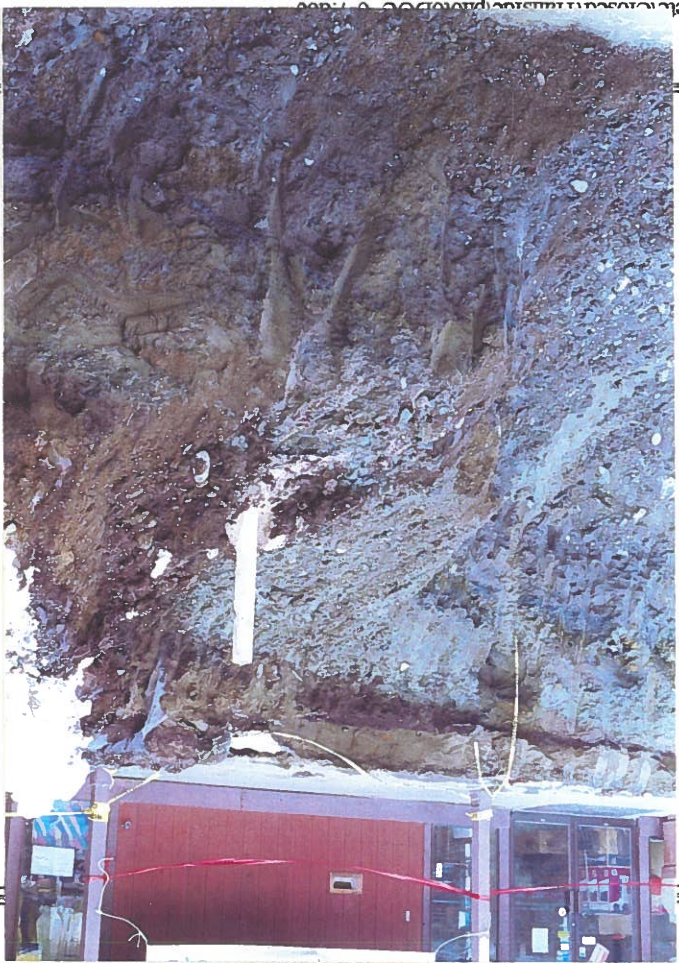
**American Environmental
PHOTOGRAPHIC RECORD
PHOTOGRAPH NUMBERS 6 AND 7**

COMMENTS: Excavation dewatering in front of Trailside General Store, sample locations TS30 & TS-31.
