Hilcorp Alaska, LLC

**Beluga River Unit Site Characterization and
Groundwater Sampling Work Plan**

June 2021

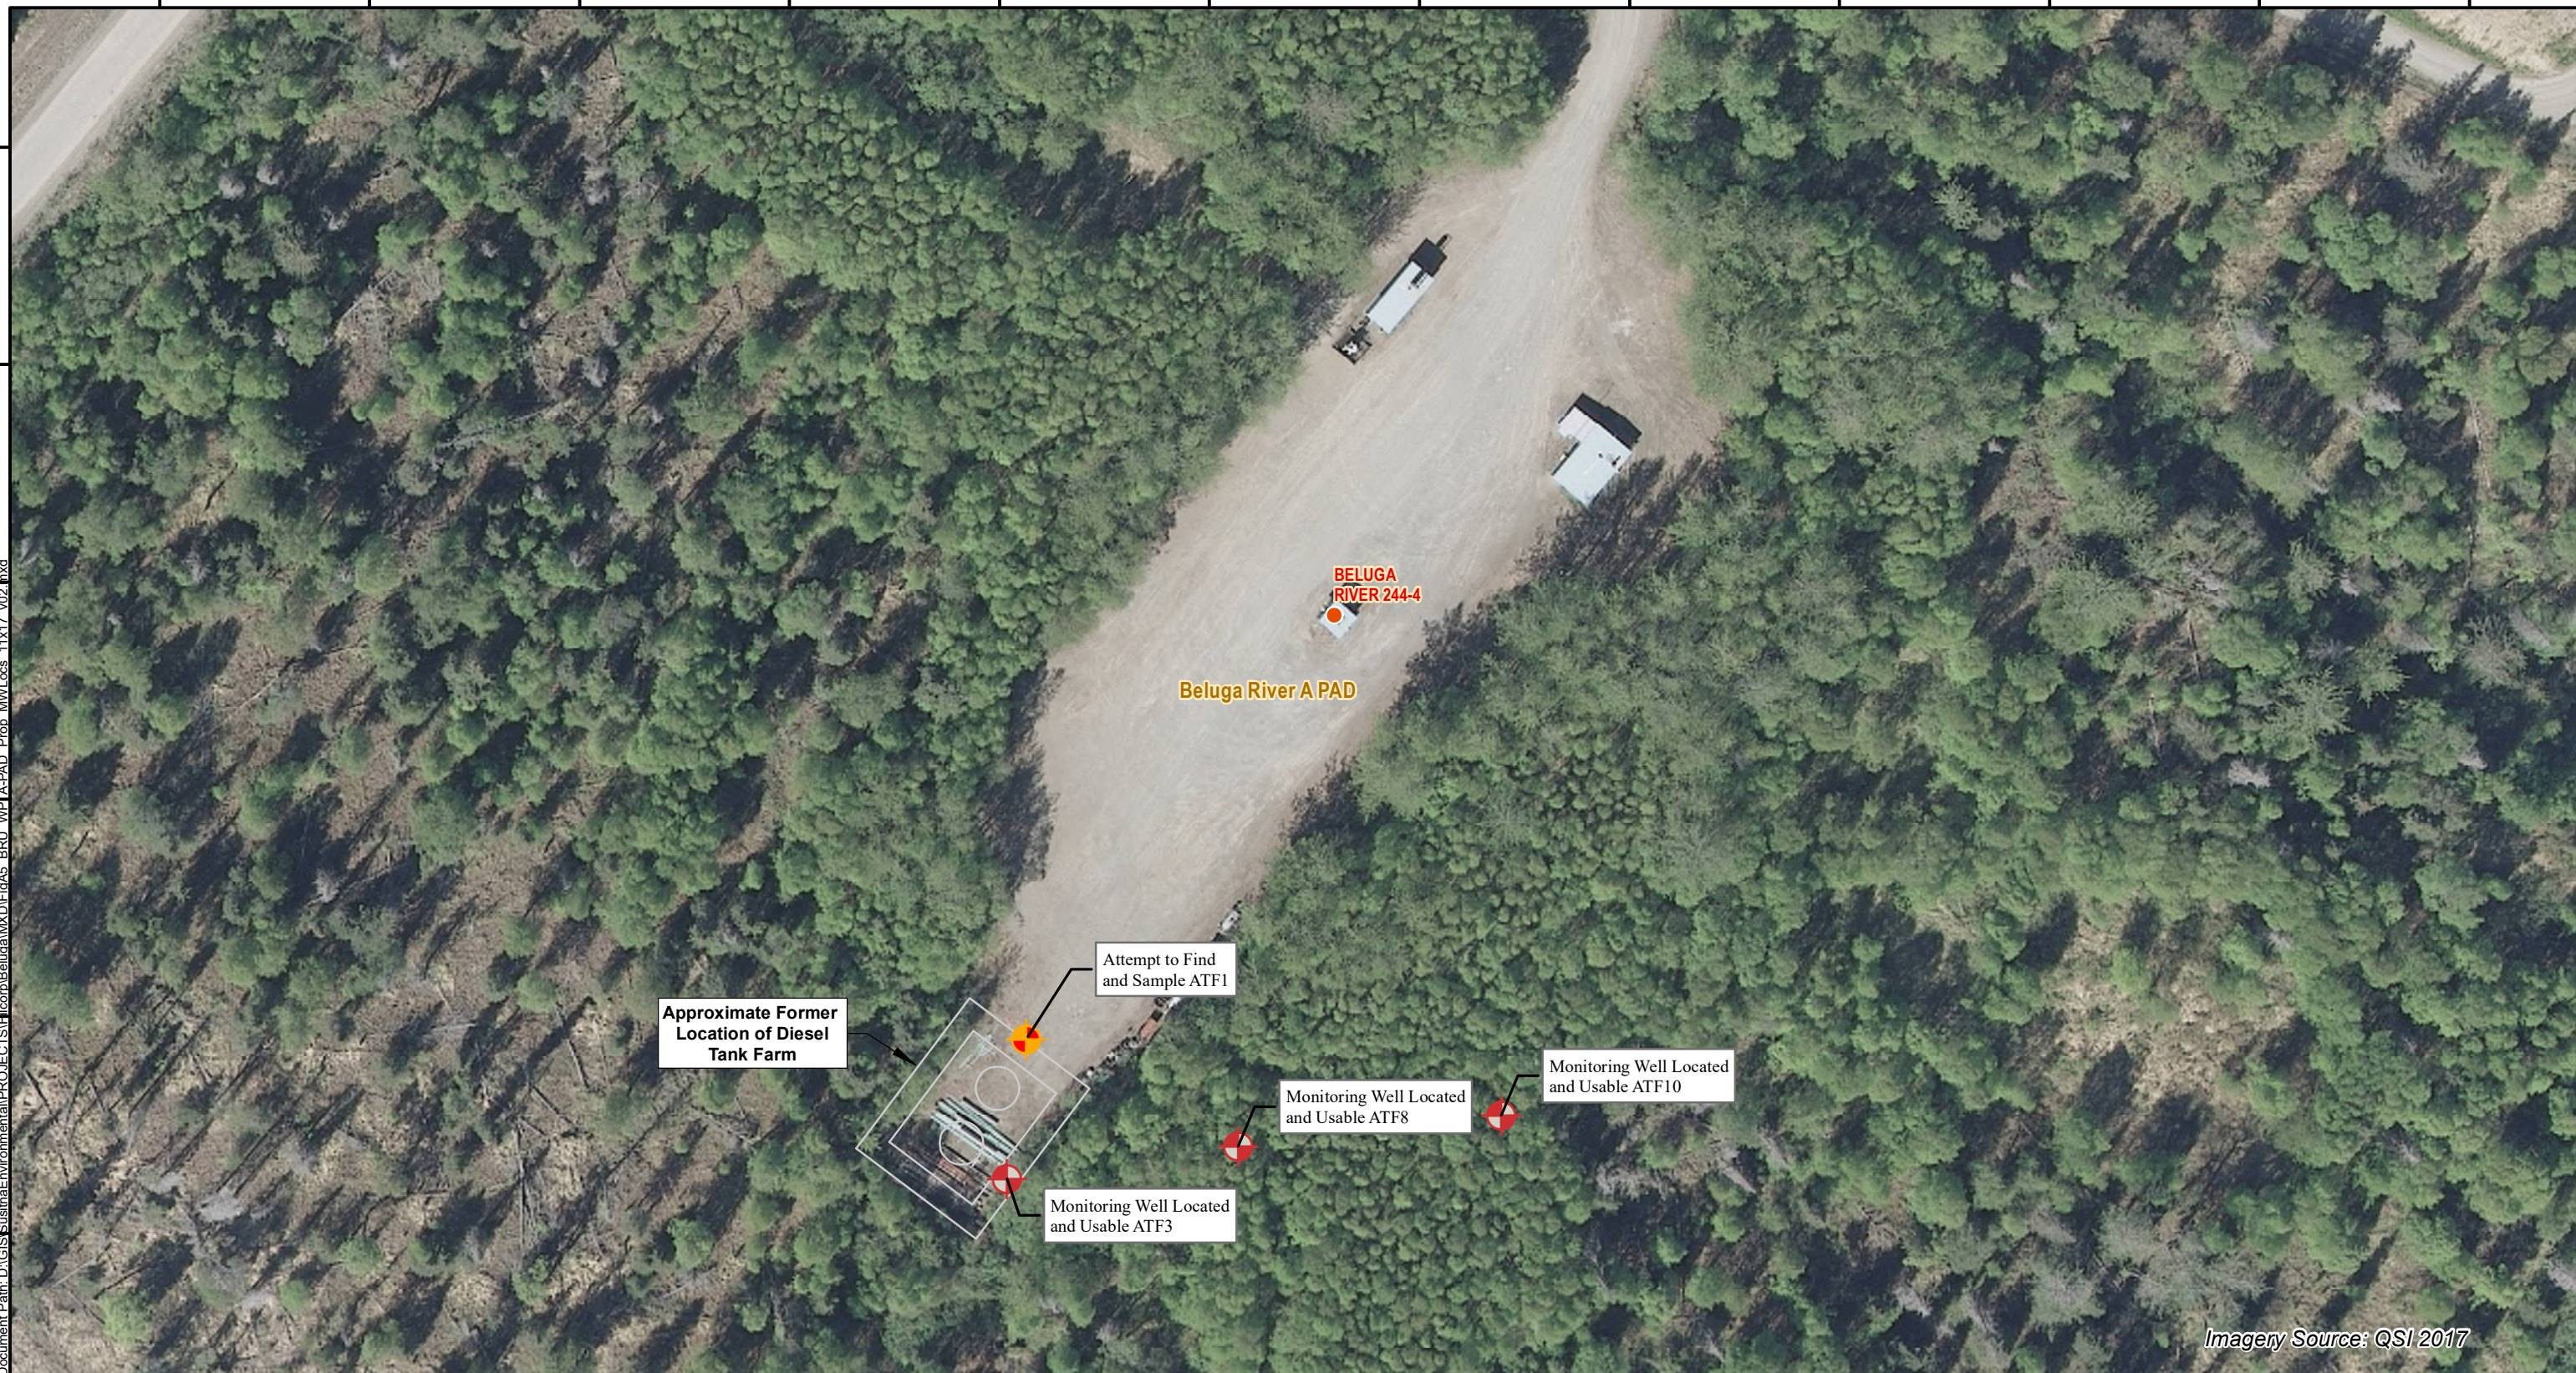
Figure No:
A-5

The October 2019 survey located three of the four monitoring wells in usable condition (ATF3, ATF8, and ATF10 – see Figure A-5) that were within the previous contaminated groundwater plume or downgradient of the plume. Historically, monitoring well ATF3 had the highest DRO concentration and will be used to determine the current status of groundwater contamination. Monitoring wells ATF8 and AFT10 are downgradient of the release area and could be used to determine the current extent of contamination. Monitoring well ATF1, which was not located during the October 2019 survey, was positioned cross-gradient of the abandoned tank farm and historically had a DRO concentration approximately half that of monitoring well ATF3.
