2016 Five-Year Review Report for Sites OT001 and LF002 at Kalakaket Creek Radio Relay Station, Alaska

**United States Air Force
Joint Base Elmendorf-Richardson, Alaska**

April 2016

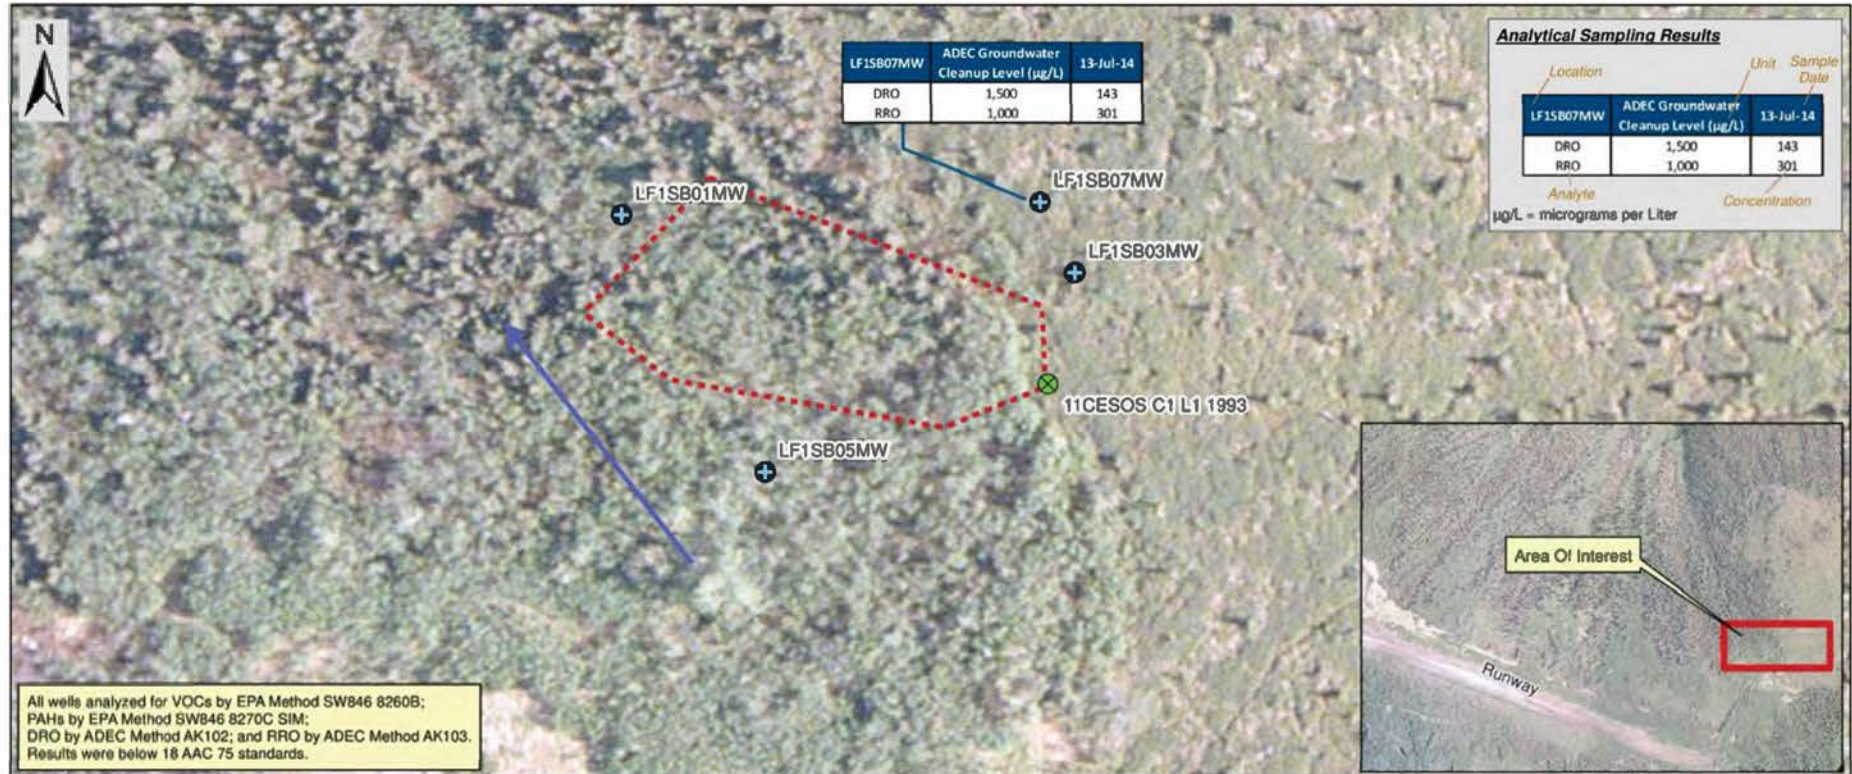
In 2013, three of the four wells at LF1 contained insufficient volumes of groundwater for the field team to collect samples, and the amber bottles containing the groundwater samples from the fourth well (LF1SB07MW) broke during shipment to the laboratory. Therefore, there was insufficient sample volume to analyze the LF1 groundwater sample for DRO and RRO in 2013 (USAF, 2014). In 2014, two wells at LF1 contained insufficient volumes of groundwater for the field team to collect complete samples, so only vials for VOC and GRO analyses were collected (USAF, 2015). A third well at Site LF002 contained insufficient groundwater for the field team to collect any samples in 2014, leaving only one well at LF1 with adequate groundwater for complete analysis. In 2012 and 2014, all analytes detected in LF1 groundwater were at concentrations substantially below their respective ADEC groundwater cleanup levels (Figure 6-2 – USAF, 2013; 2015).

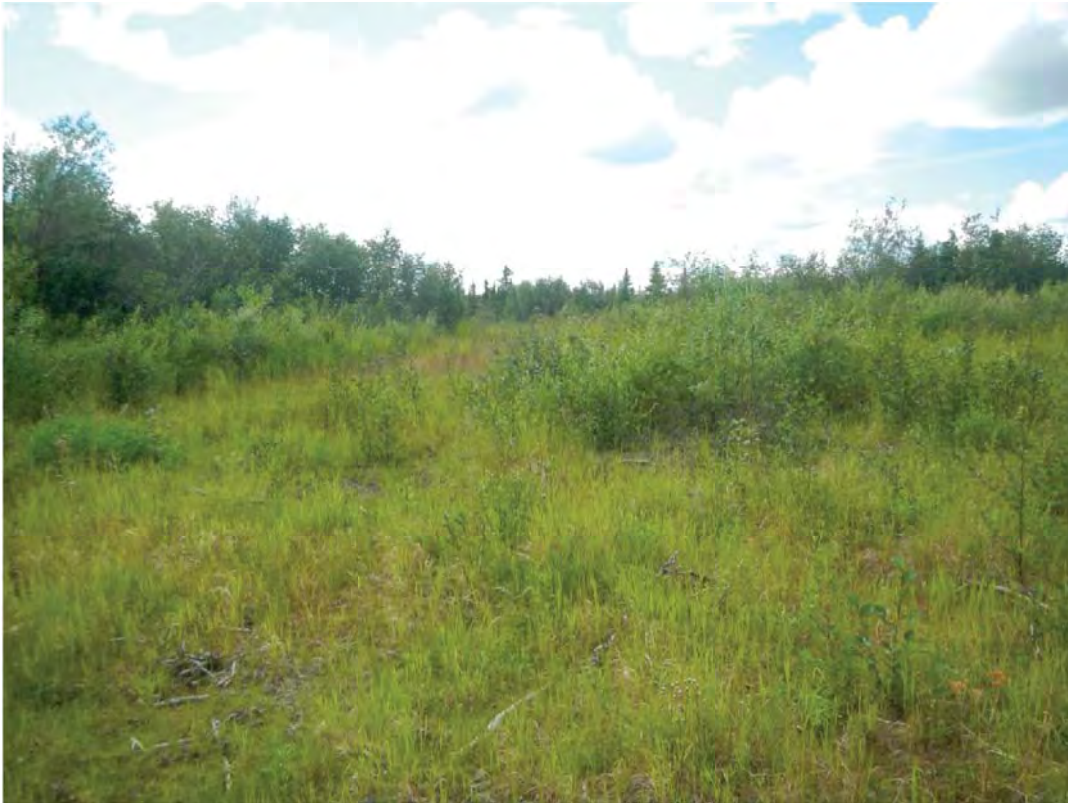
Photo 11: Site LF002, subarea LF1; view of vegetated access road/trail.
