TECHNICAL ASSISTANCE TEAM  
ON-SCENE COORDINATOR  
REPORT FOR:

Alaska Husky Battery  
Anchorage, Alaska

TDD T10-8810-039

REPORT PREPARED BY: ECOLOGY AND ENVIRONMENT, INC.  
PROJECT MANAGER: THOMAS ASHLEY  
DATE: DECEMBER 1988

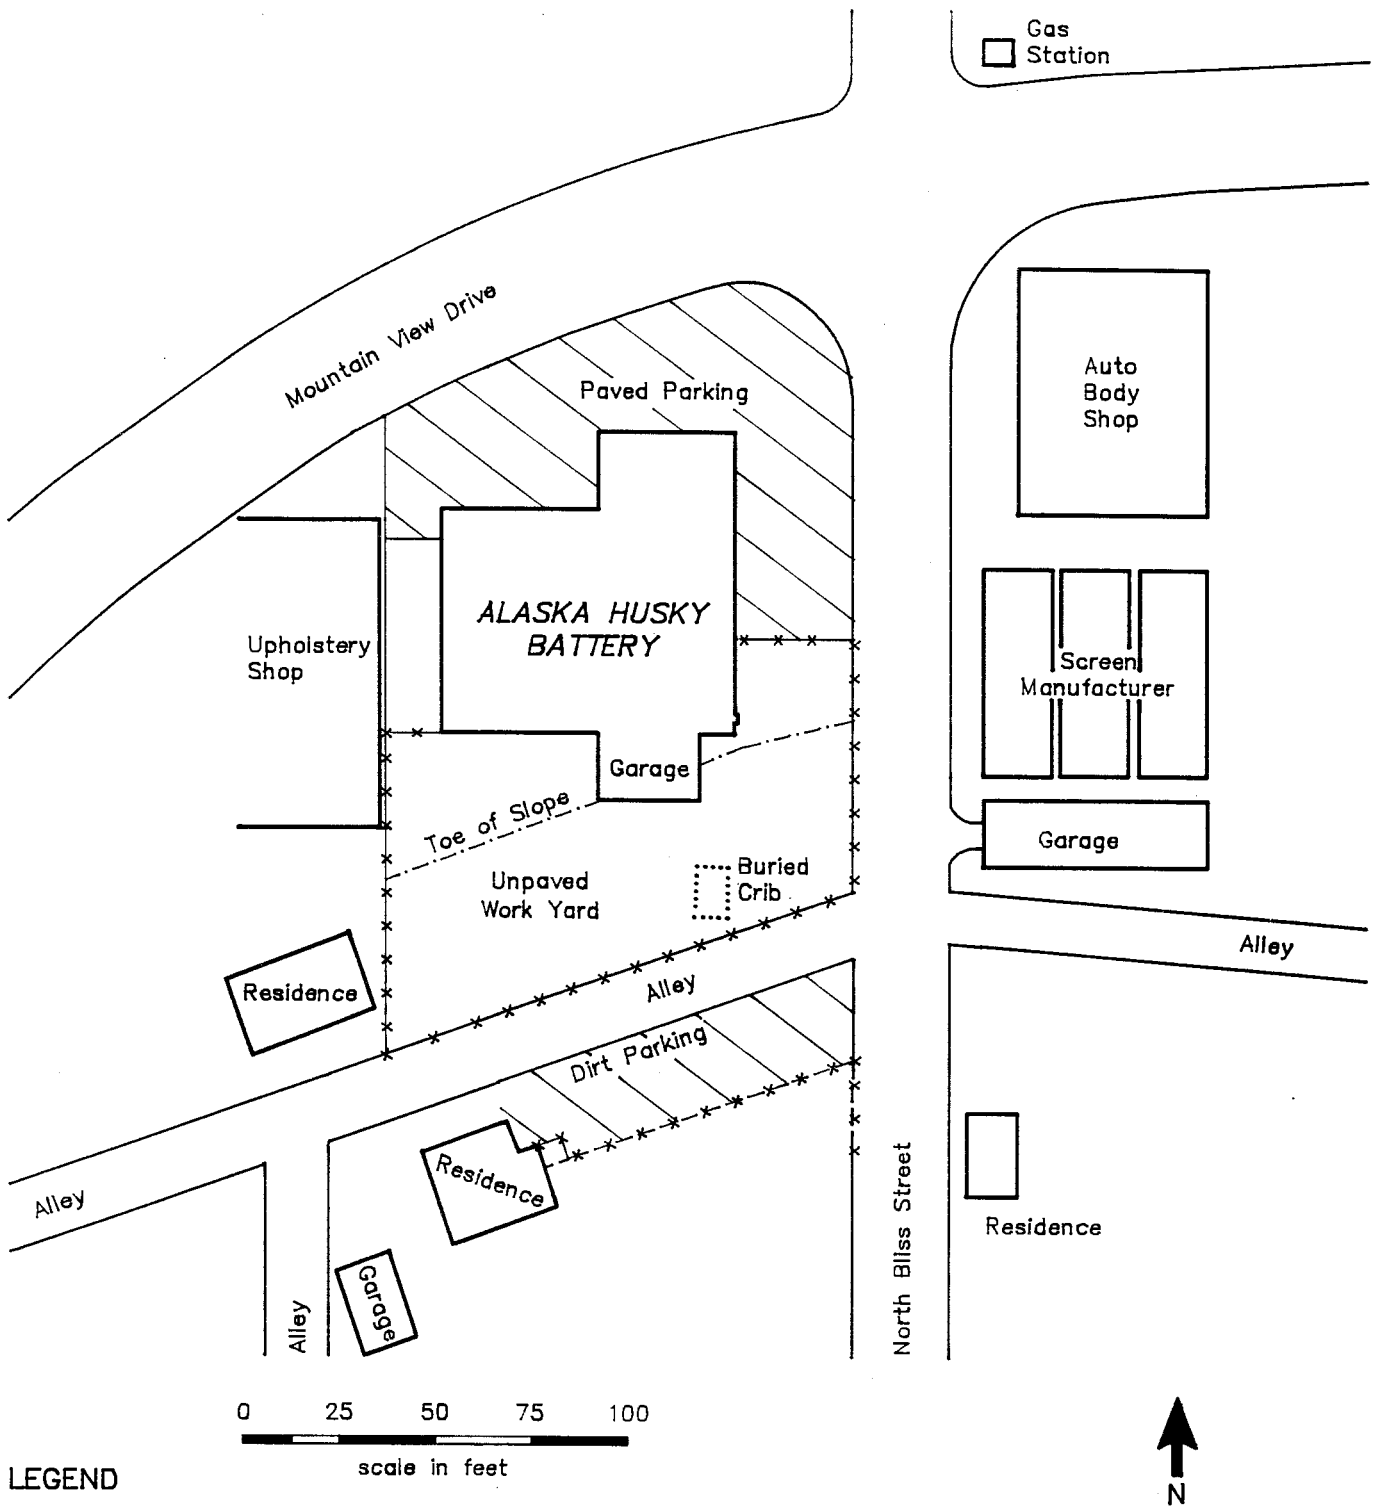
**FIGURE 2**  
**SITE MAP**  
**ALASKA HUSKY BATTERY**  
**Anchorage, AK**

Prior to 1962, all domestic and process wastewaters were discharged to a buried wooden crib located south of the AHB building (Figure 2). The 8 ft x 16 ft x 4 ft (deep) crib was constructed of 12 inch diameter timbers and was buried to a depth of approximately 10 feet below ground surface (bgs). In 1962, city sewer services were provided to the Mountain View area. At that time, the line feeding the crib was extended to the sewer main located under the alley south of the site.

The AHB site is bisected by a 45° slope which runs east-west across the property (see Figure 2). The high ground north of the slope is occupied by the AHB building and the paved parking area. The low ground to the south of the slope is occupied by a relatively flat, unpaved work yard which slopes gently to the southwest. The total change in elevation at the site is approximately 12-13 feet.

Runoff from the paved parking area flows north and east and is accommodated by concrete gutters adjacent to Mountain View Drive and North Bliss Street, respectively. Runoff from the unpaved work yard flows southwest toward the alley and proximate residences (see Figure 2).

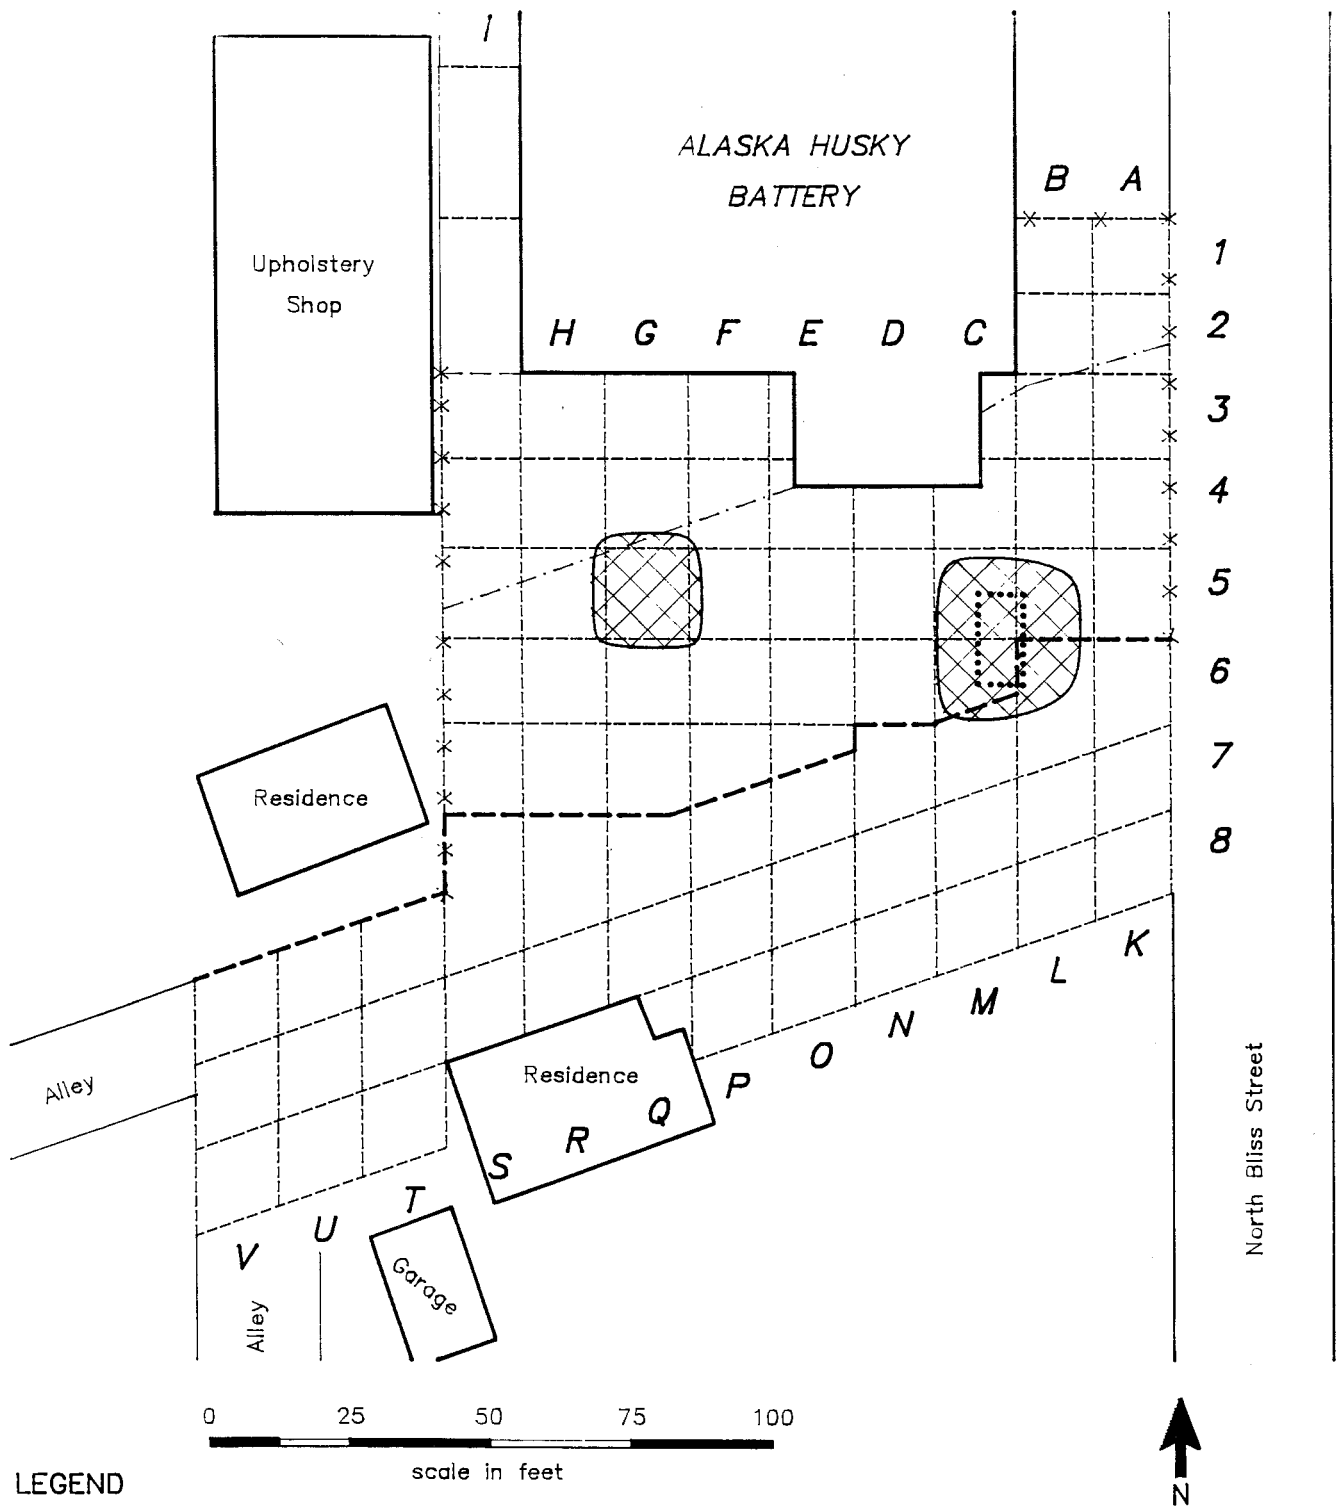
**FIGURE 8**  
**EXCAVATION LOCATIONS**  
 ALASKA HUSKY BATTERY  
 Anchorage, AK

Excavation of subsurface soils was required in two locations on the AHB premises (photographs 7 through 9)(Figure 8), and was performed using a trackhoe. Groundwater was not encountered in either location.

PCB and trichlorobenzene contamination of subsurface soils (photographs 14 through 16) was encountered in the west-central portion of the unpaved work yard (Figure 8). "Progress evaluation" samples were collected from the bottom and walls of the excavation and analyzed for lead, PCB and TCB. Excavation of contaminated soils was performed in one foot increments as described above. When completed, the excavation measured approximately 16 ft x 21 ft x 13 ft deep (approx. volume - 160 cubic yards). Two cleanup verification samples were collected from the bottom of the excavation prior to backfilling. One of the samples was analyzed for PCB and TCB, the other for PCB only. Analytical results indicated PCB concentrations of 4.6 and 3.8 ppm, respectively; TCB was not detected (at a 1 ppm detection level) in the applicable sample.

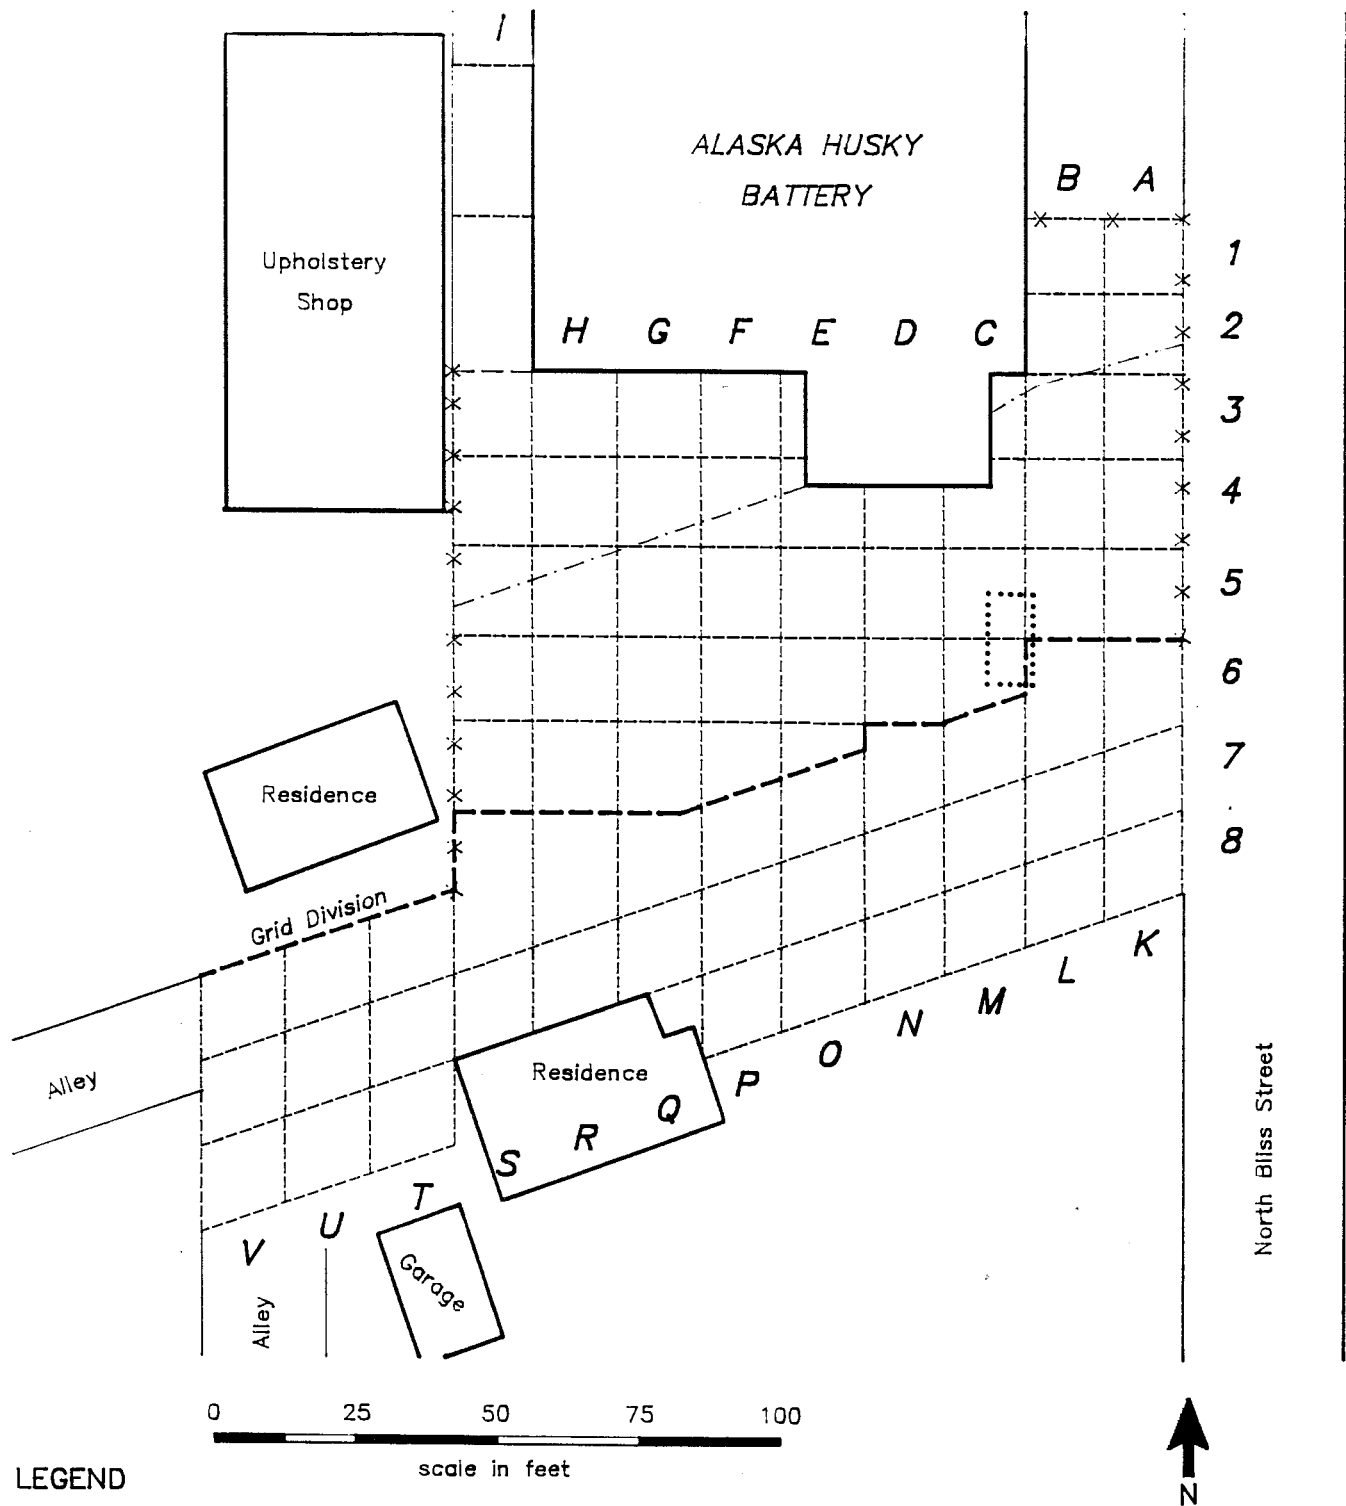
**FIGURE 9**  
**VERIFICATION SAMPLING GRID**  
 ALASKA HUSKY BATTERY  
 Anchorage, AK

Cleanup verification sampling was conducted within the 12 ft x 15 ft grid system shown in Figure 9. Application of this grid system resulted in a 4-fold increase in sampling intensity over the sampling conducted during the May 1988 site assessment. Surface soil samples (i.e., 0-3 inches bgs) were collected from the approximate center of each grid in the absence of visual indications of contamination. If potential visual indications (i.e., staining, saturation) were present, a sample was collected from the area. When analytical results indicated the presence of lead or PCB contamination exceeding the established clean up levels, surface soils were excavated to a depth of 6 inches bgs, and the grid was resampled. Residual (i.e., post removal) surface soil lead and PCB levels are presented in Figures 10 and 11, respectively.
