**FINAL REPORT
MATANUSKA RIVER DEBRIS SITE ASSESSMENT
PALMER, ALASKA**

**Alaska Department of Environmental Conservation
555 Cordova Street
Anchorage, Alaska, 99501**

**OASIS Environmental, Inc.
807 G Street, Suite 250
Anchorage, Alaska 99501**

25 August 2004

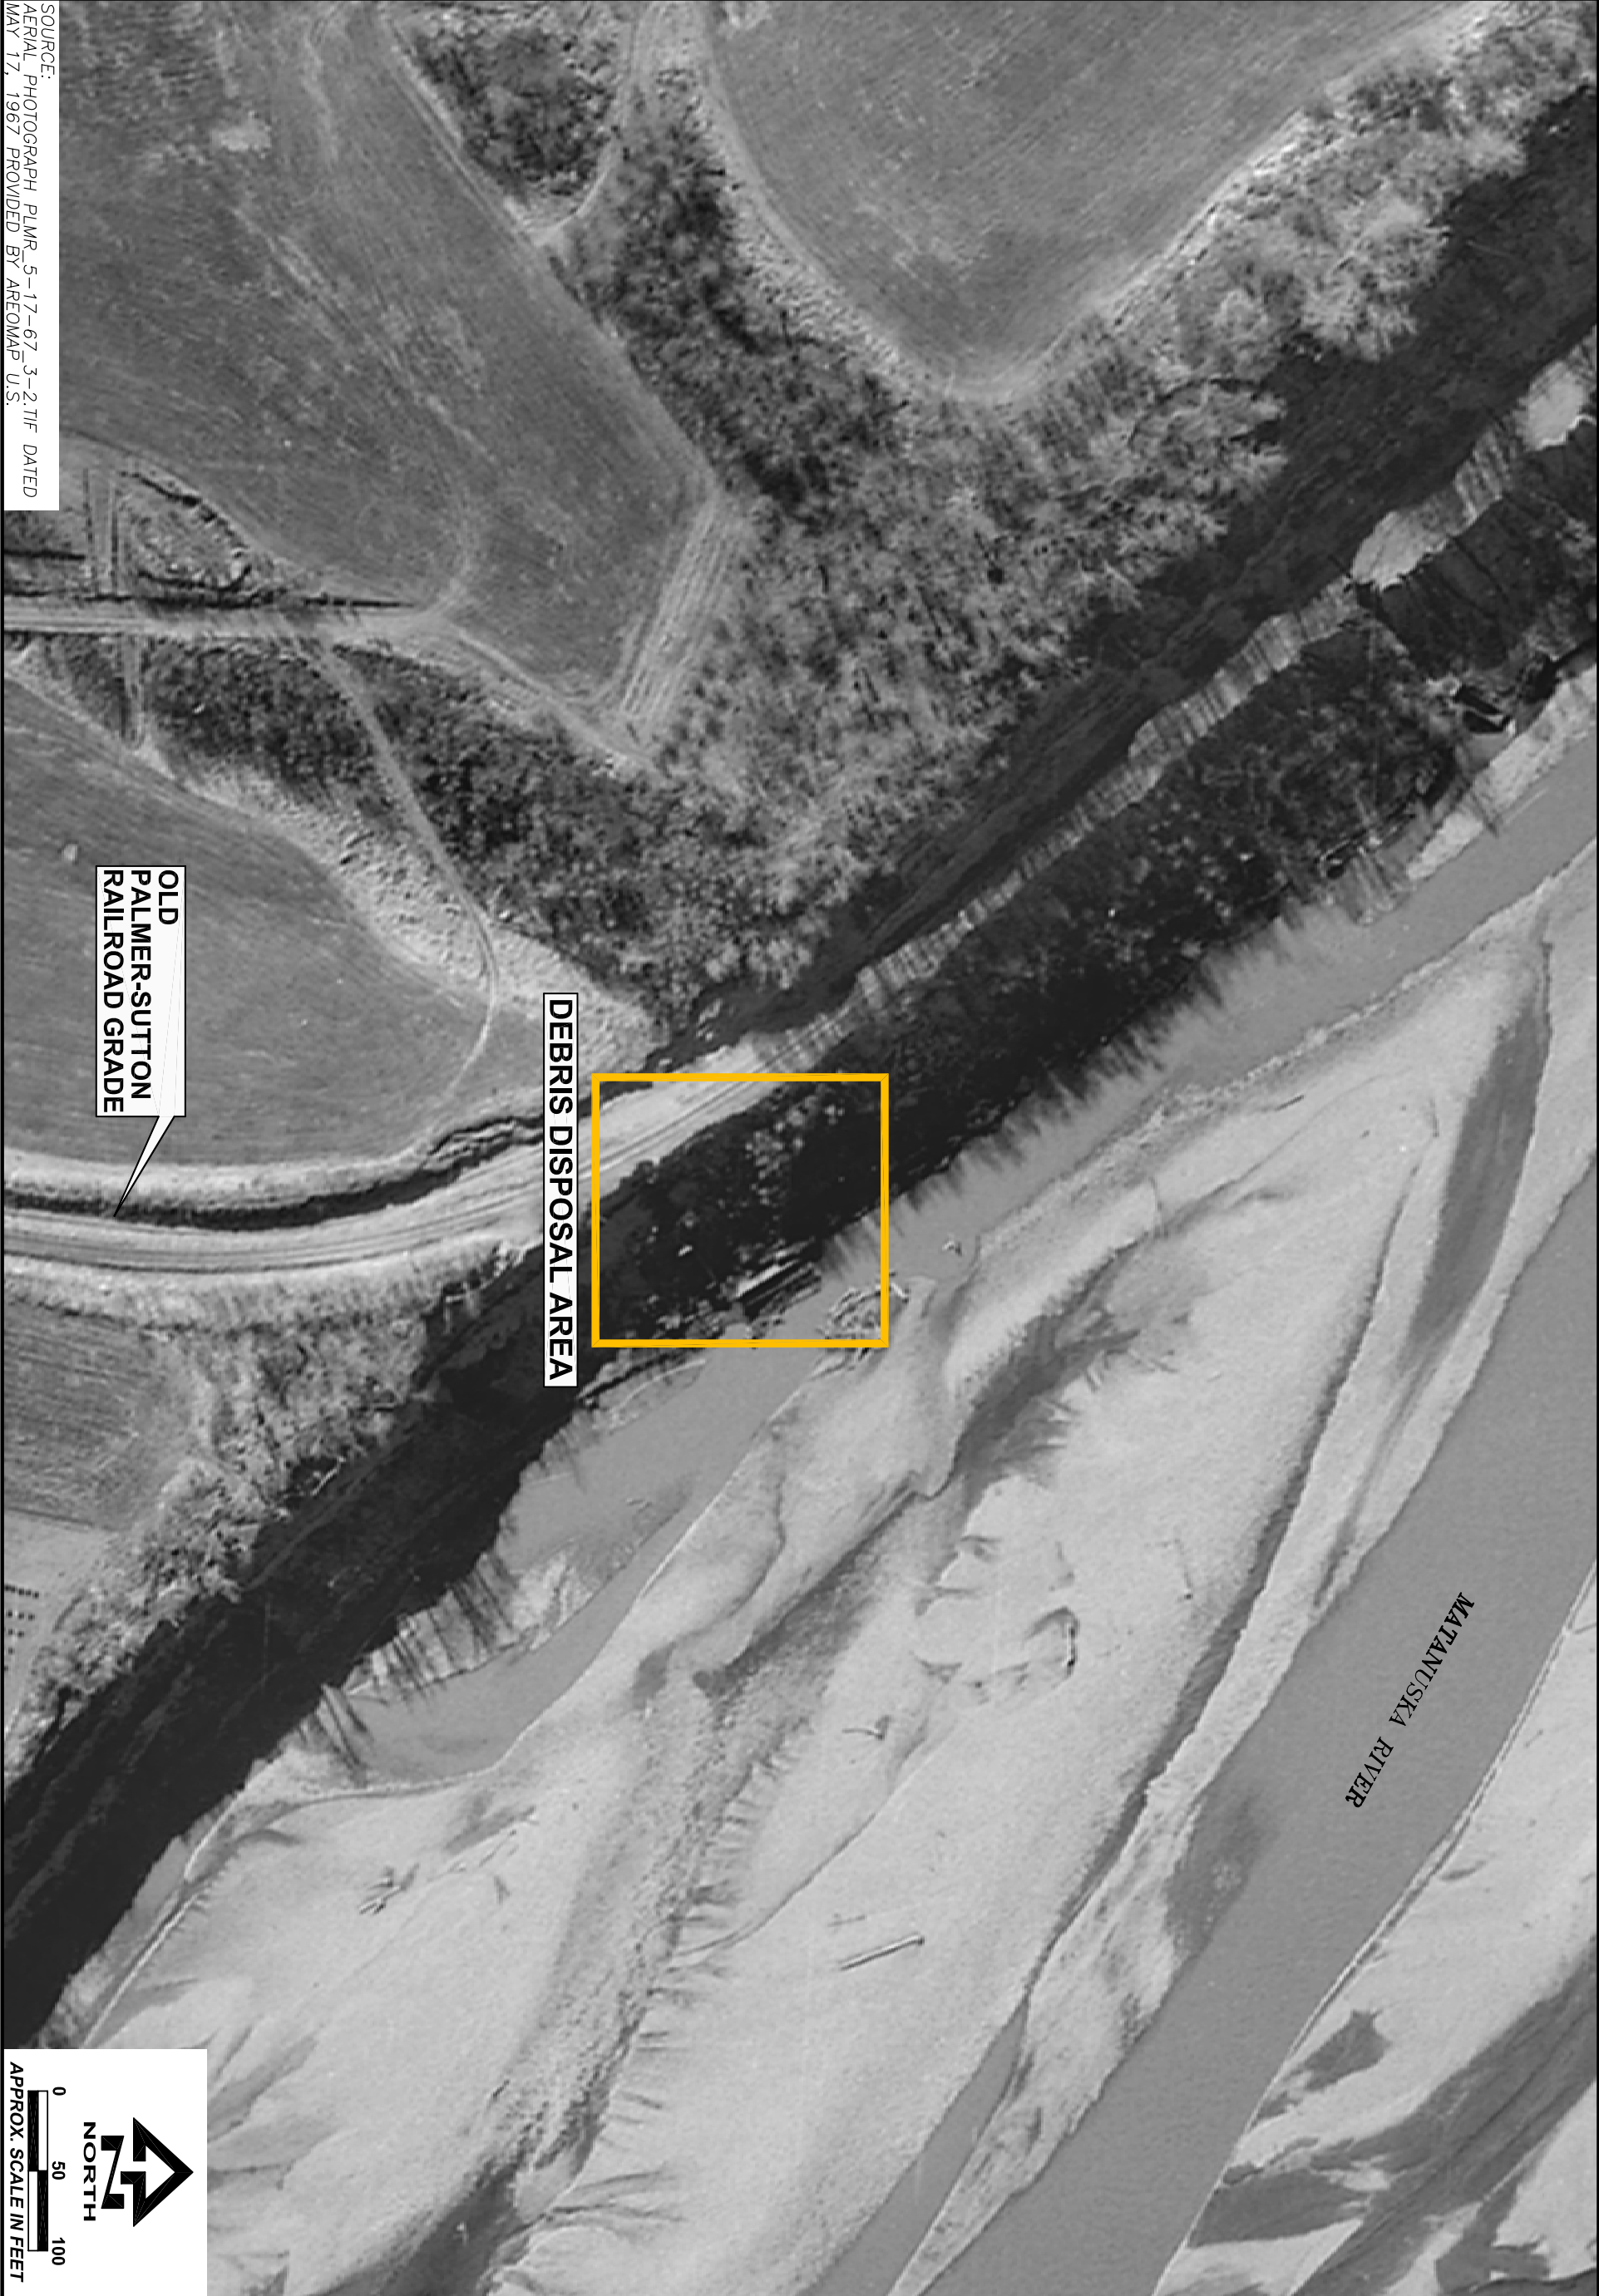
Figures 2 through 5 are aerial photos that depict general site features at various times. Figure 2 is a May 1967 aerial photo that shows the site conditions before the Alaska Railroad Corporation reportedly abandoned the Palmer to Sutton rail line in 1969. Figure 3 is a May 1989 aerial photo that shows evidence of debris accumulations within the debris disposal area. Figures 4 and 5 are May 2000 and September 2003 aerial photos of the same area.

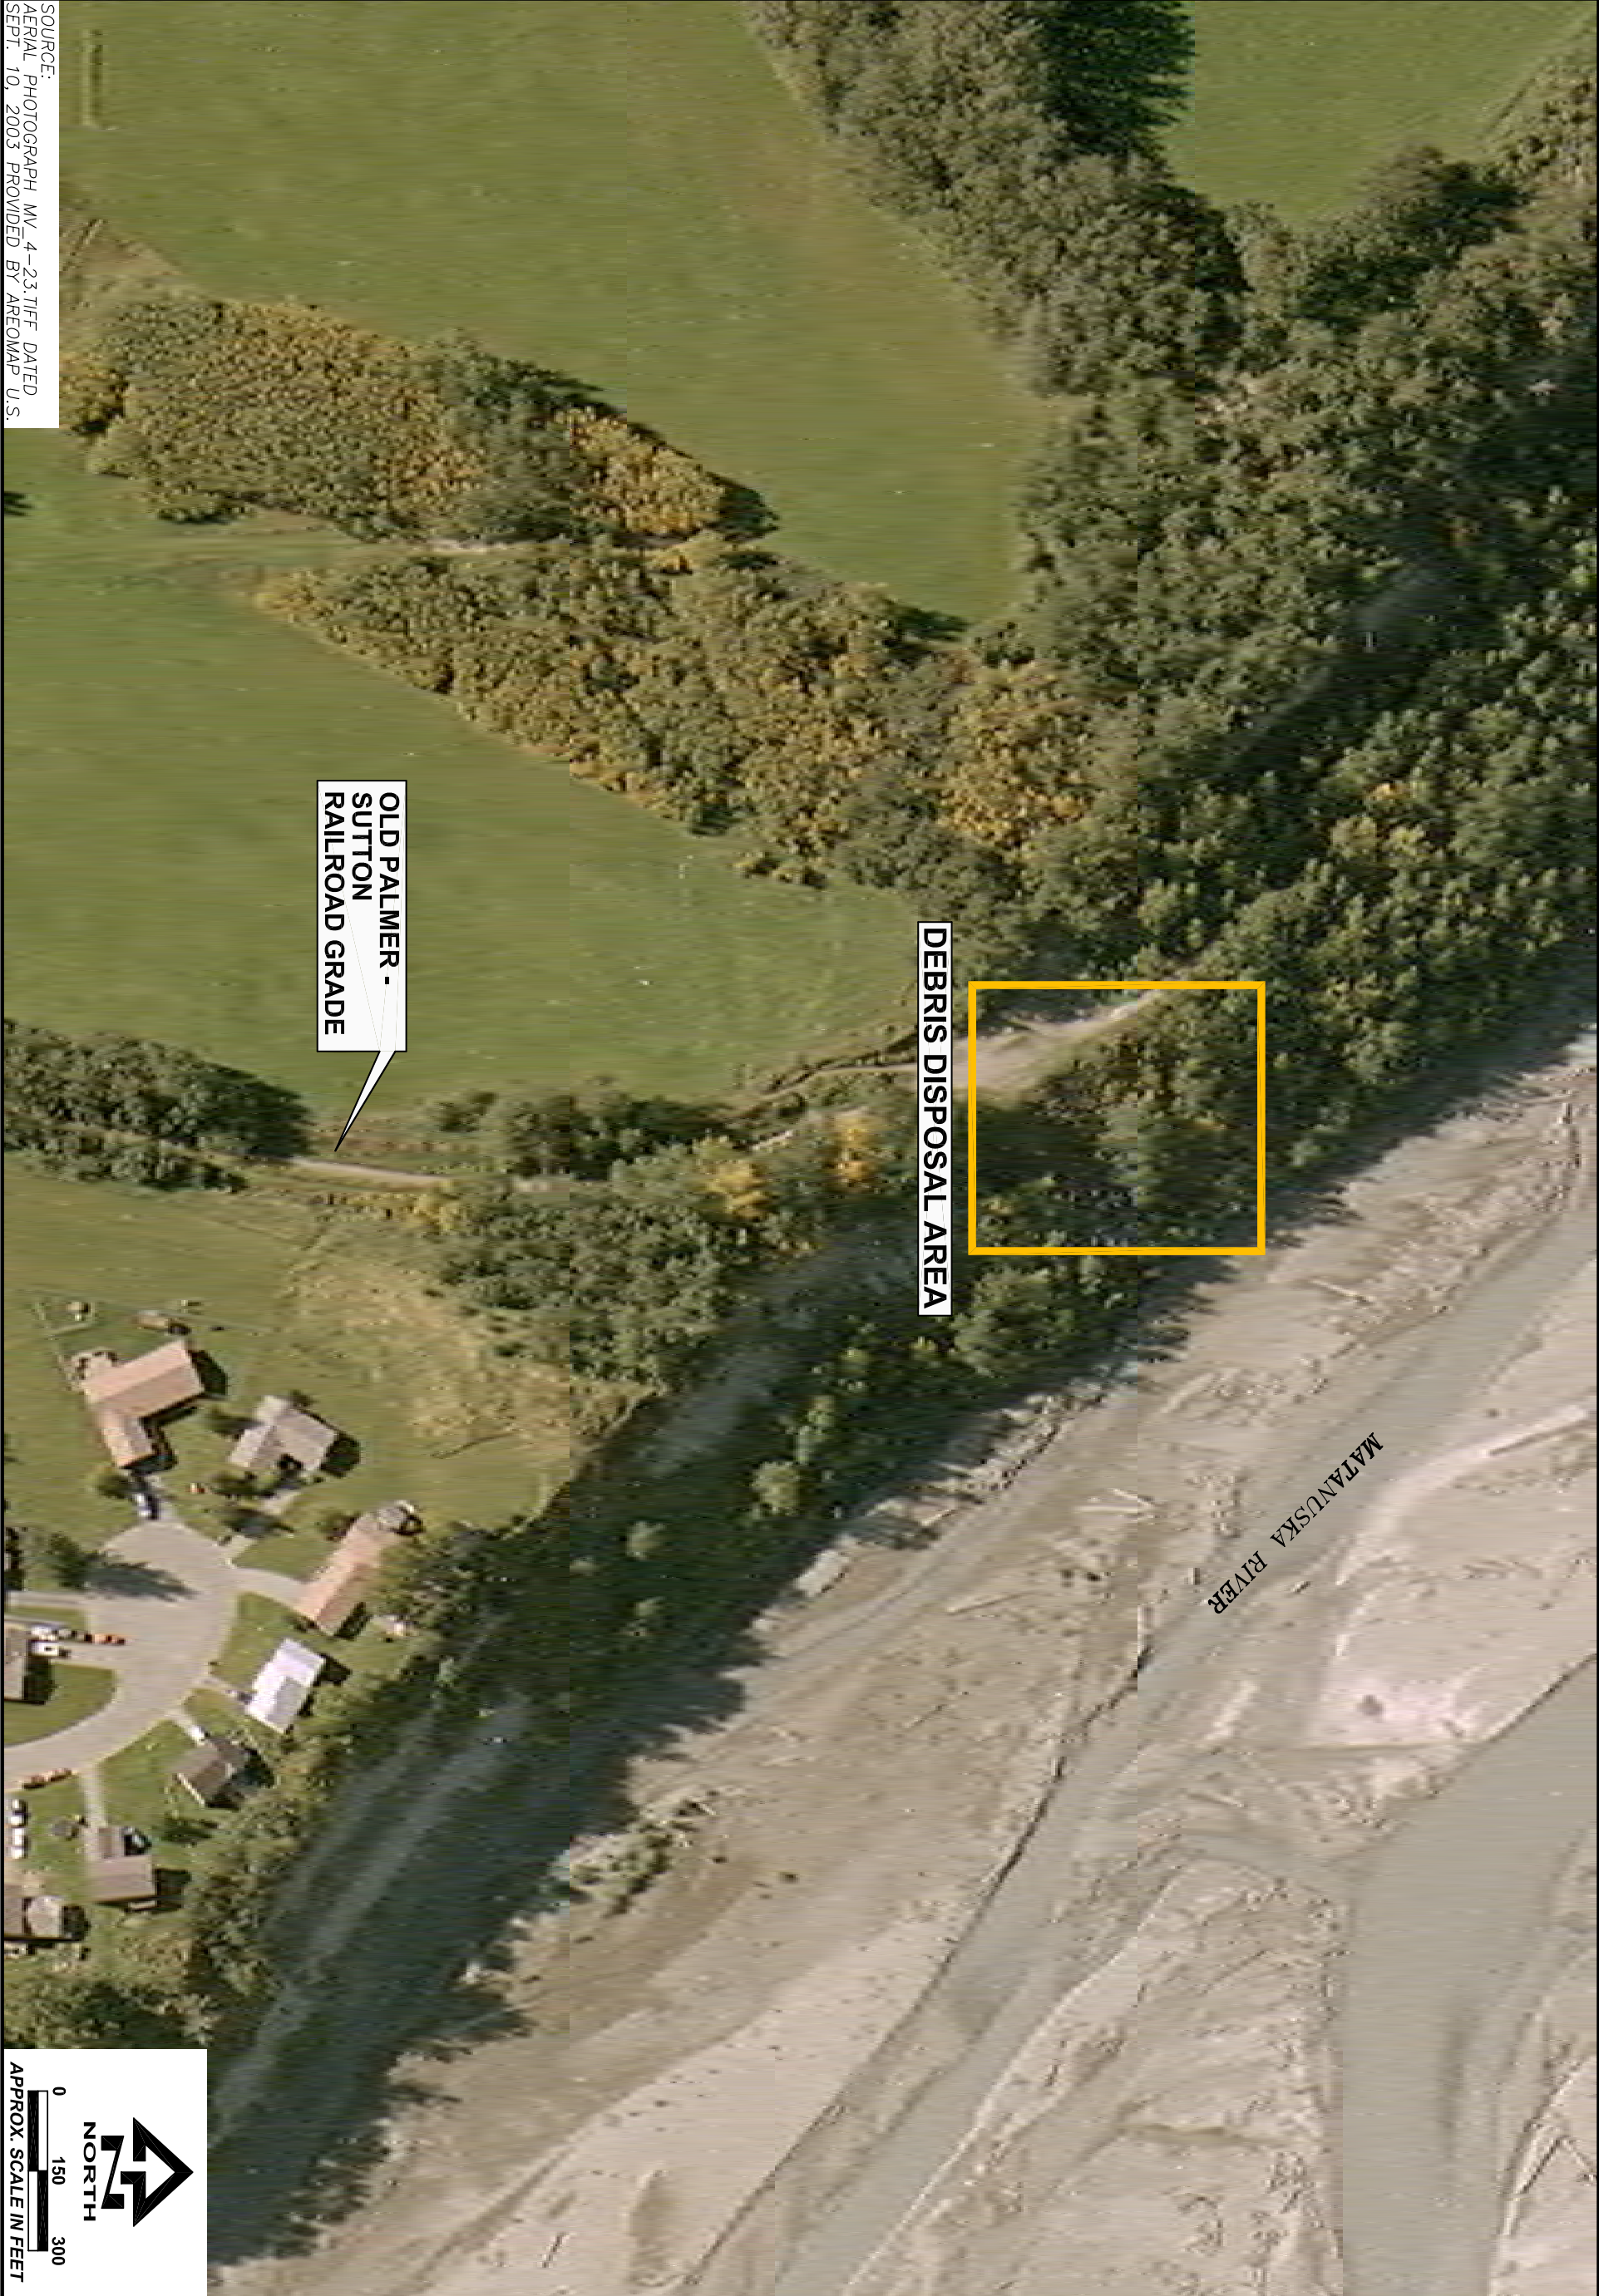
FIGURE
5

SITE MAP
SEPTEMBER 10, 2003 PHOTOGRAPH
MATANUSKA RIVER DEBRIS SITE ASSESSMENT
Palmer, Alaska

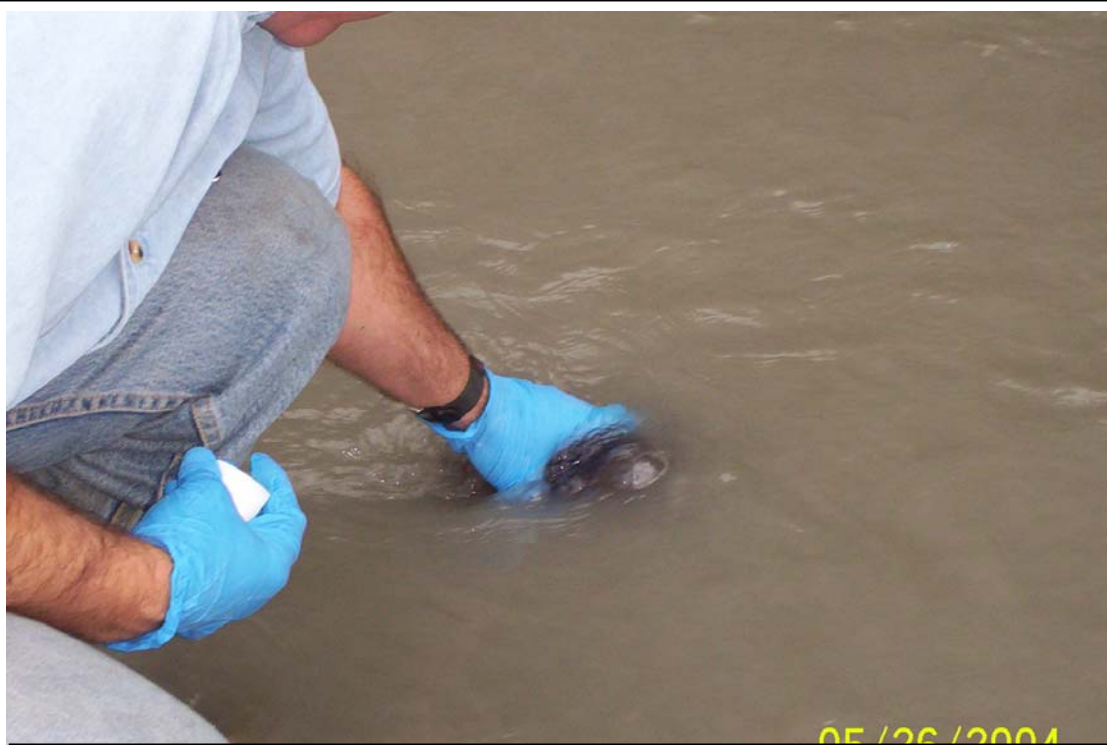
Photo #19 – Looking east at surface water and sediment sample location MD-02. Samples were collected on the far side (debris site) of the Matanuska River. (5/26/2004)
