FINAL  
LOWER JORDAN CREEK  
RIPARIAN ASSESSMENT

Organization Name: Juneau Watershed Partnership/Southeast Alaska Watershed Coalition

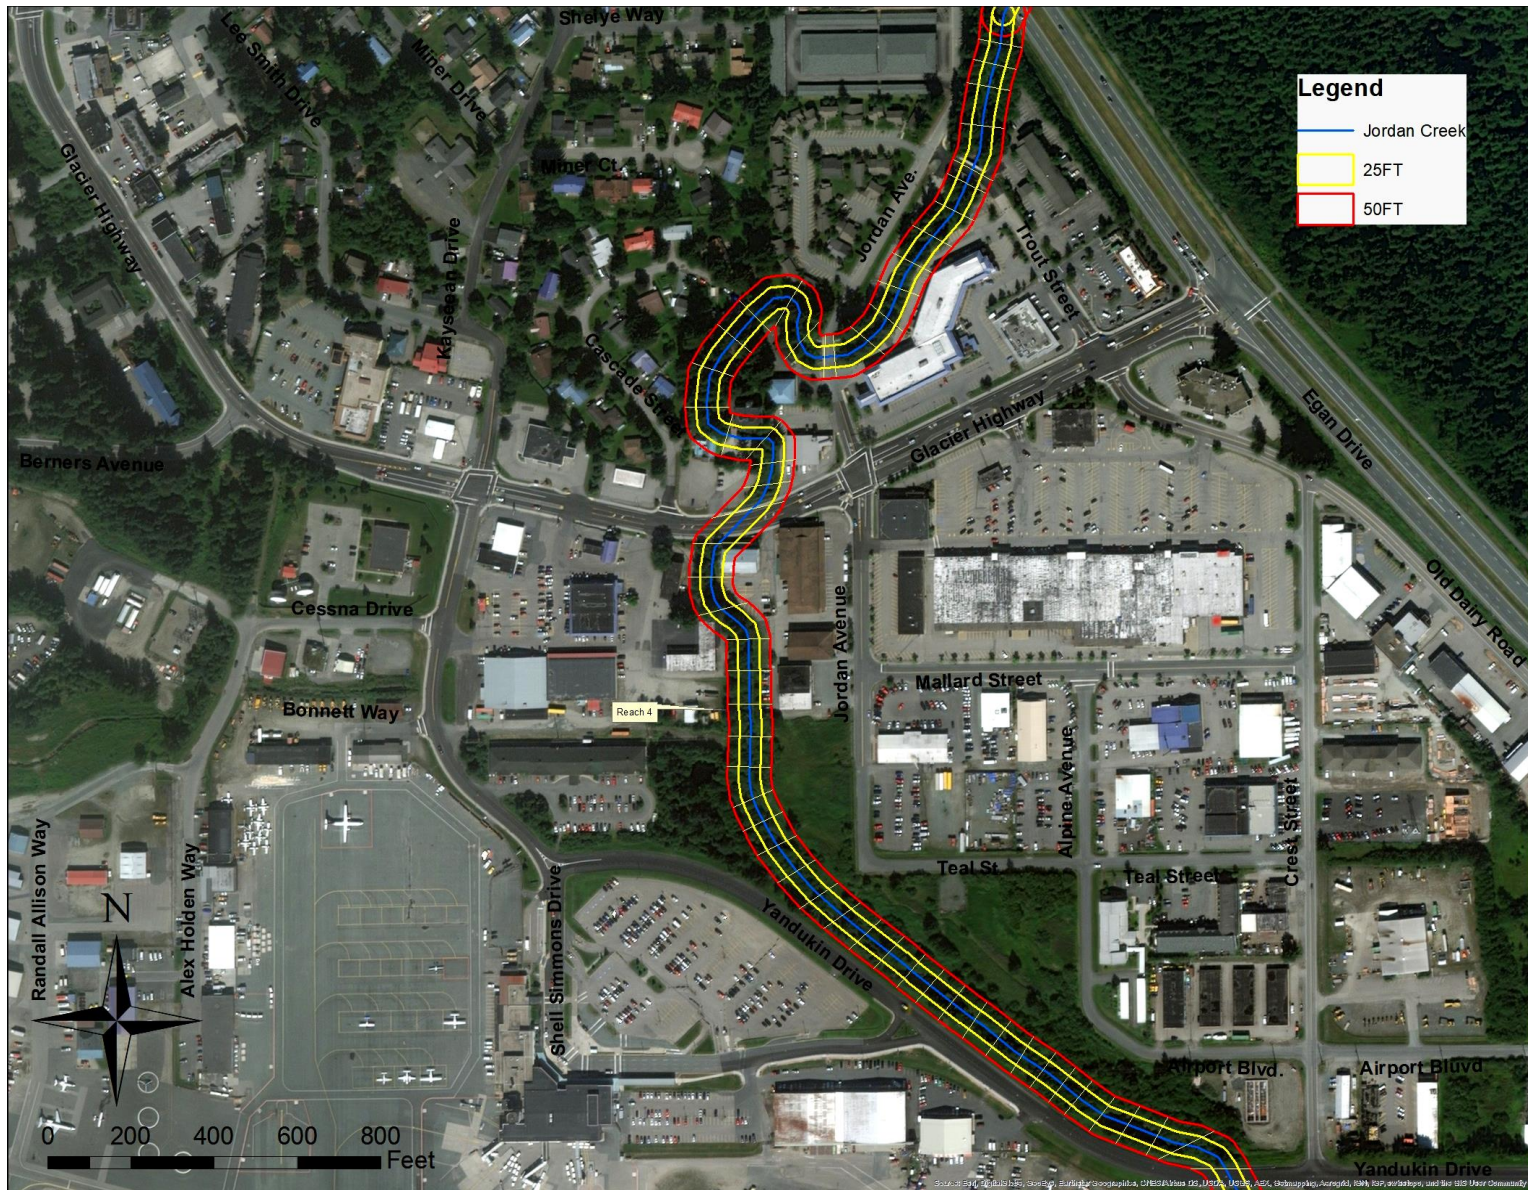
**Figure 1.** Map showing each reach, section and streamside setbacks along lower Jordan Creek. The stream flows north to south, with the right bank on the western side. This is for visualization purposes only; breaks between stream Sections were estimated using GPS waypoints and setbacks projected using the buffer tool in ArcGIS.

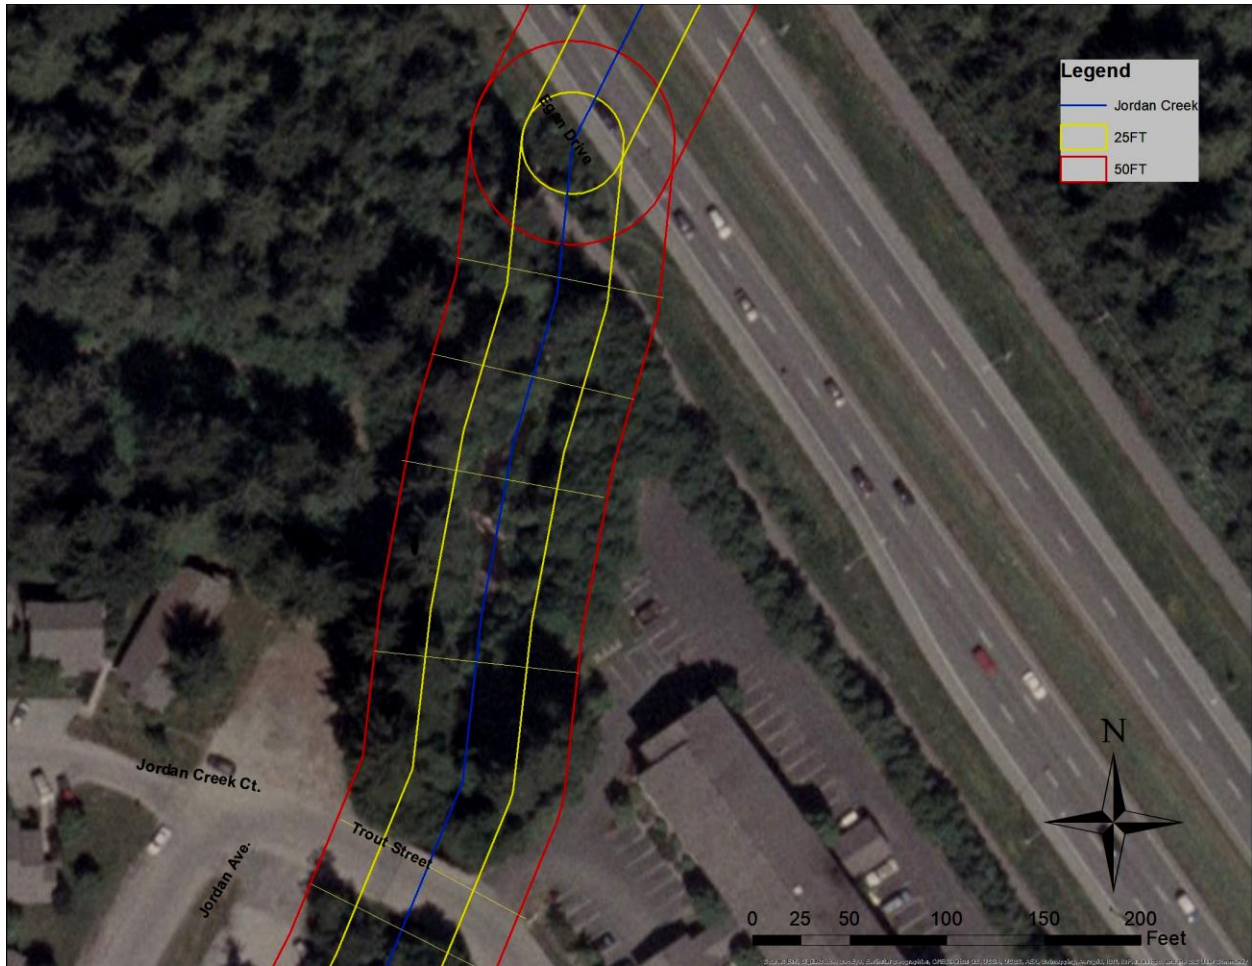
Reach 1 is bordered by Jordan Avenue on the right and Motel 8 on the left. Riparian vegetation on the right bank is largely intact, with large spruce trees and other native vegetation. The spruce overstory provides excellent canopy cover. The left bank is impacted by impervious surfaces and invasive plant species in both the 25- and 50-foot setback. Garbage was found throughout the reach, particularly on the right bank.

**Figure 3.** The 25 and 50-foot streamside setbacks along Reach 1 of lower Jordan Creek (yellow and red, respectively). The stream flows north to south, with the right bank on the western side. This is for visualization purposes only; breaks between stream Sections were estimated using GPS waypoints and setbacks projected using the buffer tool in ArcGIS. Note that the aerial photograph is not current, as Jordan Avenue has been extended, and a new storage unit and condominium complex has been built to the north-west of Jordan Creek Court, as shown in Figure 1.

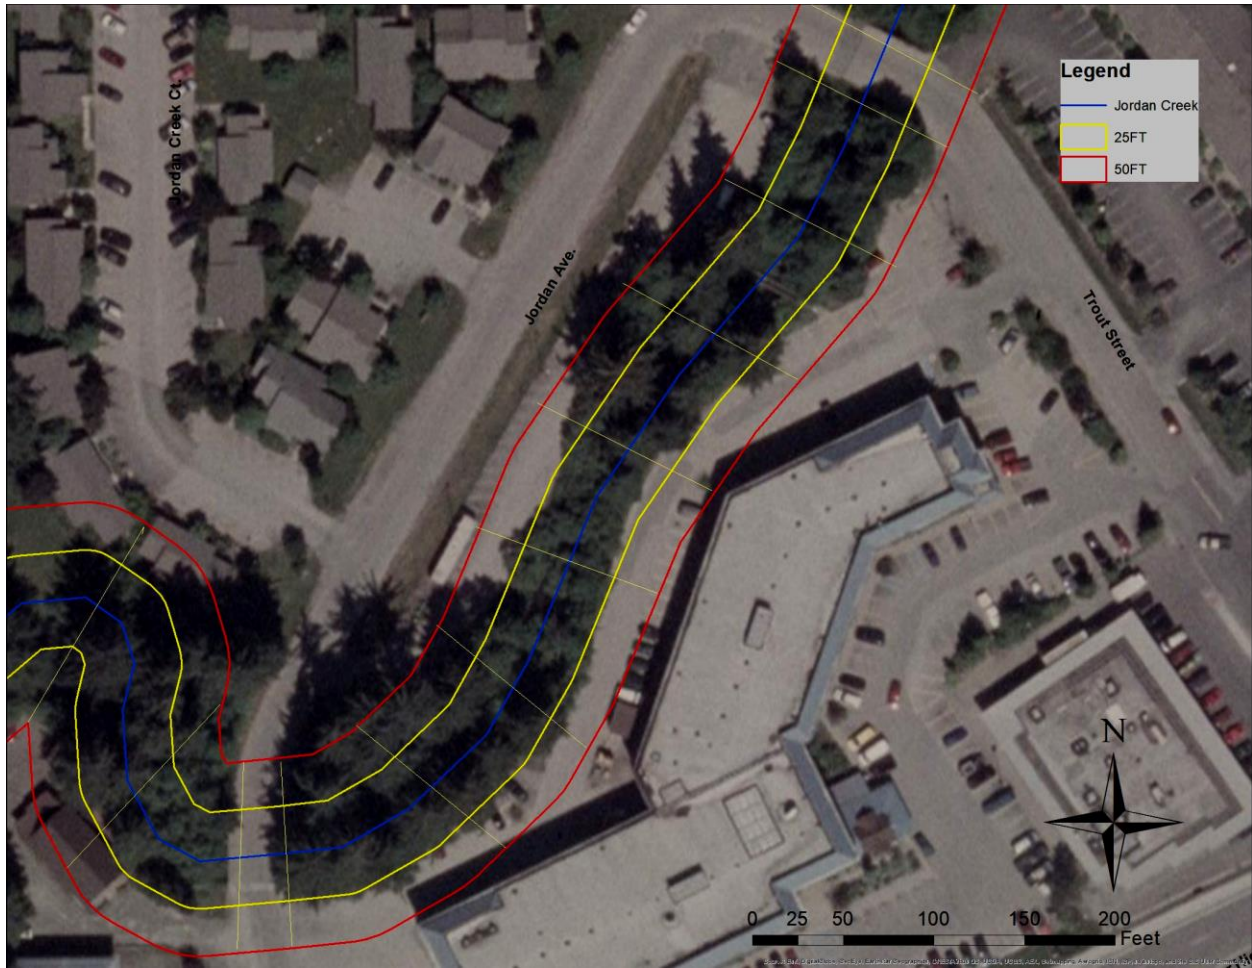
Reach 2 is bordered by the Jordan Creek Center on the left and Jordan Avenue on the right. Reach 2 has the greatest percent of the riparian zone developed with impervious surfaces in both the 25- and 50-foot setbacks. The 50-foot setback on the left bank consists almost entirely of paved parking.

**Figure 5.** The 25 and 50-foot streamside setbacks along Reach 2 of lower Jordan Creek (yellow and red, respectively). The stream flows from northeast to southwest in this reach, with the right bank on the western side. This is for visualization purposes only; breaks between stream Sections were estimated using GPS waypoints and setbacks projected using the buffer tool in ArcGIS.

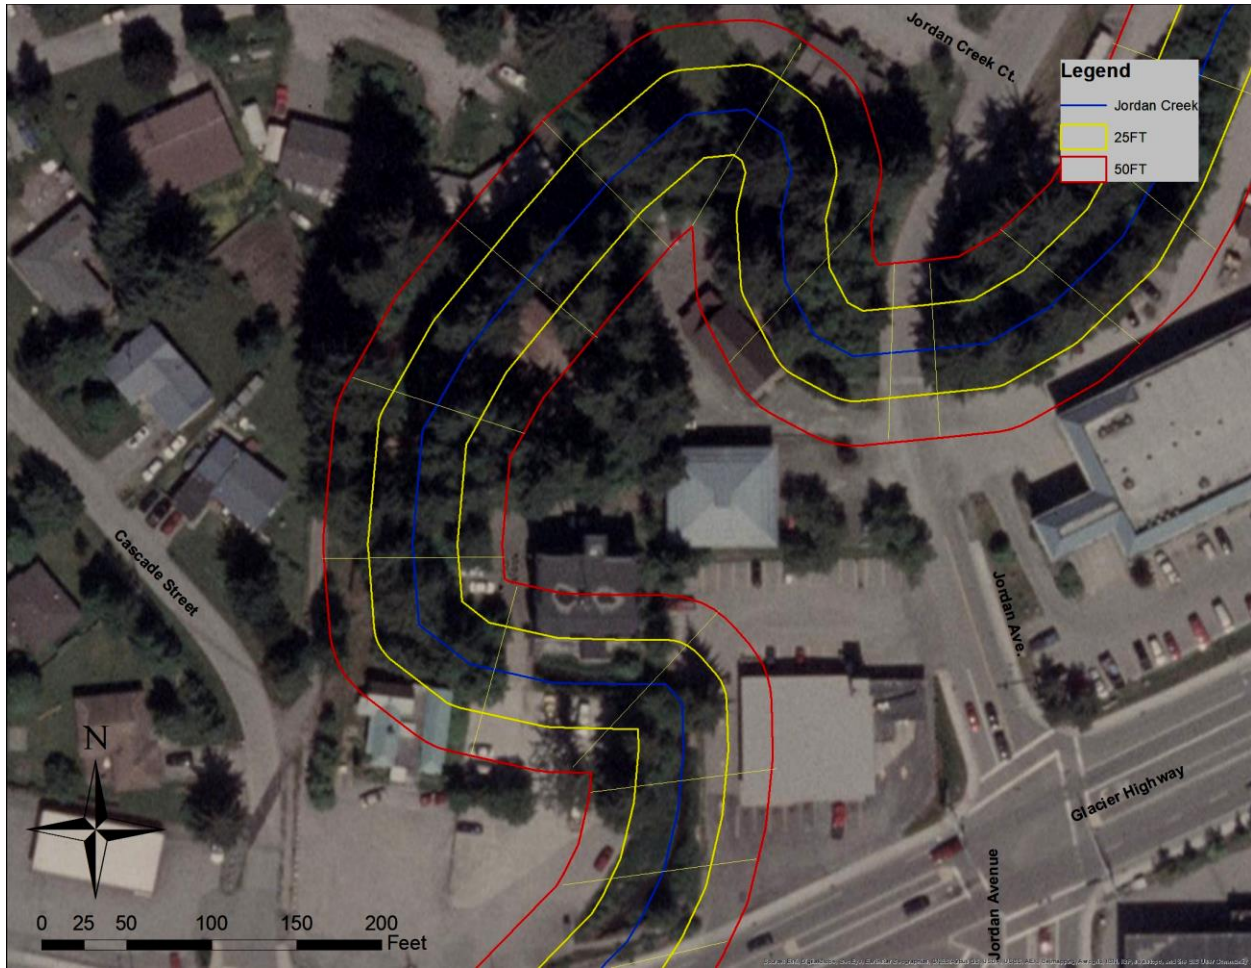
A residential area borders Reach 3 on the right and several commercial properties border it on the left. This reach meanders around the Jordan Square Building. The difference in land use has preserved native vegetation on the right bank, with some sections entirely free of invasive plant species. However, reed canarygrass dominates in the downstream sections immediately adjacent to Glacier Highway. Both banks are impacted by impervious and pervious surfaces associated with development. This reach is known to cause flooding on adjacent properties. A streambank stabilization project was completed on the upstream end of the reach on the left bank.

**Figure 7.** The 25 and 50-foot streamside setbacks along Reach 3 of lower Jordan Creek (yellow and red, respectively). The stream flows roughly north to south, meandering around the Jordan Square Building. The right bank is located on the western side. This is for visualization purposes only; breaks between stream Sections were estimated using GPS waypoints and setbacks projected using the buffer tool in ArcGIS.

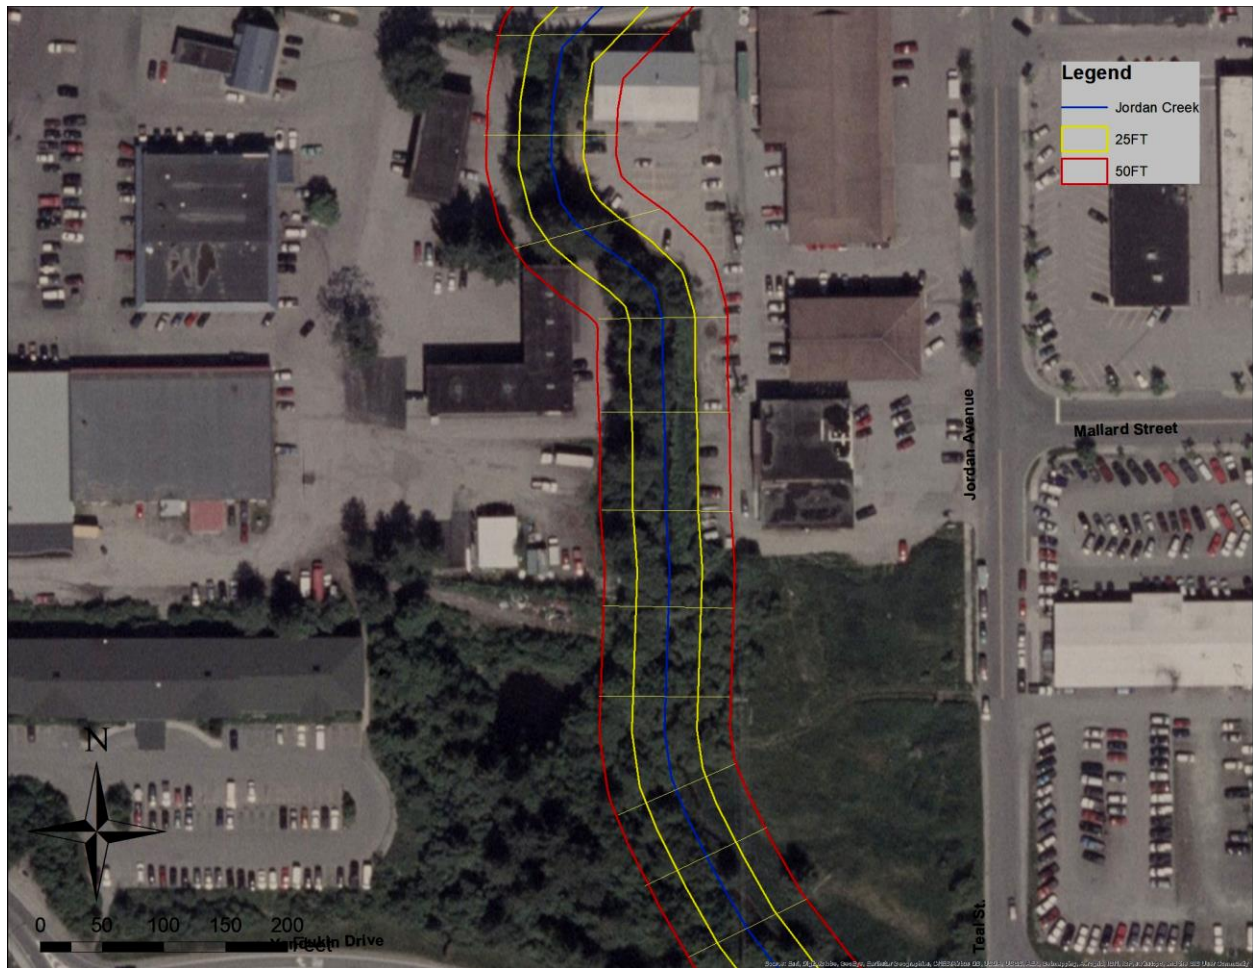
Reach 4 is bordered by office buildings and parking lots on both sides, resulting in the upstream half of this reach being severely impacted. The left bank, in particular, has a high percentage of impermeable surfaces including sections where both setbacks are almost entirely paved. There are notable problems with bank erosion throughout this reach. Invasive plant species begin to dominate the vegetated areas. Several improvements have occurred along the right bank including riparian plantings, streambank stabilization, protective fencing, and a rain garden.

**Figure 9.** The 25 and 50-foot streamside setbacks along Reach 4 of lower Jordan Creek (yellow and red, respectively). The stream flows north to south, with the right bank on the western side. This is for visualization purposes only; breaks between stream Sections were estimated using GPS waypoints and setbacks projected using the buffer tool in ArcGIS. Note that the aerial photograph is not current, as Jordan Avenue has been extended, and a new storage unit and condominium complex has been built to the north-west of Jordan Creek Court

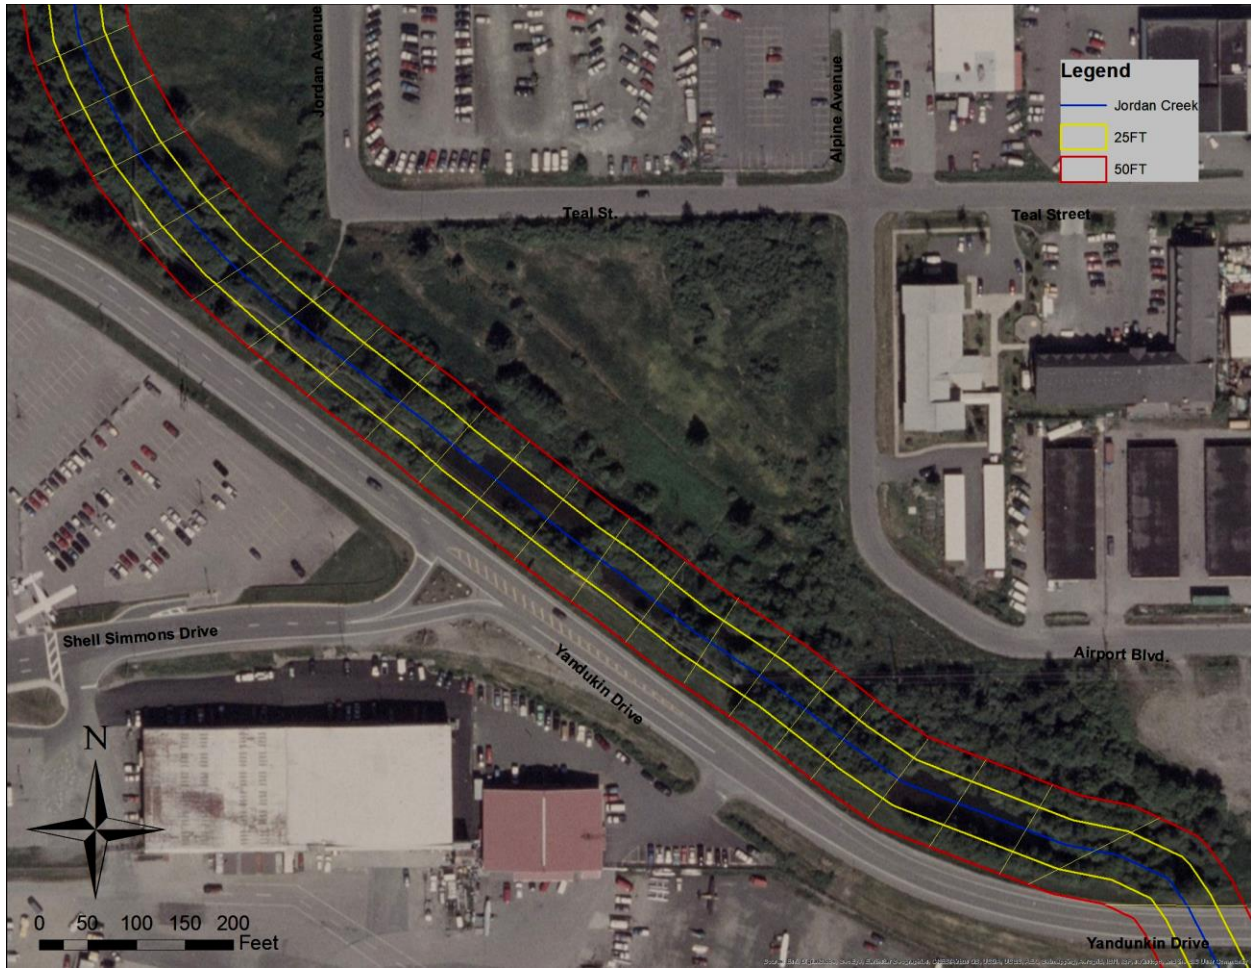
**Figure 11.** The 25 and 50-foot streamside setbacks along Reach 5 of lower Jordan Creek (yellow and red, respectively). The stream flows northwest to southeast, with the right bank adjacent to Yandukin Drive. This is for visualization purposes only; breaks between stream sections were estimated using GPS waypoints and setbacks projected using the buffer tool in ArcGIS.

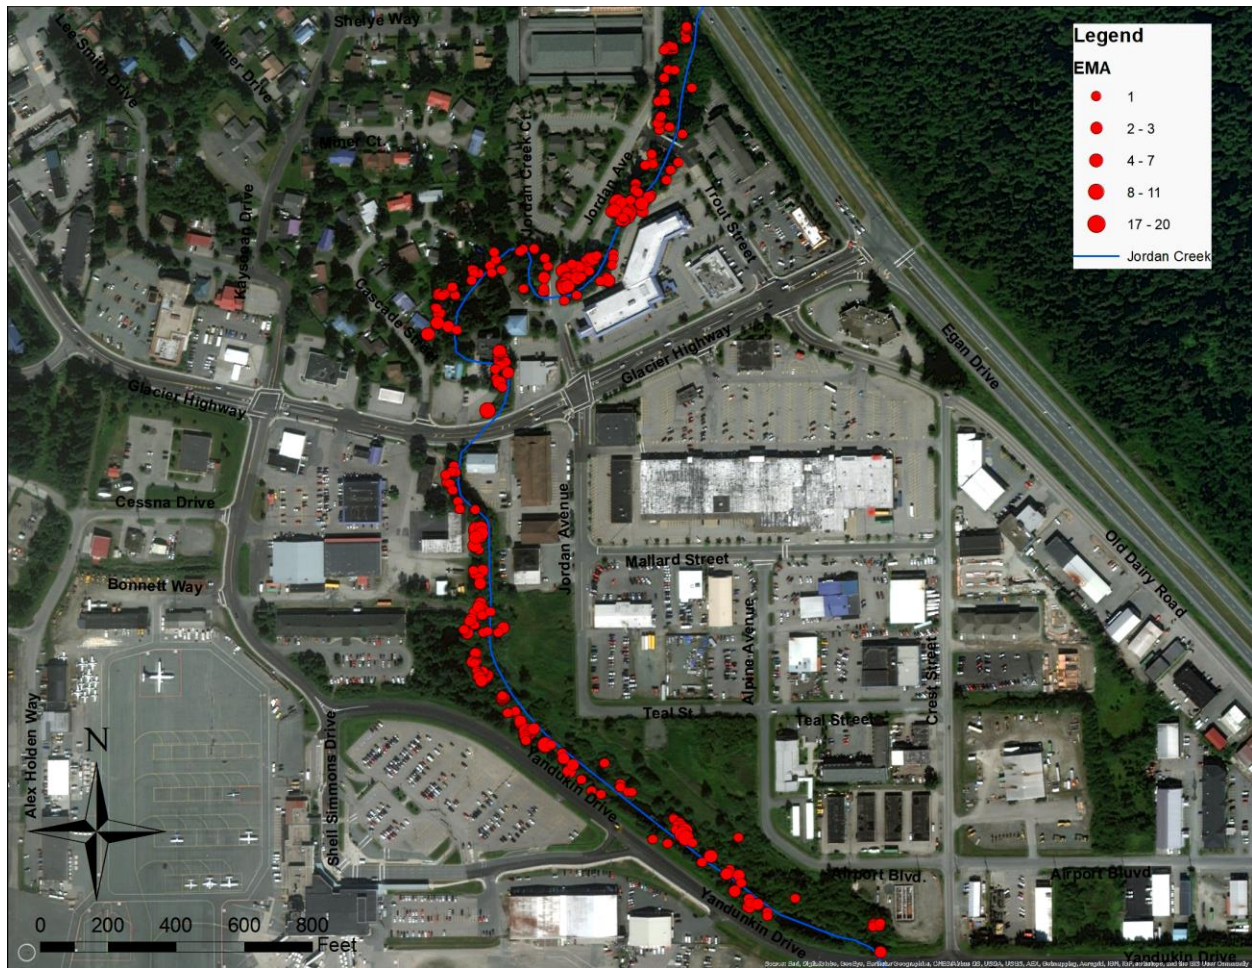
European mountain ash and European bird cherry were mapped and counted, as the occurrence of these species are of interest. European mountain ash was found throughout the lower Jordan Creek riparian area, while (Figures 16). The likely reason for the prevalence of European mountain ash is that it is a common landscaping tree and numerous trees have been planted near the west side of Reaches 1 and 2. The USFWS has been treating European mountain ash in lower Jordan Creek by girdling the trees, and this control technique appeared to be working on some of the treated trees. European bird cherry was primarily limited to Reaches 4 and 5, between Glacier Highway and Yandukin Drive (Figures 17). There are several large European bird cherry trees located in Reaches 4 and 5 that likely represent the parent stock of the trees in this area.

**Figure 16.** Location of European mountain ash in the lower Jordan Creek riparian area. Size of symbol represents the number of plants at that location.

European mountain ash and bird cherry are also prevalent in the lower watershed. However, control measures for European mountain ash and bird cherry are largely untested. Most trees can be treated by girdling, though there have been mixed results using this method on European mountain ash along lower Jordan Creek. European mountain ash can re-sprout (form secondary replacement trunks) when cut, allowing it to spread more across the canopy, so this is not a recommended practice unless the trunk can be removed.

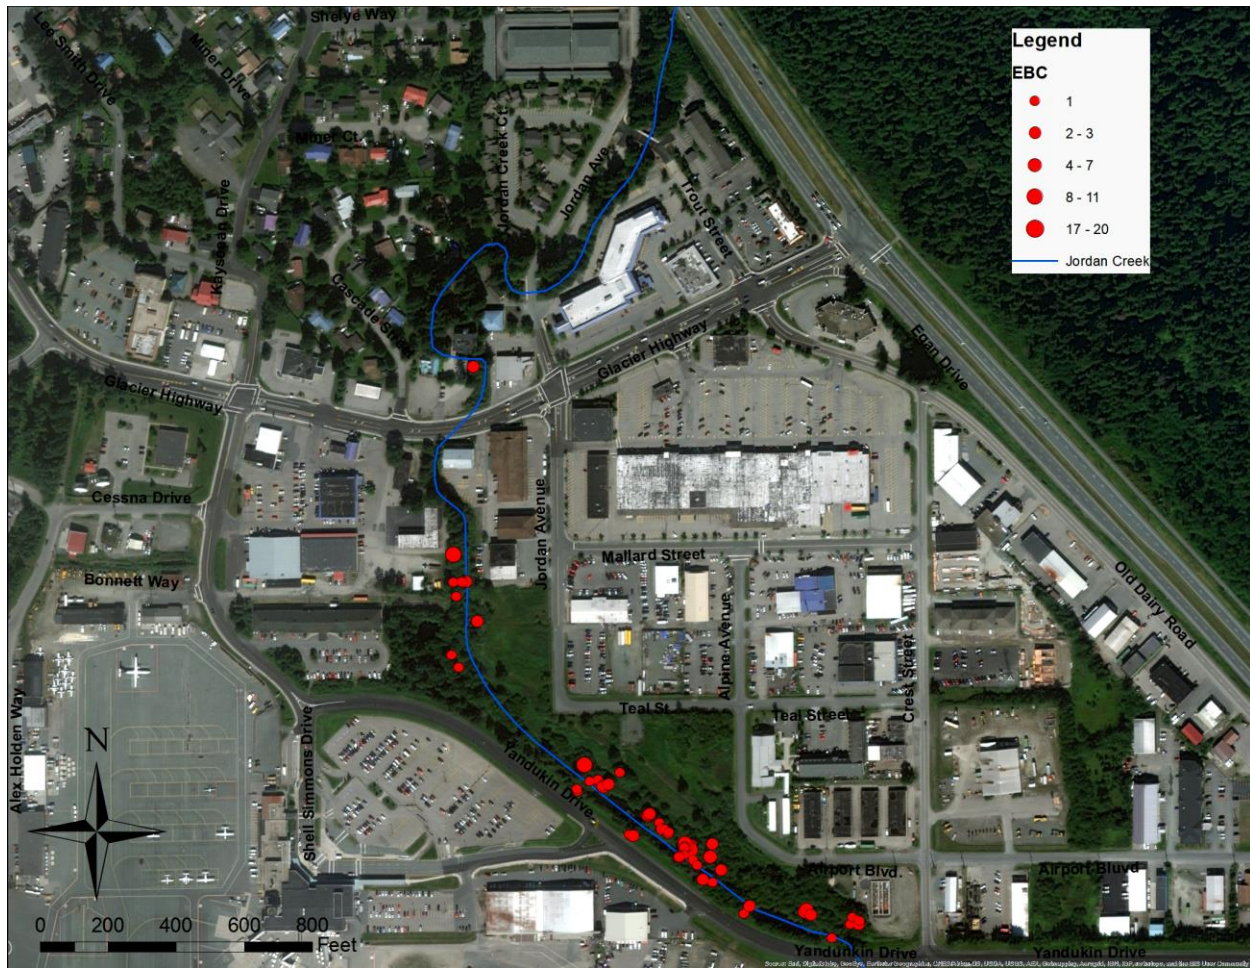
**Figure 17.** Location of European birch cherry in the lower Jordan Creek riparian area. Size of symbol represents the number of plants at that location.

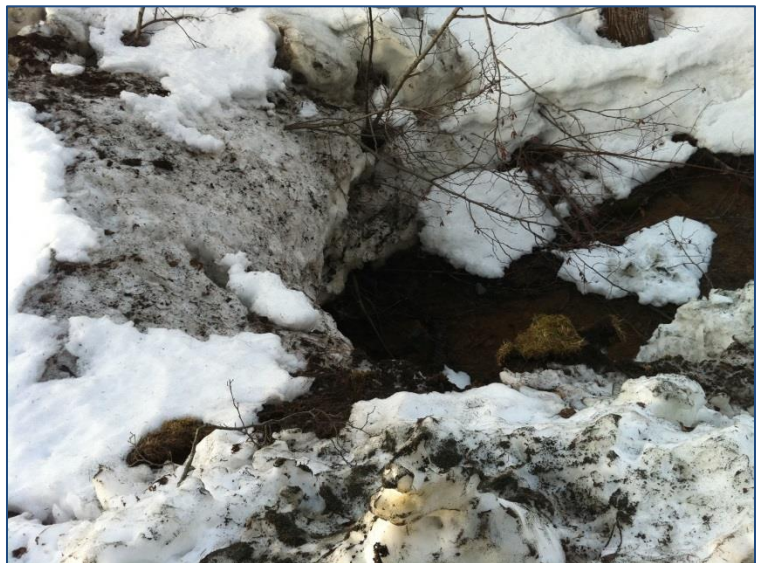
**Figure 2.** Snow plowed from our streets and parking lots isn’t pretty. Snow and meltwater convey a variety of pollutants into our waterways.

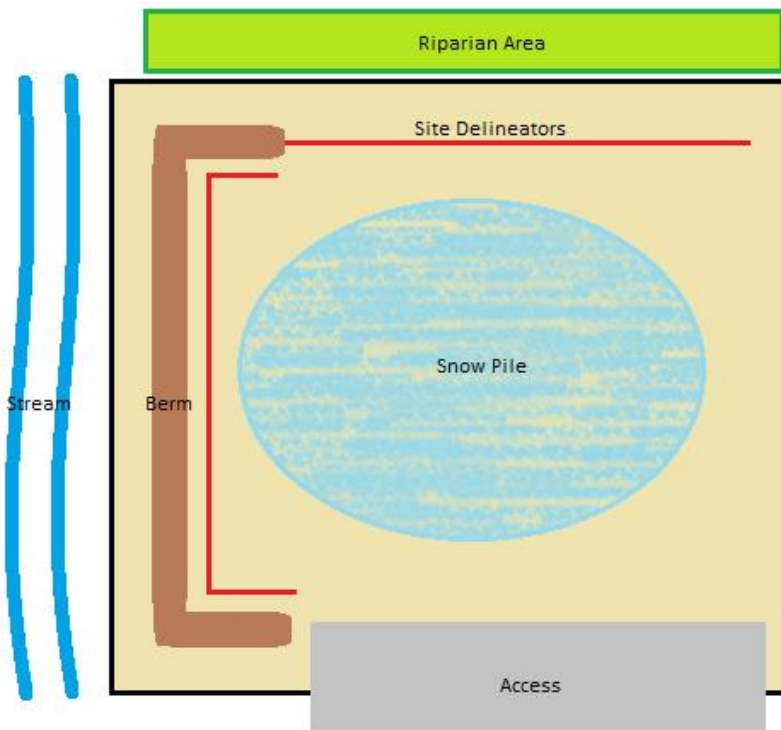
### Conceptual Design for Site:

Snow storage operations are impacting the stream and riparian vegetation. Sediment is discharging into the stream and trees are being damaged from having snow plowed up against their trunks. A berm would be most appropriate perimeter control option on this site, since it is small and has limited storage space.

1. Delineate the site to protect riparian area and berm.
2. Place berm along stream-side of site, wrapping ends along top and bottom to direct flow away from stream and prevent meltwater from circumventing the berm.
3. Re-vegetate disturbed areas from previous snow storage operations.
4. Consider vegetating the embankment using live staking or pole plantings.
