**Phase I Environmental Site Assessment
Keku Cannery Main Building
Kake, Alaska**

February 2014

32-1-17631

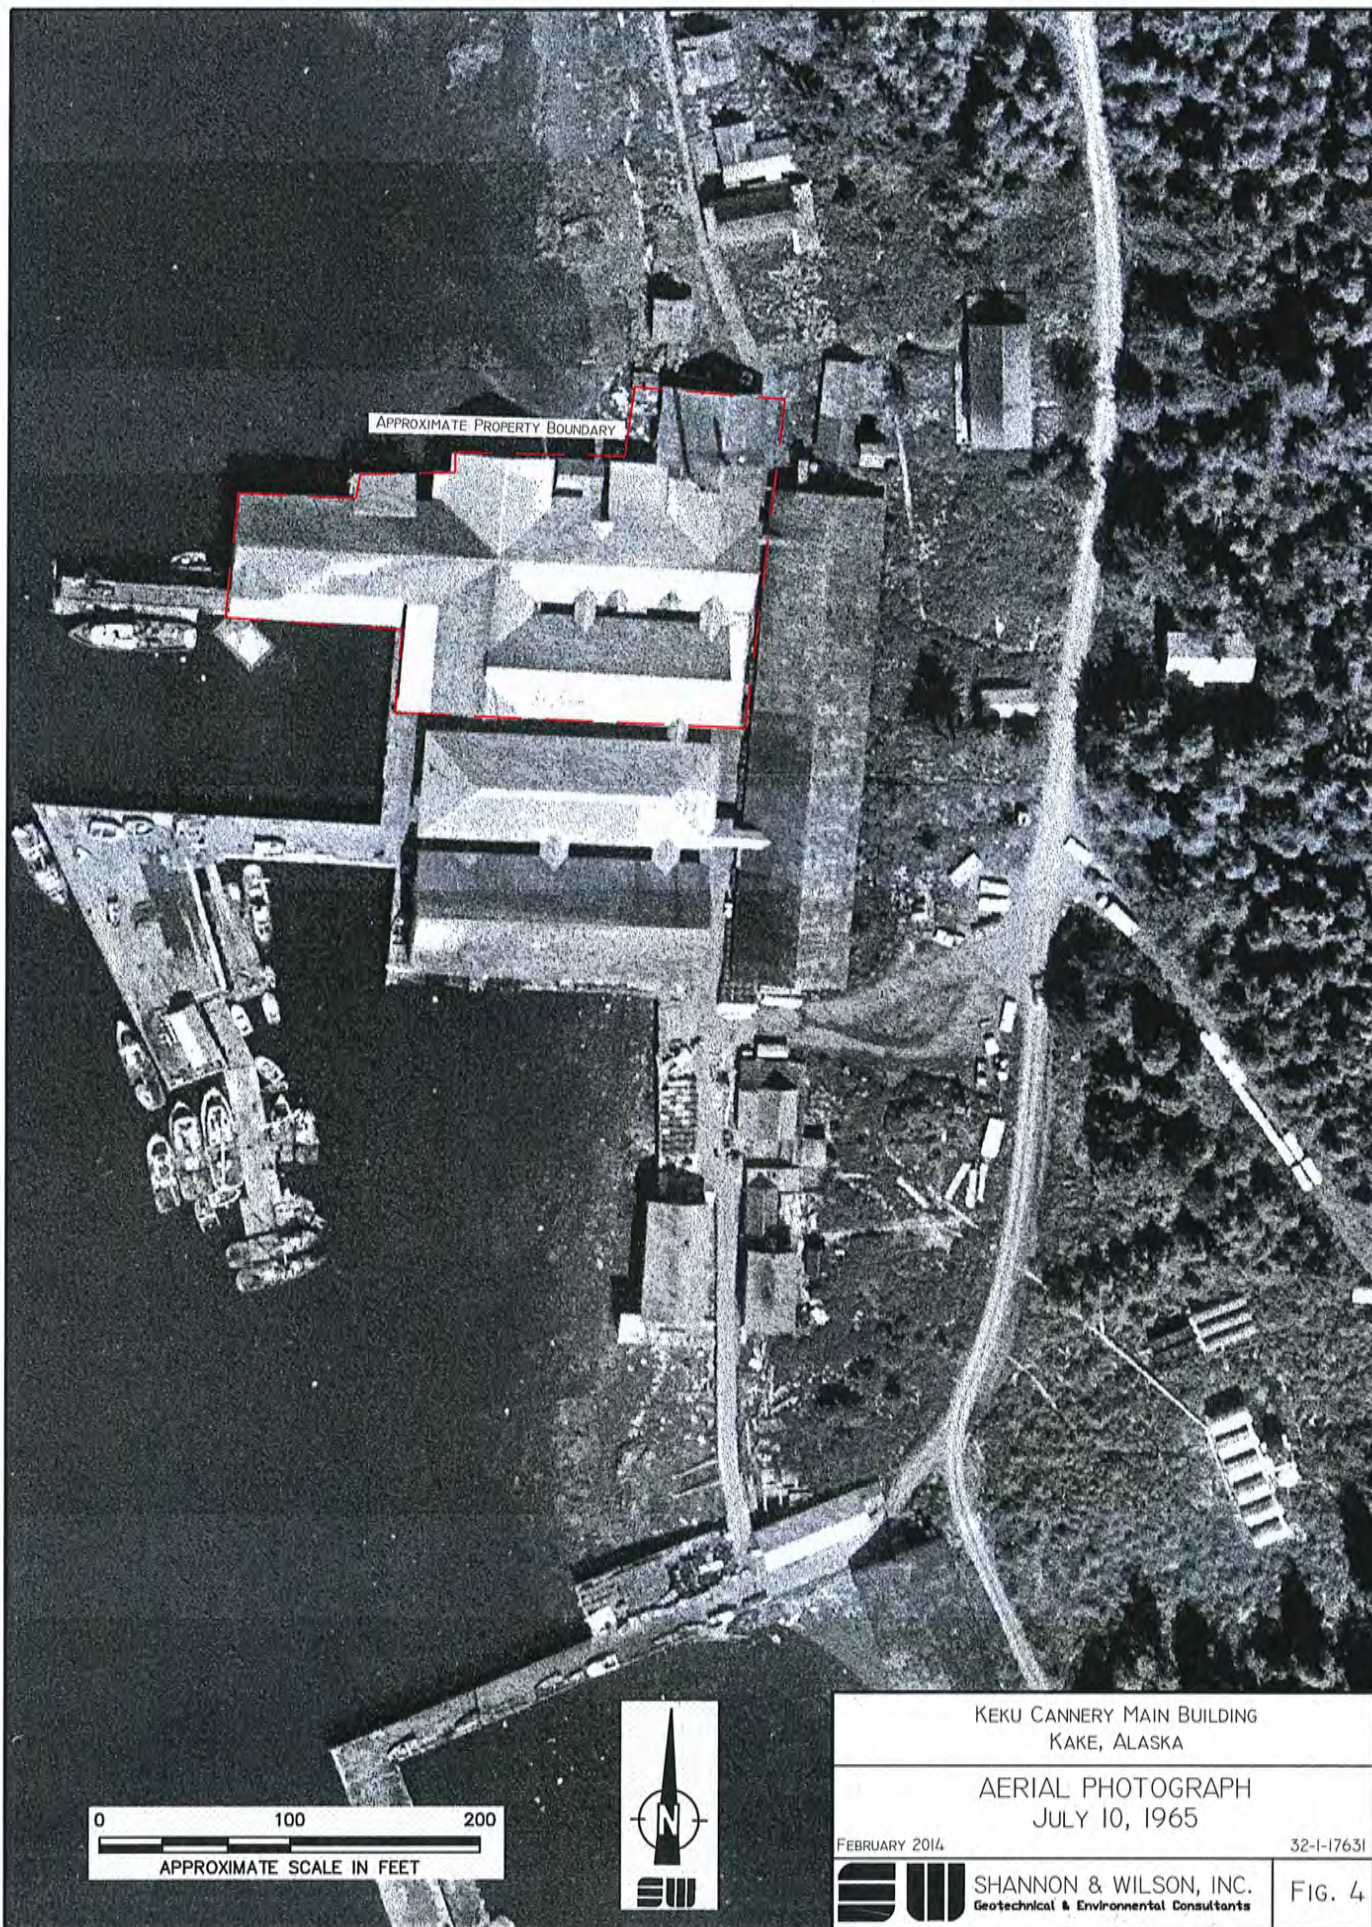
FIG. 4

The 1965 aerial photograph, included as Figure 4, shows the main cannery building with a dock adjacent to the west. There is a boat and an object present at the dock. According to information previously provided by OVK, this object could be a raft to haul fish remnants away. Two warehouse buildings and another dock are present to the south and one warehouse building is present to the east. To the north of the Property, are more cannery buildings and the beach. A tank farm is present to the southeast of the Property.
