DETAILED ACTION PLAN

ALAKANUK SOUTH SIDE DUMP SITE

WASTE EROSION ASSESSMENT & REVIEW (WEAR)

MAY 2015

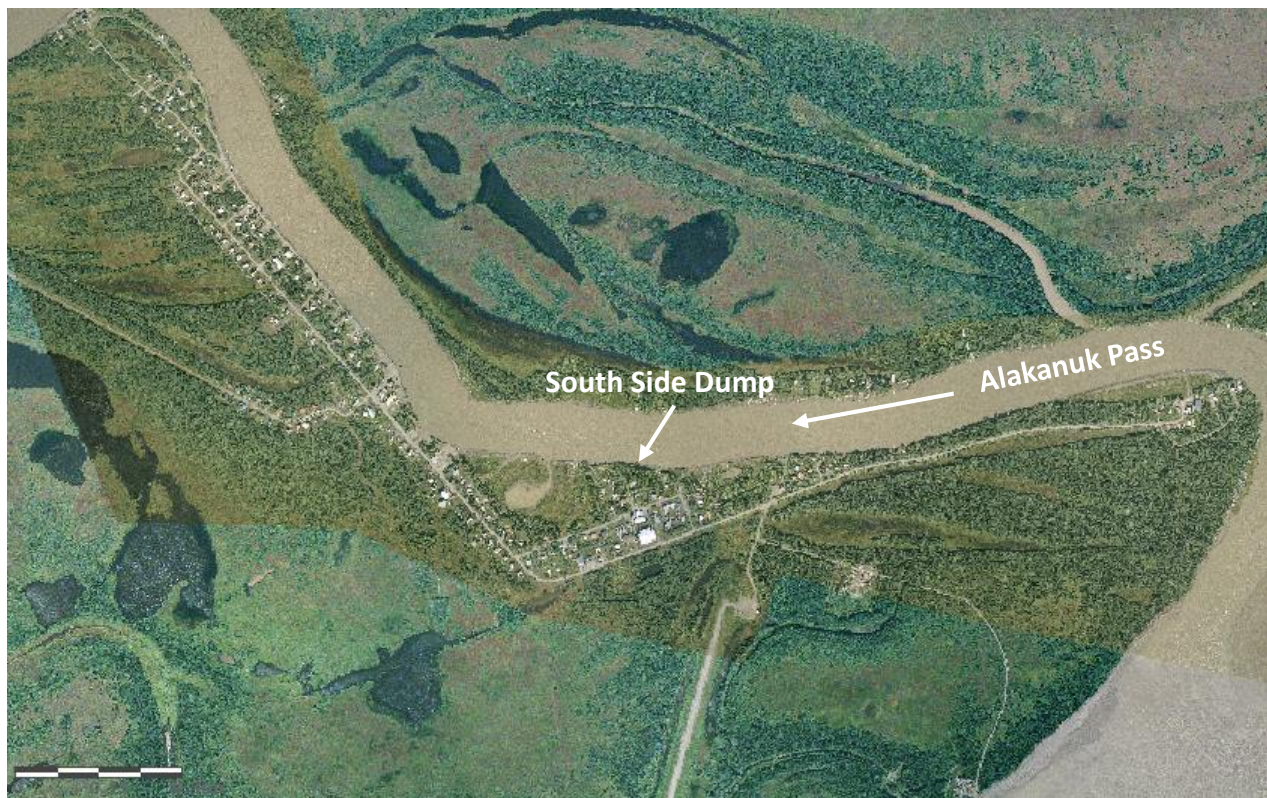
The **Alakanuk South Side Dump Site** is located at latitude 62.685556 and longitude -164.653611, along the shore towards the east end of the community. It is located on the south shore of the Alakanuk Pass, which is a tributary of the Yukon River, and was inspected for the Waste Erosion Assessment and Review (WEAR) project on July 10, 2012 and re-inspected on July 10, 2014.

Imagery Dated 2006, WEAR Map at <http://dec.alaska.gov/eh/sw/wear.html>

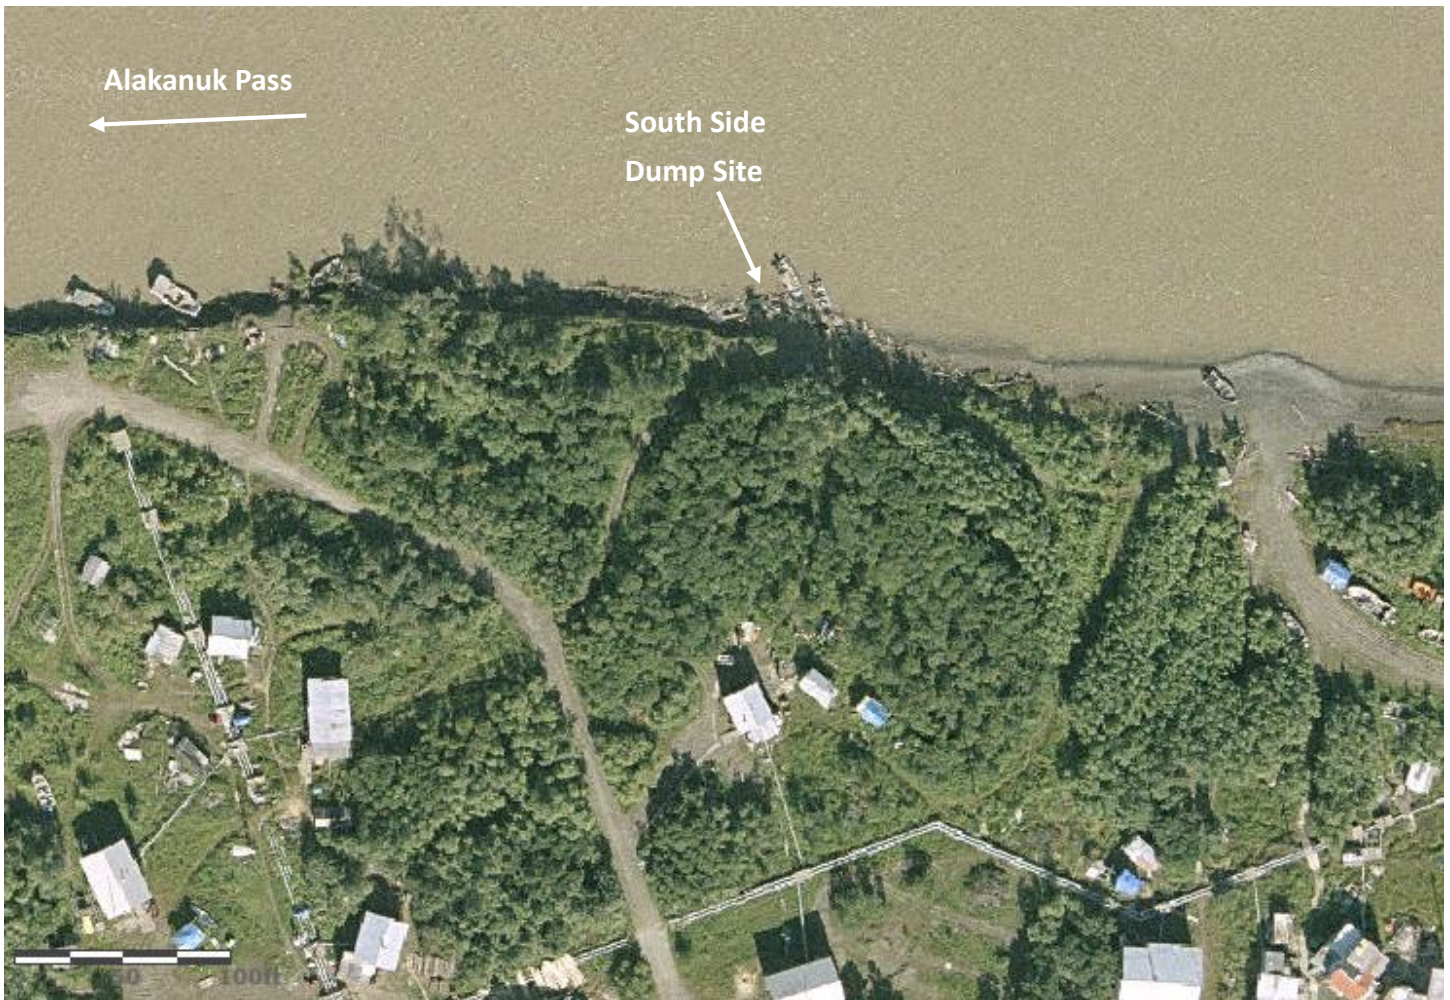
Imagery Dated 2006, WEAR Map at <http://dec.alaska.gov/eh/sw/wear.html>

As the Alakanuk South Side Dump Site is actively eroding, immediate action is recommended. As this site is near the community, erosion mitigation in this area may protect community infrastructure; however, since the site is actively eroding and a portion is already gone, removal of the site is recommended to prevent further contaminant release. Necessary steps include: determine the location of all the debris, complete an asbestos survey, locate a permitted landfill to accept the debris or permit a new landfill, and find funding and equipment to remove the debris.
