DETAILED ACTION PLAN

CHEVAK COMPANY CORPORATION TANK FARM

WASTE EROSION ASSESSMENT & REVIEW (WEAR)

MAY 2015

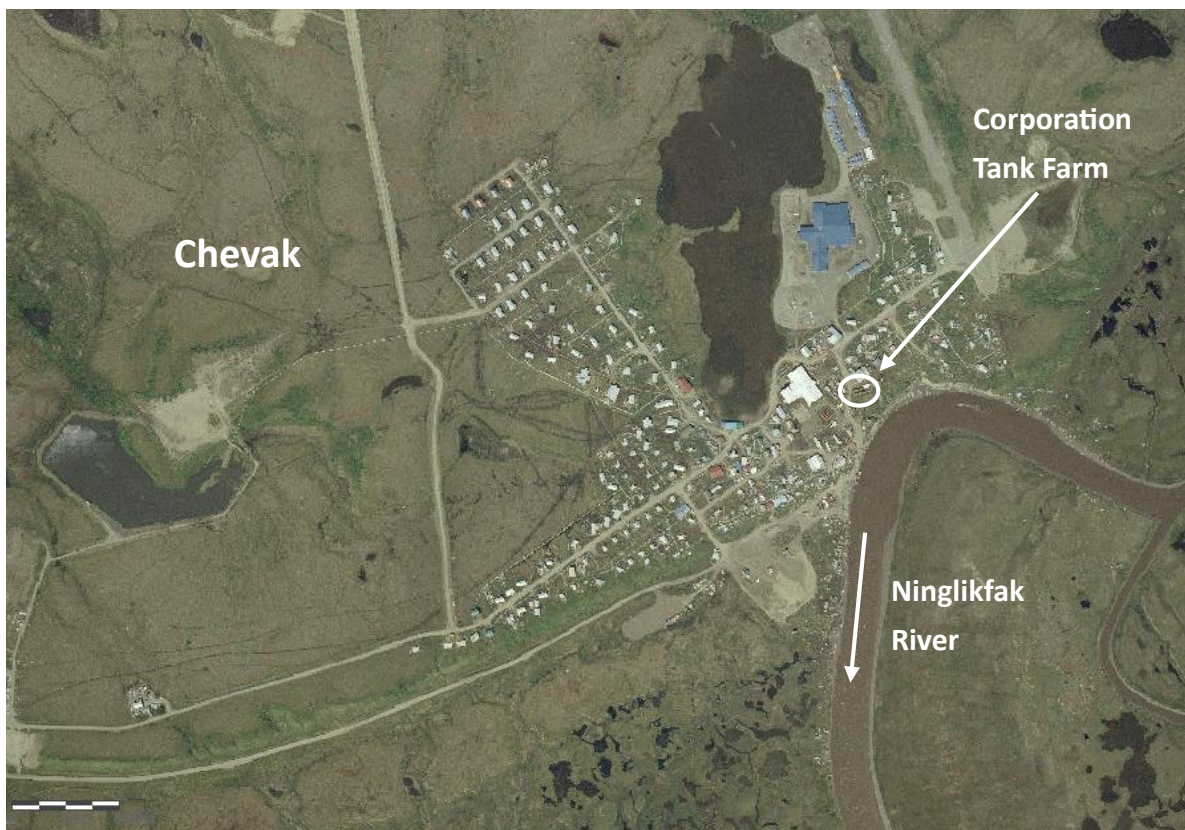
Imagery Dated 2007, WEAR Map at <http://dec.alaska.gov/eh/sw/wear.html>

The **Chevak Company Corporation Tank Farm** is located at latitude 61.528517 and longitude -165.584802. It is centrally located within the community, between the old school and the Ninglikfak River. It was inspected for the Waste Erosion Assessment and Review (WEAR) project on July 8, 2014.

The Chevak Company Corporation Tank Farm was in operation from the 1970s to 2010. This site is located centrally within the community and is 160 feet from the Ninglikfak River. The tank farm is considered a small site measuring approximately 0.13 acres. It is also a known Contaminated Site (File ID 2409.38.001) due to heating oil and gasoline spills. Site characterization work was completed in 2003, but no further remediation work has been done. The nearest residences are 200 feet from the tank farm. There was no stressed vegetation observed. It is approximately 160 feet from a subsistence area and 4,000 feet from a critical habitat area for Spectacled and Steller’s Eiders.

The Chevak Corporation Tank Farm was 135 feet from the Ningliak River according to 2007 aerial imagery. Using the 5 feet per year erosion rate calculated by the BEA and reported by community residents, it is estimated that the site will be impacted by erosion in 2034.

As the Chevak Company Corporation Tank Farm is no longer in service, it is recommended to remove the site. It has been inactive since the construction of the new consolidated tank farm in 2010 and is unlikely to be in service in the future. The empty fuel tanks could be cut into smaller pieces for easier transport to and disposal at the permitted Chevak Landfill. After the site has been cleared, the underlying soil should be characterized to determine if any contamination remains and then, if needed, a plan developed for cleanup. A sampling plan and cleanup plan would need to be approved by the ADEC Contaminated Sites Program.
