DETAILED ACTION PLAN EMMONAK LANDFILL

WASTE EROSION ASSESSMENT & REVIEW (WEAR) MAY 2015

The **Emmonak Landfill** is located at latitude 62.775086 and longitude -164.505094. The landfill is on the east side of the community along the airport access road. This site was inspected for the Waste Erosion Assessment and Review (WEAR) project on July 9, 2012 and was re-visited on July 10, 2014.

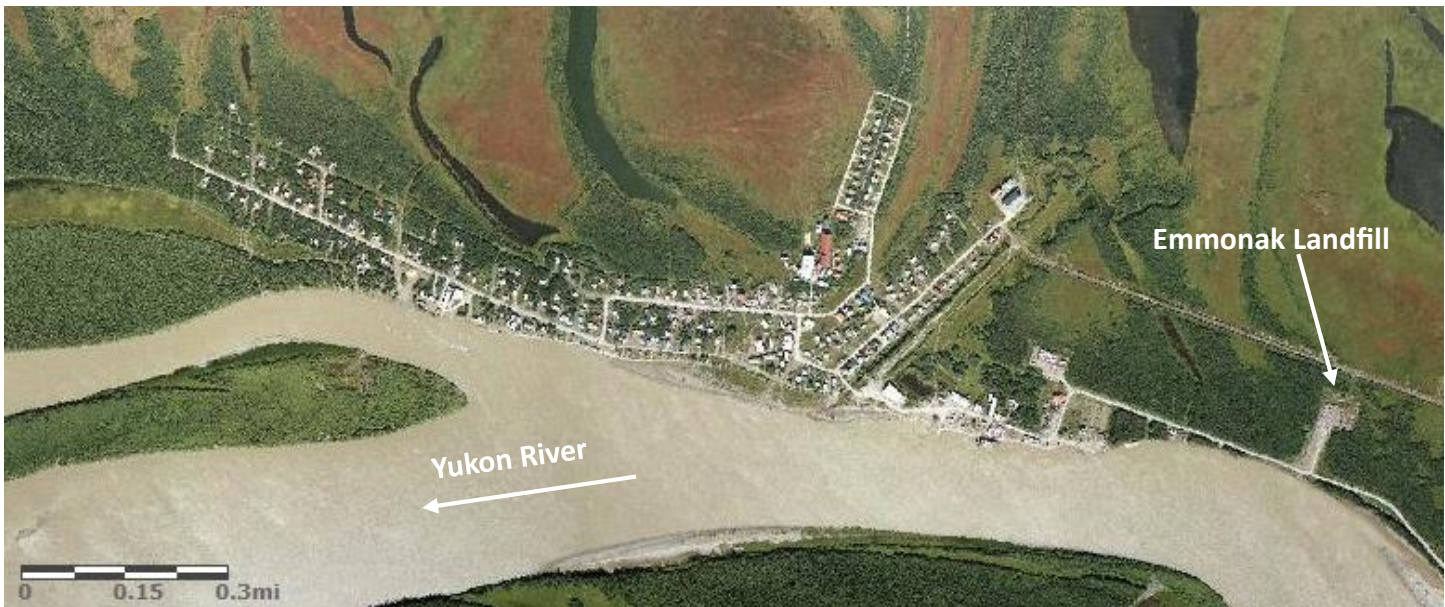
Imagery Dated 2006. WEAR Map at <http://dec.alaska.gov/eh/sw/wear.html>

The landfill is a self-haul site with a part-time operator. The site is approximately 5 acres in area with waste spread throughout the site. The landfill is located approximately 350 feet from an actively eroding bank of the Yukon River. Trash was observed along the bank for about 100 yards. The landfill is located approximately 4,500 feet upstream of the village water supply. It is reported that the majority of erosion occurs in the spring when the river breaks up and ice scours the banks.
