BENTLEY MALL EAST SATELLITE BUILDING

Database Name: Bentley Mall East Satellite

Summary updated: June 2008

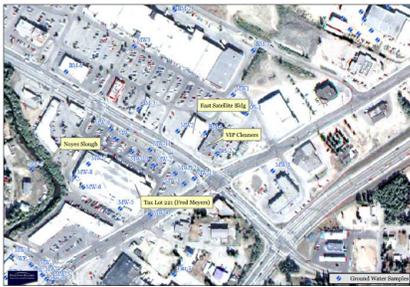
Figure 1: Bentley Mall East Satellite Building

The East Satellite is an out-building that is part of the larger Bentley Mall complex on College Road in Fairbanks, Alaska ([see Figure 1](#)). The owners of the mall, Bentley Mall LLC of San Francisco, California have worked cooperatively with the Alaska Department of Environmental Conservation ([DEC](#)) in performing an environmental assessment.

Perchloroethylene (PCE) and several of its natural degradation products were detected in 2003 during a routine real estate environmental assessment in several groundwater monitoring wells located on Tax Lot 221 (location of the Fred Meyer store on College Road, [see Figure 1](#)). The detection of the contaminants in the groundwater suggested several possibilities: there has been an historical release of PCE on Tax Lot 221; the contaminated groundwater is coming from a release that is hydraulically up gradient from Tax Lot 221; or a combination of both. To date there is no known evidence documenting a PCE release on Tax Lot 221.
