**Greater Kuparuk Area (GKA)
Western North Slope (WNS)
Corrosion Programs Overview**

March 30, 2007

Commitment to Corrosion Monitoring
7th Annual Report to the Alaska Department of Environmental Conservation

Prepared by
ConocoPhillips Corrosion Team

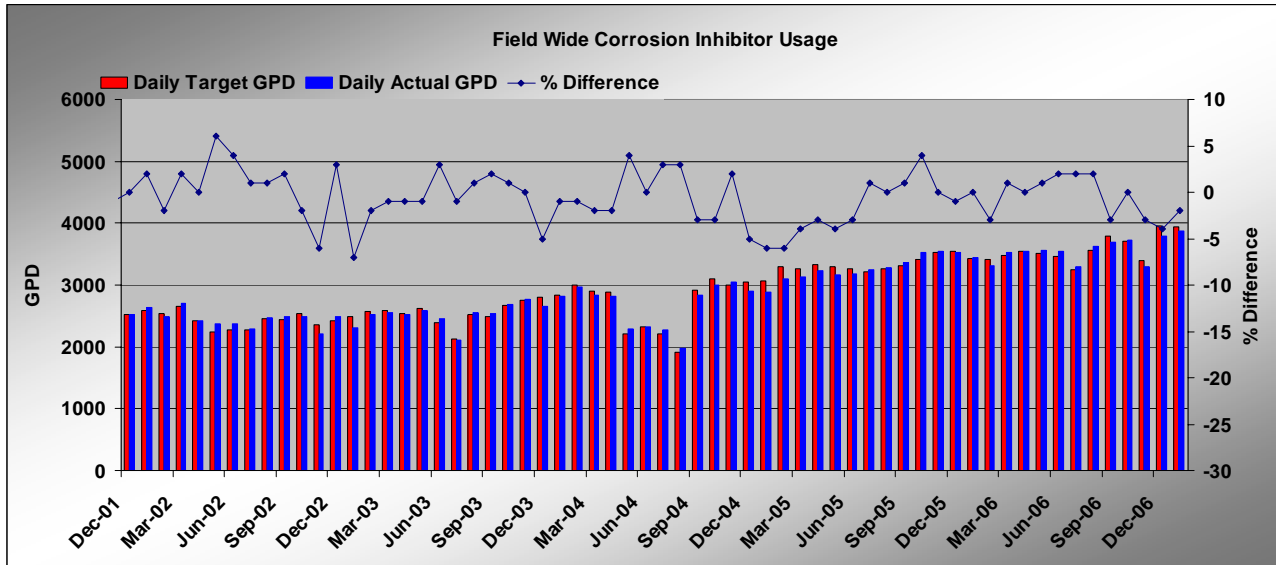
Figure 6. Field-wide Corrosion Inhibitor Use.

For the Kuparuk field, Figure 6 shows the actual number of gallons of corrosion inhibitor pumped per day, the recommended (target) number of gallons of corrosion inhibitor per day and the percent difference between the two. The average deviation for the year was -0.42%. Corrosion inhibitor use has increased since 2003 mainly because of field-wide water rate increases and increased corrosion rates caused by water and solids handling.
