ALASKA DEPARTMENT OF ENVIRONMENTAL CONSERVATION  
Division of Spill Prevention and Response  
Prevention and Emergency Response Program  
**SITUATION REPORT**

## Fuel Barge *Leo*

SITREP # 2 and Final

SPILL #: 12119925601

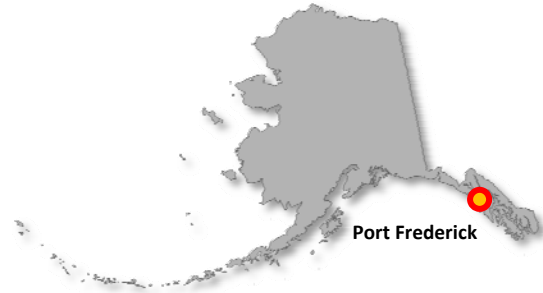
HOW AND WHEN THE SPILL WAS DISCOVERED: The crew onboard the Tug *Altair*, the tug transporting the fuel barge *Leo*, noticed sheen in the water and traced it back to a 2-inch fracture between the raised cargo tank bulkhead and deck of the barge.

CAUSE OF SPILL: Kirby Offshore Marine (Kirby) fuel barge *Leo* discovered a fracture between the raised cargo tank bulkhead and the deck of the barge near the bow of the vessel. The fracture is impacting one of the cargo tanks onboard resulting in a gasoline leak. The cause of the fracture is unknown at this time and is being investigated.

SOURCE CONTROL: A temporary seal was placed on the fracture and an internal transfer of fuel was completed the night of September 12. These actions stopped the fuel leak.
