ALASKA DEPARTMENT OF ENVIRONMENTAL CONSERVATION
Division of Spill Prevention and Response
Prevention and Emergency Response Program
SITUATION REPORT

F/V Eyak Grounding

SITREP #2

SPILL #: 15-11-99-019-01

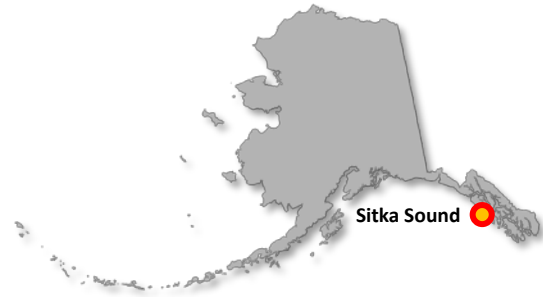
The Tug *Marauder* arrived on scene the morning of January 27 with a barge containing dive equipment and a crane for use during salvage operations. SEAPRO removed the boom surrounding the sunken vessel, so SEAL could secure 4 lift bags to the F/V *Eyak* and reposition the vessel 200 yards east of its previous location. The lift bags were inflated, and the vessel was successfully repositioned into deeper waters to shelter it from increasing winds. SEAPRO redeployed its boom in a U-configuration down current from the F/V *Eyak* and salvage barge as a precautionary measure. On January 25, SEAPRO deployed 500 feet of exclusion boom to protect Crane Cove,

an environmentally sensitive area near the vessel. SEAPRO repositioned 900 additional feet of boom near the salvage site from north of Calligan Island.

The salvage barge is currently alongside the F/V Eyak and crews are currently rigging the sunken vessel in preparation to conduct repairs and salvage operations. ADEC and USCG personnel are onsite to oversee response and salvage operations.
