ALASKA DEPARTMENT OF ENVIRONMENTAL CONSERVATION
Division of Spill Prevention and Response
Prevention, Preparedness, and Response Program
SITUATION REPORT

Frosty Fuels Cold Bay Diesel Spill

SITREP #: 2 and Final

SPILL #: 15259930701

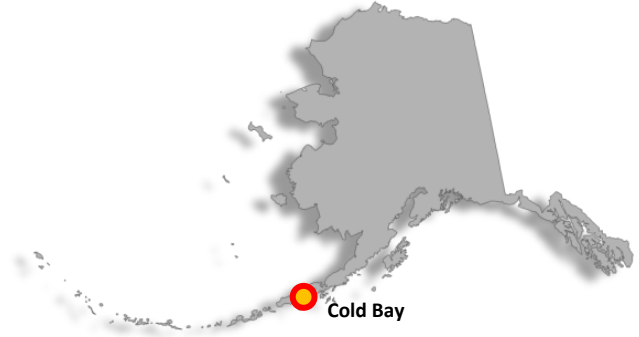
HOW/WHEN SPILL WAS DISCOVERED: On November 3, 2015 Frosty Fuels, LLC personnel responded to a loud noise in the vicinity of the Cold Bay dock. Upon investigation they observed a ruptured flexible spool coupling on the diesel pipeline discharging diesel fuel onto the tundra, surrounding area, adjacent to shoreline and dock.

CAUSE OF SPILL: The investigation into the cause of the spill was conducted by an engineering contractor hired by the PRP. There were several possibilities identified in the investigation report; however, the exact cause was not determined.

SOURCE CONTROL: Source control has been established. The diesel pipeline was drained down and the ruptured pipe was isolated with a blank flange. Approximately 800 gallons of diesel was removed from the pipe before the flow stopped and the release was terminated. Product removed from the pipeline was placed into portable containers and then transported to a fuel tank at the Frosty Fuels terminal for recycling.
