ALASKA DEPARTMENT OF ENVIRONMENTAL CONSERVATION
Division of Spill Prevention and Response
Prevention Preparedness and Response Program
SITUATION REPORT

Qinaq River Submerged Caterpillar EL180

SITREP #: 2

SPILL #: 16279908401

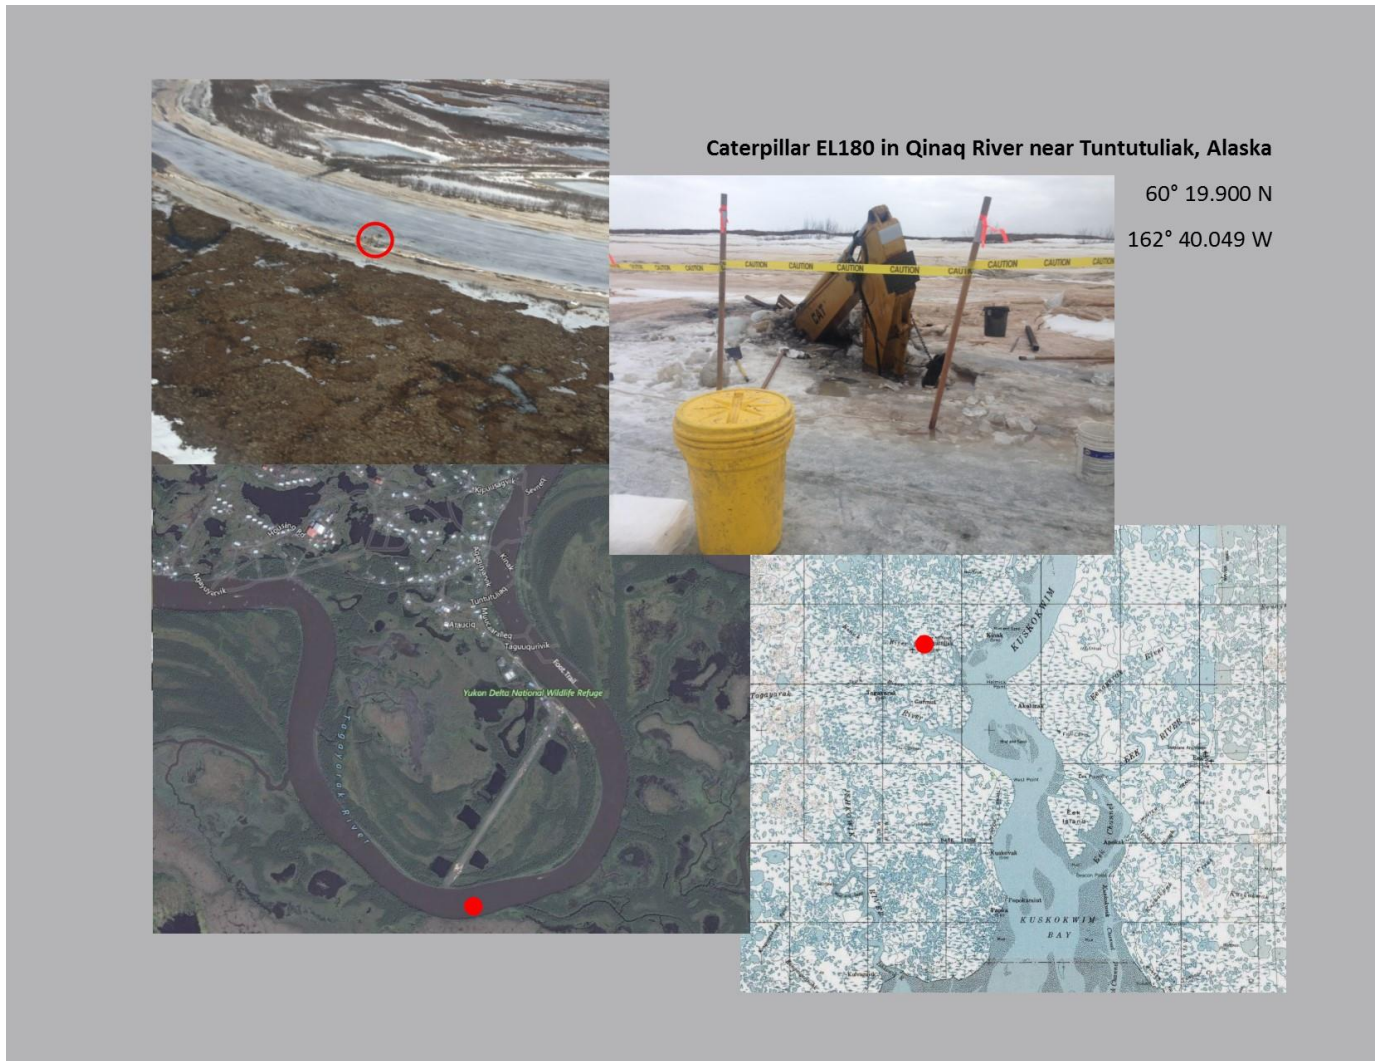
CAUSE OF SPILL: The responsible party was driving the equipment from Tuntutuliak to Kongiginak and broke through the ice about 15 feet from the south shore of the Qinaq River.

FUTURE PLANS AND RECOMMENDATIONS: A PRP local employee will continue to monitor the site several times daily deploying absorbent materials if a release is observed and it is safe to access. The PRP will report weekly or more frequently as needed to apprise the Coast Guard and ADEC of updates and notable information.

Due to safety hazards involved in equipment recovery while the river remains iced up, it is not likely that the equipment will be recovered until spring breakup.
