CITY OF ATKA

**FEBRUARY 2008**

**VILLAGE SAFE WATER  
OUTFALL INSPECTION REPORT**

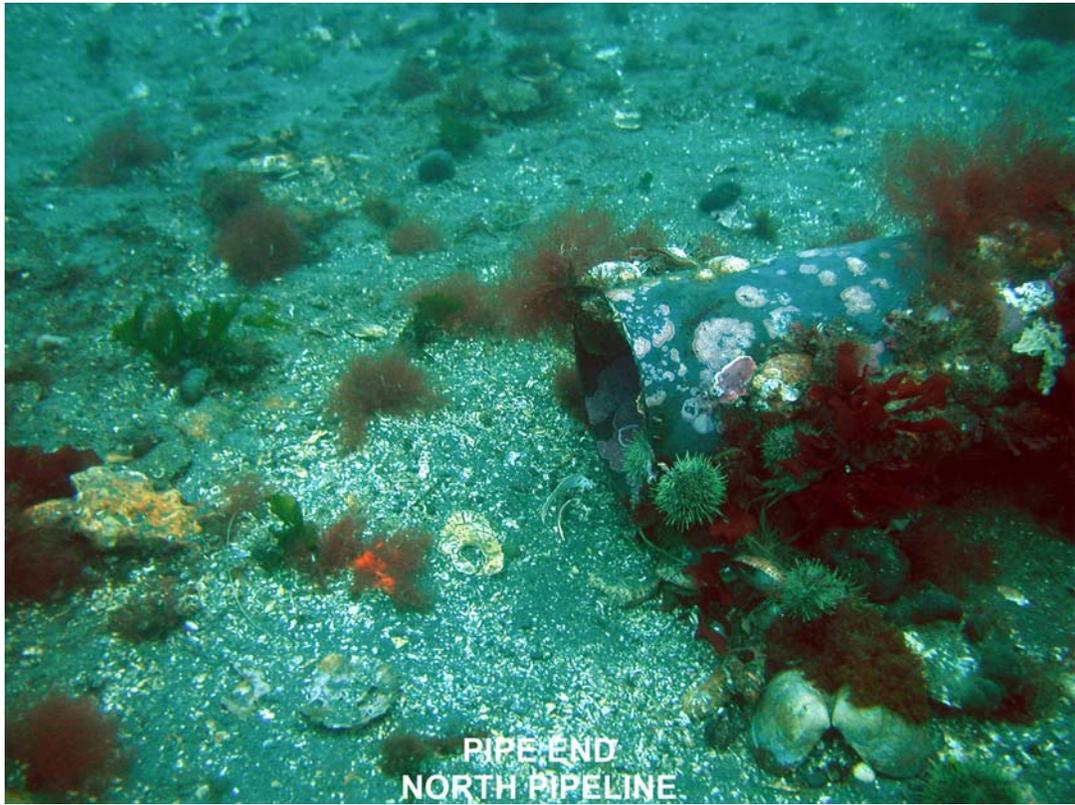
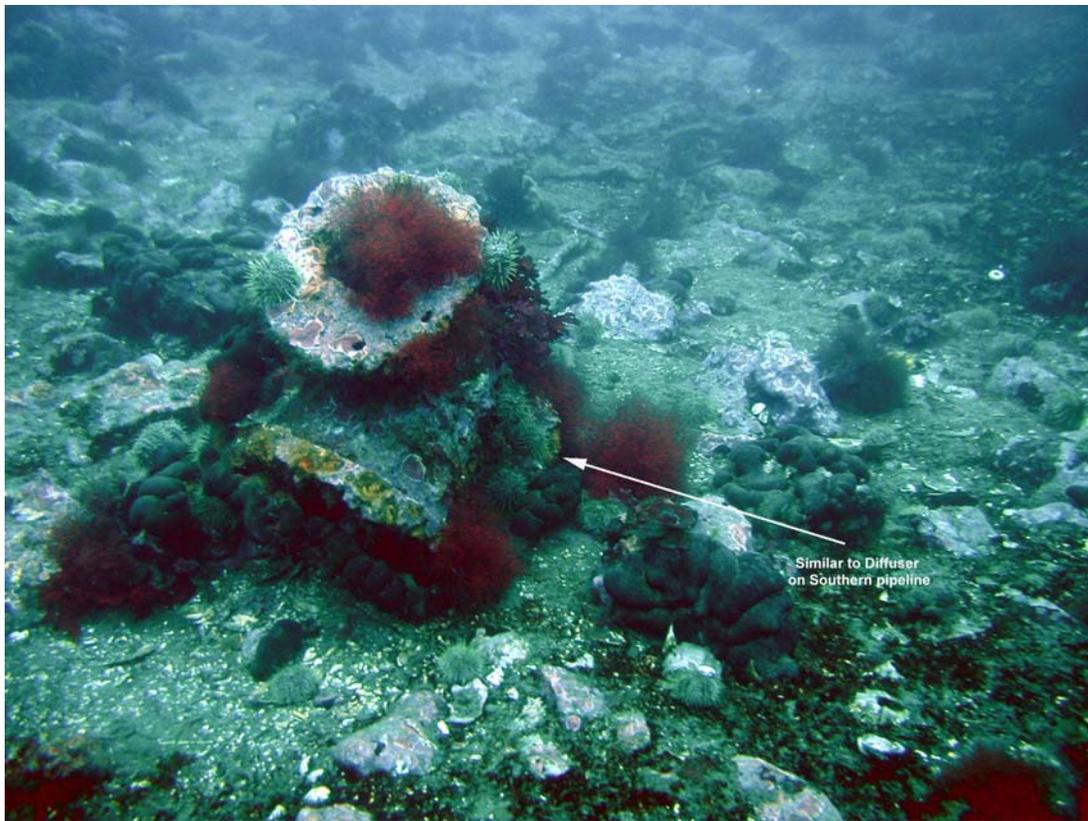
The northern pipe is a HDPE pipe that is disconnected from the PVC supply side in the inter-tidal zone. The line extends approximately 330 feet in an easterly direction before terminating in -26 feet MLLW. The end appears to be sheared clean which could indicate one of the following:

- A failed weld
- Cut by vessel
- Detached diffuser

**NORTHERN PIPE TERMINATION**

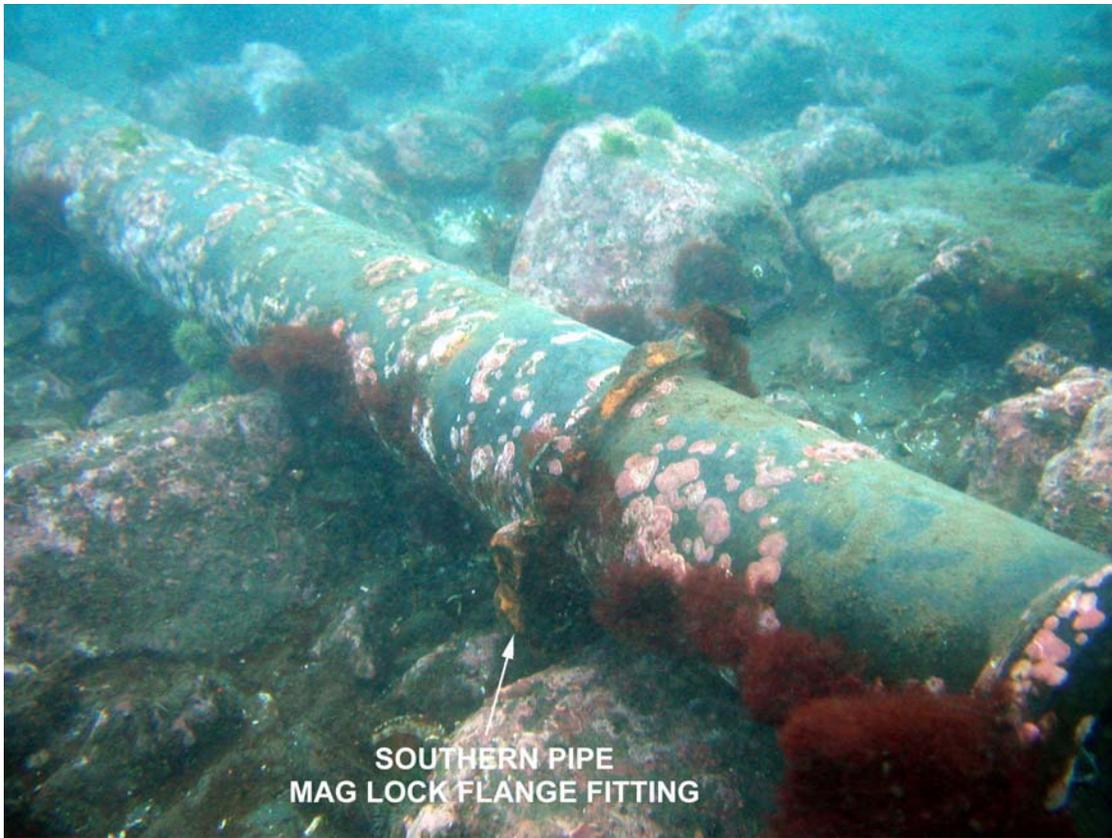
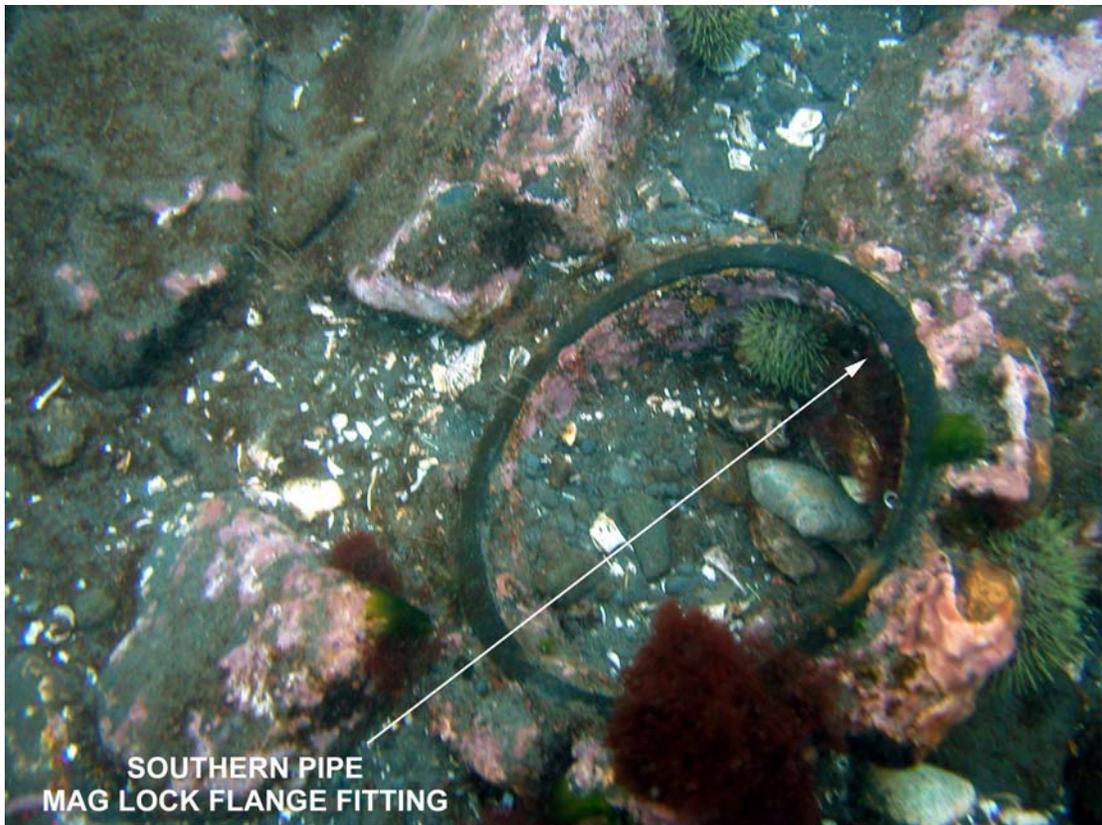
**SOUTHERN PIPE  
BECOMES EXPOSED OFFSHORE**
