STATE OF ALASKA

DEPARTMENT OF ENVIRONMENTAL CONSERVATION DIVISION OF SPILL PREVENTION AND RESPONSE CONTAMINATED SITES PROGRAM

Re: Decision Document; McCully Truck Rollover 32.1 Taylor Hwy.
Cleanup Complete Determination

32 Mile Taylor Highway
Diesel Tanker Spill Site

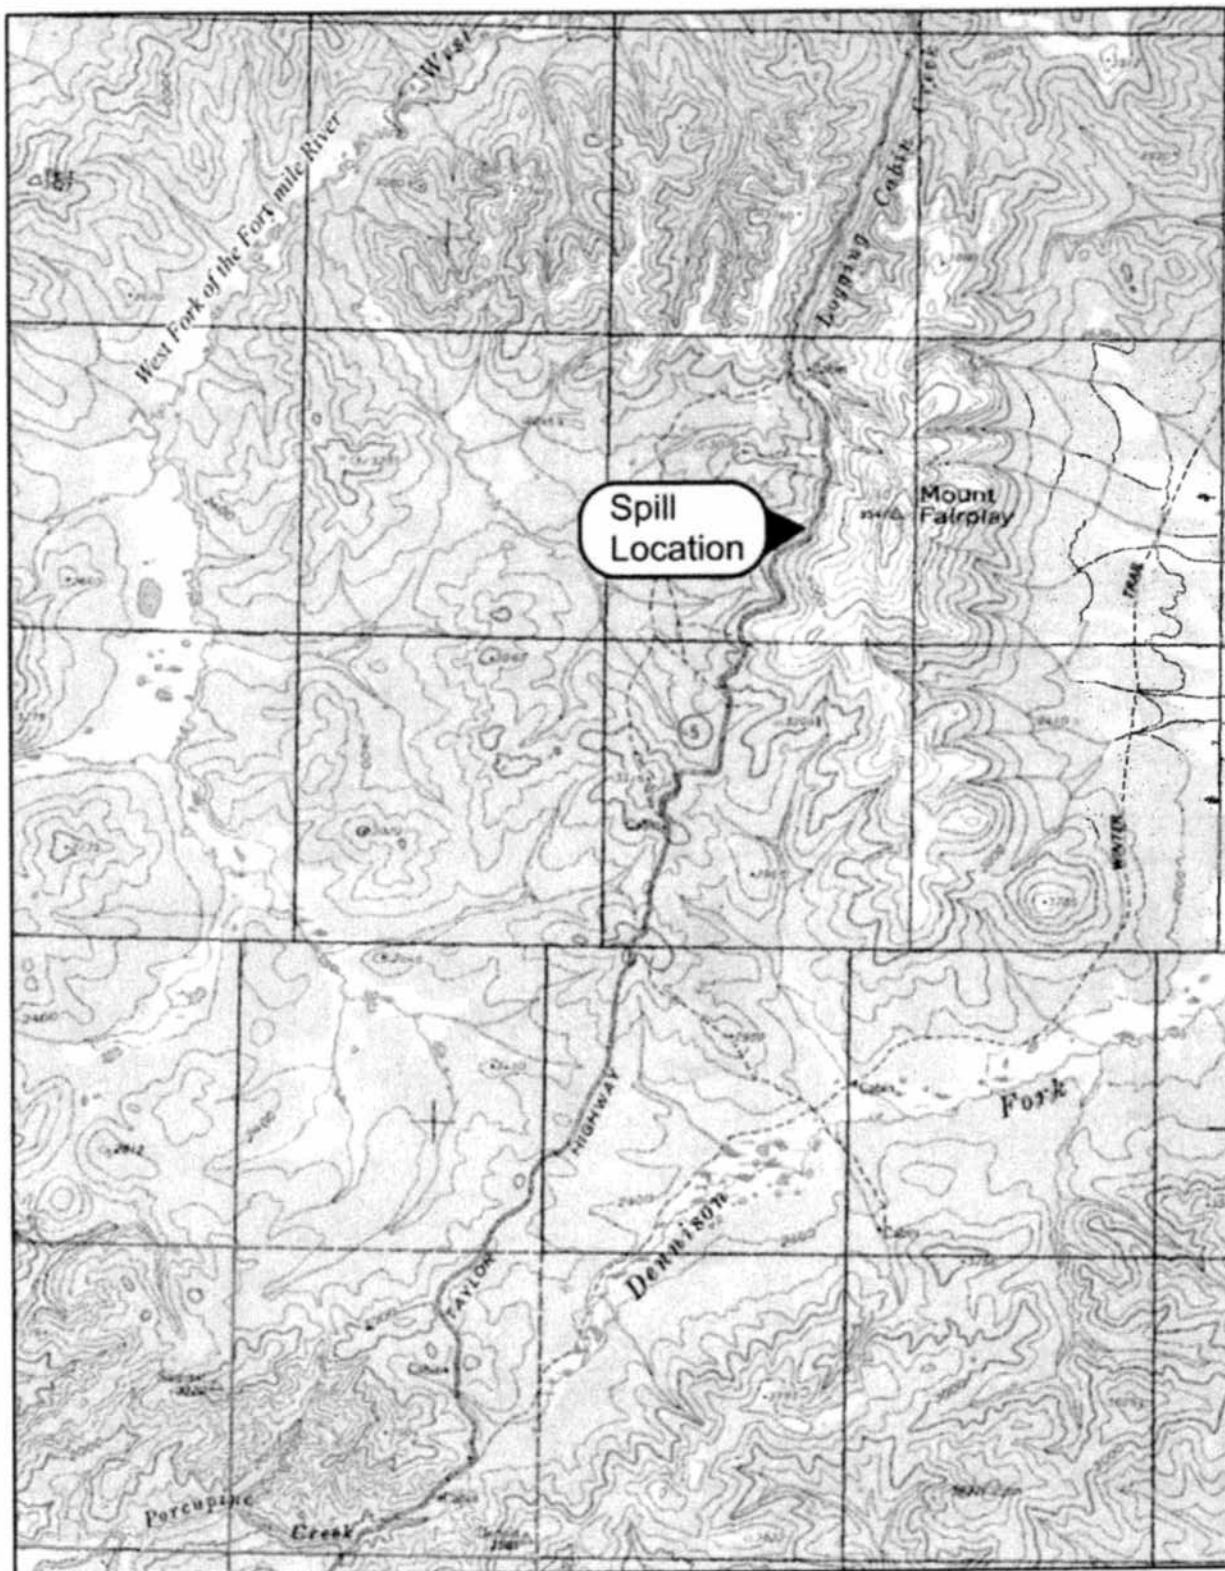
Enclosure: Site Map and Drawing showing spill location and remaining contamination

Shannon & Wilson conducted another site visit in May 2009. The underflow dam at the end of the spill site had been partially washed out in the early spring of 2009 and was repaired. The ditch where the original spill took place did not retain any water but the dam had retained some water approximately one foot deep. Surface water samples were taken from behind the dam and from the creek. No sheen was detected behind the dam or on the creek. Analytical results showed no BTEX or PAH analytes were detected above their PQLs in either location and TAH/TAqH water quality criteria were not exceeded. The contaminated surface soils had previously been removed to a depth of 2 to 4 feet and backfilled with clean material. Based on this information, Shannon & Wilson determined that contamination above cleanup levels at the site is limited to subsurface soils in the location of the original release.
