**Department of Environmental
Conservation**

Re: Decision Document: Wrangell Sawmill
Cleanup Complete Determination

Wrangell Sawmill
7 Mile Zimovia Highway
Wrangell, Alaska 99929

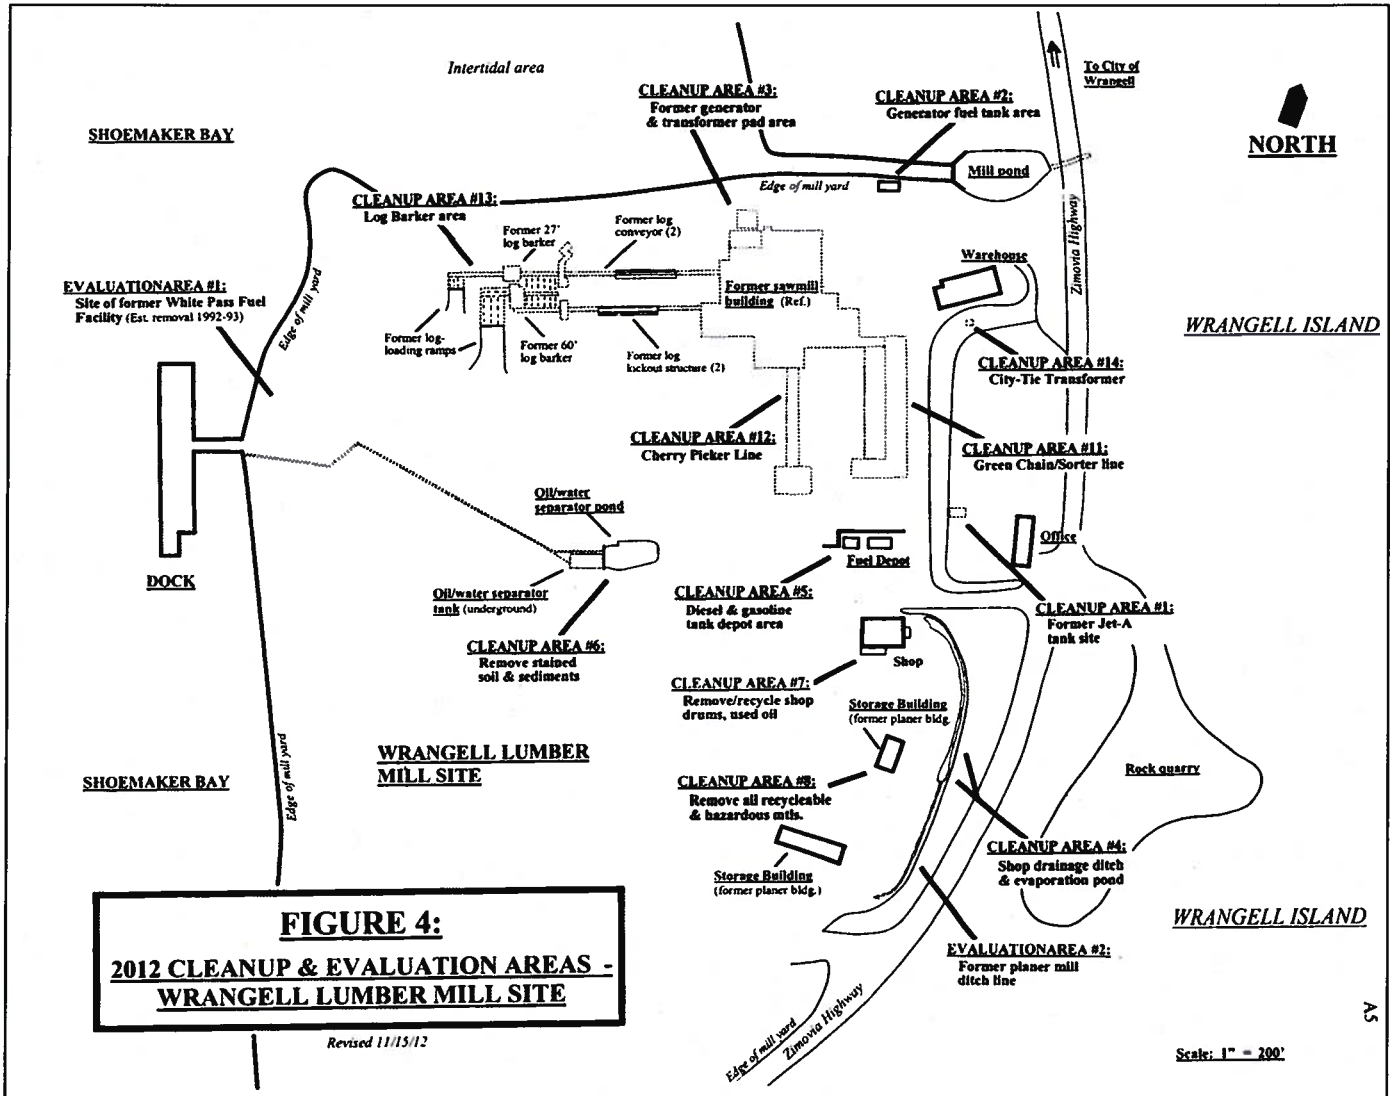
The following sections detail the cleanup work done at multiple areas identified across the Wrangell Sawmill property. Figure 4 below depicts these areas.

Area 1 - Office Jet-A tank site: The site was excavated on 7/1/12, leaving an 8'x30'x4.5' hole directly under the tank location. Sample results of the excavated stockpile showed low detections of DRO and RRO, 11-120 mg/kg and 52-110 mg/kg respectively. The stockpiled material was then used as backfill and the area was confirmed to meet cleanup criteria. No soils were removed for bioremediation.

Area 2- Generator tank site: The site was excavated on 5/17/12 once the concrete foundation was moved back. After excavating 12"-18" directly under the tank's former discharge pipe location, little contamination was found. Confirmation samples for DRO and RRO were below cleanup levels at 160-180mg/kg and 220-440 mg/kg, respectively. The area was confirmed to meet cleanup criteria and no soil was removed for bioremediation.

Area 3- Emergency generator/ transformer pad site: Initial excavations began on 5/15/12. After an 8' wide space was opened between the foundations of the generator building and sawmill transformer, a significant amount of contamination was found almost immediately. By 5/19/12, the excavation had extended to nearly 100' x 80' x 14' and eventually revealed four possible source areas. High levels of DRO and RRO directed the excavations early on but high concentrations of DRO drove the excavation and characterization until 8/22/12. Confirmation samples eventually revealed DRO levels that ranged from 31-3000 mg/kg. The emergency/ transformer pad site was also evaluated for GRO, BTEX, PCB's, and nine semi-volatile organic compounds (SVOCs). All GRO and BTEX samples were non-detect. One PCB analyte (Aroclor 1260) and the nine SVOCs were detected but all below DEC cleanup criteria.

Area #5- Fuel Depot: The fuel depot bulkhead was removed on 6/4/12. Considerable diesel-contaminated soil was found and excavated to 2.5' below the concrete surface until clean soil appeared. As the excavation continued toward the gasoline tanks location, high PID readings were encountered at a depth of 4-5 feet bgs. Characterization samples showed GRO concentrations were above DEC cleanup criteria. As a result, GRO and the gasoline compounds, BTEX, were added as potential COCs for this location. Excavations continued over the course of the summer. After a July 20, 2012 site visit, DEC recommended the evaluation of SVOCs and RCRA-8 metals for this area. On 9/16/12 the final excavations took place. An additional 10'-15' section of the concrete surface was removed and soil was excavated to 12' depths. Along the embankment DRO levels were 3,900-4,400mg/kg. All other COC confirmation samples confirmed RRO, GRO, BTEX, SVOCs, and RCRA-8 metals also were below cleanup levels. Approximately, 1,090 c.y. of contaminated soil was removed for treatment.
