**ENVIRONMENTAL SITE INVESTIGATION**

**TATITLEK DOCK  
AND  
EQUIPMENT FACILITIES SITE**

**TATITLEK, ALASKA**

**MARCH 1994**

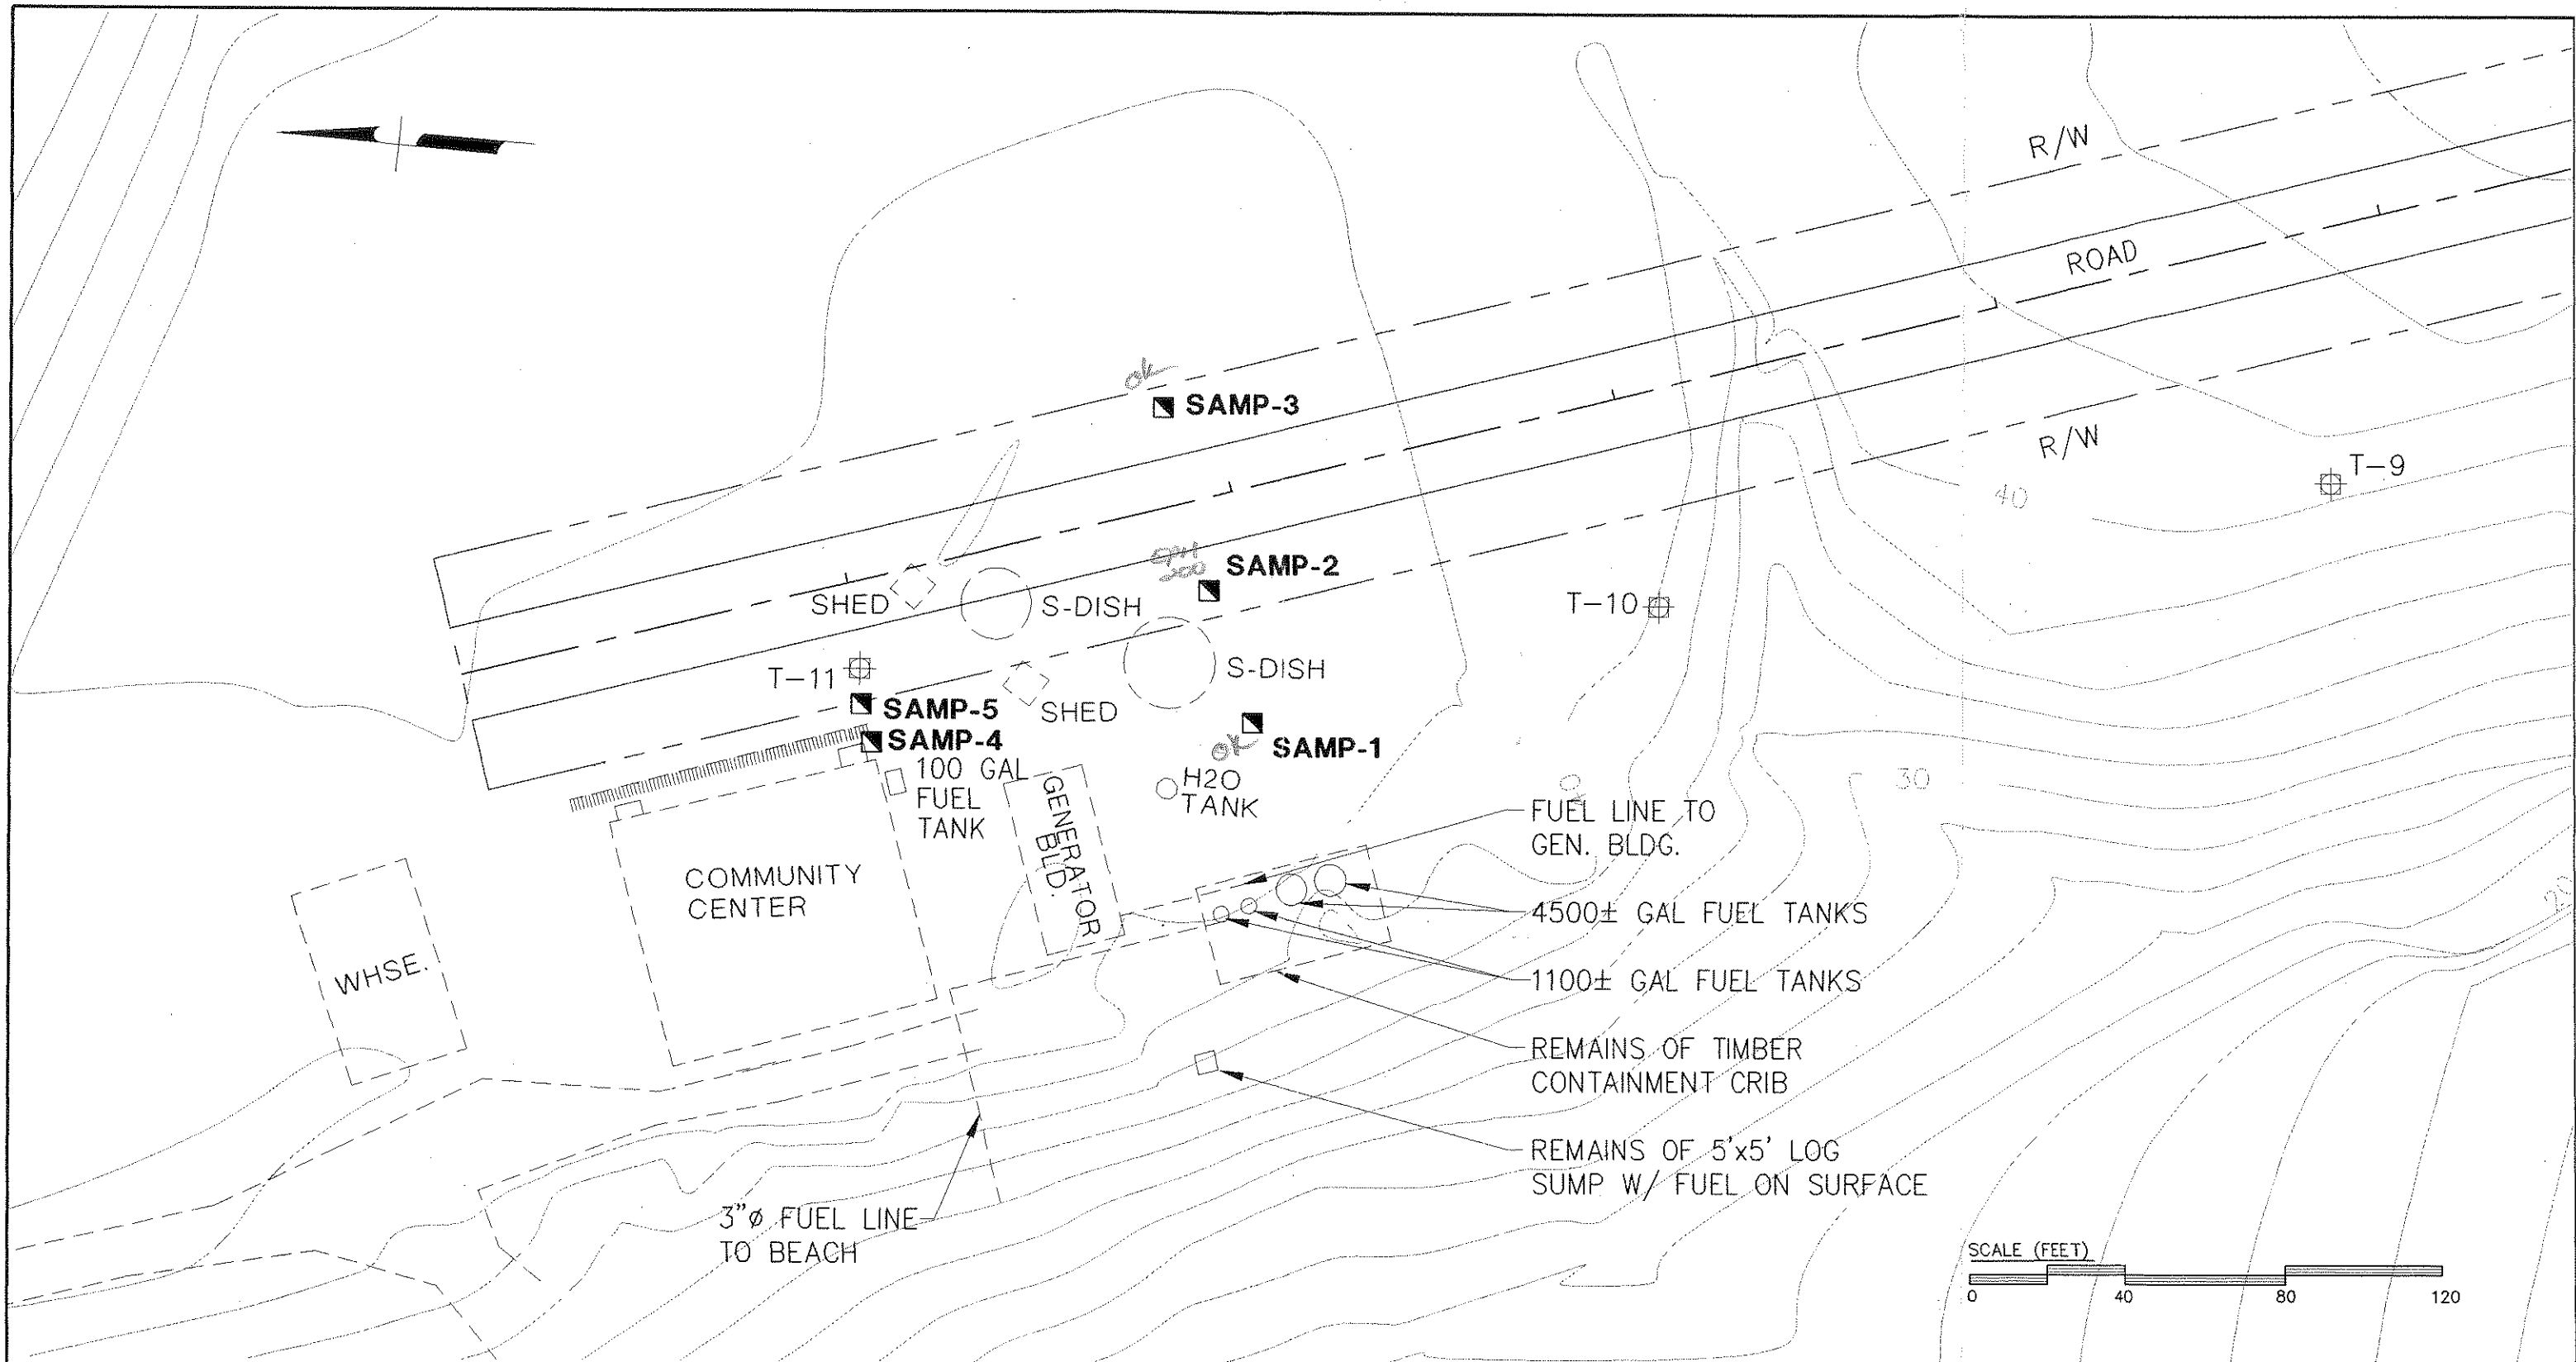
Subsurface samples were taken upgradient from the visible stained areas; in-between the stained areas and the proposed right-of-way and within the right-of-way (map 3). The samples were taken by digging down to the sample depth with a trowel and obtaining a sample from the bottom and sides of the hole (picture

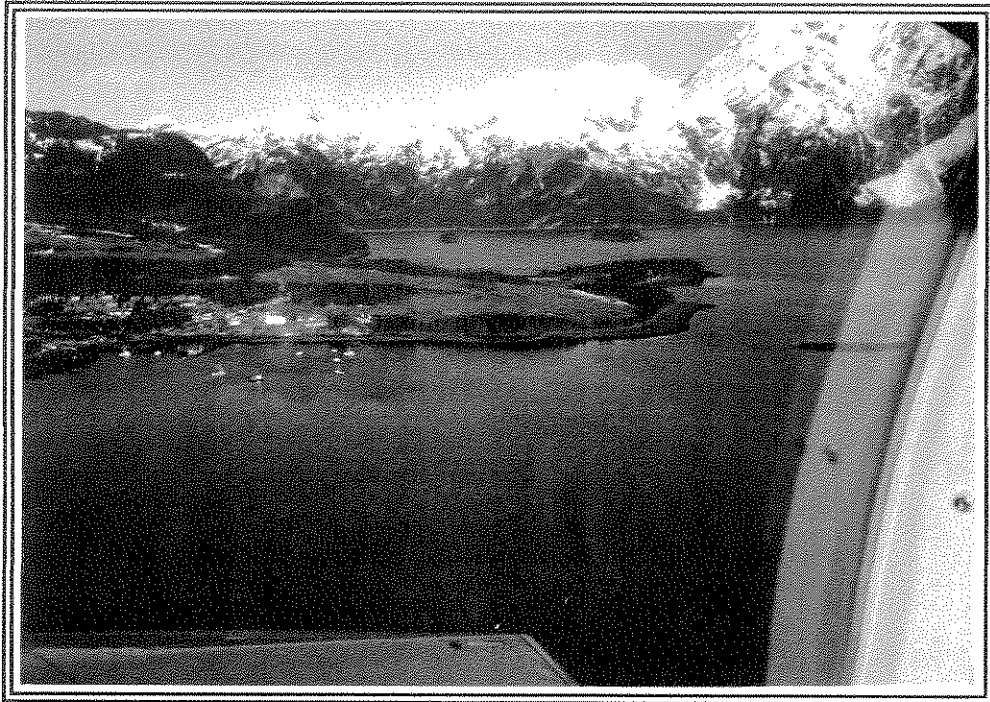
Picture 1: Tatitlek and proposed project area.

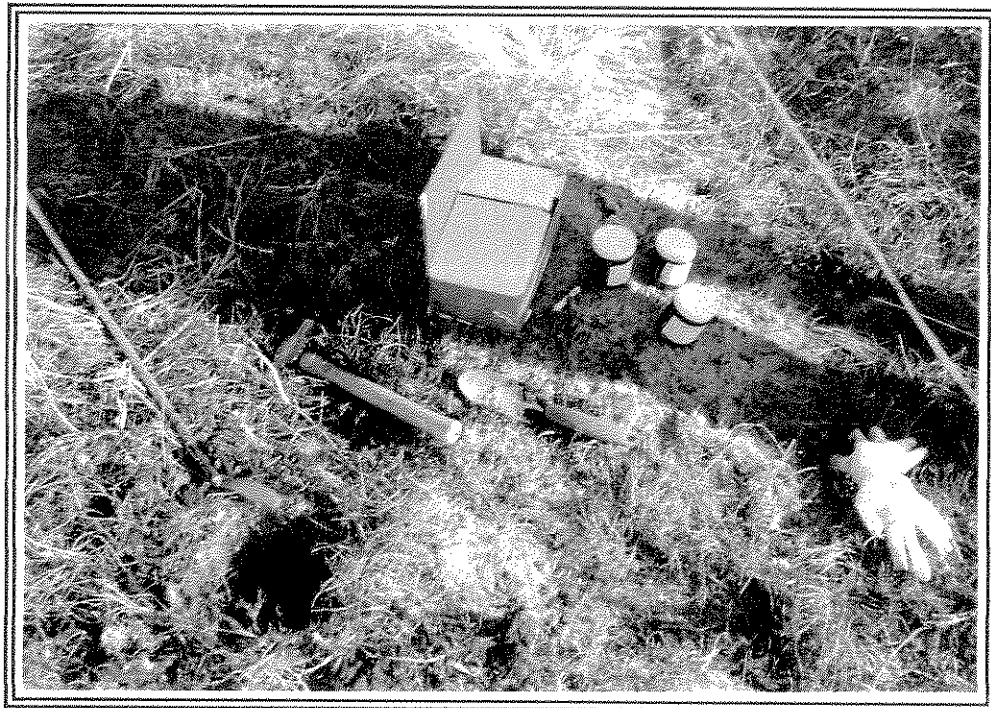
#10). A clean trowel was used in both steps of the sample gathering from the excavated holes. The soil was moist muskeg with no observed water table. The depth of muskeg ranged from 2 - 4± feet, with progressively deeper muskeg the further away from the visibly stained areas.

Picture 10: Typical sample hole.
