**AGRA EARTH & ENVIRONMENTAL, INC.  
PHASE I ENVIRONMENTAL SITE ASSESSMENT  
GOLD HILL LIQUOR AND GROCERY  
FAIRBANKS, ALASKA**

September 1994

32-01110-00

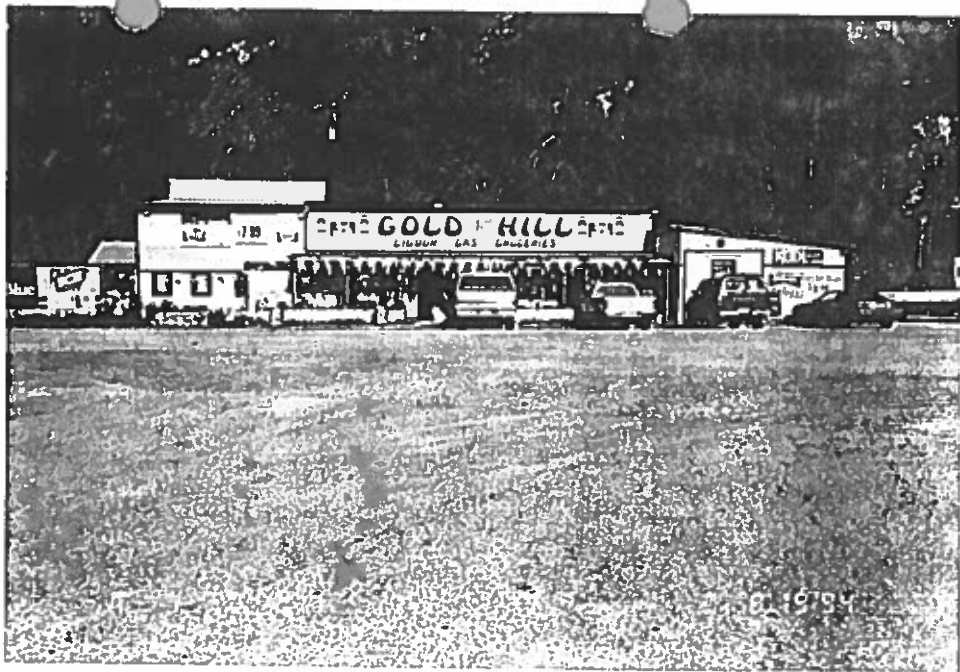
The site inspection was conducted following the interview with Mr. Carboy. For the purpose of describing the site, the property can be divided into four quadrants. The southwest quadrant includes the store and the graveled driveway and parking area (Photo 1). The southeast quadrant contains a dumpster area that is leased to the FNSB (Photo 2). A stockpile of hydrocarbon-contaminated soil from the UST closure is currently located in the northeast quadrant (Photo 3), and the northwest quadrant is a storage area for old vehicles and miscellaneous items (Photo 4). The site is generally free of vegetation except for the northern and western edges of the property. The vegetation that does exist appears to be second growth and consists of willow and alder bushes, birch trees, and low brush (Photo 5). Scattered throughout the brushy areas are small piles of discarded lumber and wooden pallets.

Photo 1: Front view of the Gold Hill Store.
