# SITE CHARACTERIZATION, CORRECTIVE ACTION AND DECOMMISSIONING REPORT

**HIPAS OBSERVATORY  
7795 CHENA HOT SPRINGS ROAD  
FAIRBANKS (TWO RIVERS), ALASKA**

**MARCH 5, 2013**

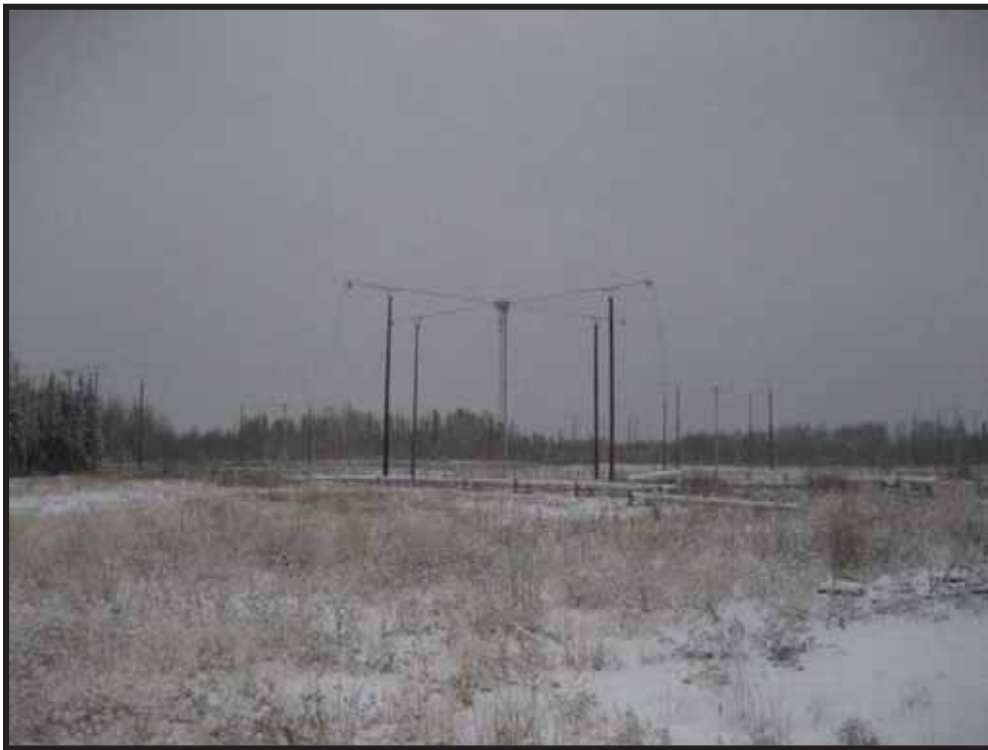
**Photo 1:** Looking east at original Main Transmitter Antenna Array. All piping, antenna, anchors, and ground grid materials have been removed (2008)

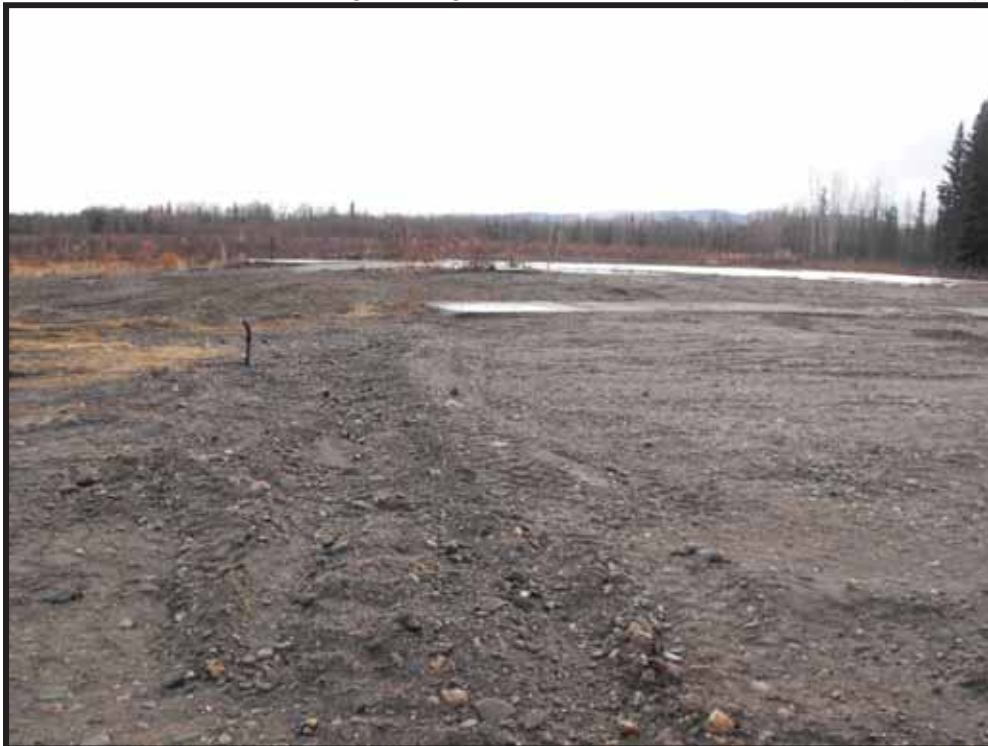
**Photo 2:** Looking east across the Main Transmitter Antenna Array area over the former electrical pad and former Transmitter Building Foundation (2012)

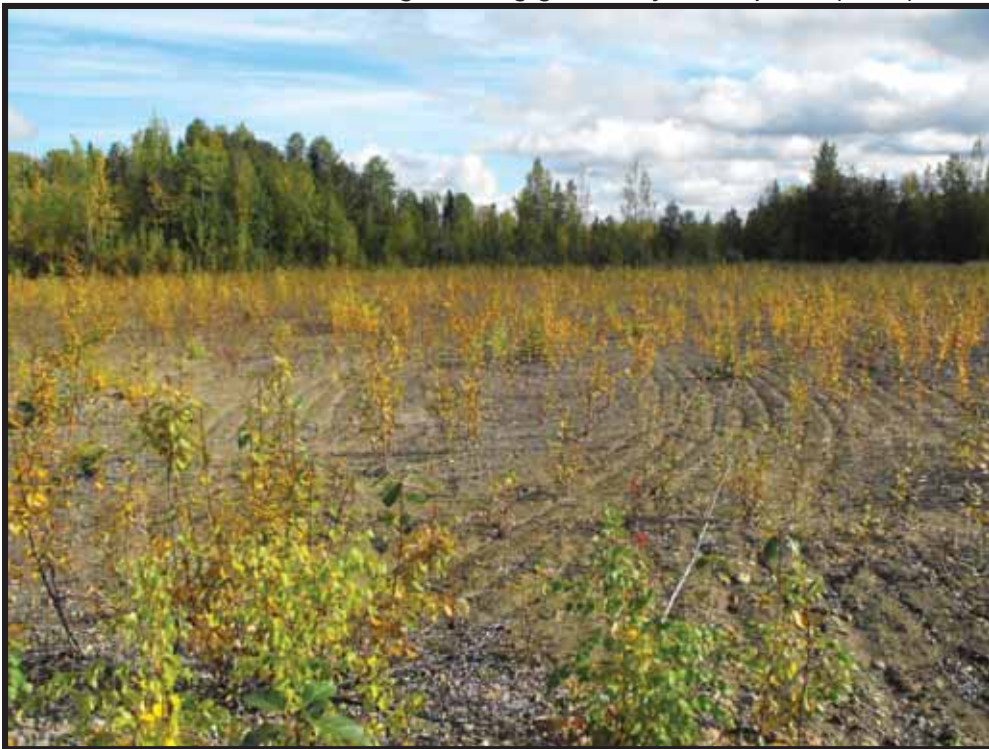
**Photo 4:** *Looking east across Main Transmitter Array after removal and disposal of ground grid wires*

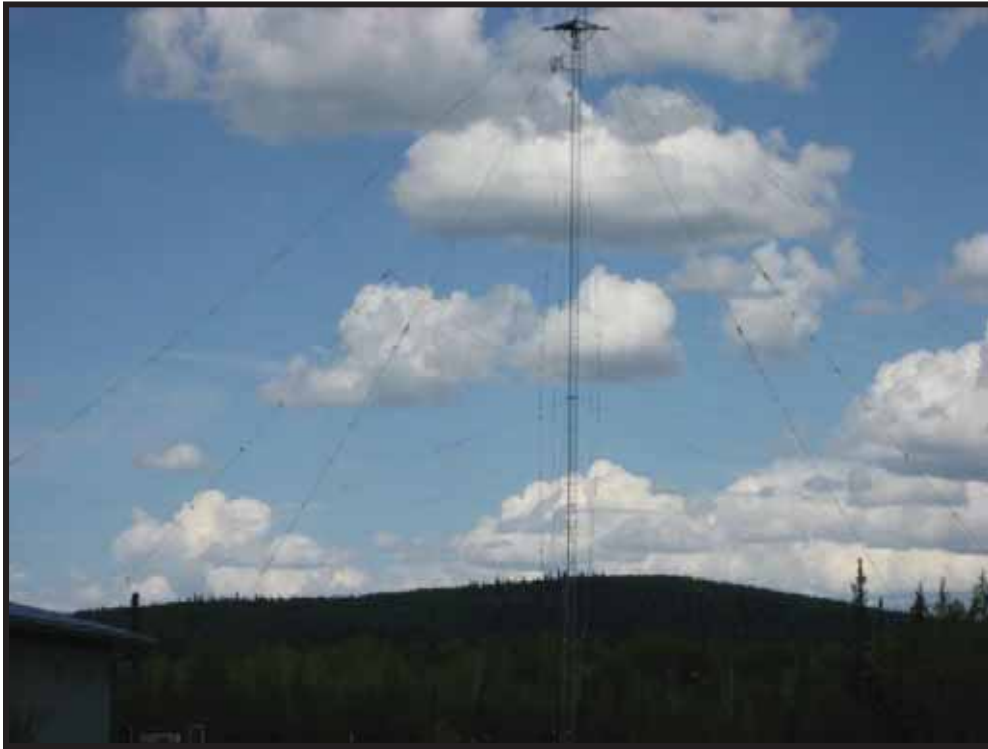
**Photo 5:** Looking north at square antenna field with generator building in lower left (2009)

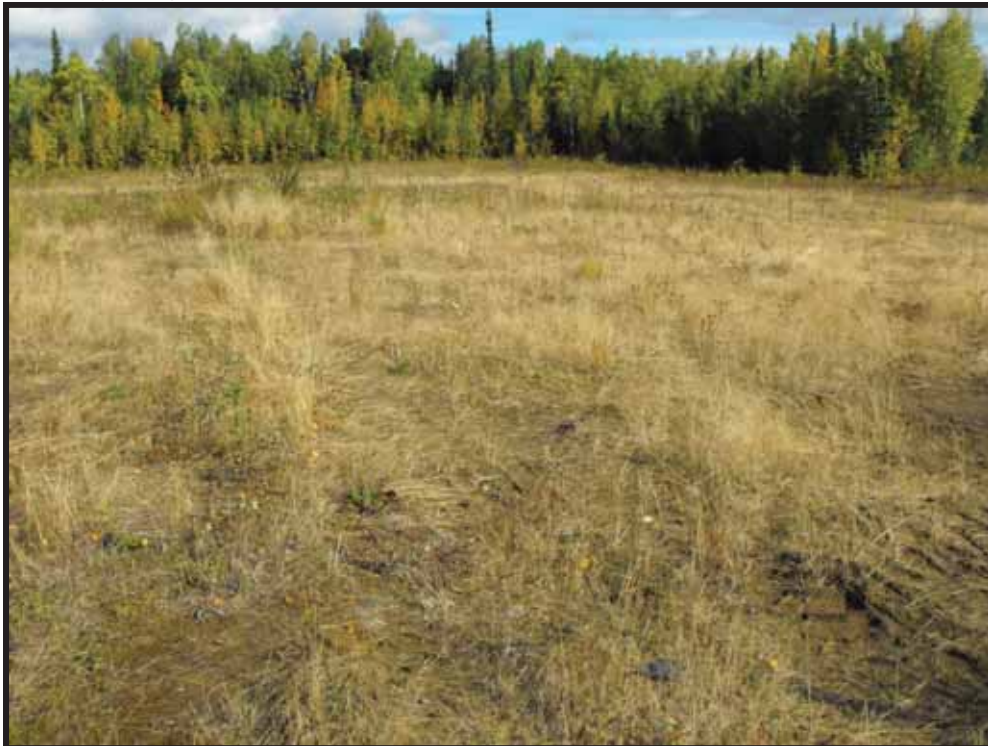
**Photo 6:** Looking north across square antenna field after removal of antenna, anchors, and all other debris (2012)

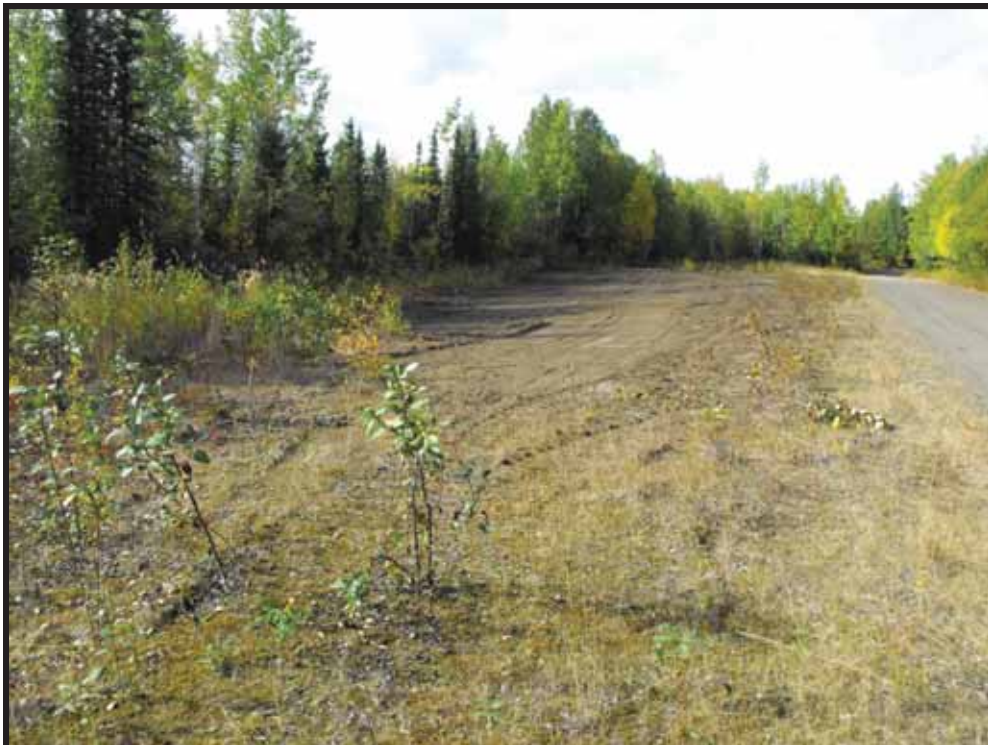
**Photo 8:** Looking west at loading dock area after removal of all materials and debris (2012)

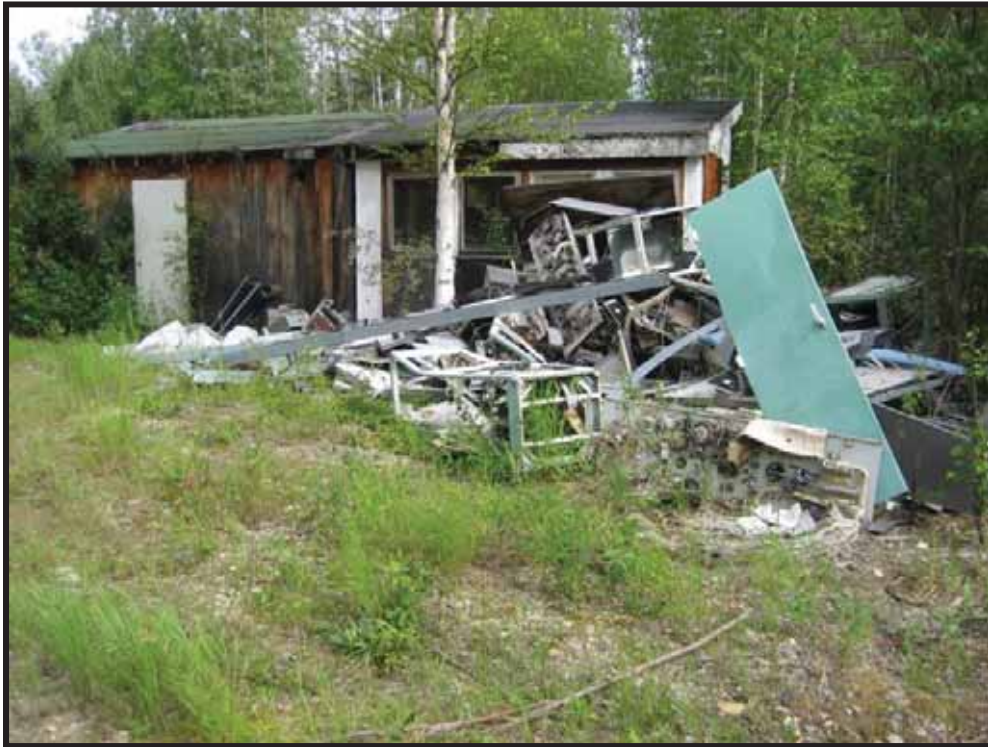
**Photo 9:** *Looking east at debris pile and storage trailers in Boneyard area (2010)*

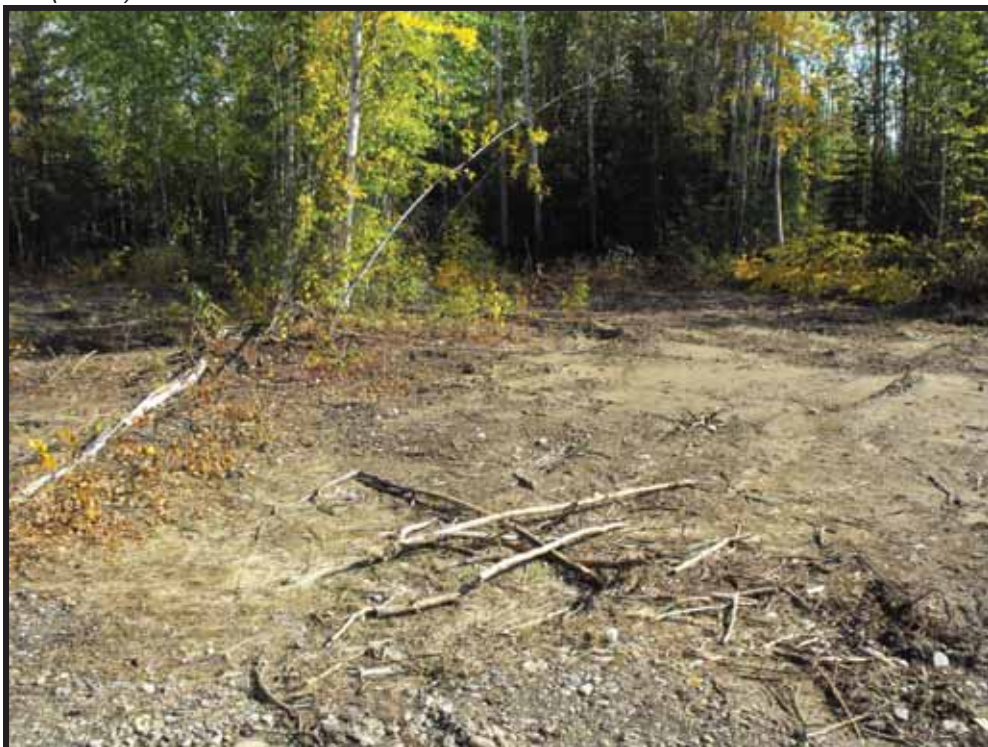
**Photo 10:** *Looking east at former trailer area (left) and dish area in Boneyard following removal of all debris (2012)*

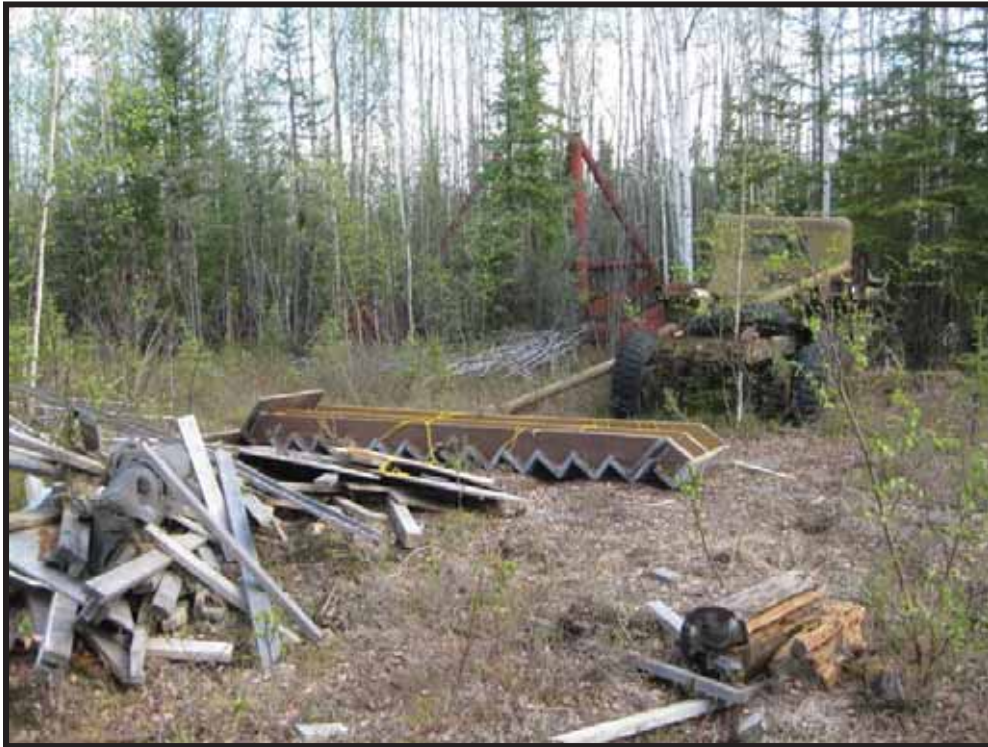
**Photo 11:** Looking east at truck and other debris in Boneyard area (2010)

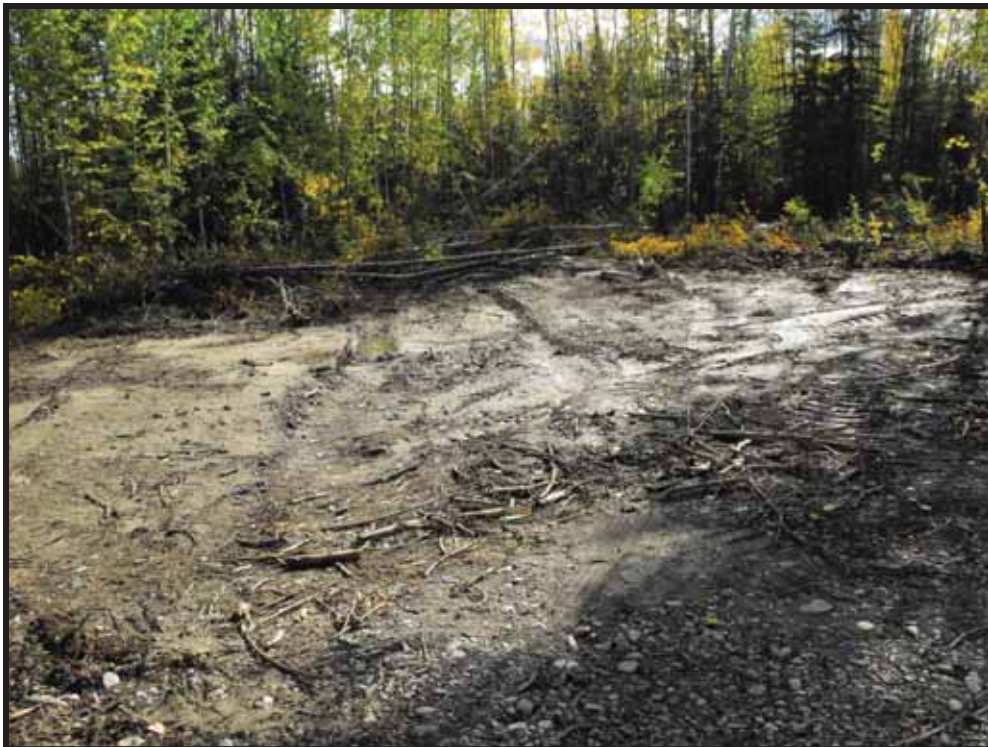
**Photo 12:** Looking southeast at former truck and debris location on Boneyard area (2012)

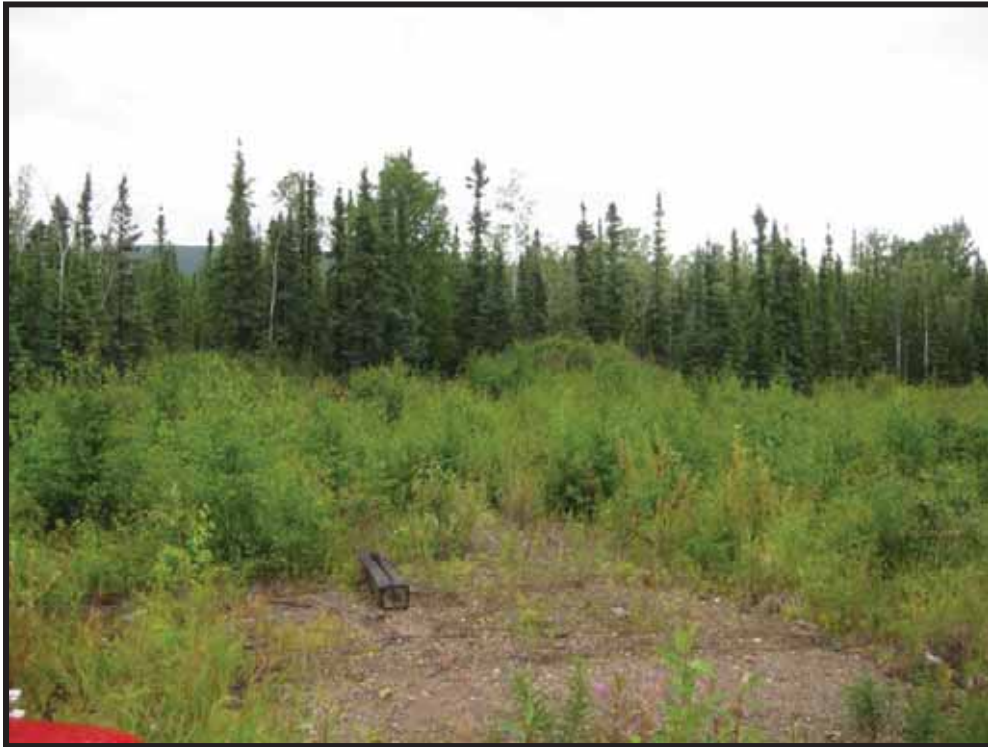
**Photo 13:** Looking north at berms along northern edge of cleared area on eastern portion of site (former dipole area) (2010)

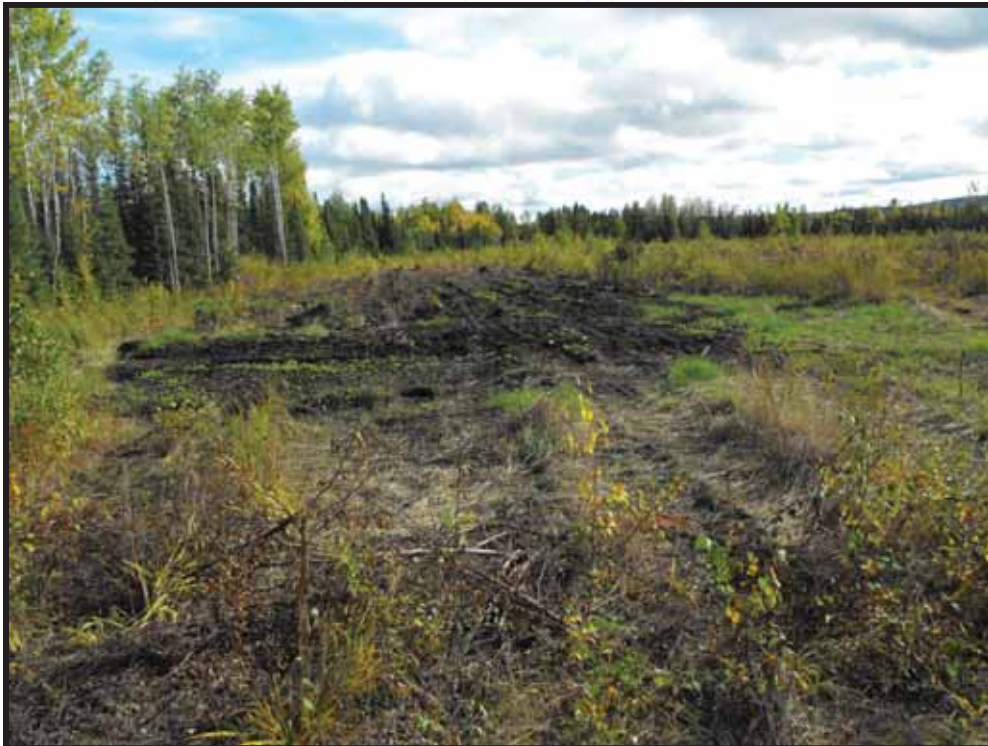
**Photo 14:** Looking east along northern edge of cleared area following spreading of berms and removal of debris (2012)

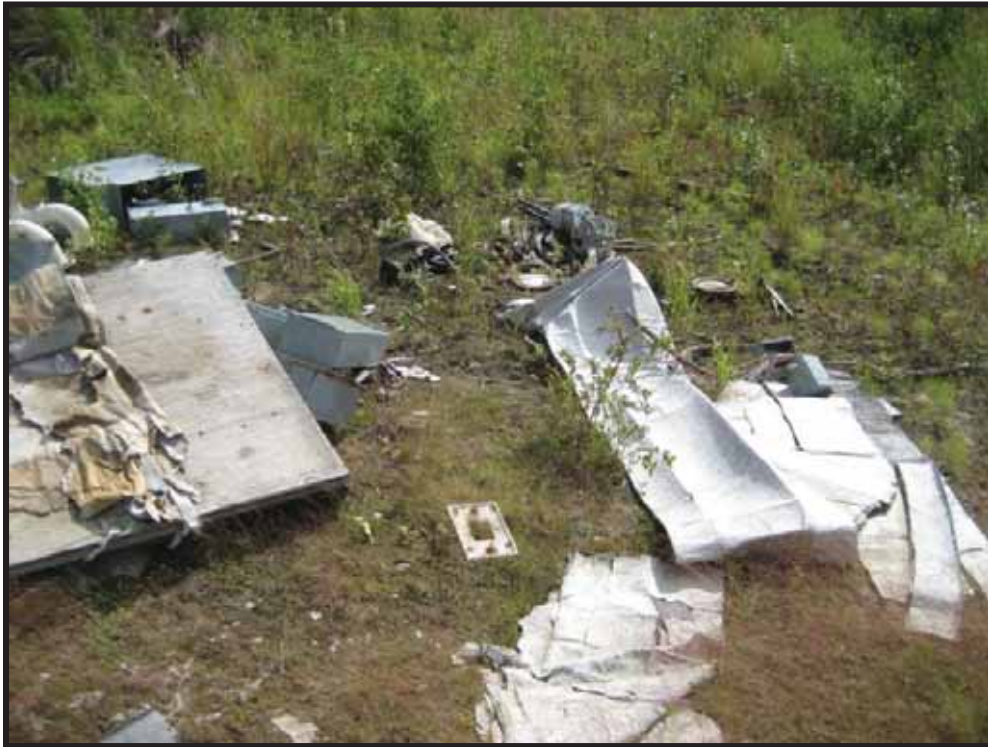
**Photo 15:** *Debris between berms in central portion of cleared area (2010)*

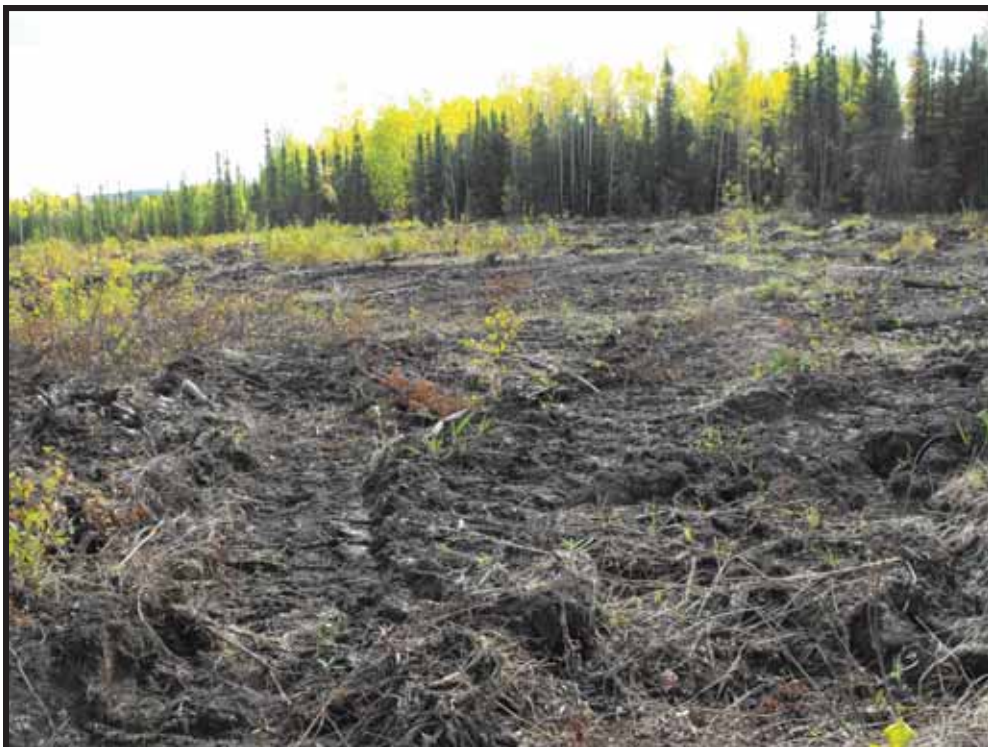
**Photo 16:** *Looking southeast across the central and southern portion of the cleared area after berms were spread and debris removed (2012)*

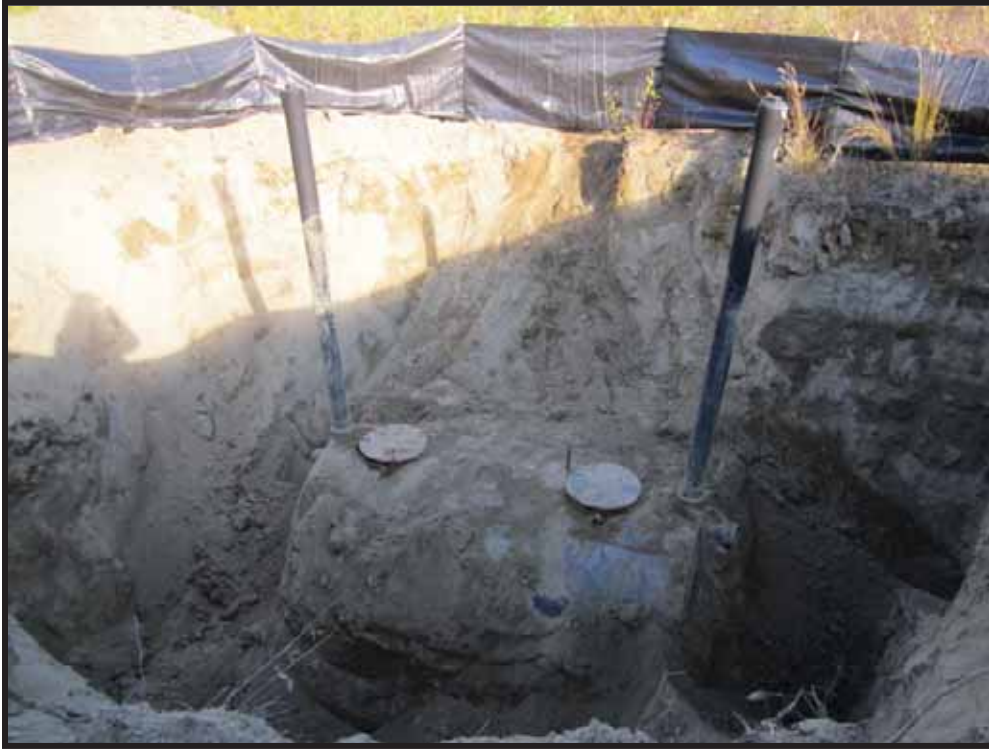
**Photo 1:** Typical septic tank excavation, southeast of Antenna Building.

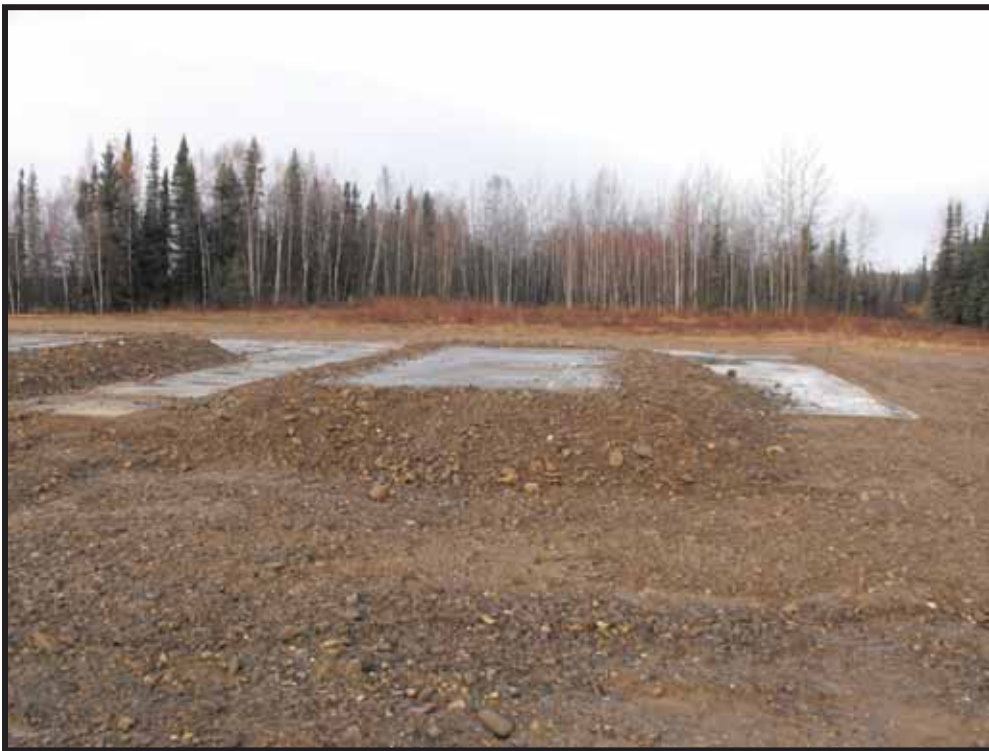
**Photo 2:** Final grading of site with Generator Building foundation in foreground and former septic tank location in upper left.

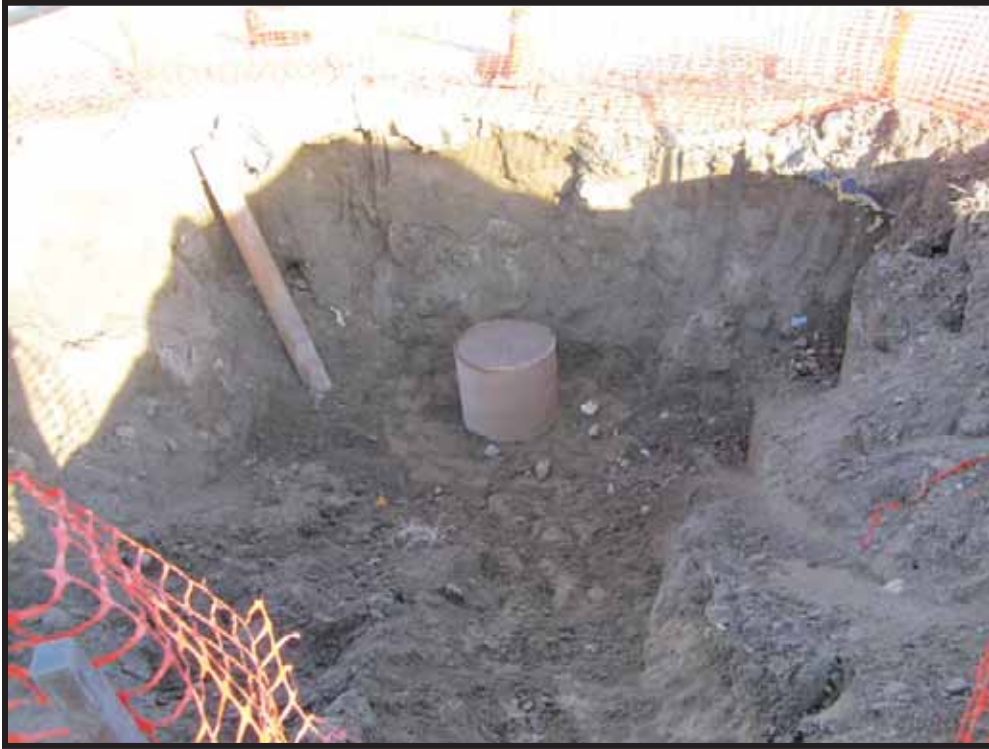
*Photo 3: Typical well decommissioning, after Sonotube filled with concrete.*

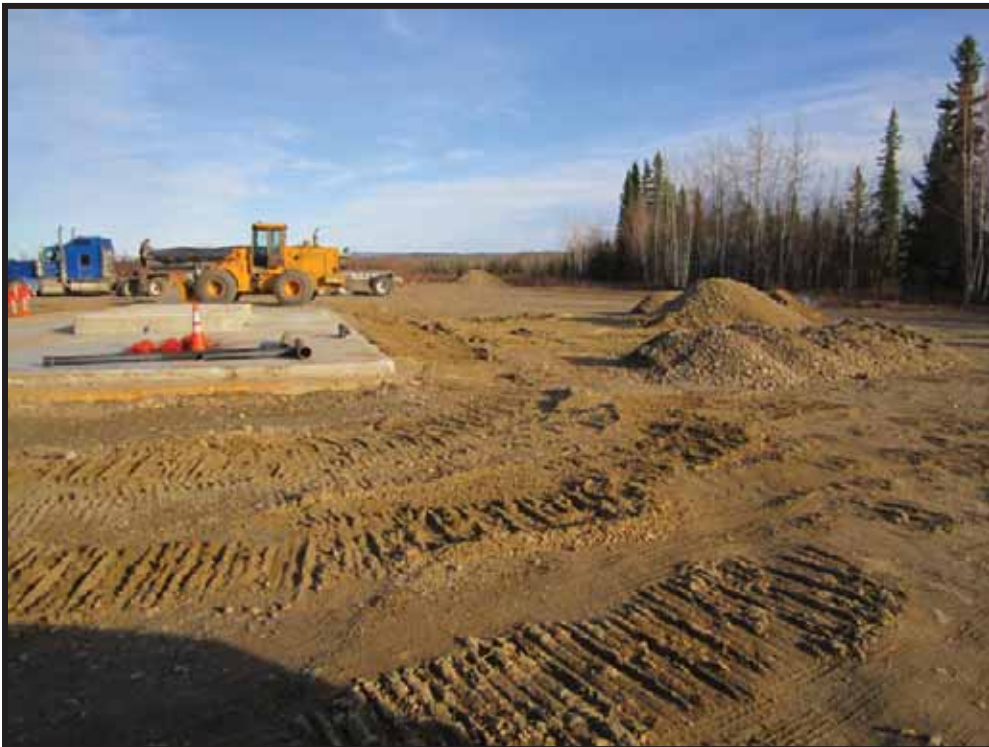
*Photo 4: Typical excavation backfilled, between stockpiles of backfill material and slab.*

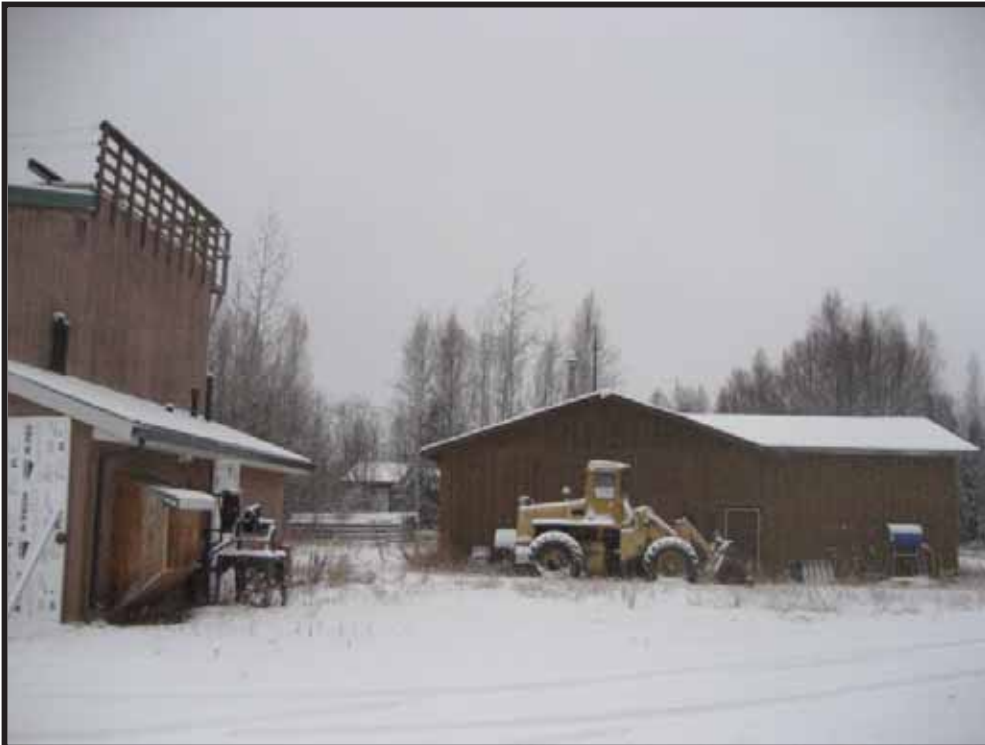
**Photo 1:** LIDAR Garage on right. Note loader and above-ground gasoline tank. Heating fuel AST is behind the loader. Building, loader and tanks were sold at auction and removed.

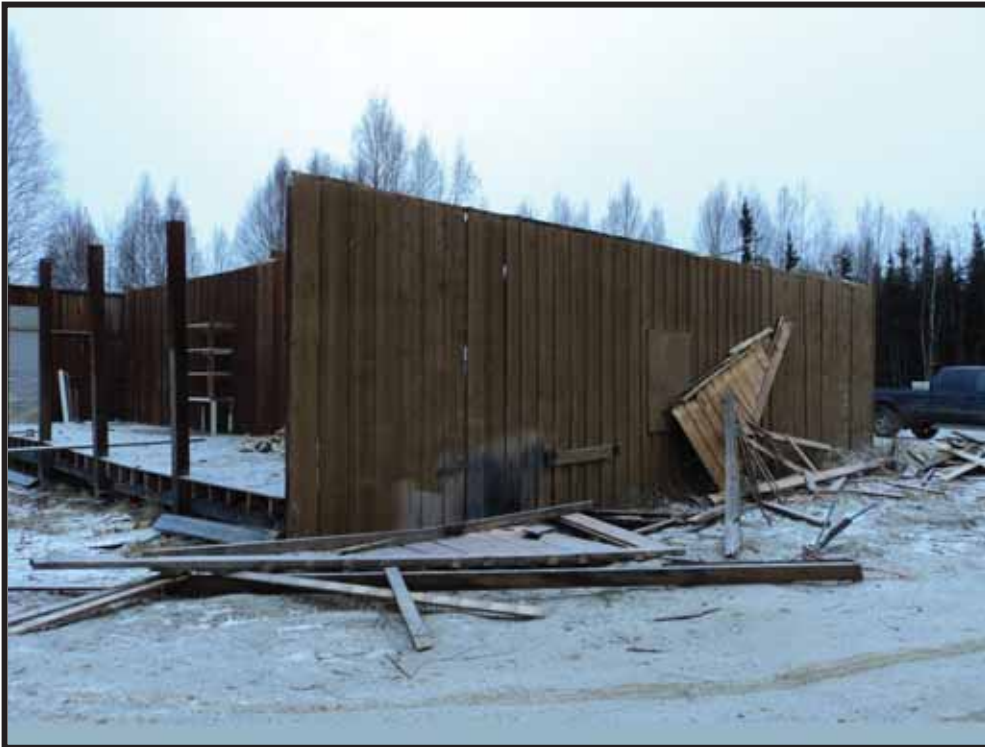
*Photo 3: Photo taken facing southeast during LIDAR garage demolition.*

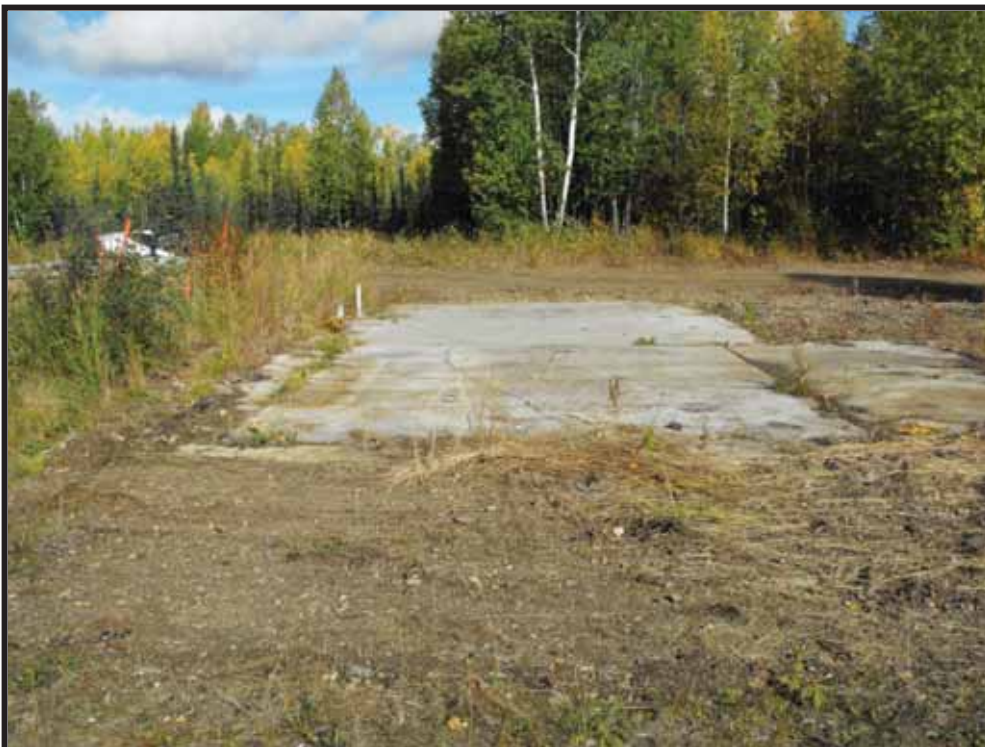
*Photo 4: Photo taken facing north showing LIDAR garage slab.*

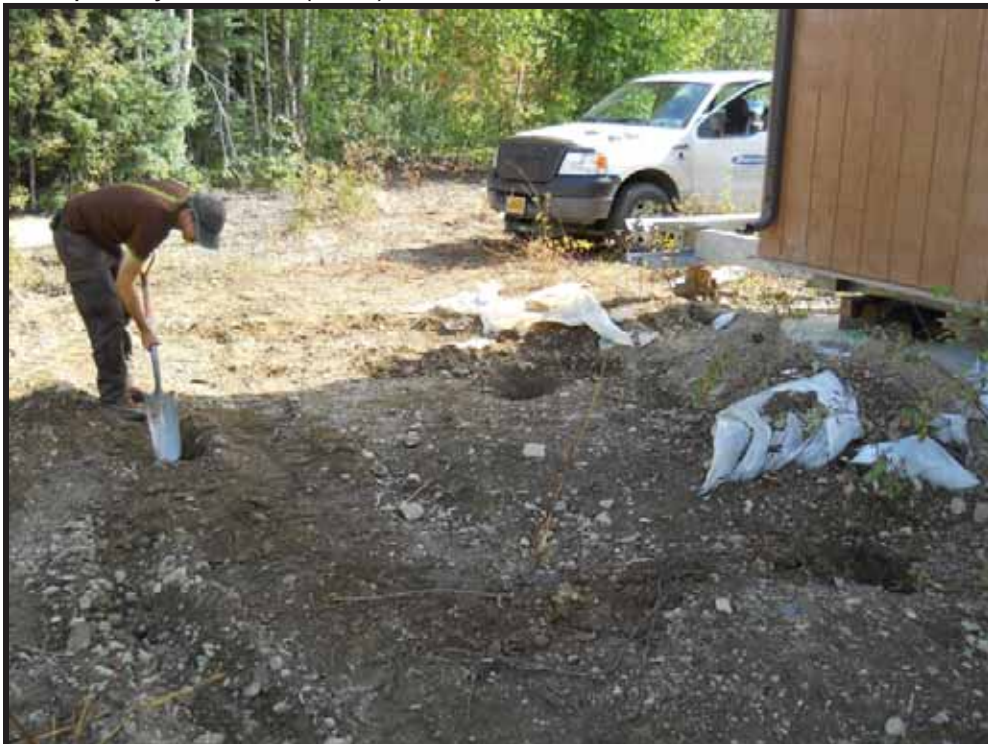
**Photo 2:** Field screening before removal of building in vicinity of former location of heating fuel AST(2010).

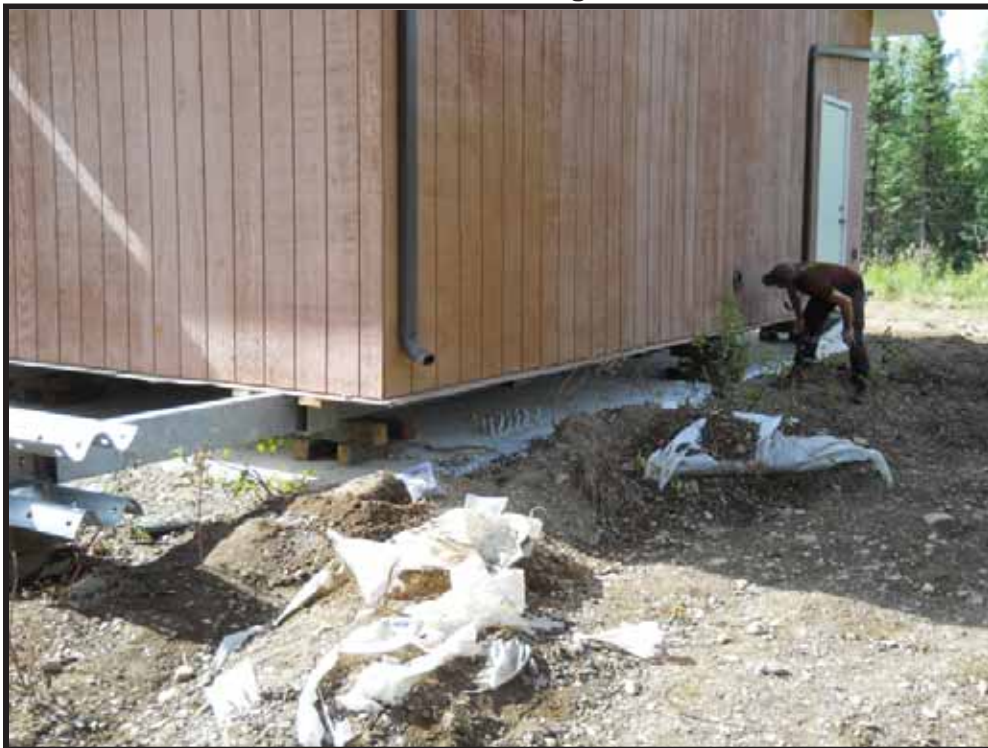
**Photo 3:** During building removal in vicinity of former location of heating fuel AST.

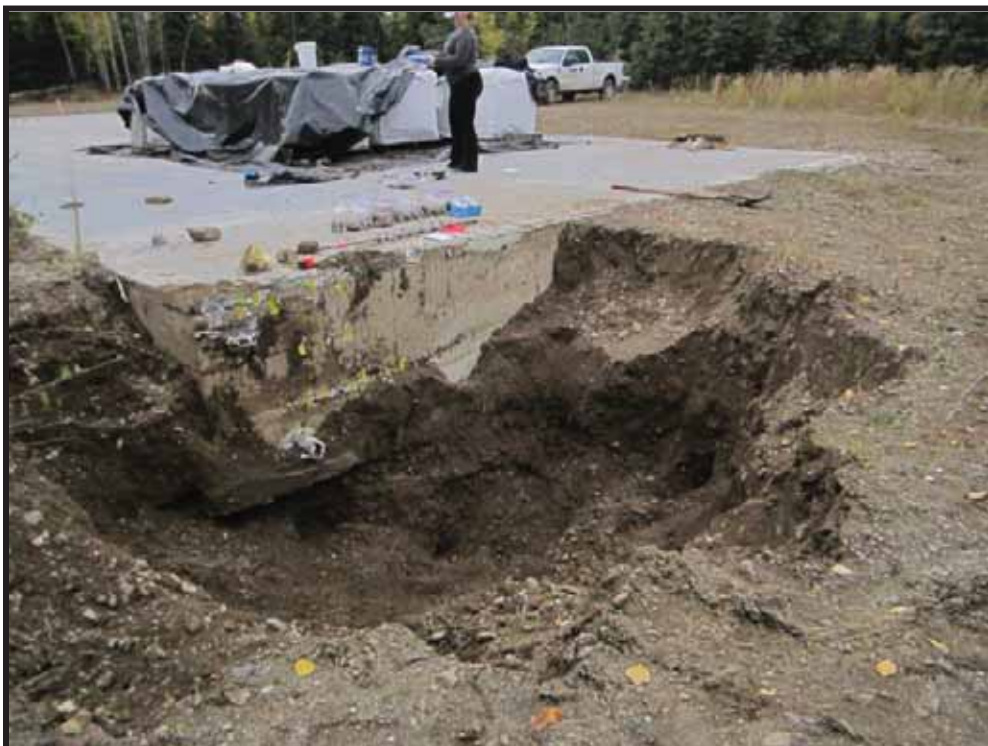
**Photo 4:** Looking southeast showing LIDAR AST excavation limits with containerized mercury-contaminated soil on slab.

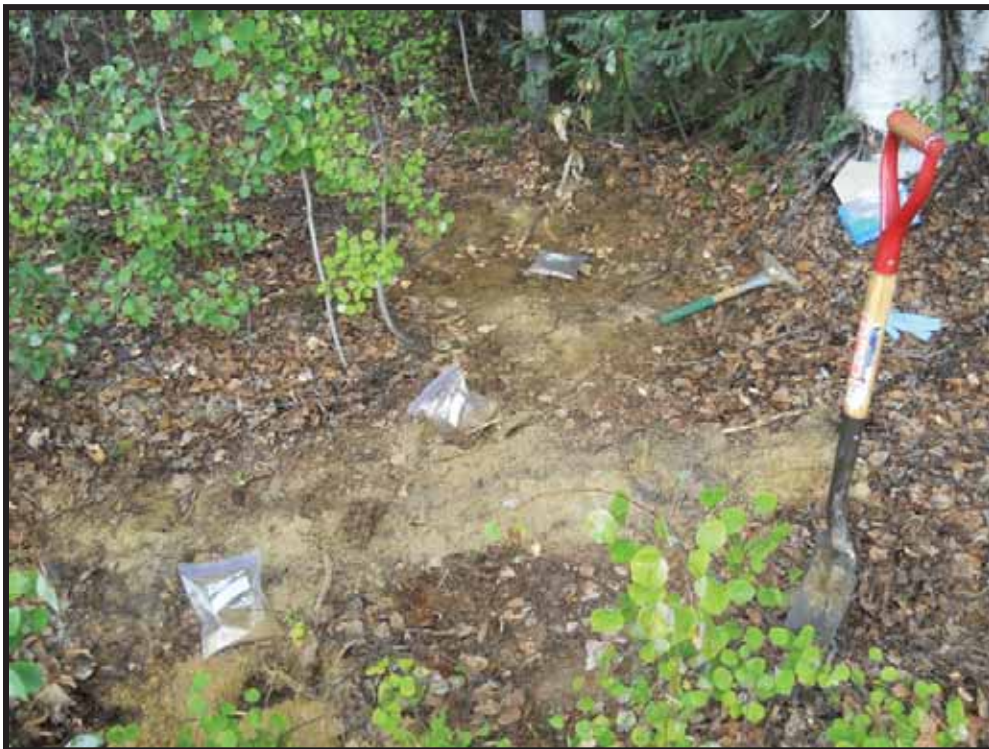
*Photo 2: Initial assessment at abandoned transformer in LIDAR area.*

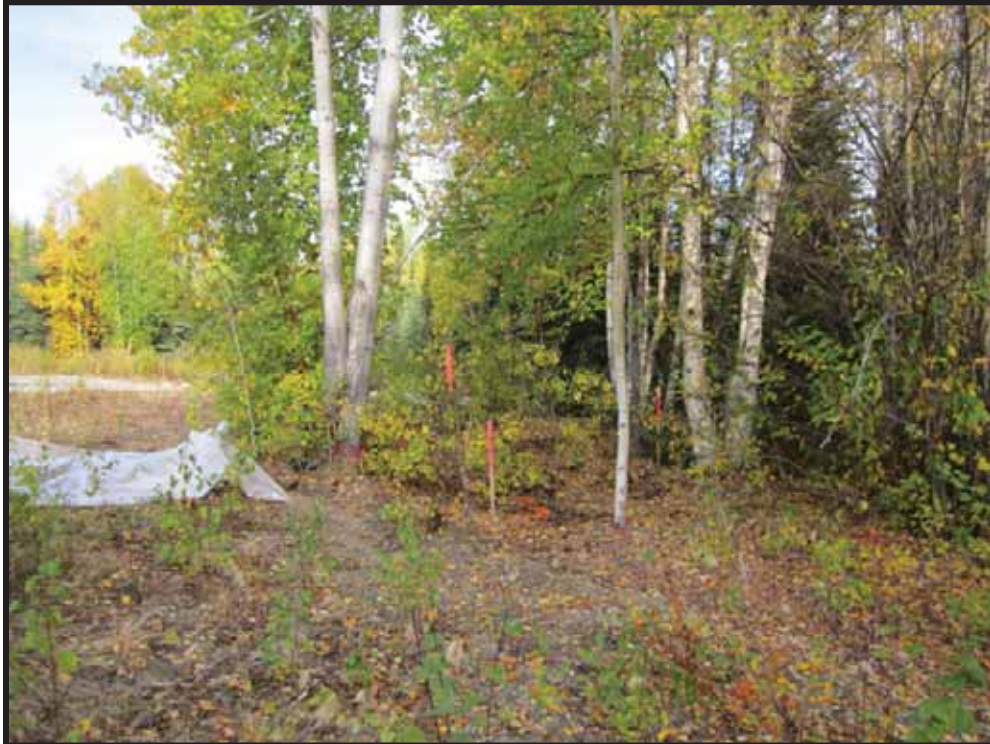
**Photo 3:** Photo taken facing northwest. Flagged area is former location of transformer.

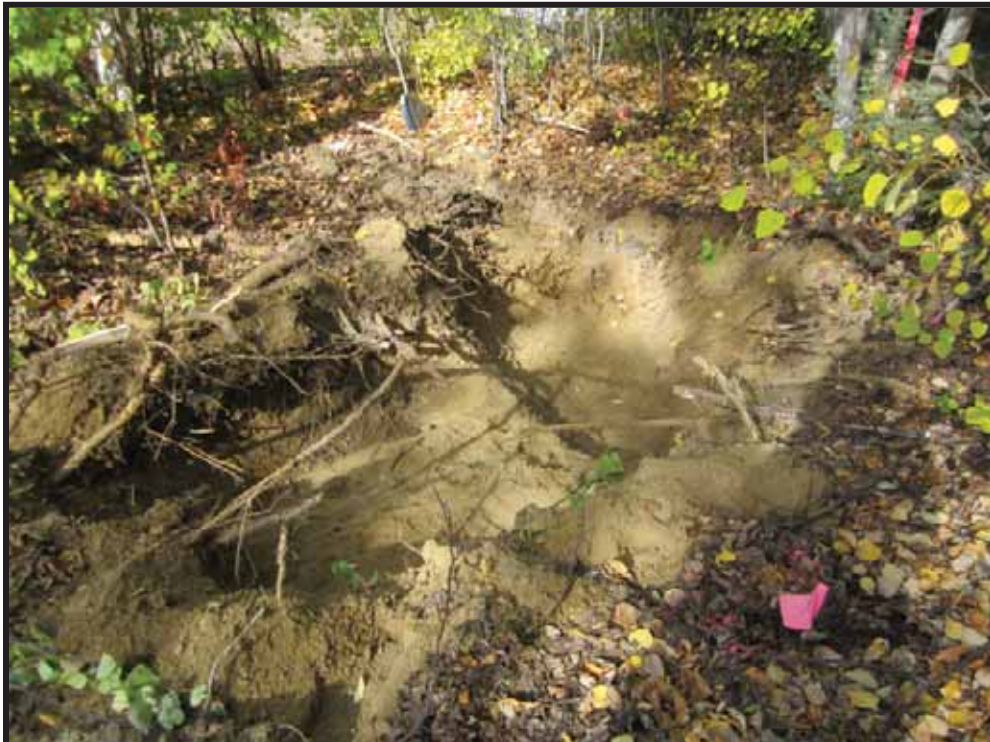
**Photo 4:** Final extents of excavation.

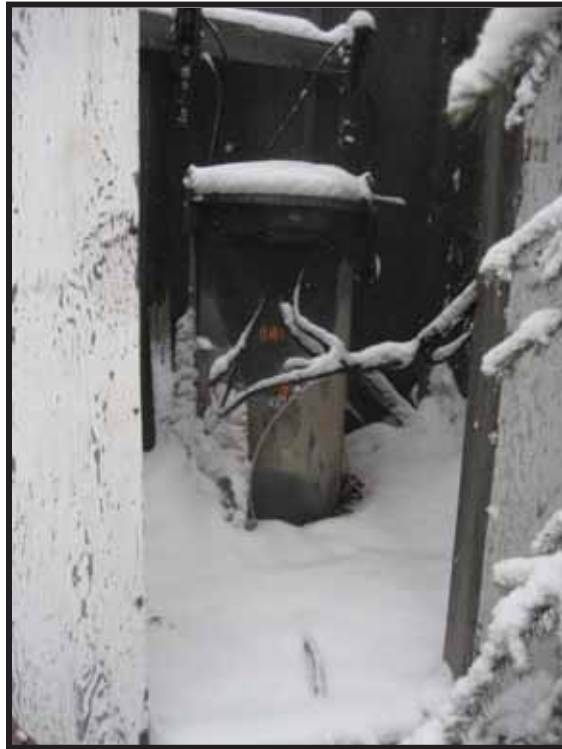
*Photo 1: The Boneyard area transformer and shed.*

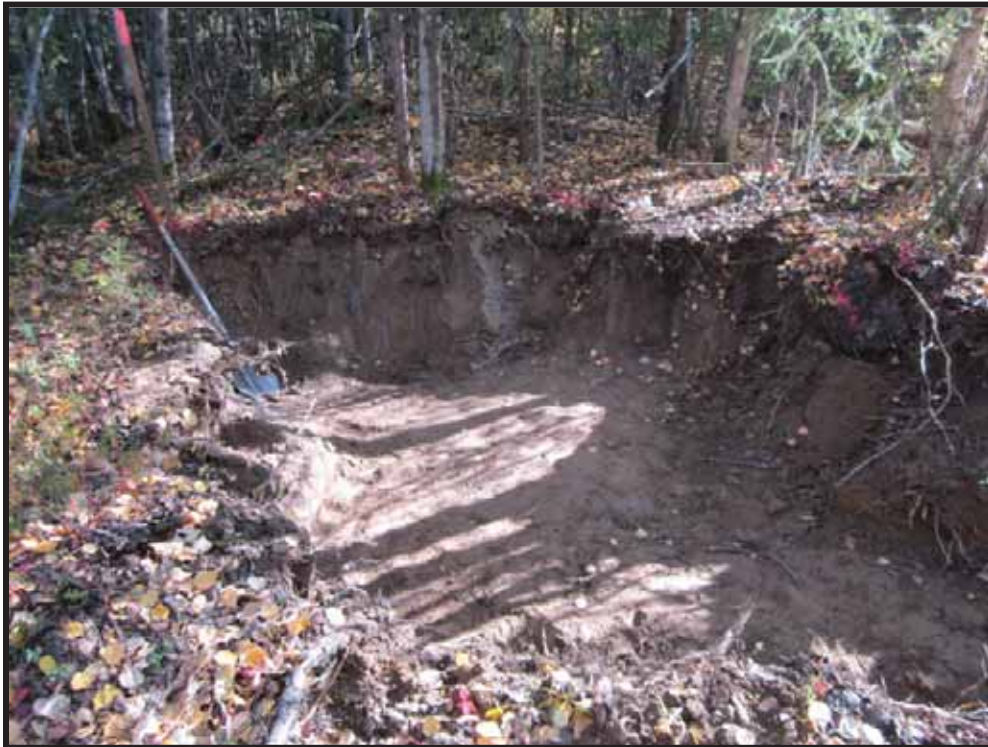
*Photo 3: Looking southeast after September 2012 excavation.*

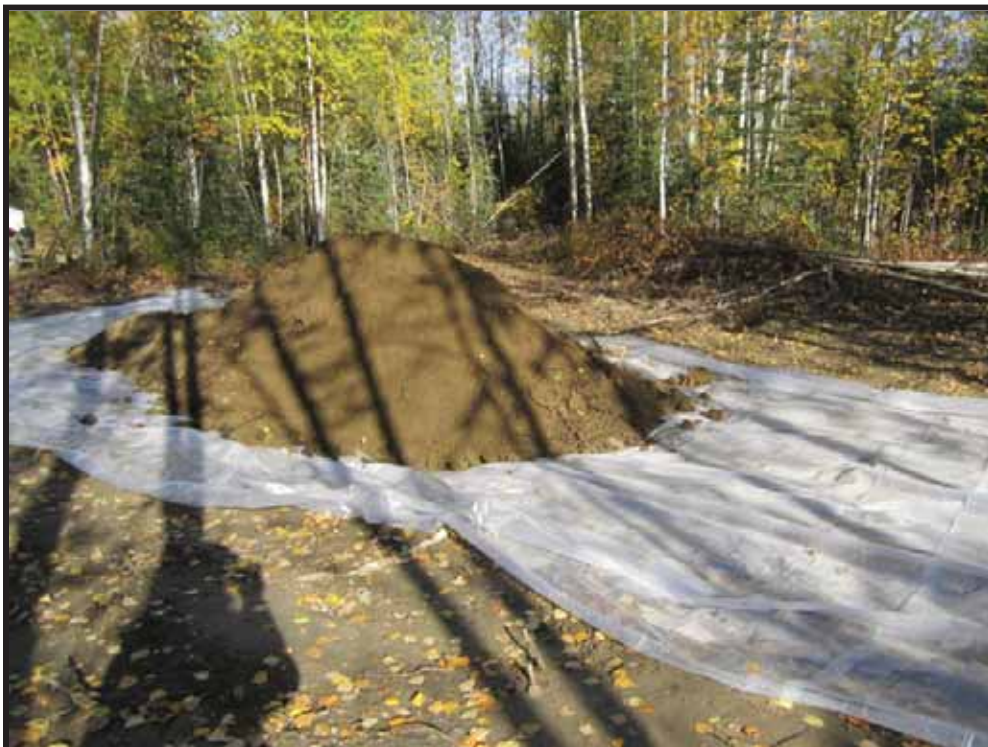
*Photo 4: Typical stockpile construction with reinforced polyethylene liner and cover.*
