# SITE CHARACTERIZATION, CORRECTIVE ACTION AND DECOMMISSIONING REPORT

**HIPAS OBSERVATORY  
7795 CHENA HOT SPRINGS ROAD  
FAIRBANKS (TWO RIVERS), ALASKA**

**MARCH 5, 2013**

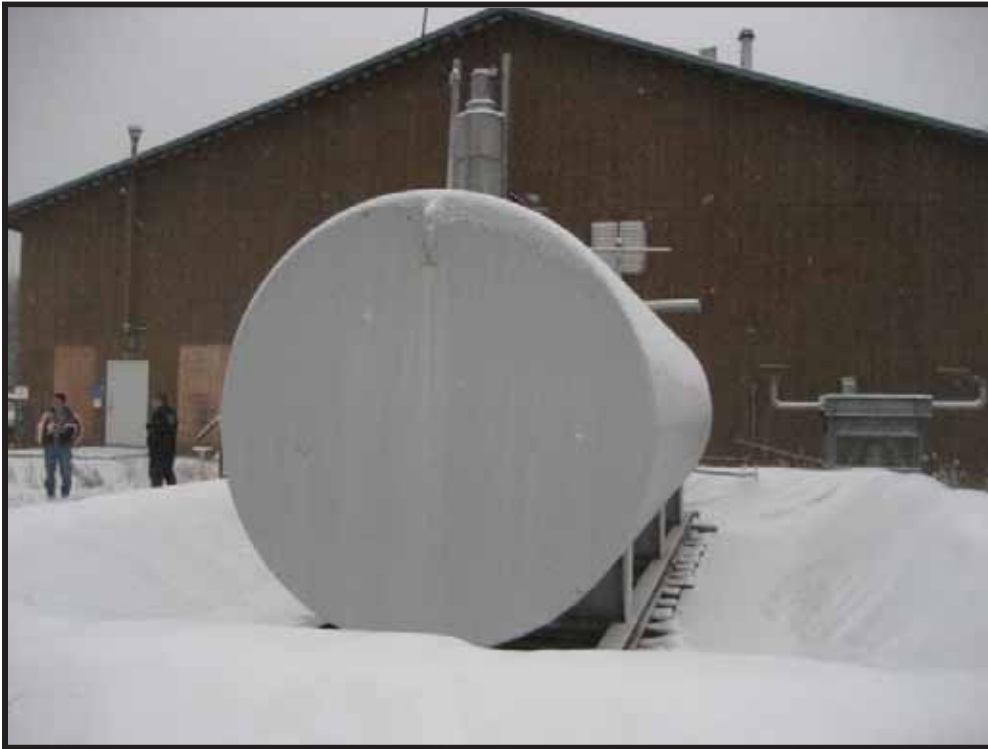
*Photo 1: 10,000 gallon Generator Building AST with lined containment berm.*

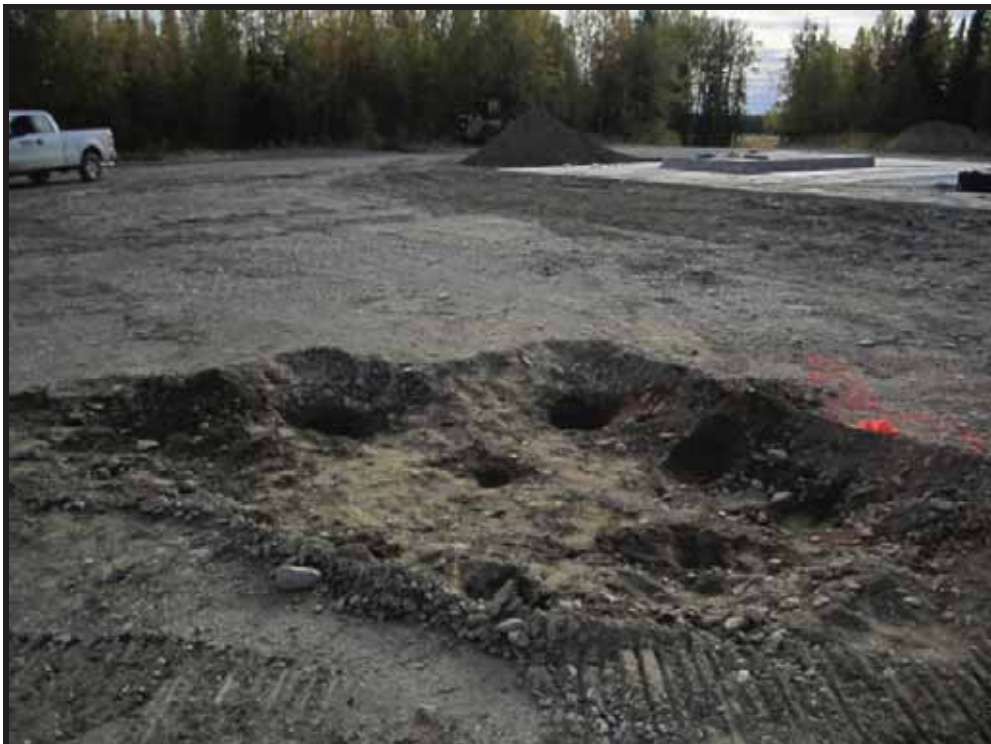
*Photo 2: Photo taken facing southwest. Preliminary characterization September 2012.*

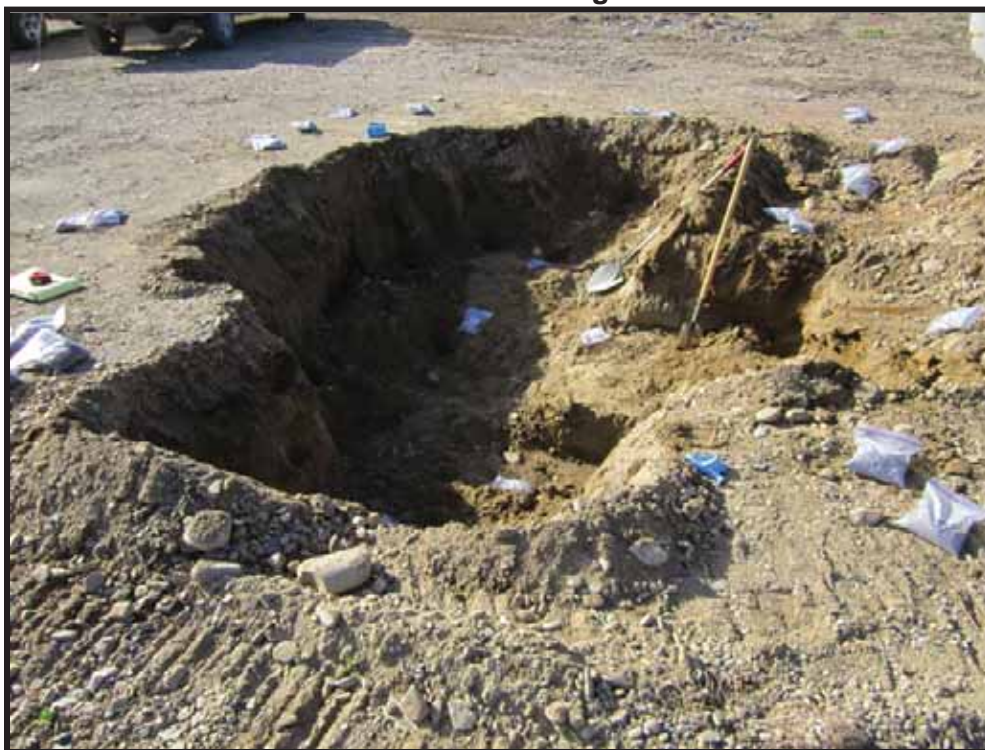
*Photo 3: Looking south at final excavation limits.*

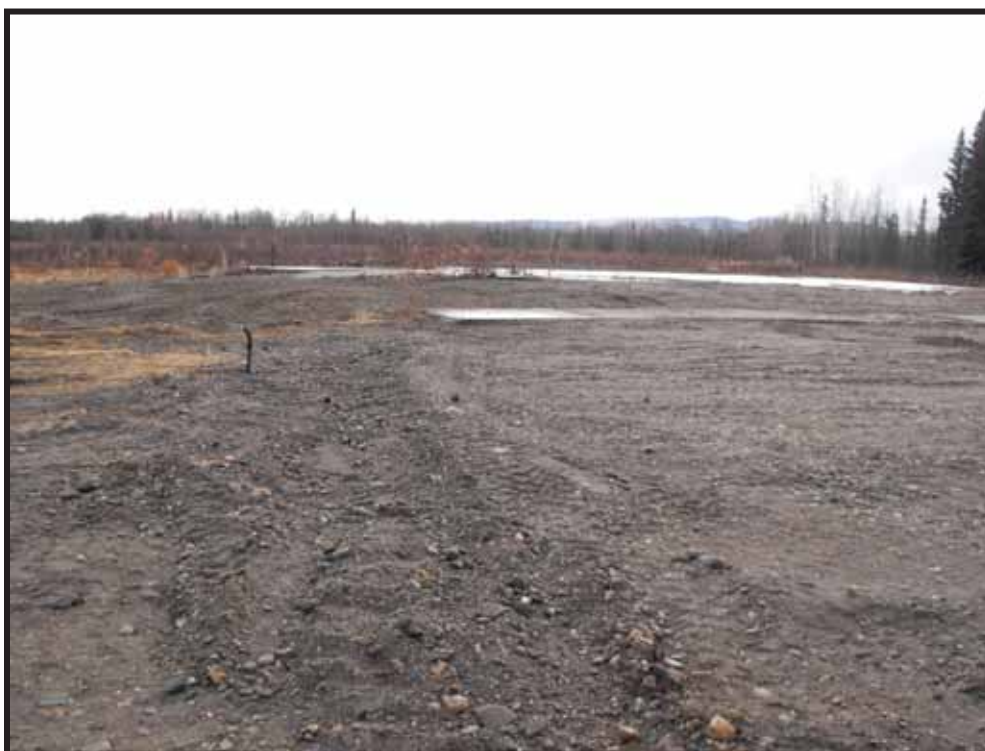
*Photo 4: Excavation backfilled to grade October 2012, typical of each location.*

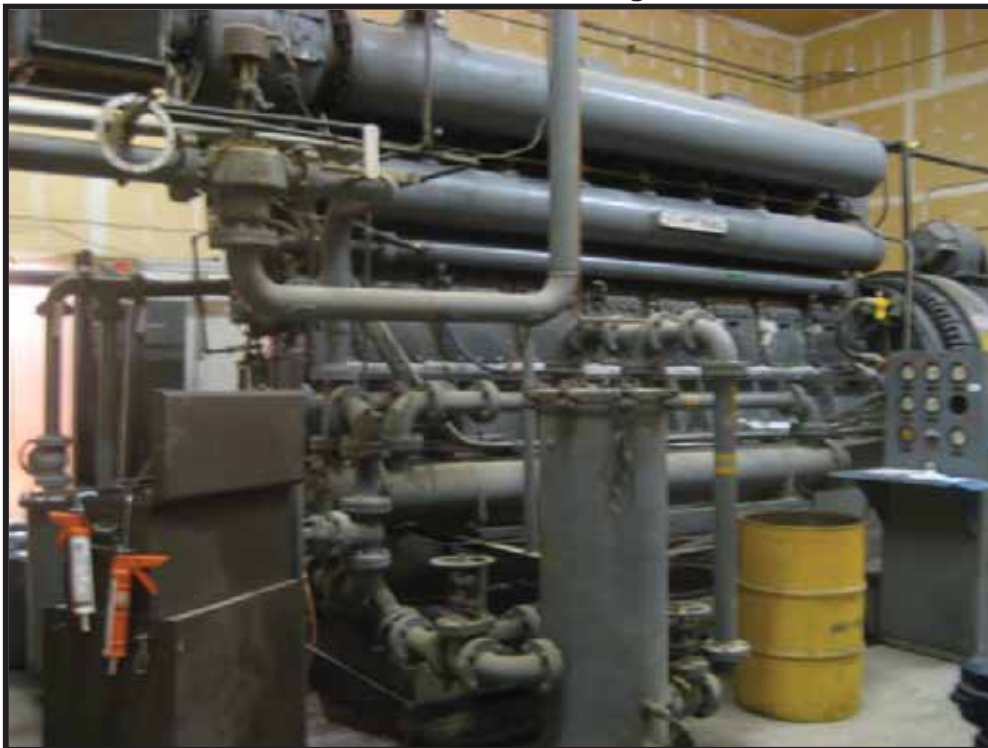
**Photo 1:** Looking southwest at one of two generators. Coolant system in foreground with fuel pump on left.

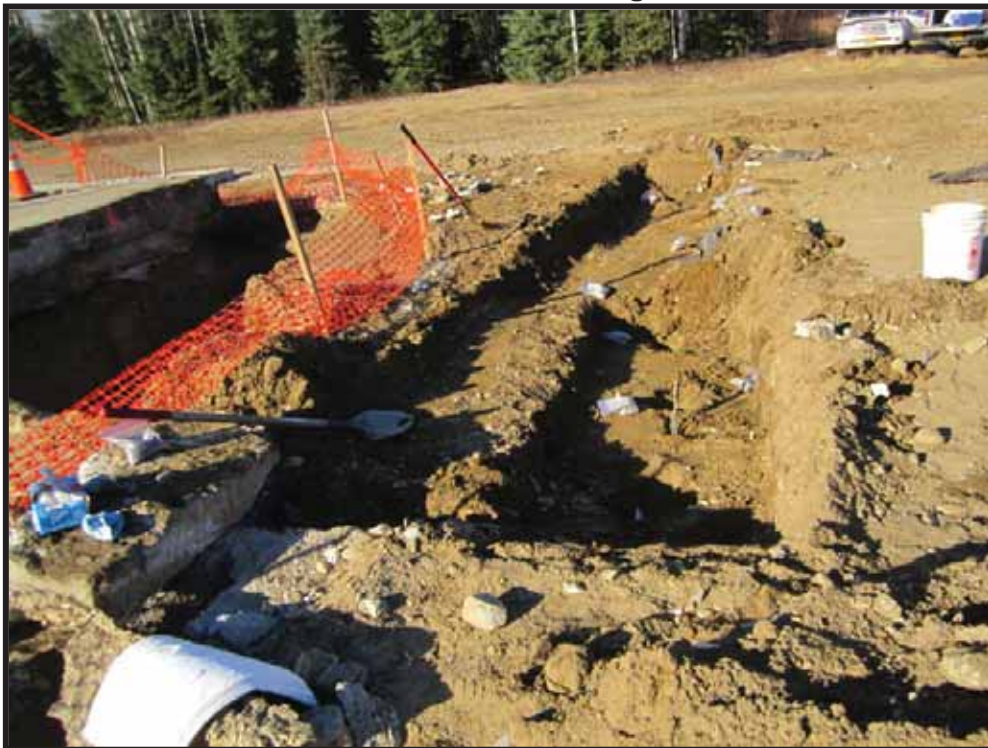
*Photo 7: Excavation outside footing perimeter on east side of north pedestal.*

The larger areas with suspected diesel fuel contamination required the removal of additional concrete floor slab on the east side of the generator pedestals. Remedial excavation of these areas began after the removal of the floor slab. This work was undertaken in several phases based on field observations, including interim characterization samples confirming DRO contamination. At the completion of the remedial excavation of the eastern ends of the northern and central pedestals, approximately 50 cubic yards of contaminated soil had been placed in the temporary stockpiles. Field screening results were used to guide the remedial excavation down the side of the pedestals and a few feet below and underneath the pedestals. The final excavations extended to a depth of approximately seven feet below the top of the slab and approximately 10 feet east of each pedestal. Figure 7 details the extent of excavation at this site.

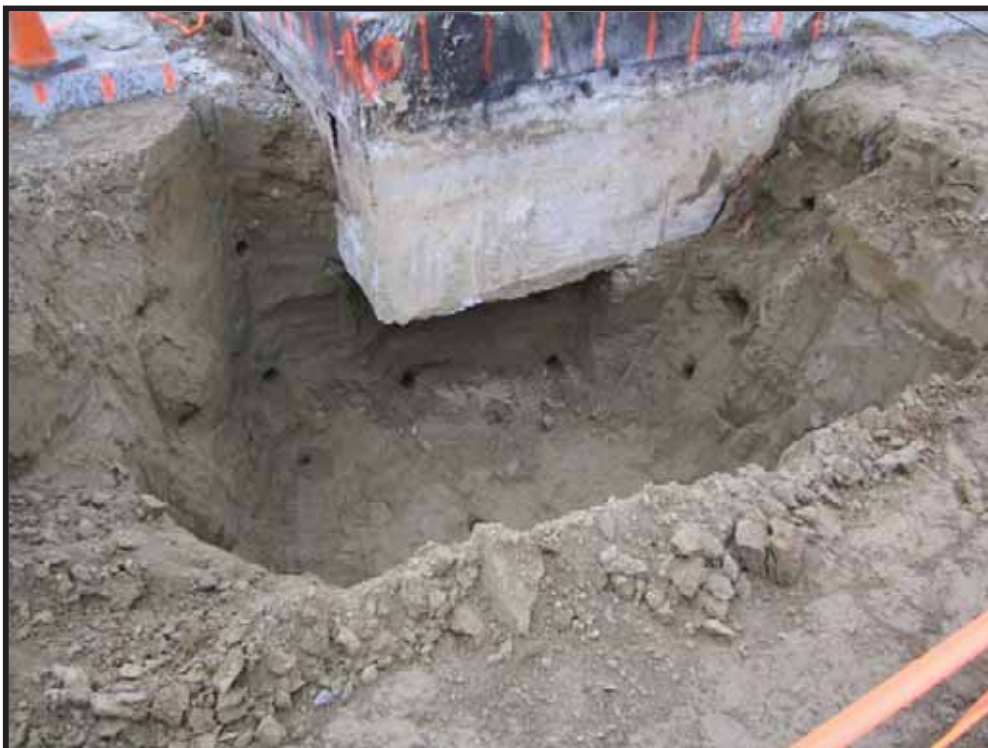
*Photo 8: Final limits of excavation on east side of central pedestal. Orange markings are 1-foot demarcation lines.*

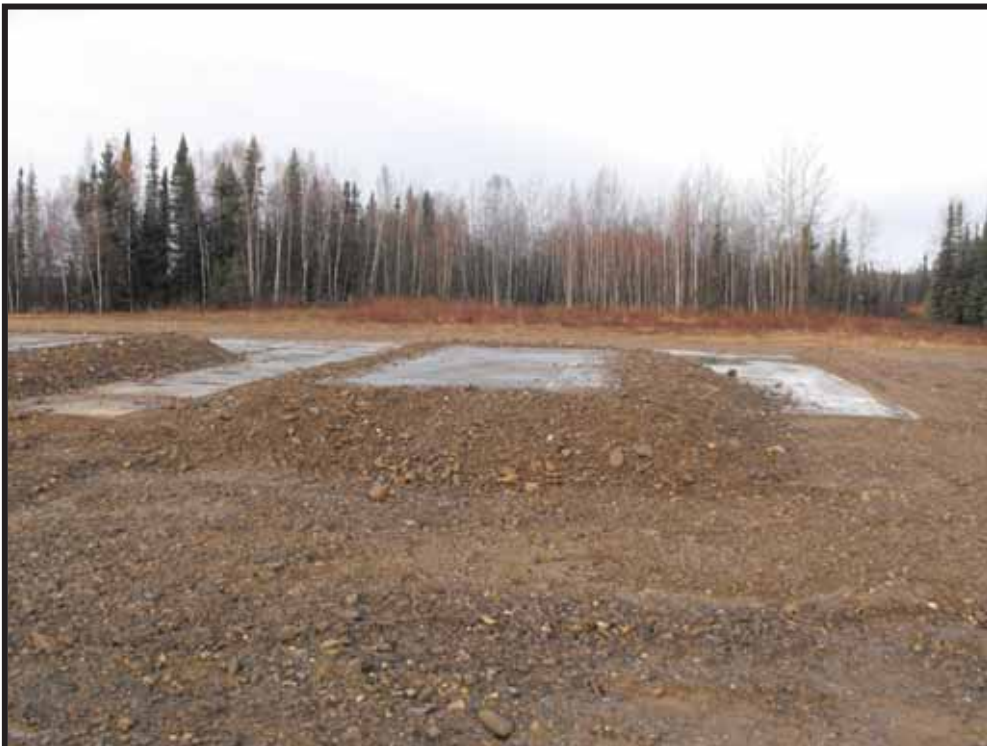
**Photo 10:** Looking west at north generator pedestal after surface cleaning with clean fill installed.

The concrete surfaces of the generator pedestals were cleaned to remove petroleum staining to the extent possible. Following scrubbing and sandblasting, only slight discoloration was observed and no residue was observed during wiping with a rag. The concrete foundation items that remain in place are shown in Figure 7. Gravel backfill was used to create a slope from the top of the generator pedestals to the concrete floor slab to make the site more level.

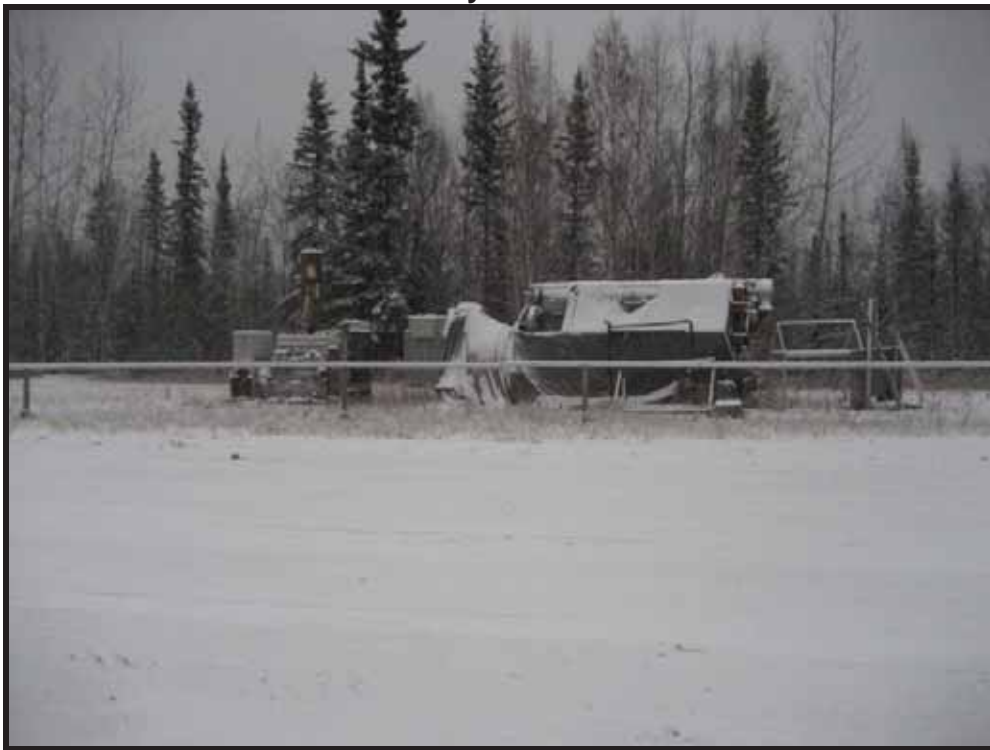
*Photo 1: Looking south at the parts generator south of the powerhouse.*

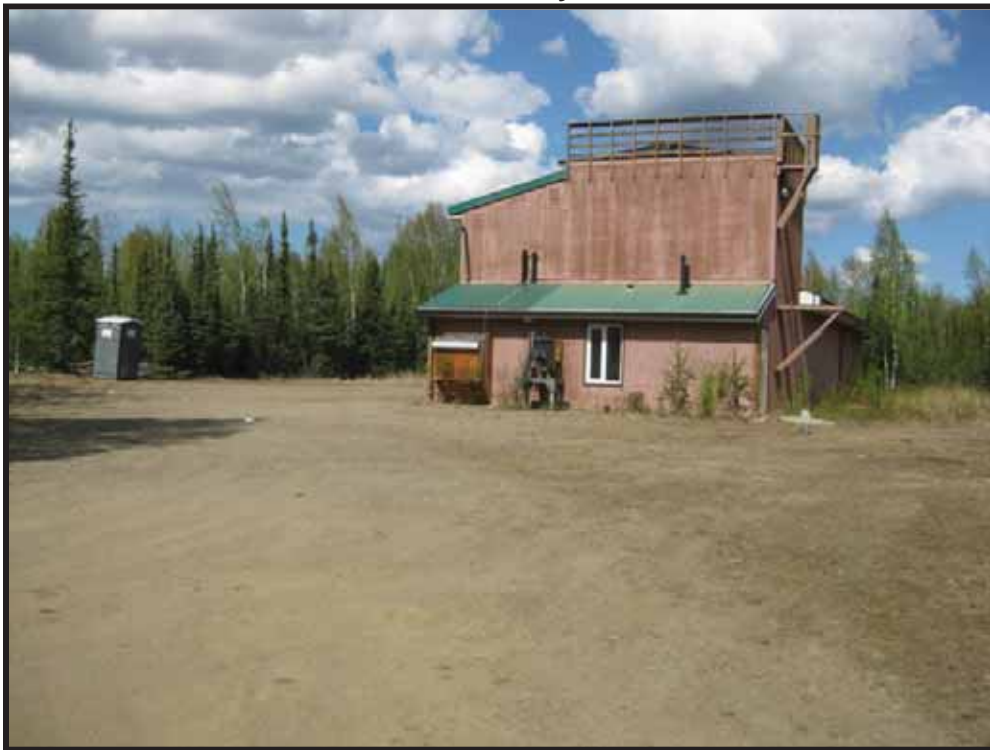
*Photo 1: LIDAR Tower site containing Liquid Mirror Telescope (LMT).*

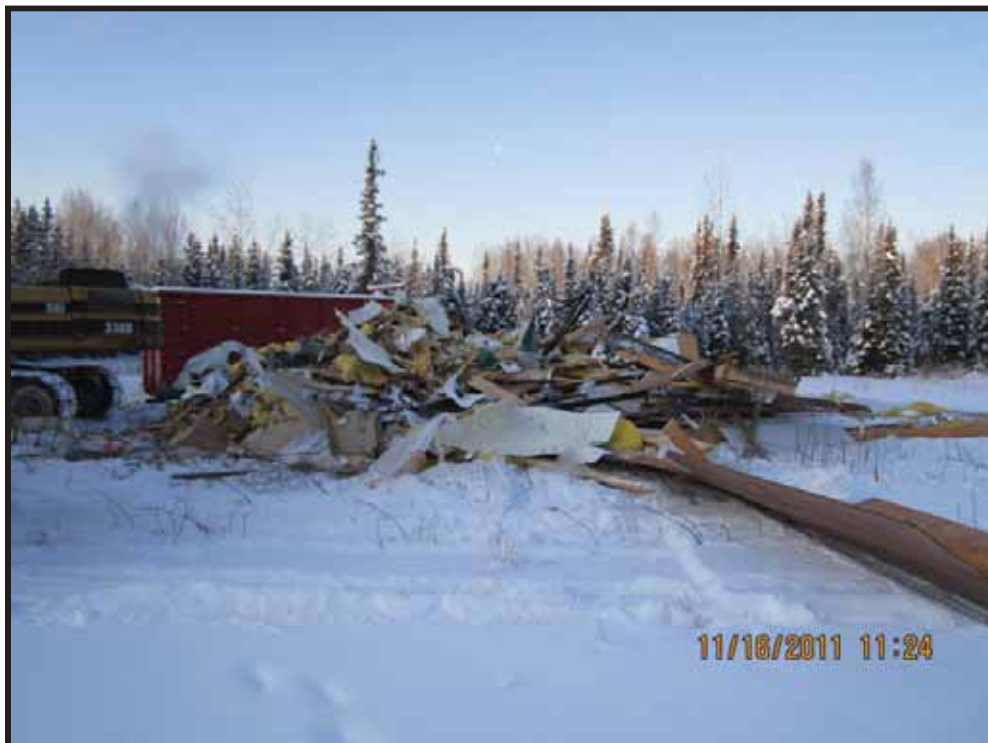
*Photo 4: Building during mechanical demolition.*

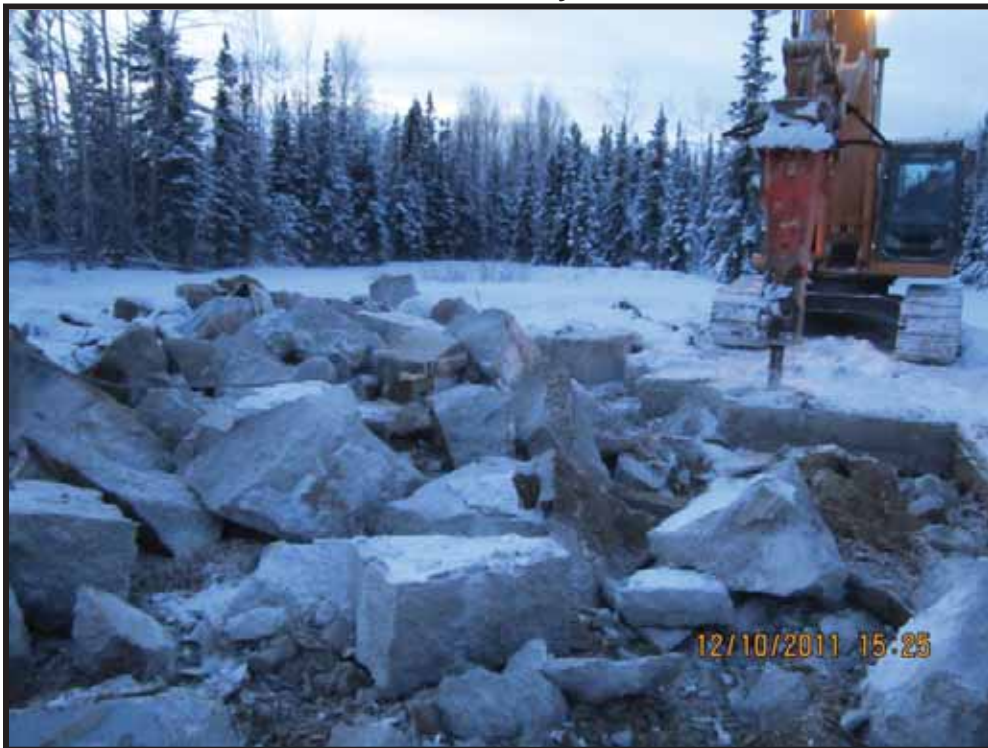
*Photo 5: Concrete foundation during mechanical demolition.*

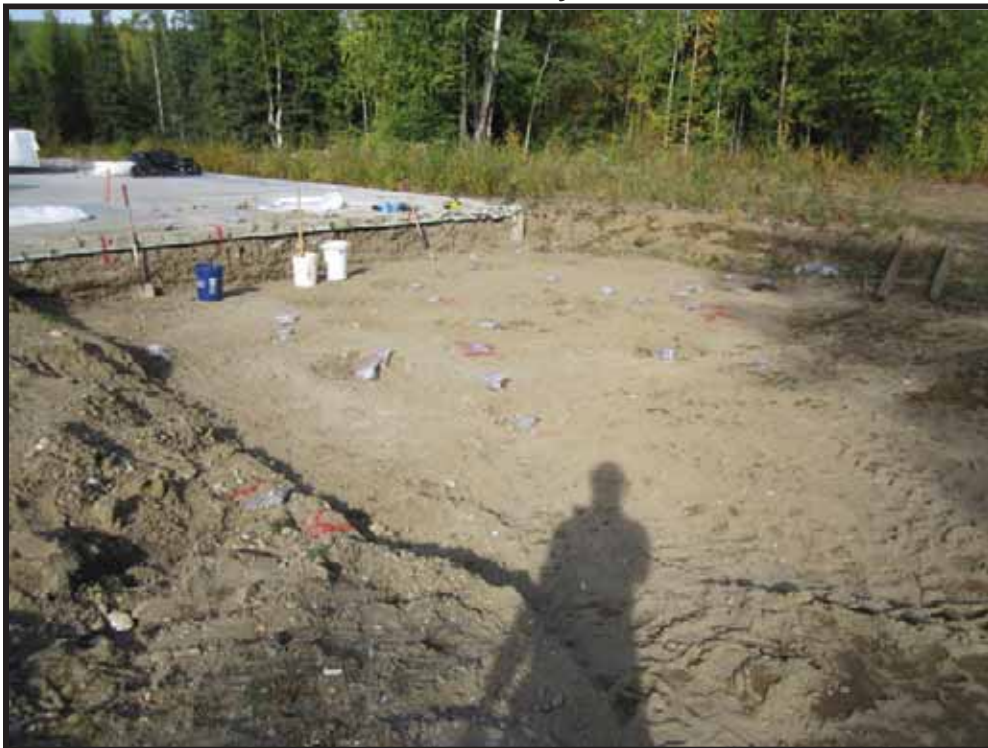
*Photo 7: Final extents of excavation with field screening samples.*
