**U.S. AIR FORCE
FORMER PORT HEIDEN RADIO RELAY STATION,
ALASKA**

Final Report

**First Five-Year Review
of Environmental Restoration Program Sites OT001,
WP002, SS004, LF007, and Four Unnumbered Sites
(Antenna Pads, Contaminated Soil Removal Areas, Drum
Storage Area, and Focus Area) Former Port Heiden Radio
Relay Station**

AUGUST 2014

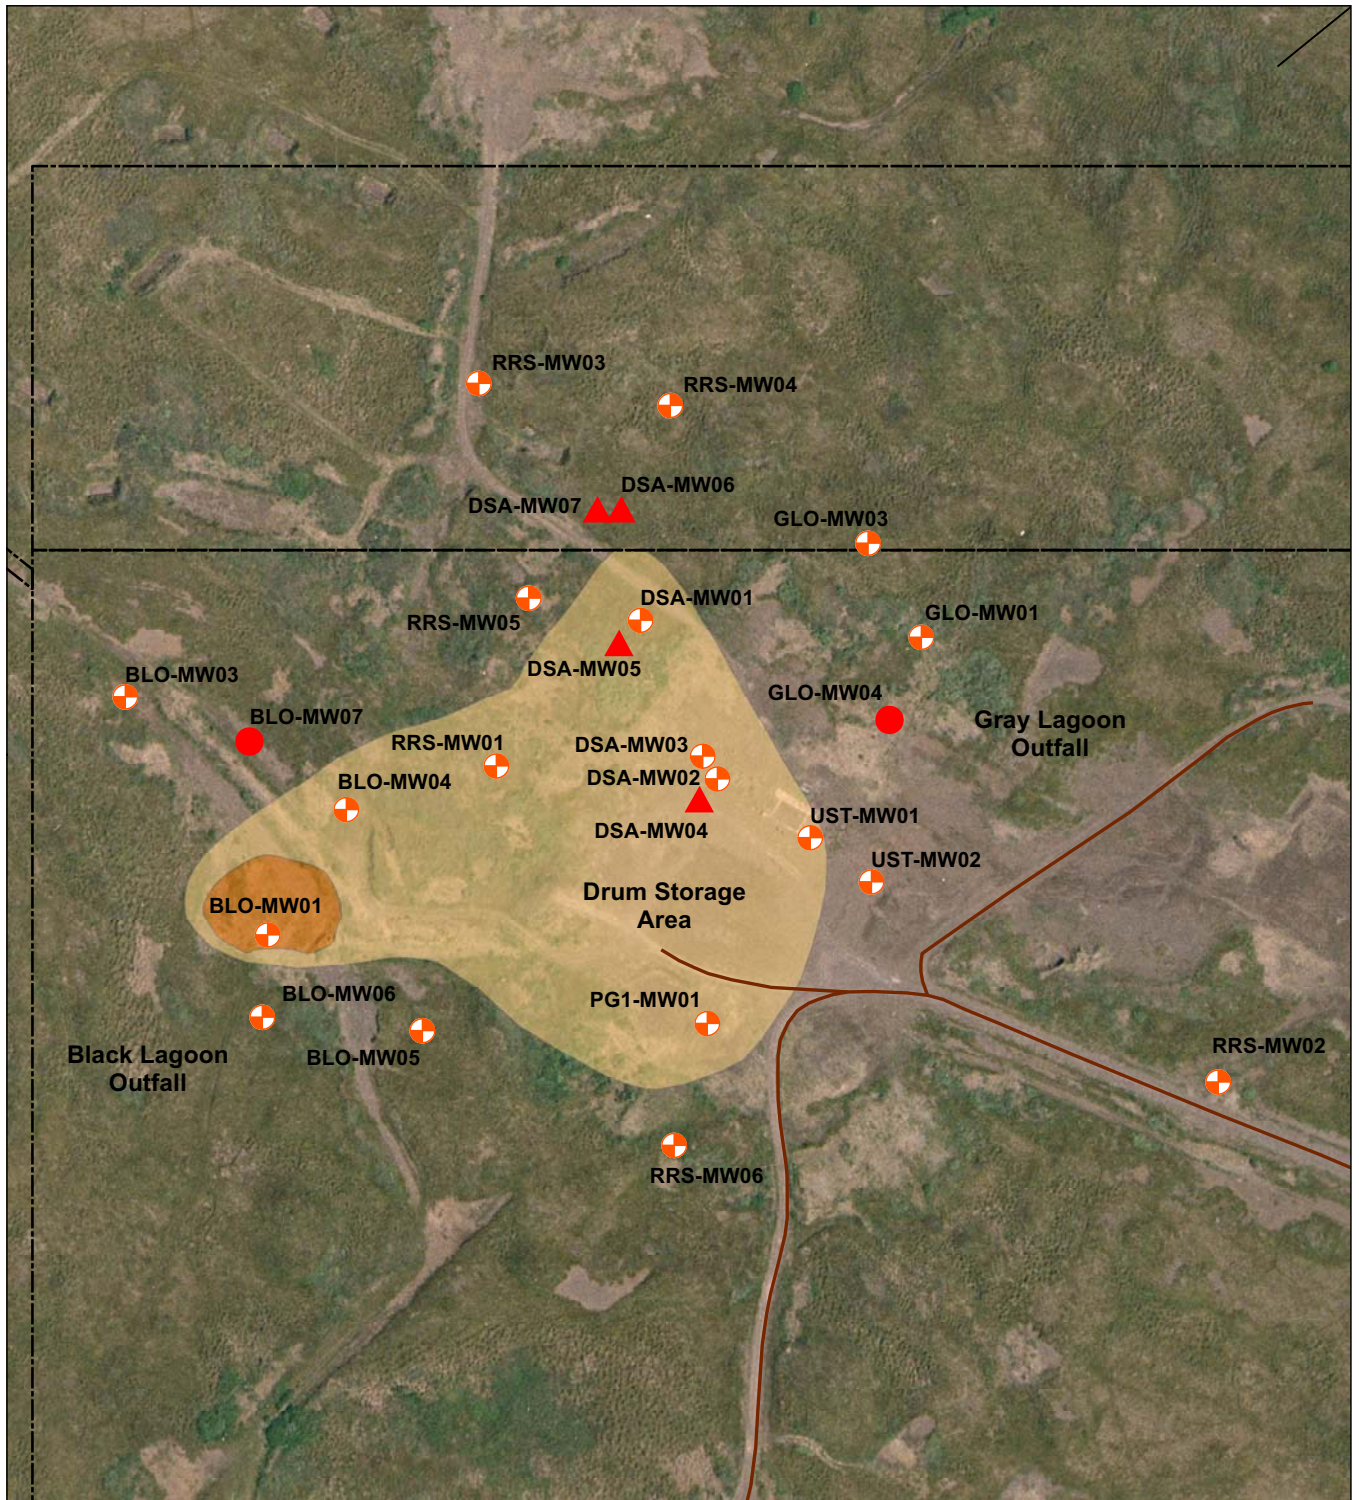
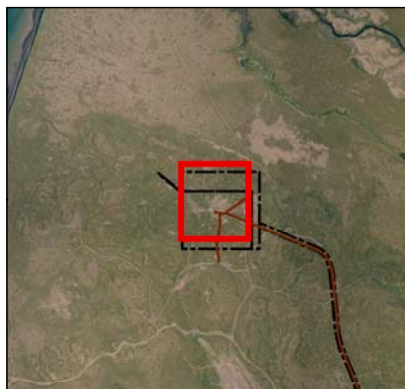
FIGURE 4
Black Lagoon Outfall
and the Former
Facility Area Plumes
 Port Heiden RRS 5-Year Review
 Port Heiden RRS, Alaska

- Figure 4 of the report depicts composite TCE and POL plumes in combined shallow and deep aquifer zones. Future reports should depict separate shallow and deep aquifer plumes to more clearly show what contamination is present within each aquifer zone.

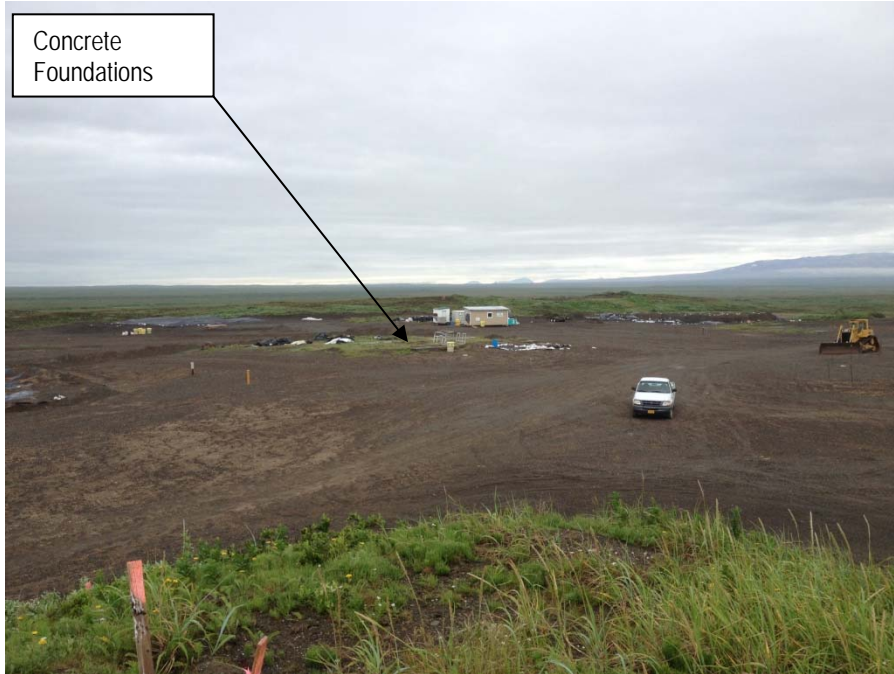
Photograph 1: OT001 and four unnumbered sites, facing east.

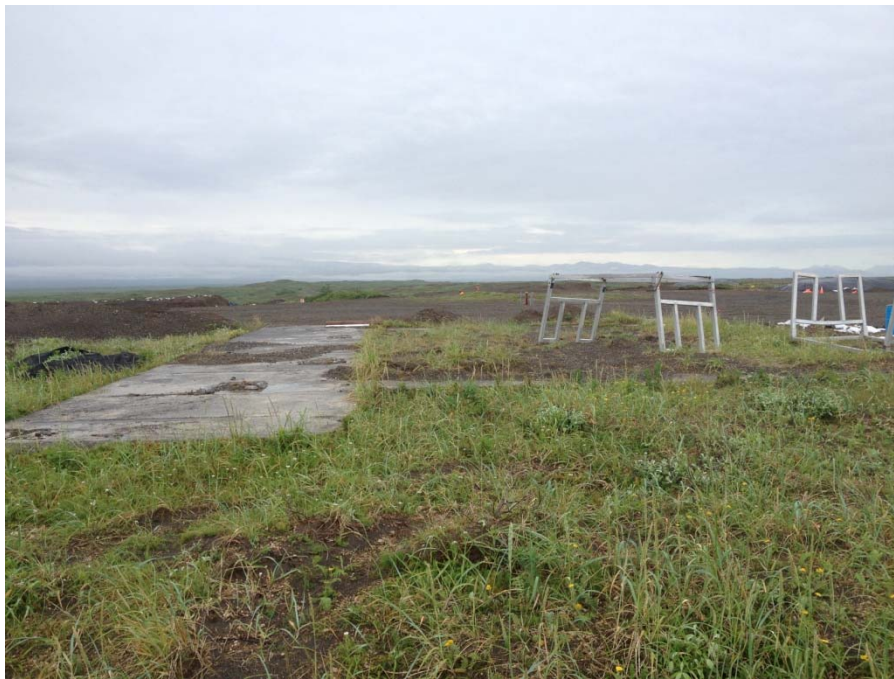
Photograph 2: OT001, former Composite Building concrete pad, facing southeast.

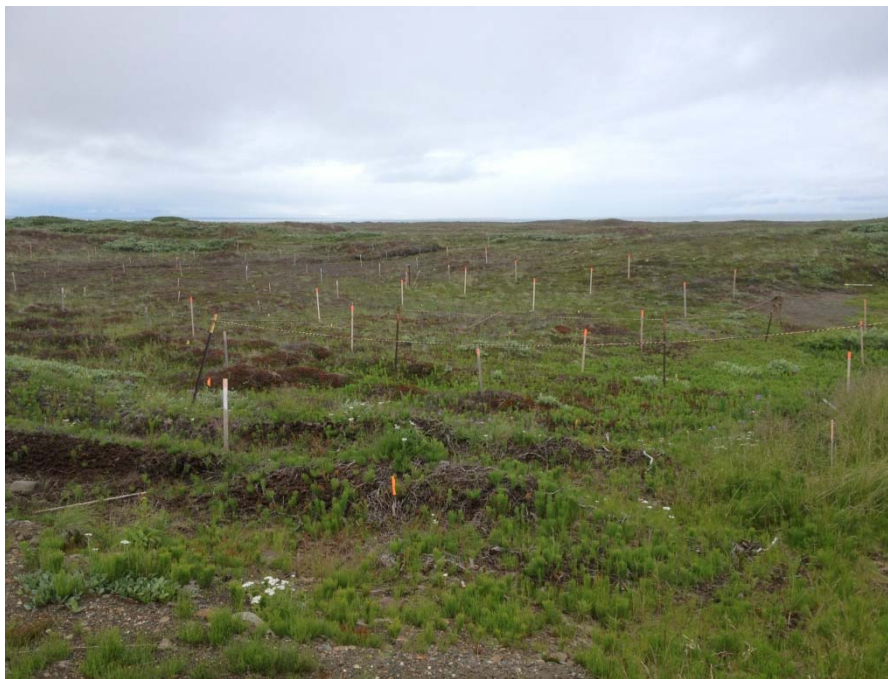
ERP Site WP002, consisting of a former blackwater pond, was located southwest of the gravel area. It consisted of partially vegetated, uneven terrain that was generally a depressed area (Photograph 5, Attachment 5). At the time of the site inspection, another contractor was advancing geoprobe borings in this area. The geoprobe borings were being advanced to collect soil samples for analytical analysis.

Photograph 5: WP002, facing east west.
