REF: Demolition of CHPP (Project No. 8046), JBER-R, Alaska

SUBJ: Notice of Completion of all Demolition Activities and Summary of Soil Contamination Encountered during the Project and Foundation Left in In-Place

SITE OVERVIEW
SOIL REMOVAL LOCATIONS

JBER Richardson P8046 CHPP Demo Below Grade Concrete Structures Remaining in Place

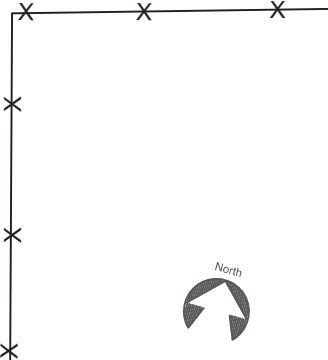
soils at this location is connected to the large area of contamination left under the former CHPP basement floor.

5) Remaining Concrete Structures: As background to why these partial foundations remain in place, on September 25, 2018 during the demolition and excavation activities, differing site conditions were encountered. Petroleum contamination was encountered under the turbine and boiler room basement floors and outside of the west foundation wall of the boiler building. To access these areas located approximately 30 feet below the groundwater surface, the project had a ADEC approved dewatering program in place. The dewatering permit required the discharge to be shut down if a sheen was detected. Maintaining dewatering activities was essential to limit the exacerbation of contamination within the excavation and for completion of foundation demolition, backfill, and compaction. After a series of meetings and discussions between September 25, 2018 and
