**KASAAN LIBRARY  
117 KASAAN STREET  
KASAAN, ALASKA**

**PROPERTY ASSESSMENT AND CLEANUP PLAN**

**DECEMBER 2019**

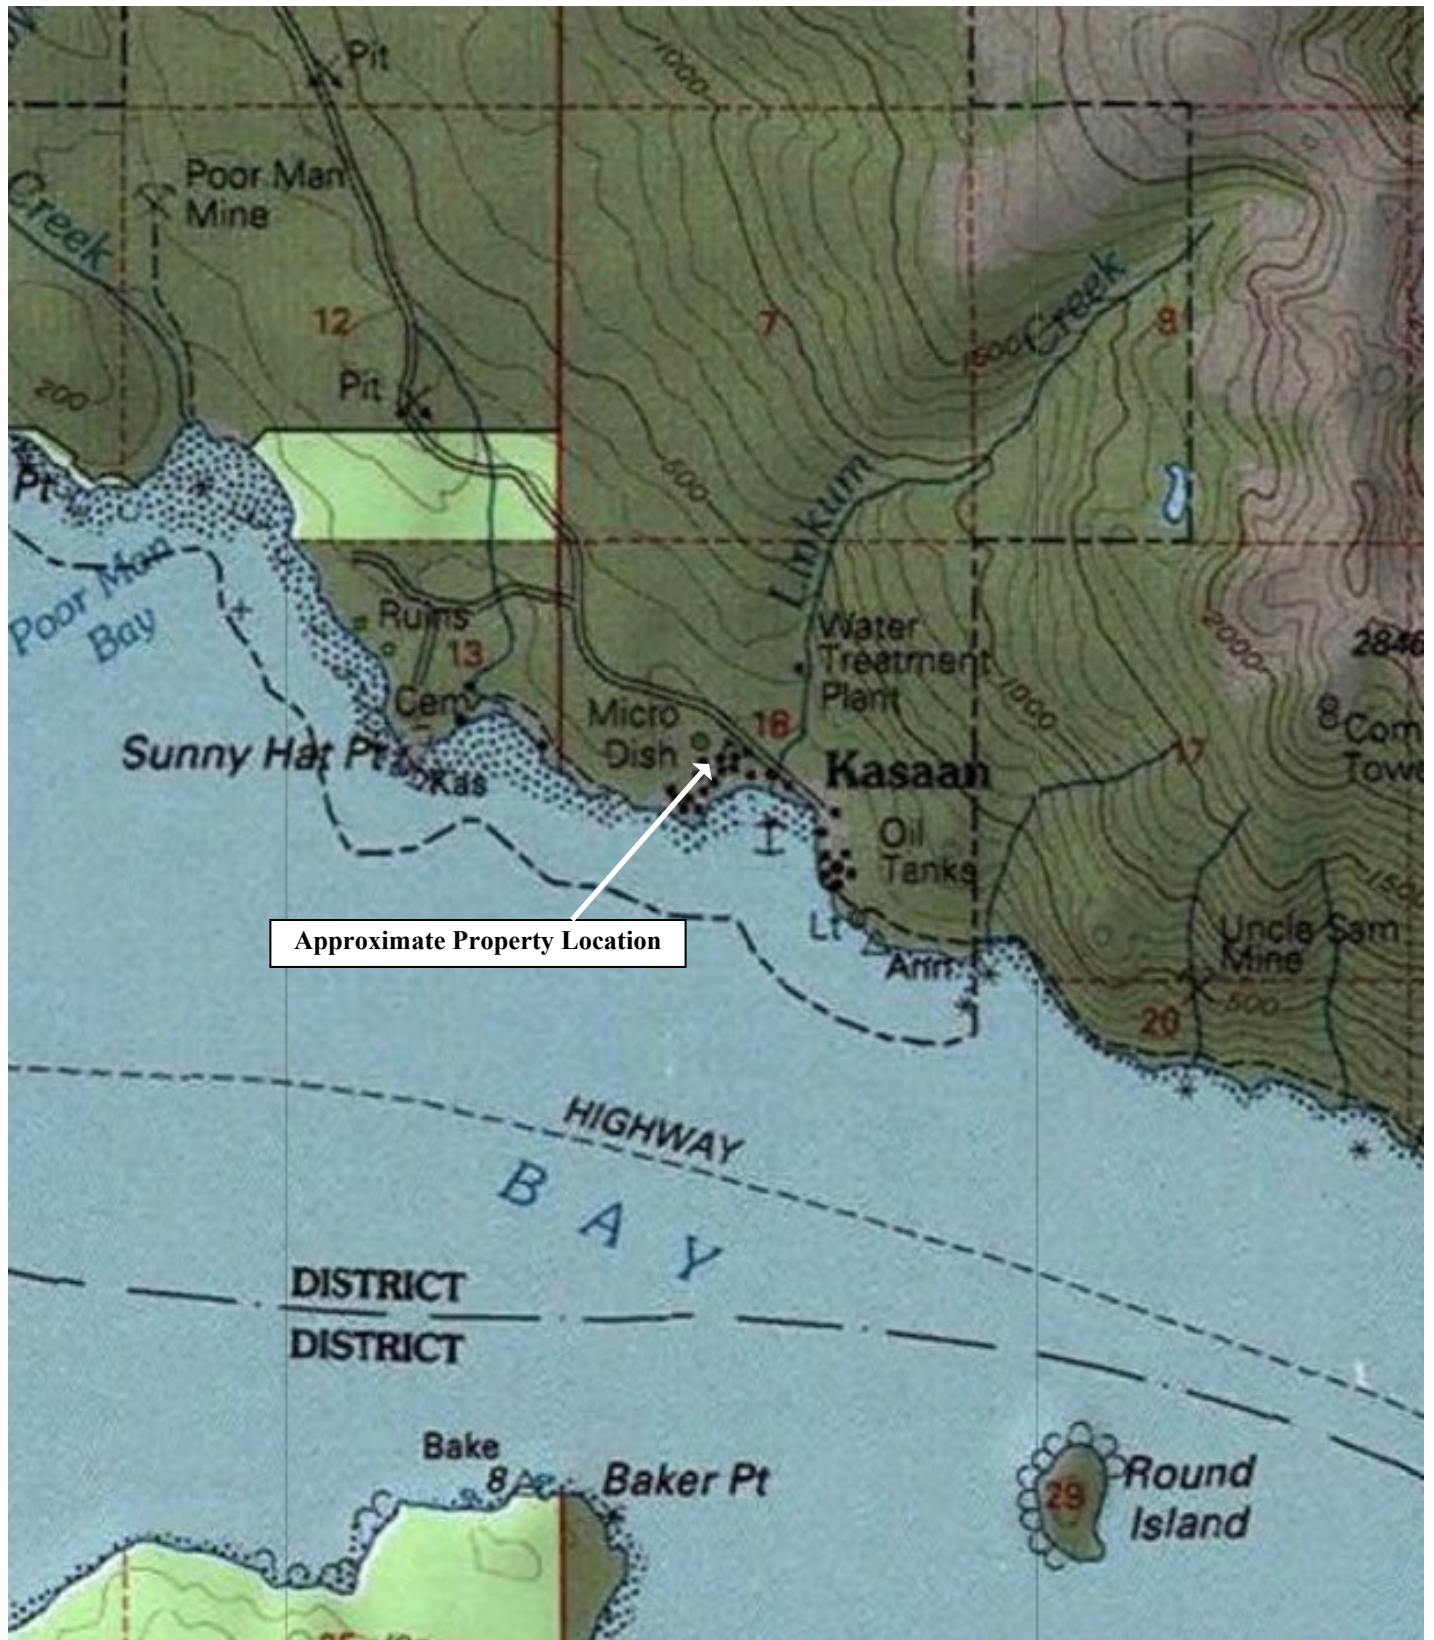
**Figure 1**

Under the supervision of the Alaska Department of Environmental Conservation (ADEC), BGES, Inc. (BGES) performed a site characterization at the library located at 117 Kasaan Street in Kasaan, Alaska; hereafter referred to as the “subject property” (Figure 1). The purpose of this assessment was to evaluate the potential presence of hazardous building materials, such as lead-based paint (LBP) and asbestos-containing materials (ACMs) in the building on the subject property.

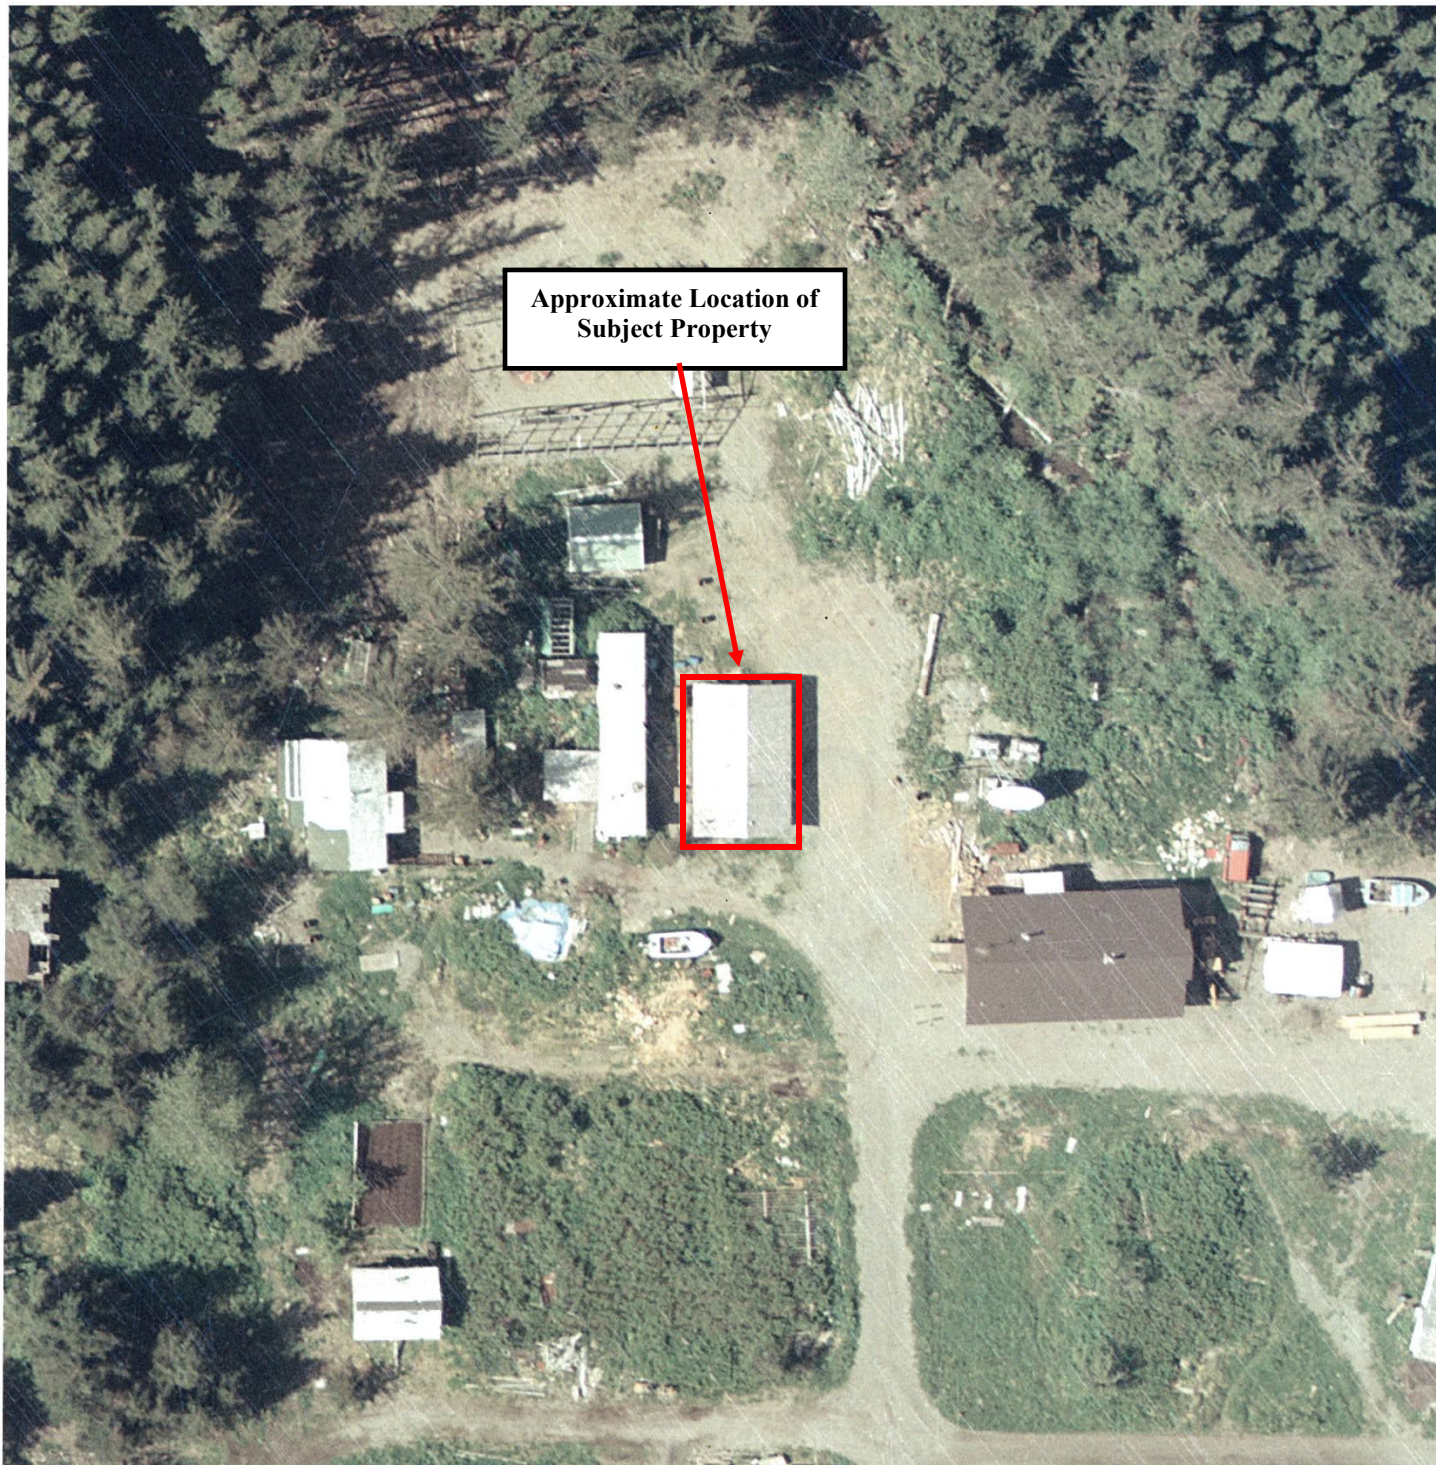
**Figure 2**

The May 23, 1980 aerial photograph showed the subject property as being developed and the library in the same location it was during the site visit. Buildings were located to the west and northwest of the library. The framework of a larger building was visible further to the northwest of the library. The June 1, 1982 aerial photograph, included as Figure 2, appears the same as the previous photograph.

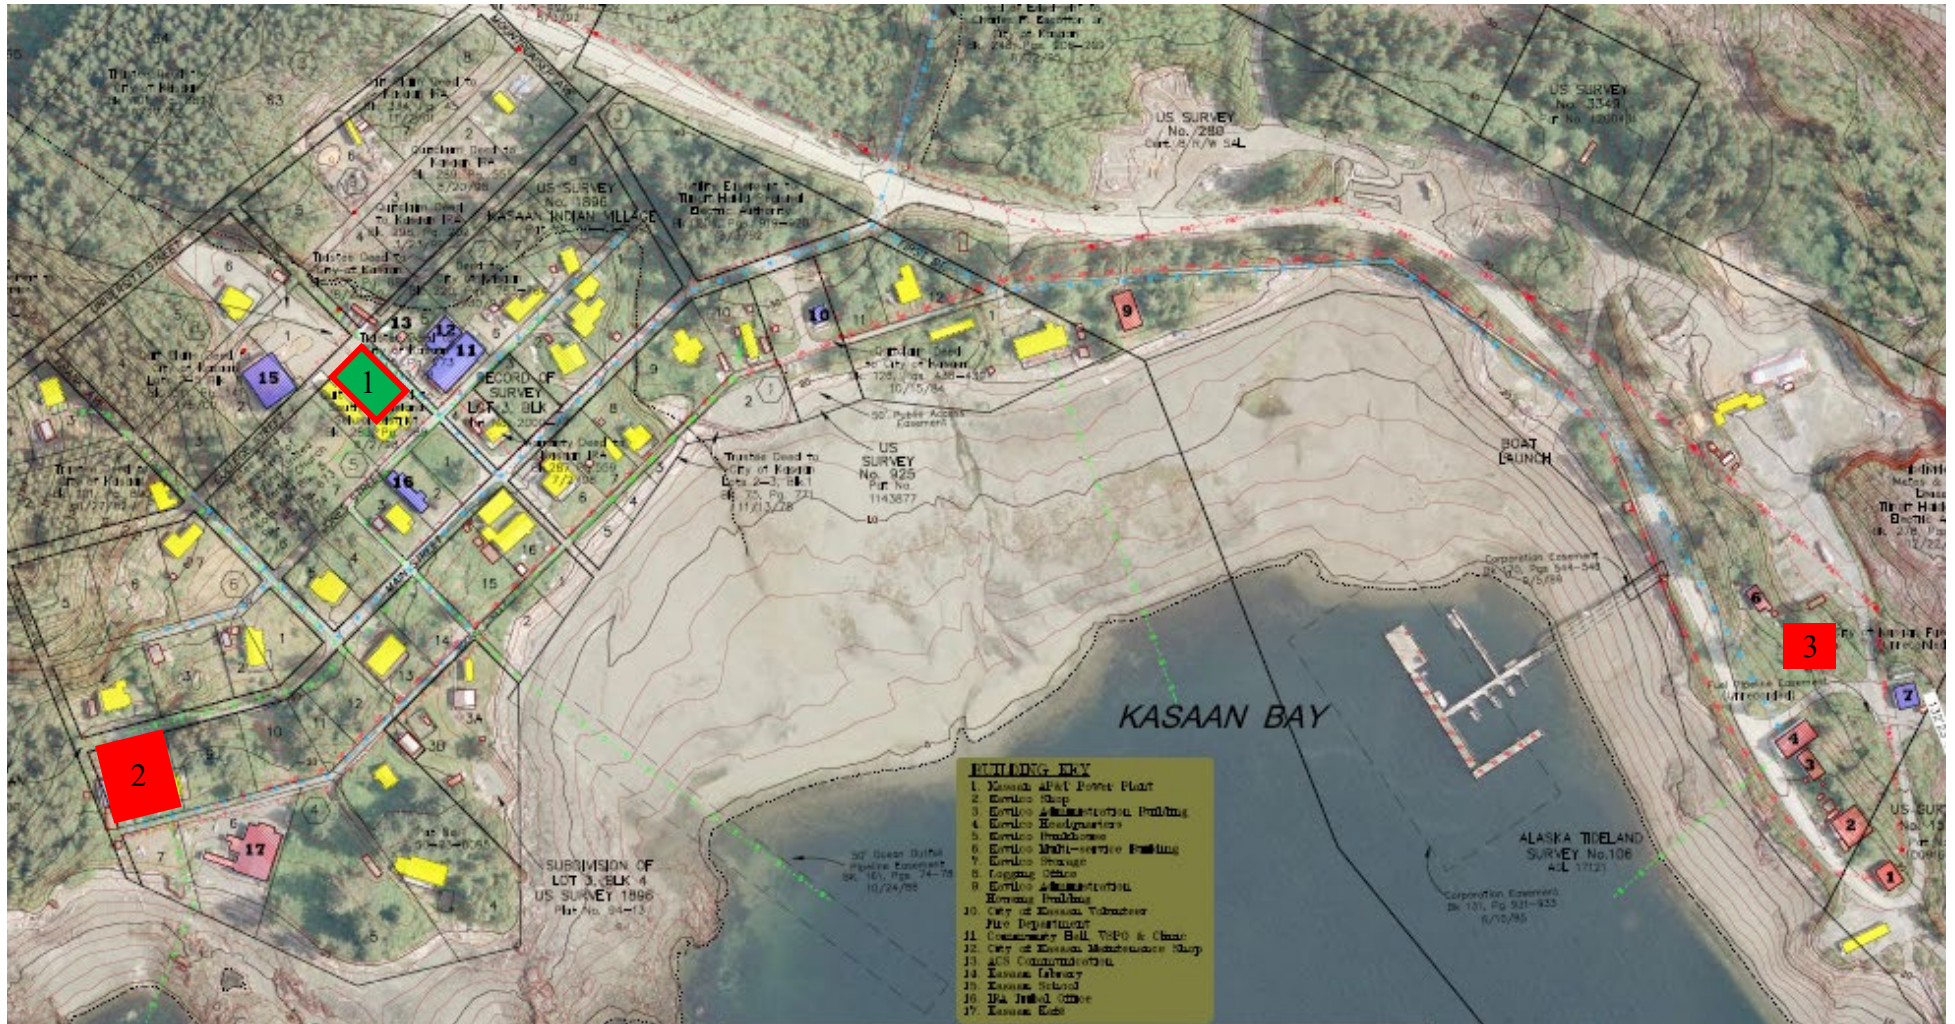
December 2019	Figure 4
--	---------------	----------

The Kasaan Library (Site 1 on Figure 4), located on the subject property, was listed as an “Informational” site; indicating that the ADEC has created a file for information pertaining to this site, but that

The Discovery Campus Kasaan site (Site 2 on Figure 4), located more than 500 feet southwest of the subject property, was also listed as an “Informational” site. According to the ADEC Cleanup Chronology report pertaining to this site, soil contamination was identified at this site during the removal of a residence and a heating oil tank. A site characterization work plan was approved in March of 2019, and no further actions have been recorded. Because of the distance between this site and the subject property (with respect to the potential for contaminant migration through soil, groundwater, or soil vapor), and because of the likelihood that the local groundwater flow direction is towards Kasaan Bay, rendering the subject property side-gradient to upgradient of this contaminated site; it is our opinion that there is a reduced potential for adverse environmental impact to the subject property stemming from contamination at this site, and it does not constitute a recognized environmental impact with respect to the subject property.
