**LEVEL I
ENVIRONMENTAL SITE ASSESSMENT
FOR CLOSEOUT OF LEASED PROPERTY
FORMERLY KNOWN AS THE SERVS DOCK FACILITY
VALDEZ, ALASKA**

June 1995

Project 5103-030.S5

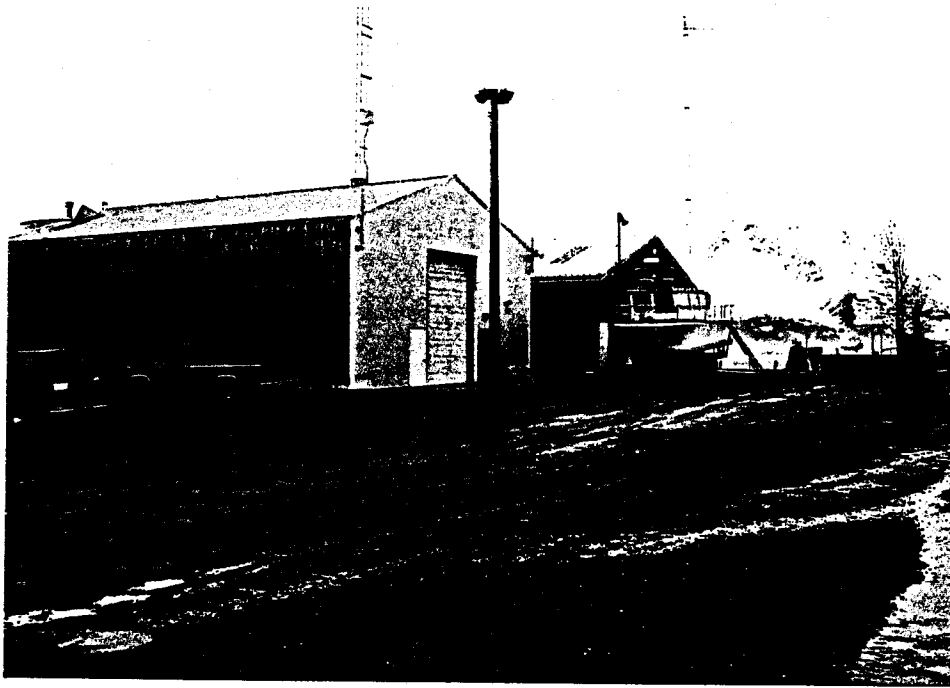
Photograph No. 5: May 8, 1995; Silver and Blue Buildings
