Hilcorp Alaska, LLC

**Beluga River Unit Site Characterization and
Groundwater Sampling Work Plan**

June 2021

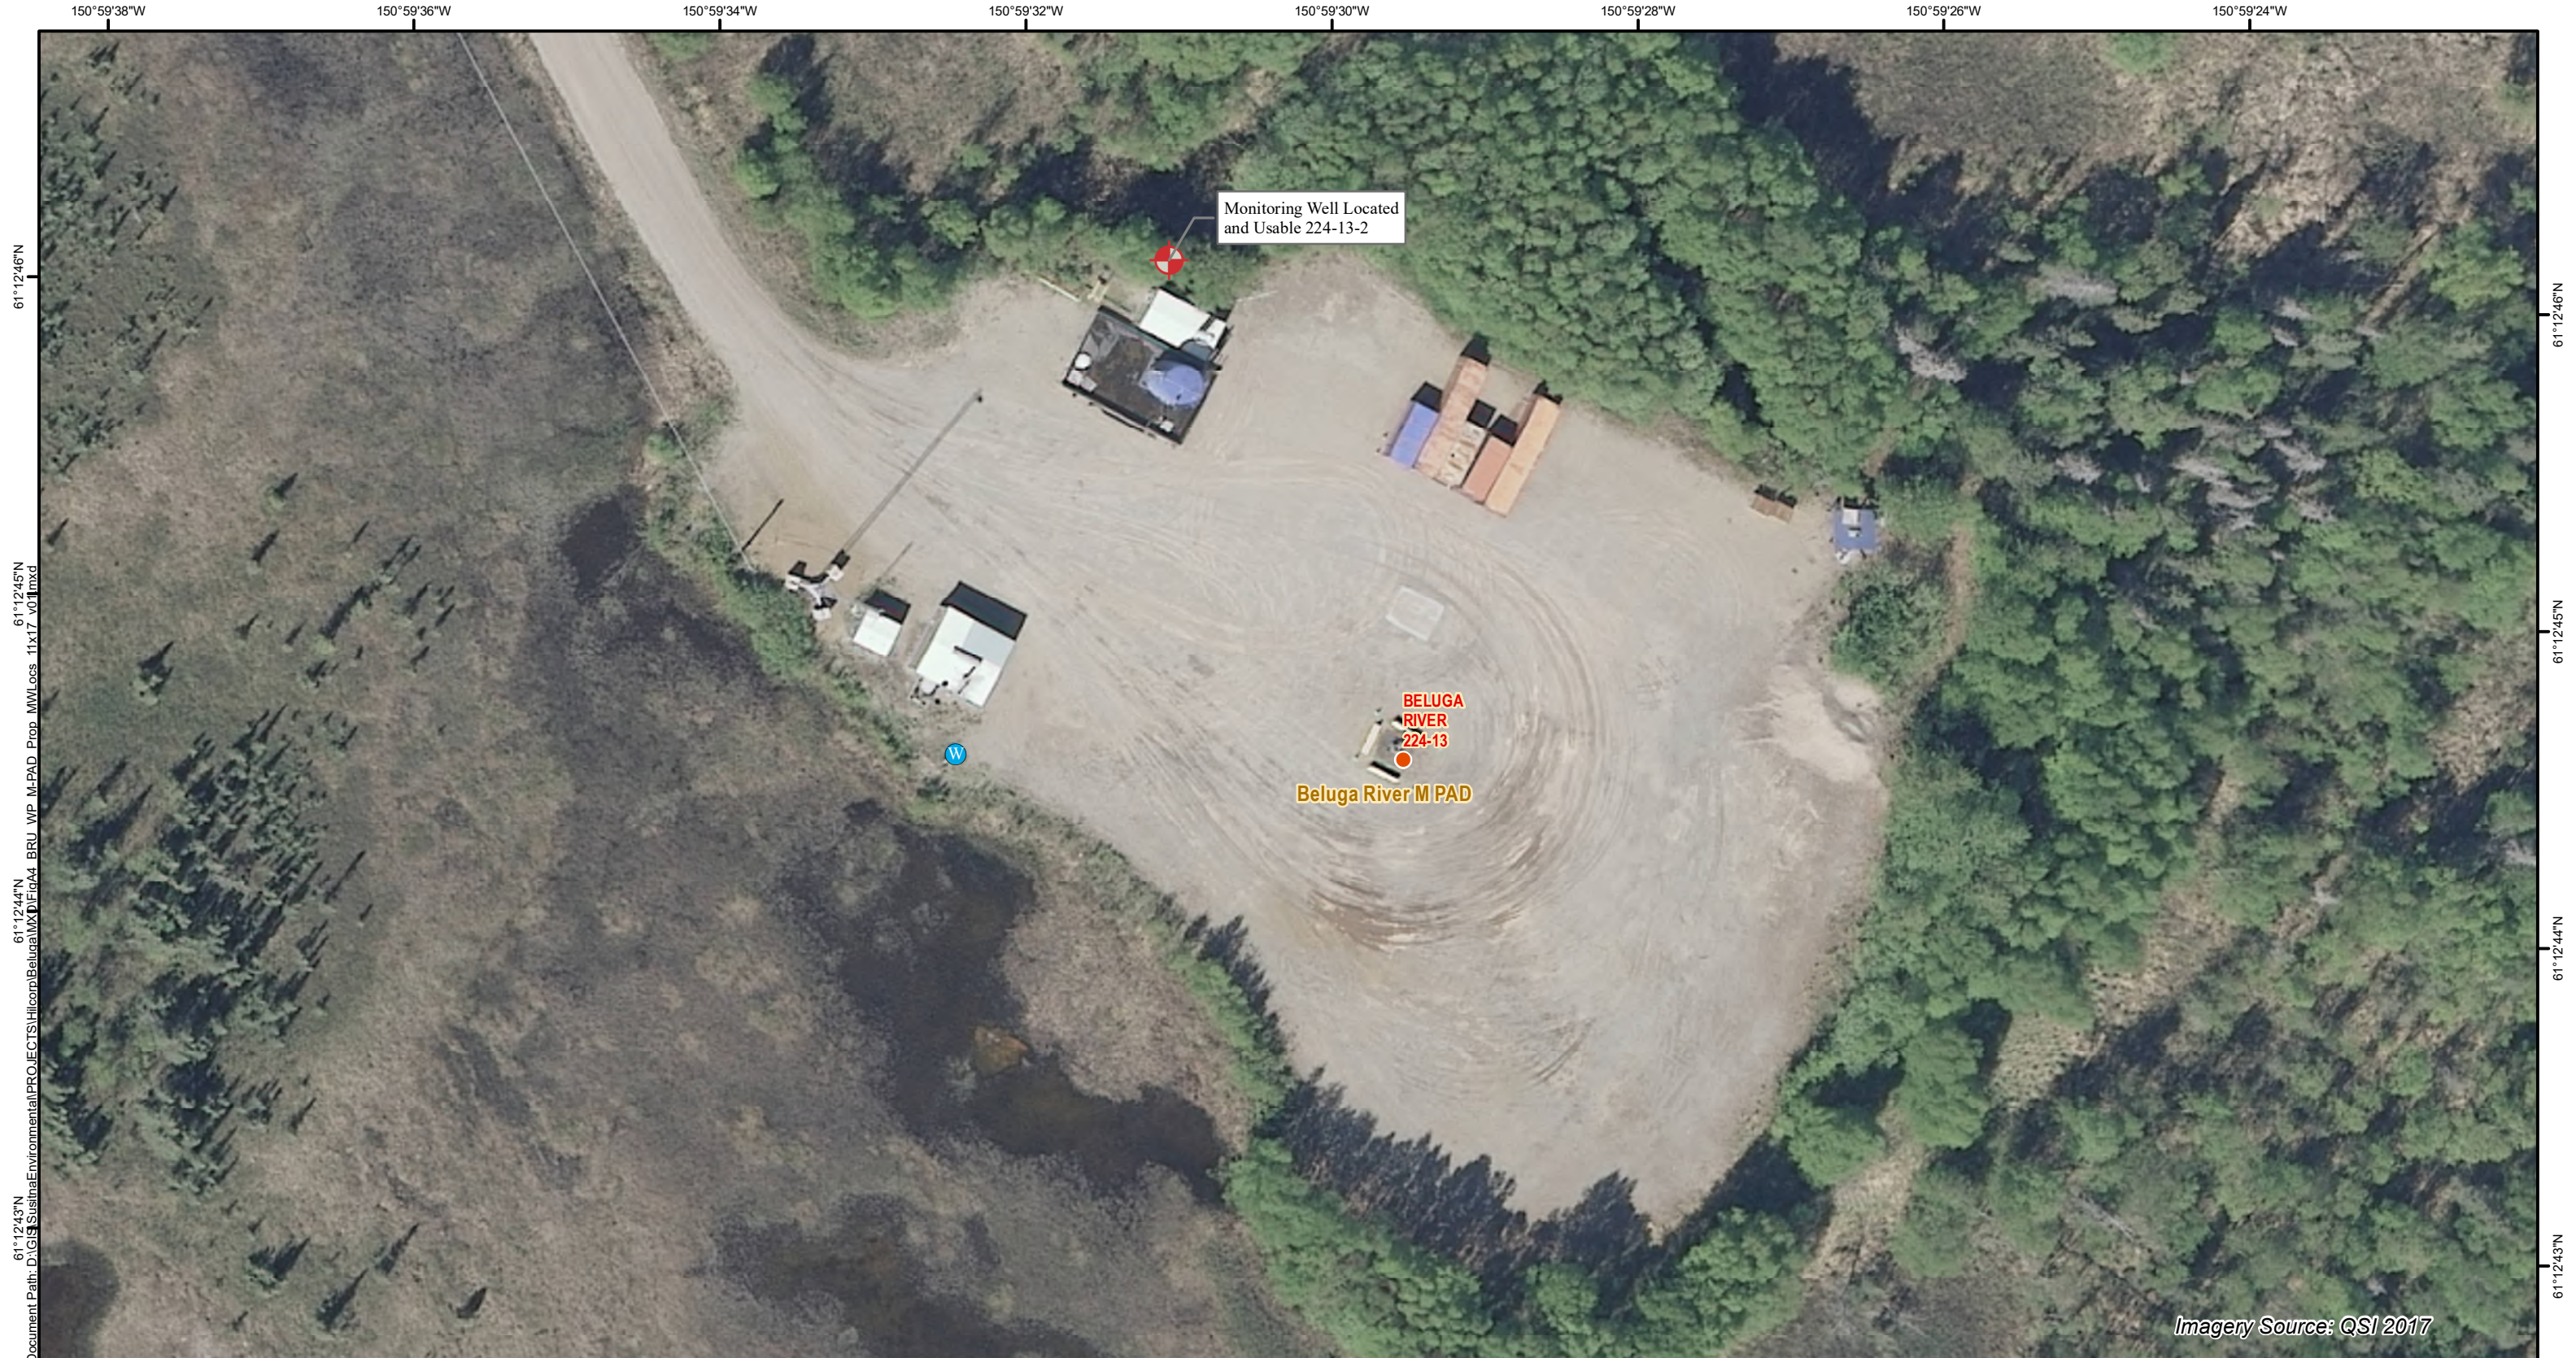
Date Prepared: 6/2/2021	Company Name: Hilcorp Alaska, LLC.	Drawn By: HAK - MRA
Monitoring Well Locations		
Beluga River 224-13 (M Pad)		
BELUGA RIVER UNIT, COOK INLET, ALASKA		
Scale: @ 11x17 map size 1 in = 50 feet	Figure No:	A-4

During the October 2019 survey, only one of the two monitoring wells was located in usable condition (well 224-13-2, located in the northwest portion of the pad – see Figure A-4). The other monitoring well (224-13-1) was positioned west of the wellhead building but was not located during the October 2019 survey.
