**Hilcorp Alaska, LLC**

**Beluga River Unit Site Characterization and  
Groundwater Sampling Work Plan**

**June 2021**

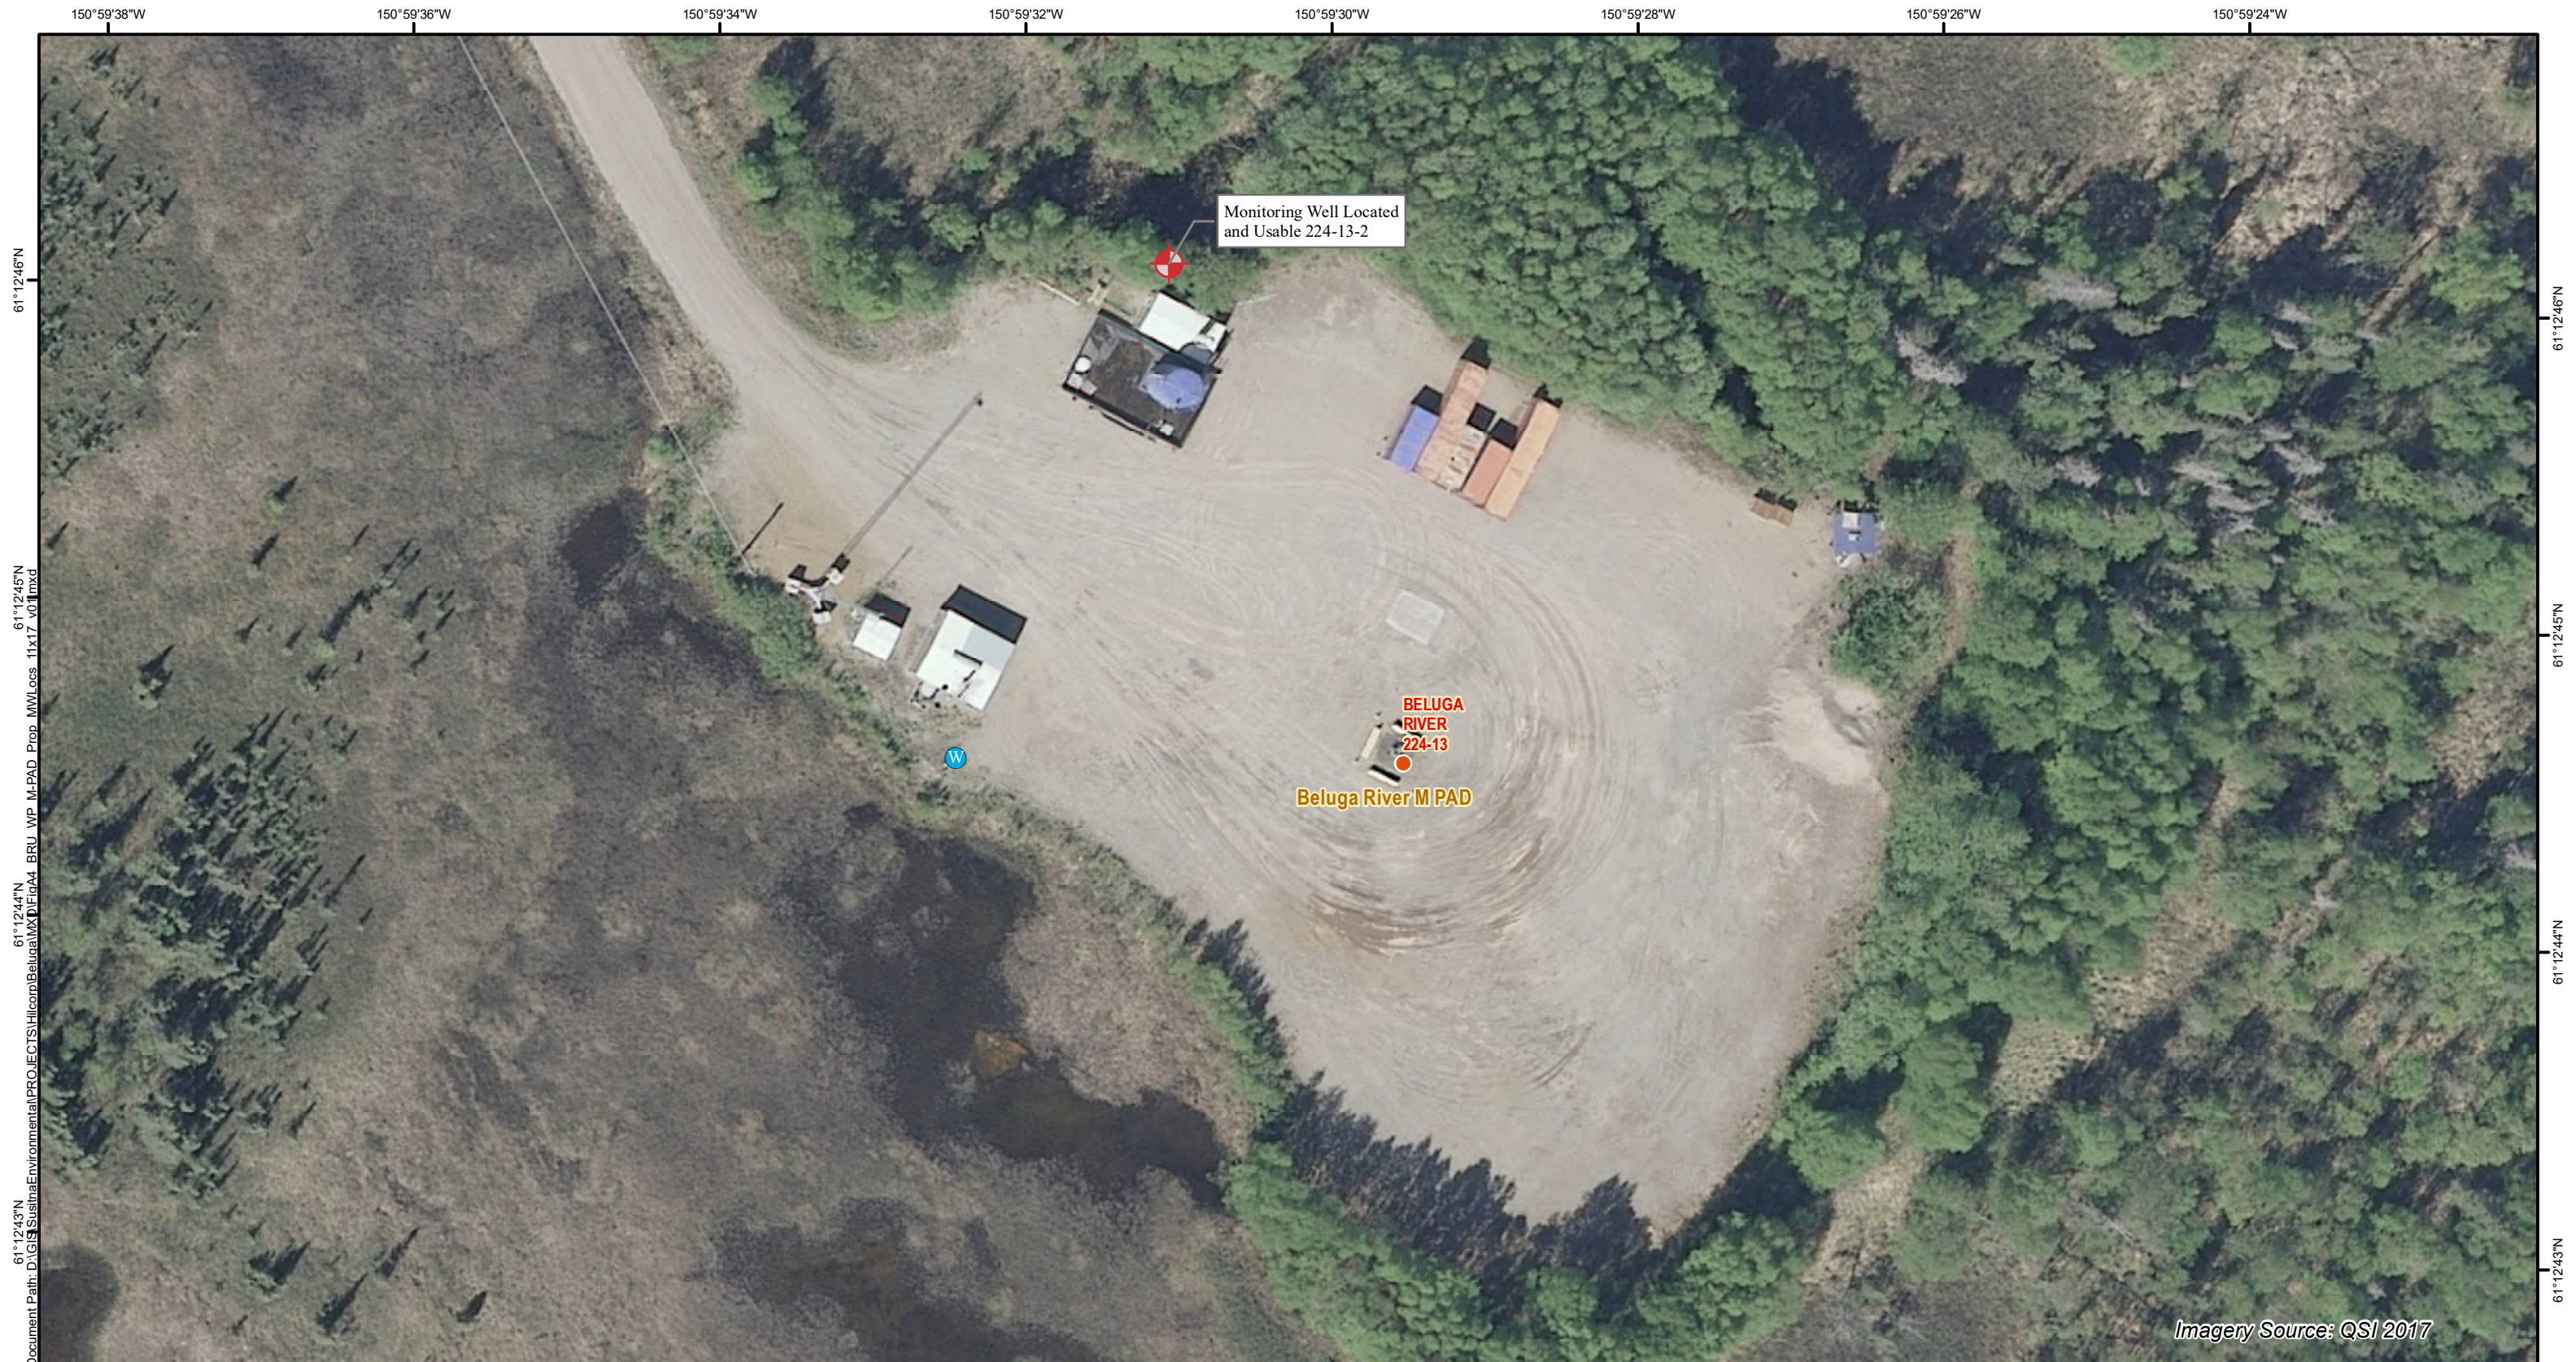
Date Prepared: 6/2/2021	Company Name: Hilcorp Alaska, LLC.	Drawn By: HAK - MRA
Monitoring Well Locations Beluga River 224-13 (M Pad)		
BELUGA RIVER UNIT, COOK INLET, ALASKA		
Scale: @ 11x17 map size 1 in = 50 feet	Figure No:	<b>A-4</b>

During the October 2019 survey, only one of the two monitoring wells was located in usable condition (well 224-13-2, located in the northwest portion of the pad – see Figure A-4). The other monitoring well (224-13-1) was positioned west of the wellhead building but was not located during the October 2019 survey.

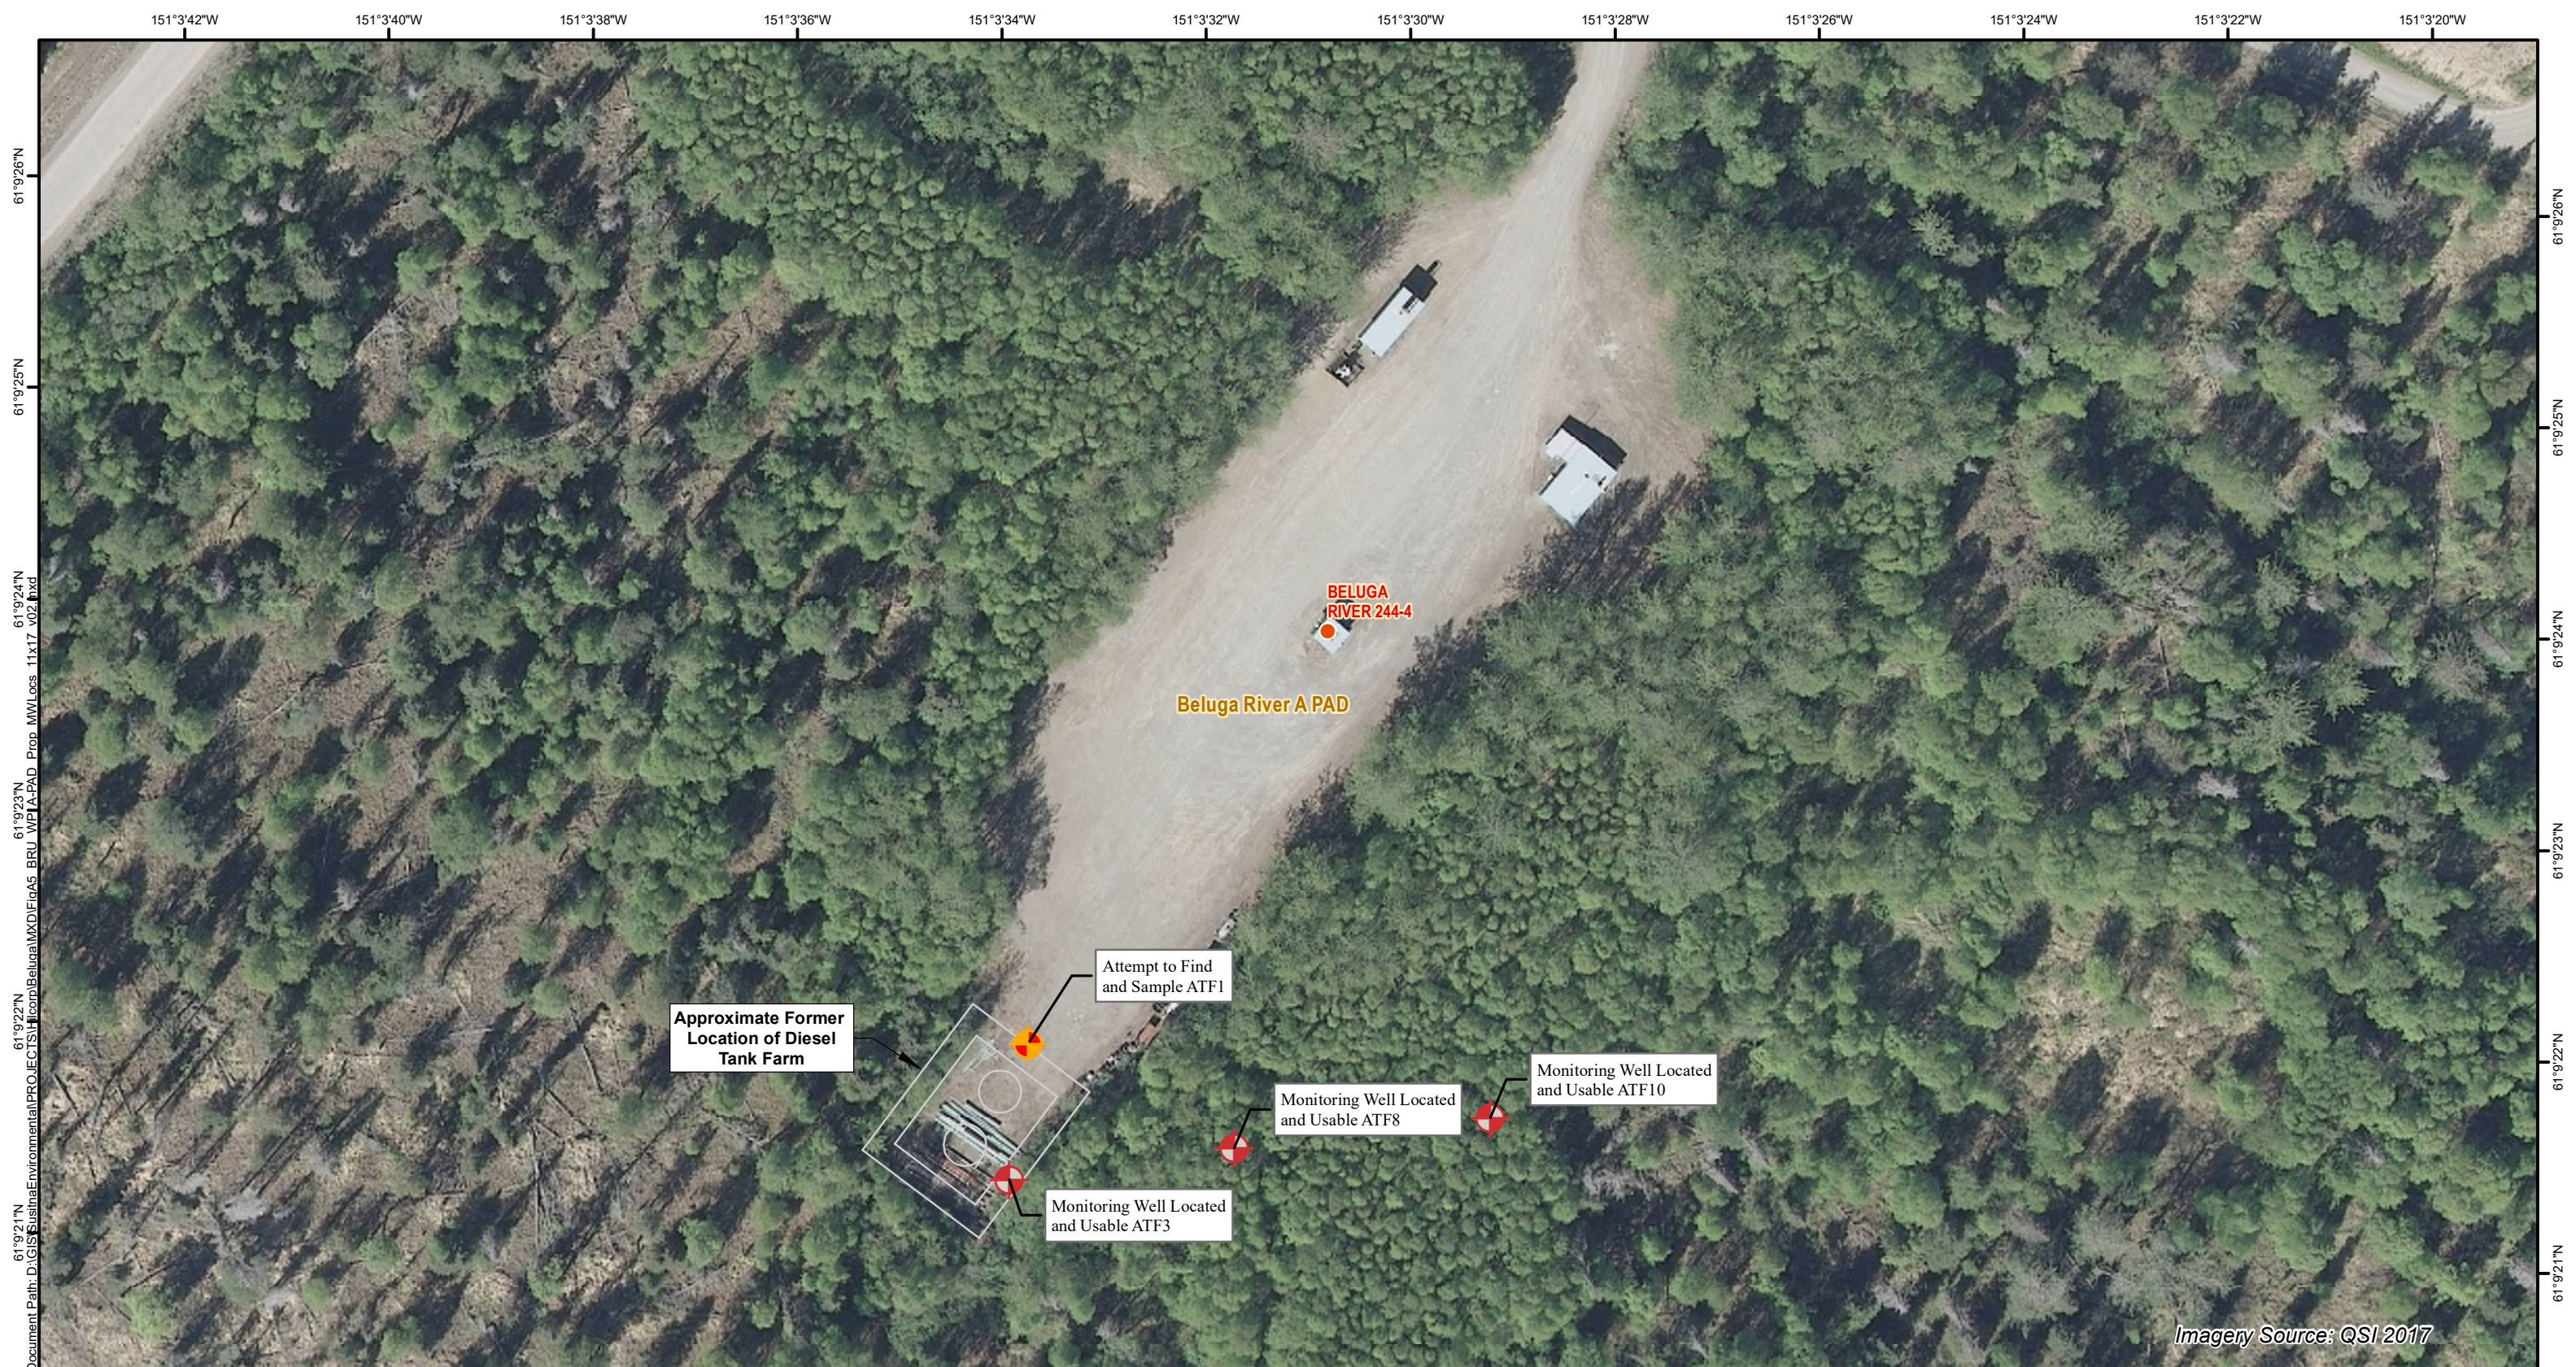
Date Prepared: 6/14/2021	Company Name: Hilcorp Alaska, LLC.	Drawn By: HAK - MRA
Monitoring Well Locations Beluga River Abandoned Diesel Tank Farm (A Pad)		
BELUGA RIVER UNIT, COOK INLET, ALASKA		
Scale: @ 11x17 map size 1 in = 75 feet	Figure No:	<b>A-5</b>

The October 2019 survey located three of the four monitoring wells in usable condition (ATF3, ATF8, and ATF10 – see Figure A-5) that were within the previous contaminated groundwater plume or downgradient of the plume. Historically, monitoring well ATF3 had the highest DRO concentration and will be used to determine the current status of groundwater contamination. Monitoring wells ATF8 and AFT10 are downgradient of the release area and could be used to determine the current extent of contamination. Monitoring well ATF1, which was not located during the October 2019 survey, was positioned cross-gradient of the abandoned tank farm and historically had a DRO concentration approximately half that of monitoring well ATF3.

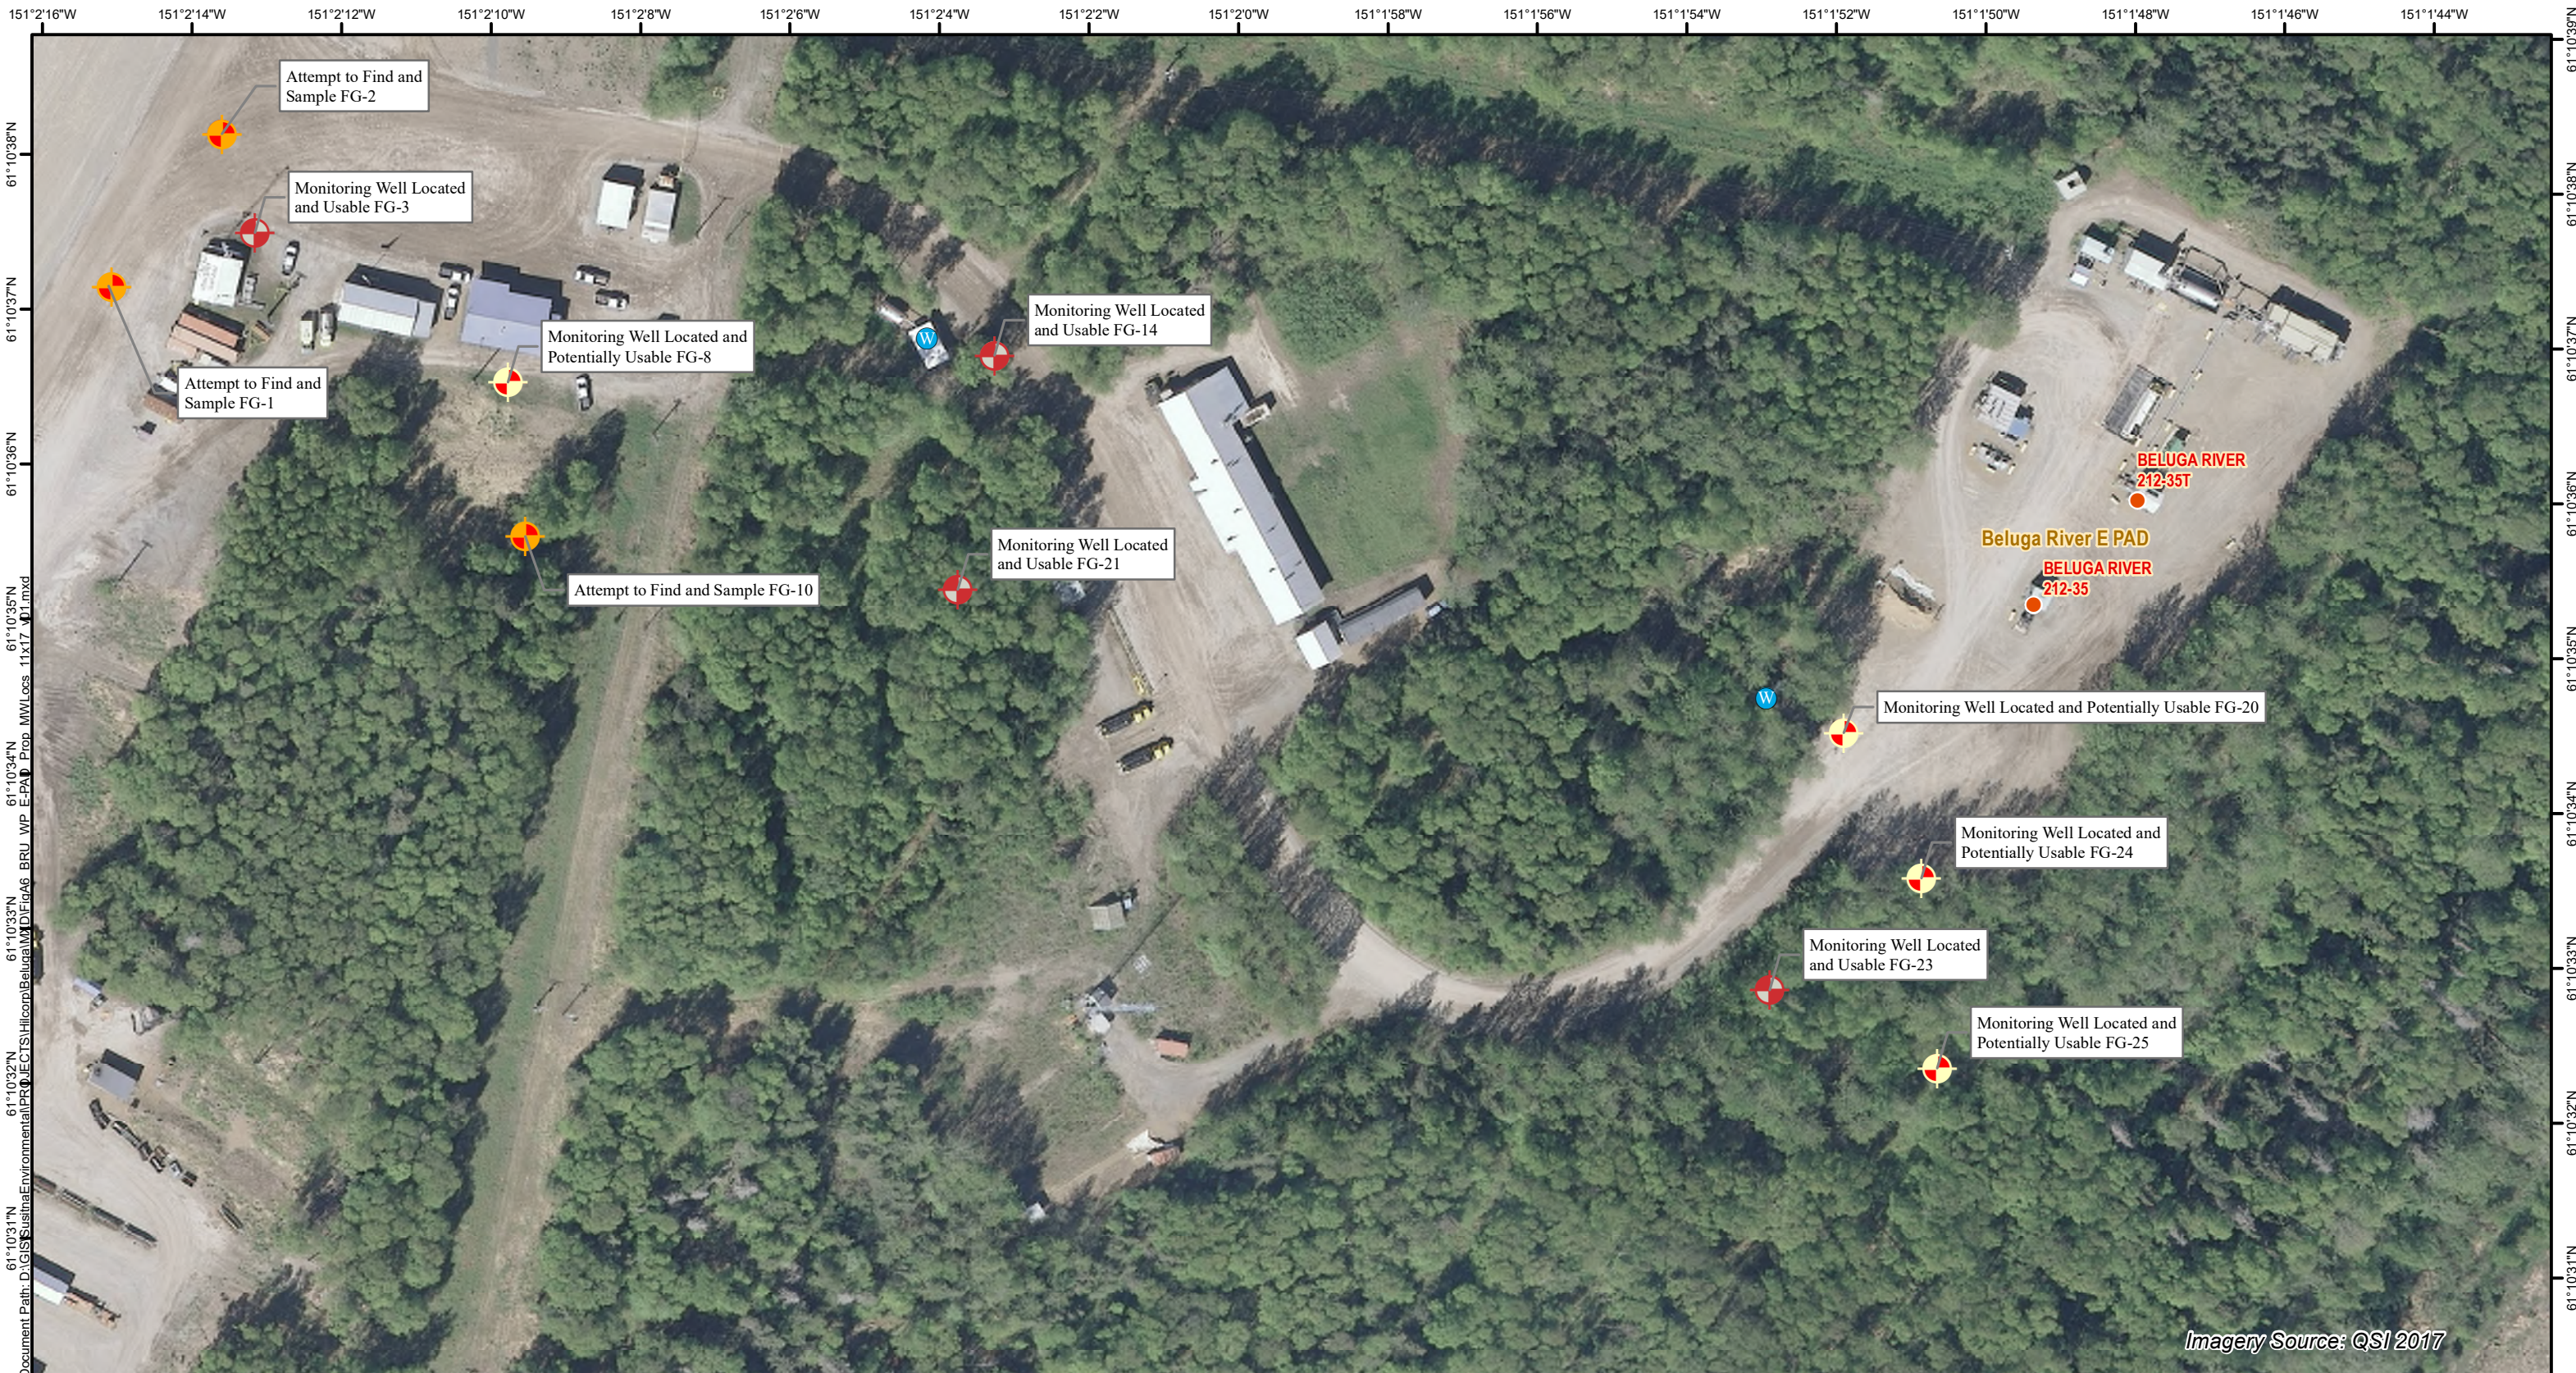
Date Prepared: 6/8/2021	Company Name: Hilcorp Alaska, LLC.	Drawn By: HAK - MRA
Monitoring Well Locations Beluga River Pump Area Assessment (E Pad)		
BELUGA RIVER UNIT, COOK INLET, ALASKA		
Scale: @ 11x17 map size 1 in = 103 feet	Figure No:	<b>A-6</b>

- FG-03 – Good condition, no obstruction
- FG-08 – Located but monument was knocked over and the top of well is crushed
- FG-14 – Good condition, no obstruction
- FG-15 – Good condition with no obstruction but no water was present in the well, possibly due to the dry summer
- FG-20 – Good condition, no obstruction
- FG-21 – Good condition, no obstruction but slightly sunken
- FG-23 – Good condition, no obstruction
- FG-24 – Located but unable to open cap
- FG-25 – Located but unable to open cap

Monitoring well FG-08 historically had the highest DRO and benzene concentrations from the western plume but found to be damaged during the 2019 survey. Two downgradient monitoring wells (FG-14 and FG-21) were located (Figure A-6), but a third (FG-11) could not be located. Monitoring wells FG-24 and FG-25, within the eastern plume, could not be fully assessed due to stuck caps. FG-25 historically had the highest DRO concentration from the eastern plume. The upgradient monitoring wells FG-20 and FG-23 were both located and usable.

Monitoring wells FG-03, FG-14, and FG-21 will be sampled from the western plume. Additionally, the field team will attempt to repair and sample FG-08 and find and sample FG-10. If successful, each well will be redeveloped and then sampled. Monitoring wells FG-20, FG-23, FG-24, and FG-25 will be redeveloped and sampled from the eastern plume. All samples will be analyzed for DRO, GRO, and BTEX. The field team will attempt to find and sample wells FG-01 and FG-02 and determine the location and sampling protocol for the current potable water well serving camp.

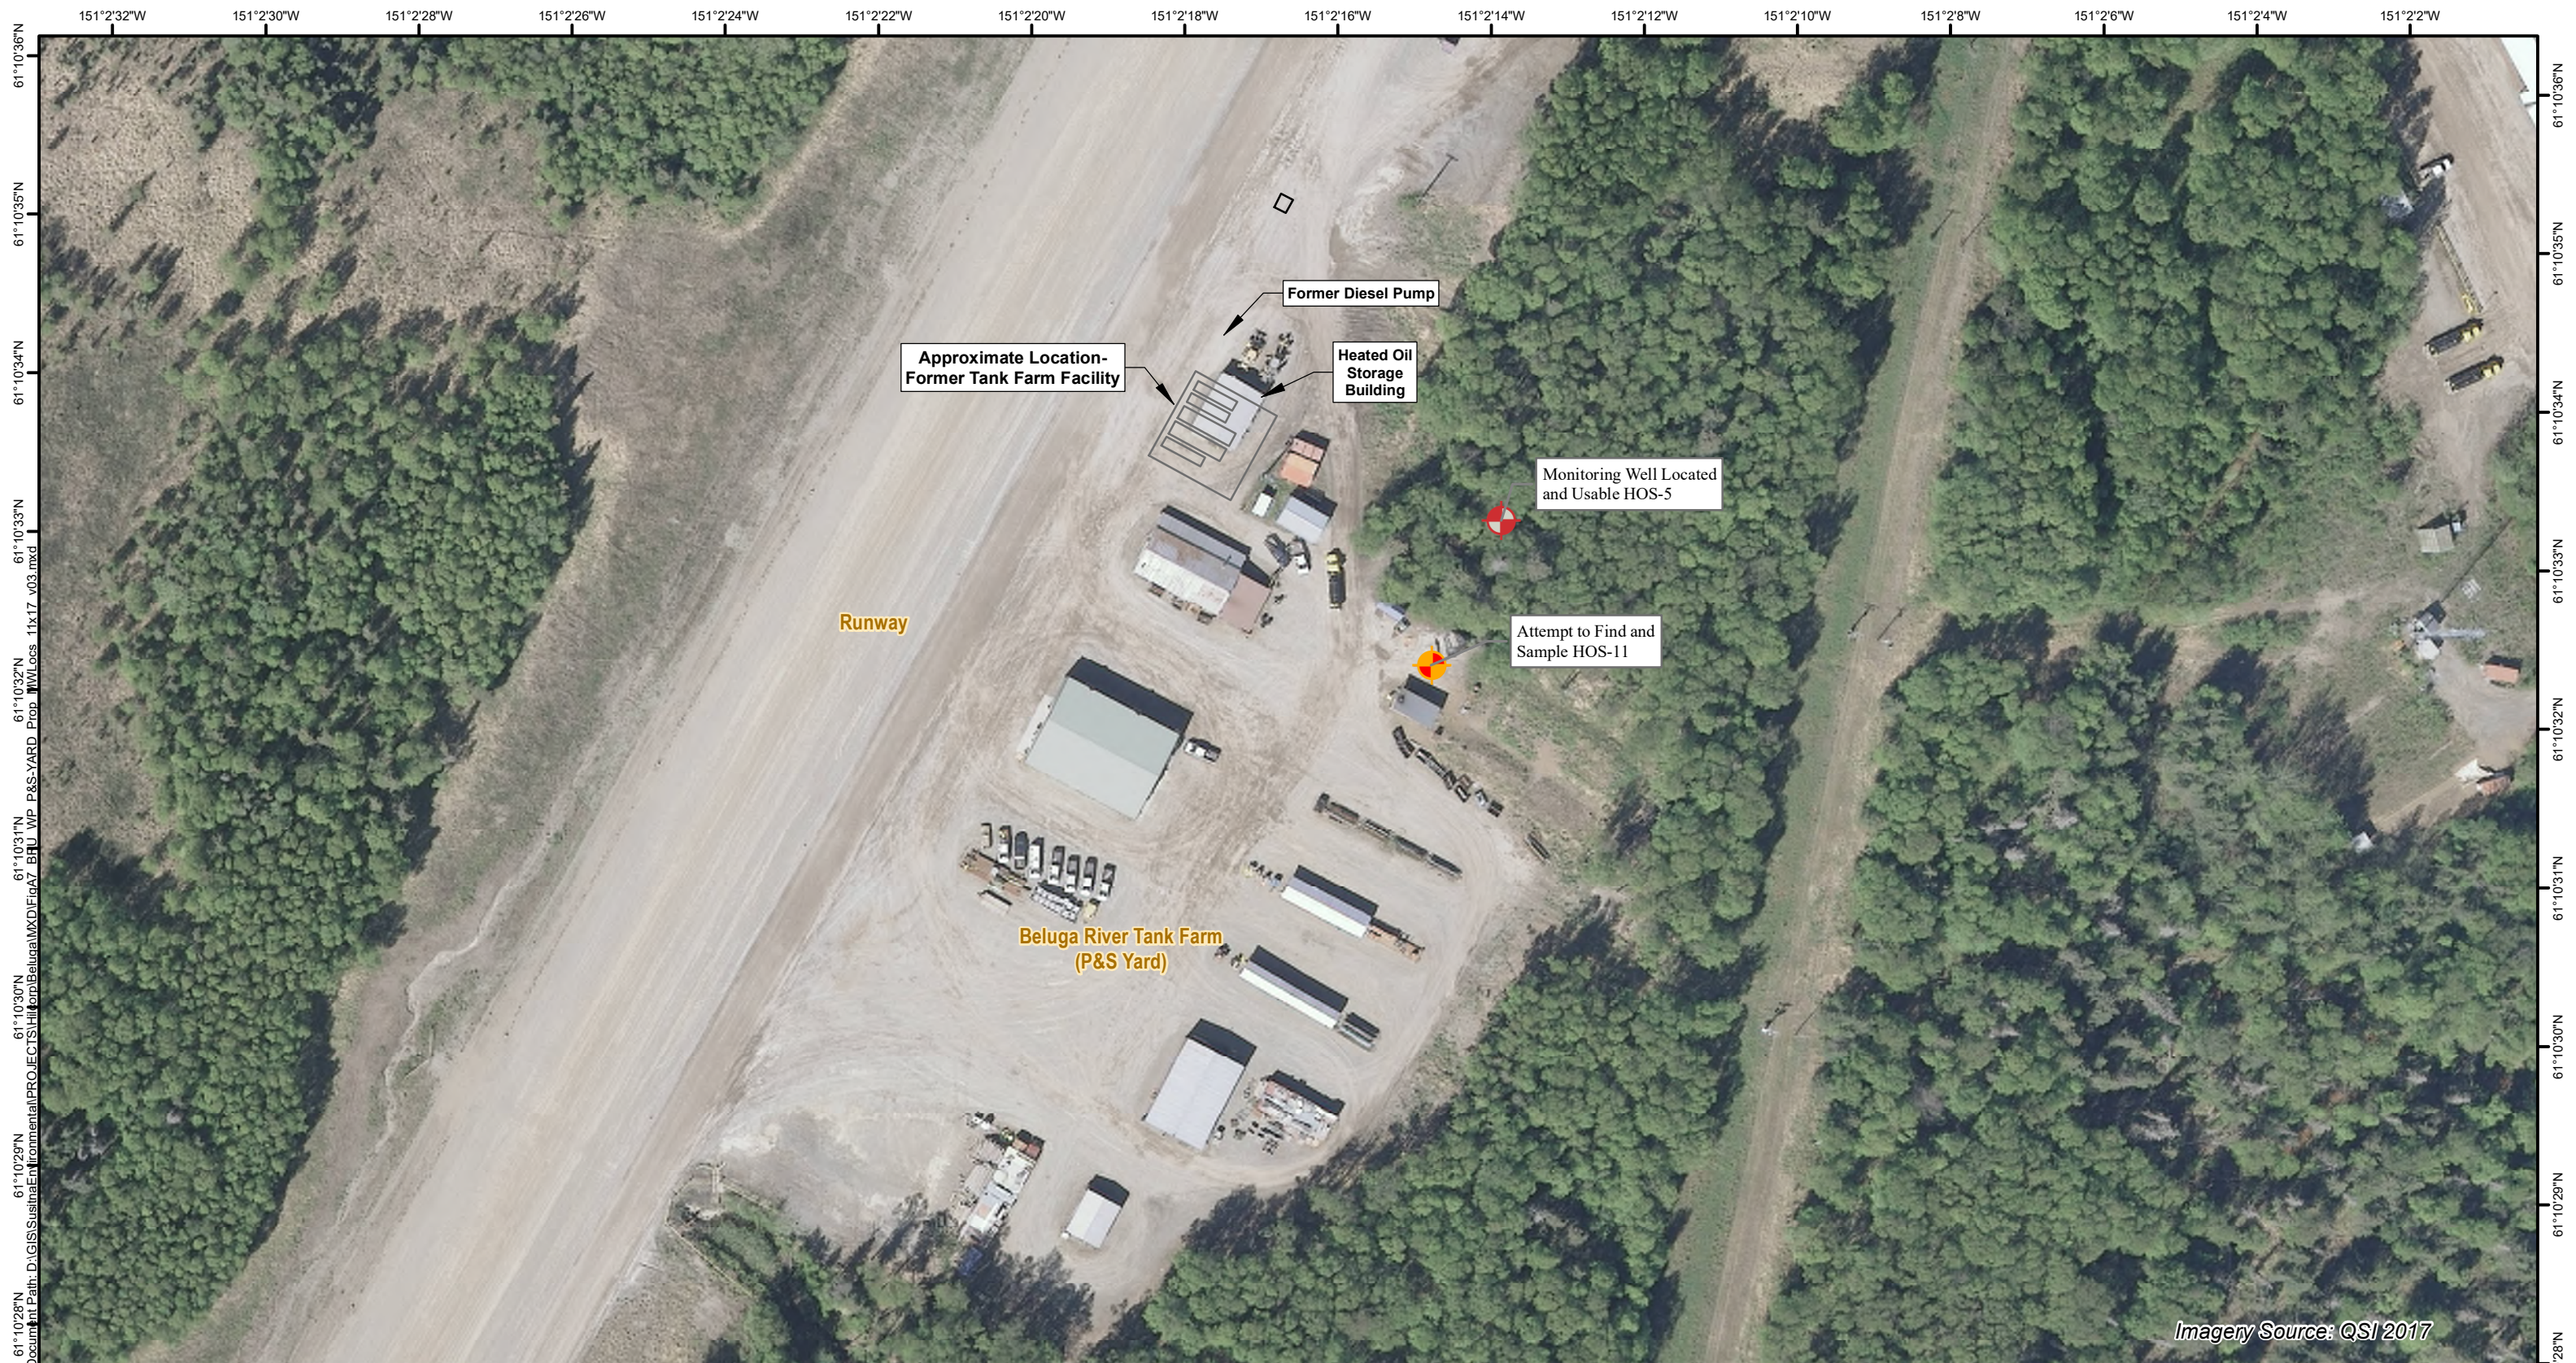
Date Prepared: 6/15/2021	Company Name: Hilcorp Alaska, LLC.	Drawn By: HAK - MRA
Monitoring Well Locations Beluga River Tank Farm (P&S Yard)		
BELUGA RIVER UNIT, COOK INLET, ALASKA		
Scale: @ 11x17 map size 1 in = 100 feet	Figure No:	<b>A-7</b>

the survey, only one of the priority monitoring wells (HOS-5) was located and found to be in potentially usable condition. This well did not have a cap in place and had a petroleum odor. Accumulation of dirt/debris in this well is possible, which could impact the ability to properly redevelop and collect a groundwater sample from this well. Historically this monitoring well had the highest benzene concentration at the site and, if usable, shall be used to assess the potential for contamination remaining onsite. Monitoring well HOS-11 is not a priority well and was located cross gradient to HOS-05. This well was not assessed during the 2019 survey and its current condition is unknown. The field team will attempt to locate the HOS-11 and if found will collect a groundwater sample at this location as well.

If contaminated groundwater is found in monitoring well HOS-5, then an additional well located further downgradient (Figure A-7) will be installed, developed, and sampled to determine the extent of groundwater contamination since the last round of sampling. Samples will be analyzed for DRO, GRO, and BTEX. The location(s) of any additional monitoring wells will be based on the results of the initial groundwater sampling. Additional monitoring well installation will be conducted during a second mobilization to the site.

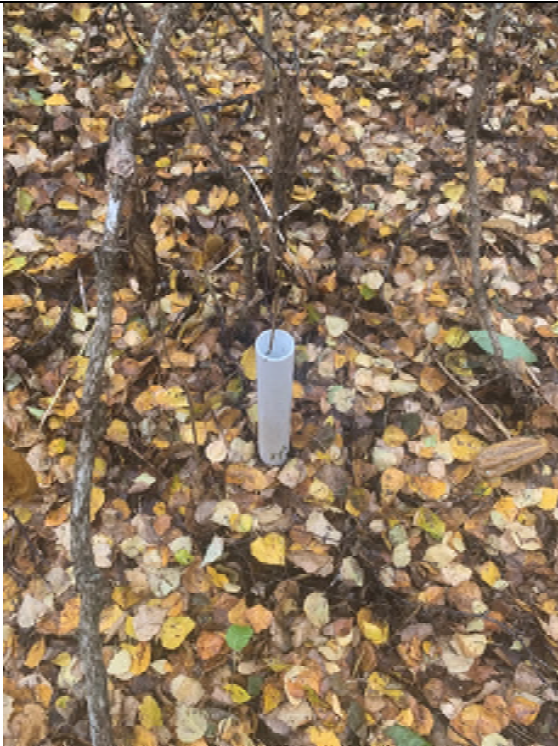
Closeup of ATF 8  
Facing North

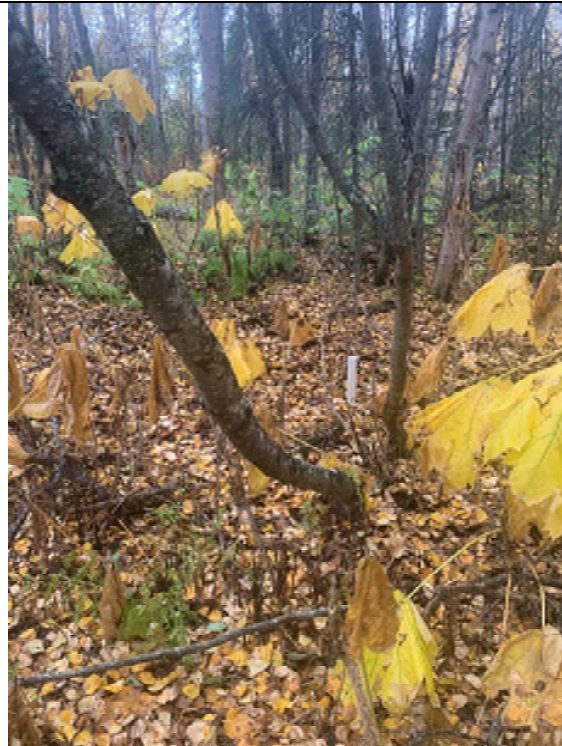
ATF8 surroundings  
Facing North

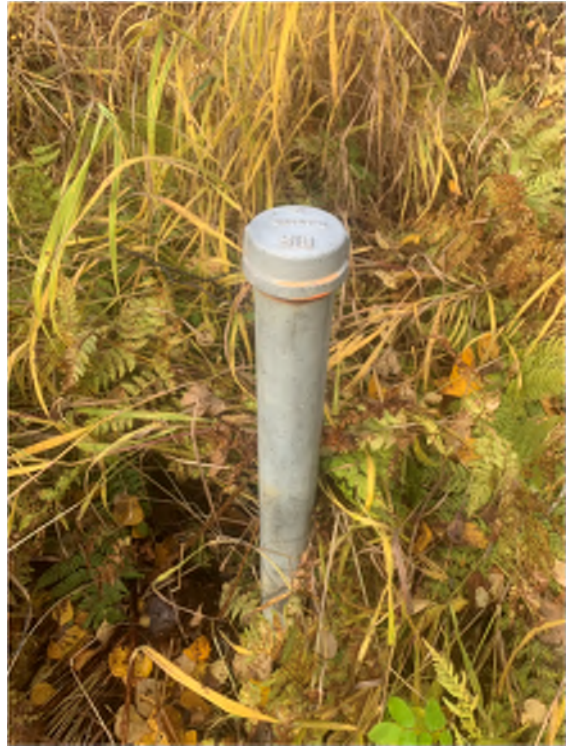
FG-25 Closeup
