7/12 AMENDMENTS TO THE CLEANUP PLAN -
WRANGELL LUMBER MILL SITE

6.5-Mile Zimovia Highway
Wrangell, Alaska

Prepared by
Southeast Management Services
1061 Mendenhall Peninsula Road, Juneau, Alaska 99801

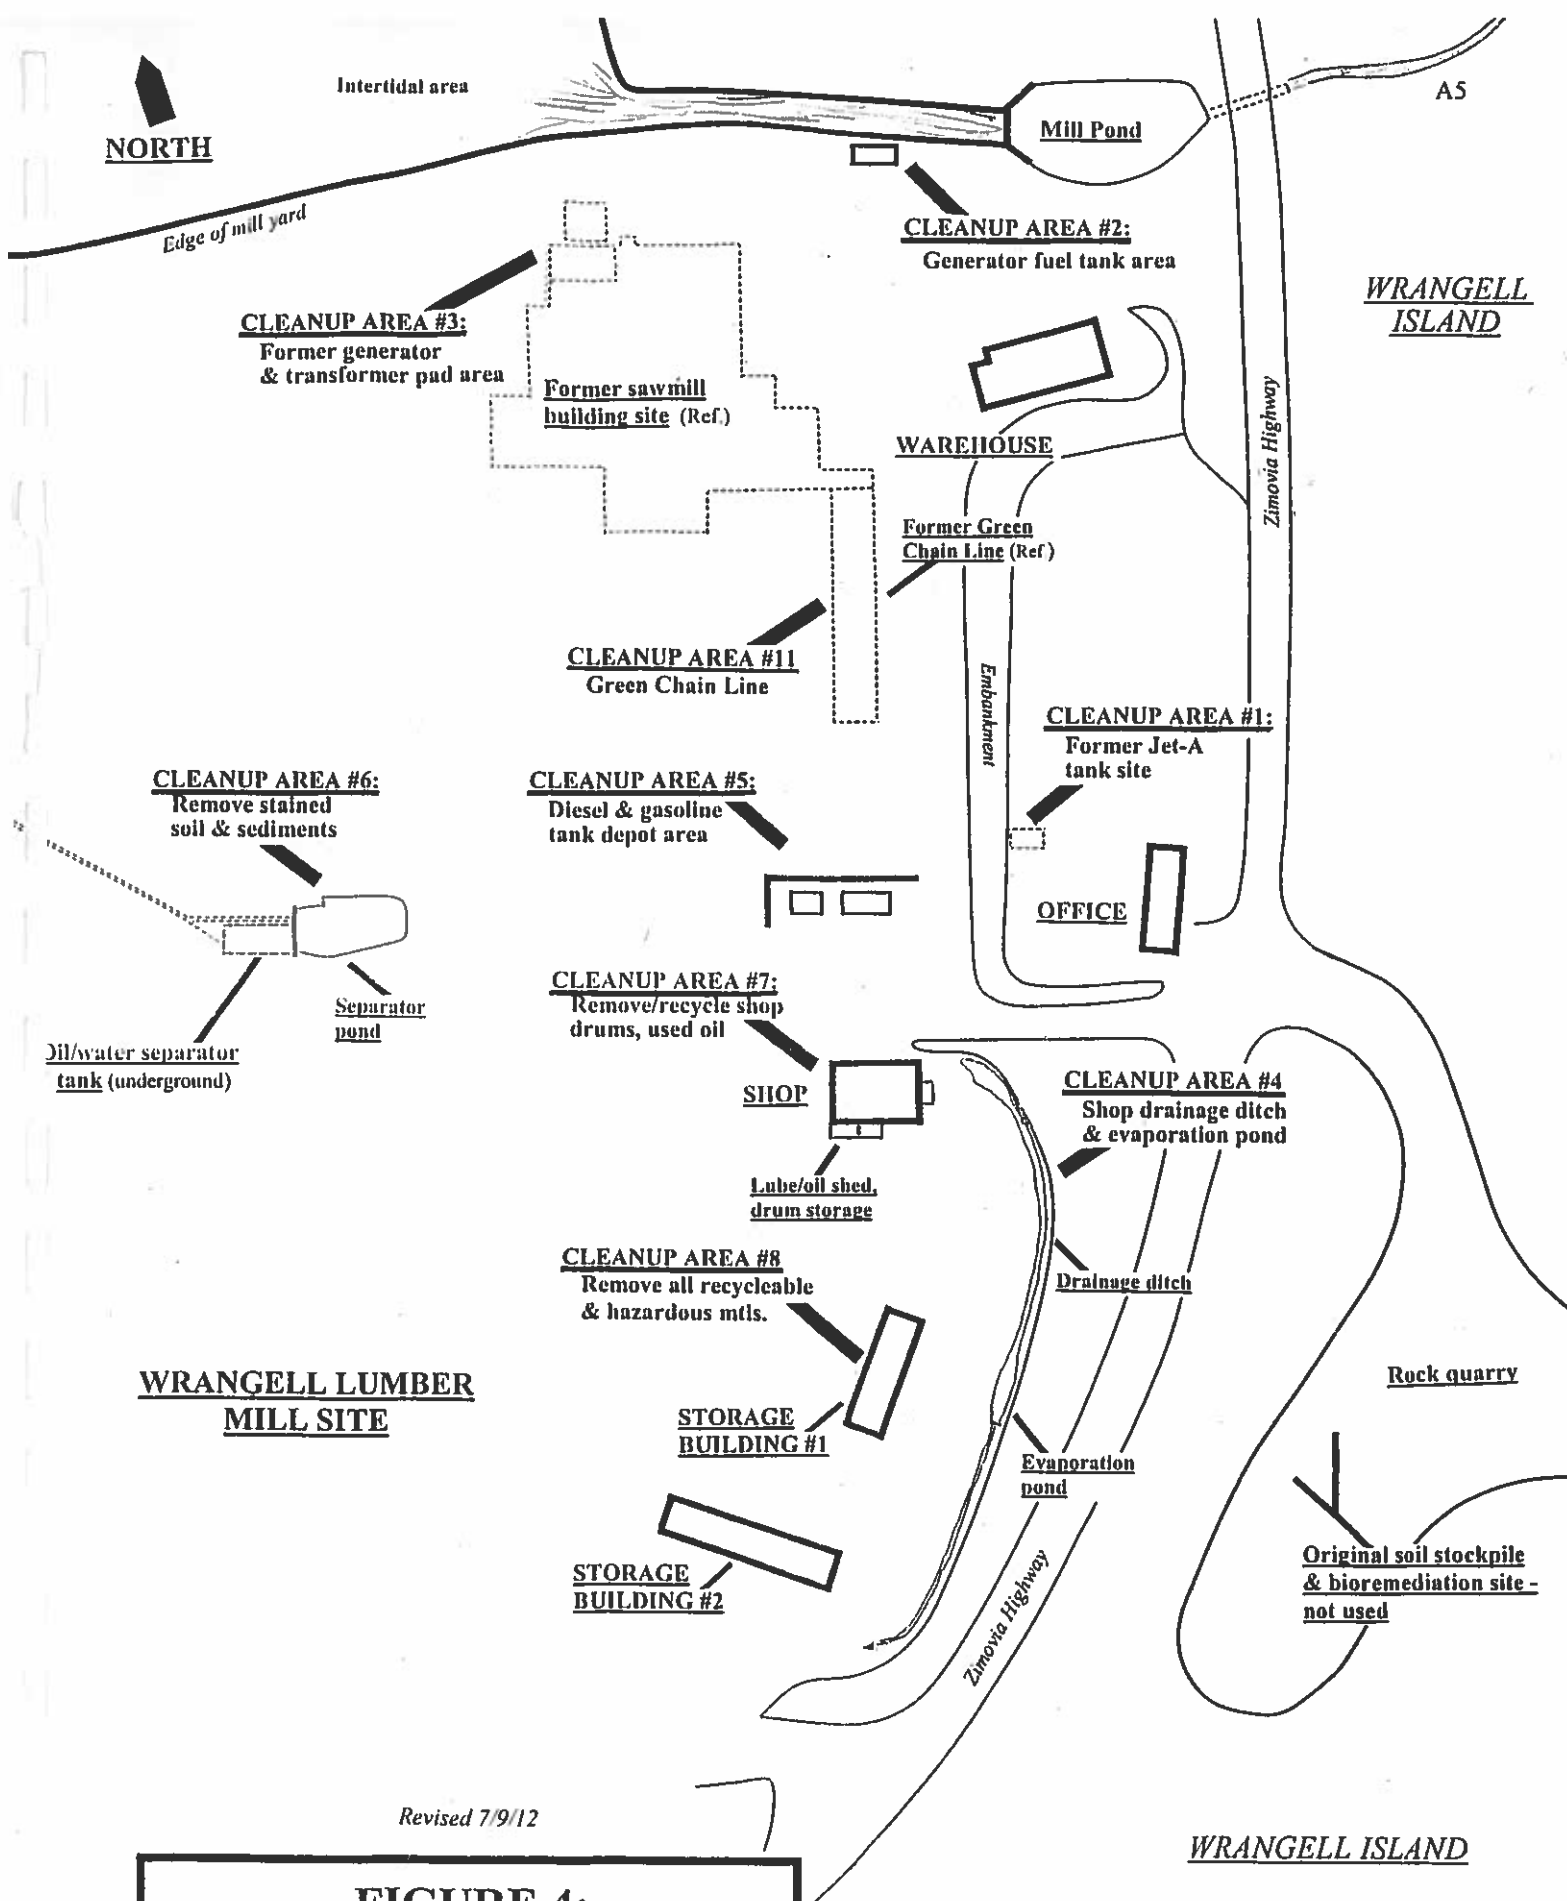
FIGURE 4:
2012 CLEANUP AREAS -
WRANGELL LUMBER MILL SITE

7. Green Chain Line (Cleanup Area #11). [Figure 4](#) (page A5) shows the green chain line area of the former Wrangell Lumber sawmill, where sawn lumber product exited the mill and was sorted/banded for export. Photo #27 (page B15) shows the area when it was inspected on 5/19/12 and found to have dark stained surface soil. Several shallow hand excavations confirmed the presence of oily contaminated soil, and two soil samples taken from a 2'-deep exploratory excavation on 6/5/12 (Photo #28) had high DRO levels of 5,500-11,000 mg/kg and RRO levels of 15,000-25,000 mg/kg.

Figure 4 (page A5) shows the Wrangell Lumber rock quarry on the uphill side of Zimovia Highway from the mill site, where the bioremediation facility was first proposed. The intended bioremediation area was cleared and leveled, then initially used for stockpiling the first 7 truckloads of contaminated soil on 5/15/12 (Photo #33, page B18). However, the excavations quickly generated larger contaminated soil volumes than the quarry space could handle. As a result, the contaminated soil stockpile was relocated to a cleared concreted area at the mill site.
