**Summary Site Assessment Report
Port of Anchorage Area
Anchorage, Alaska**

July, 1992

**Petroleum Users Group
Port of Anchorage
2000 Anchorage Port Road
Anchorage, Alaska 99501**

SHANNON & WILSON, INC.

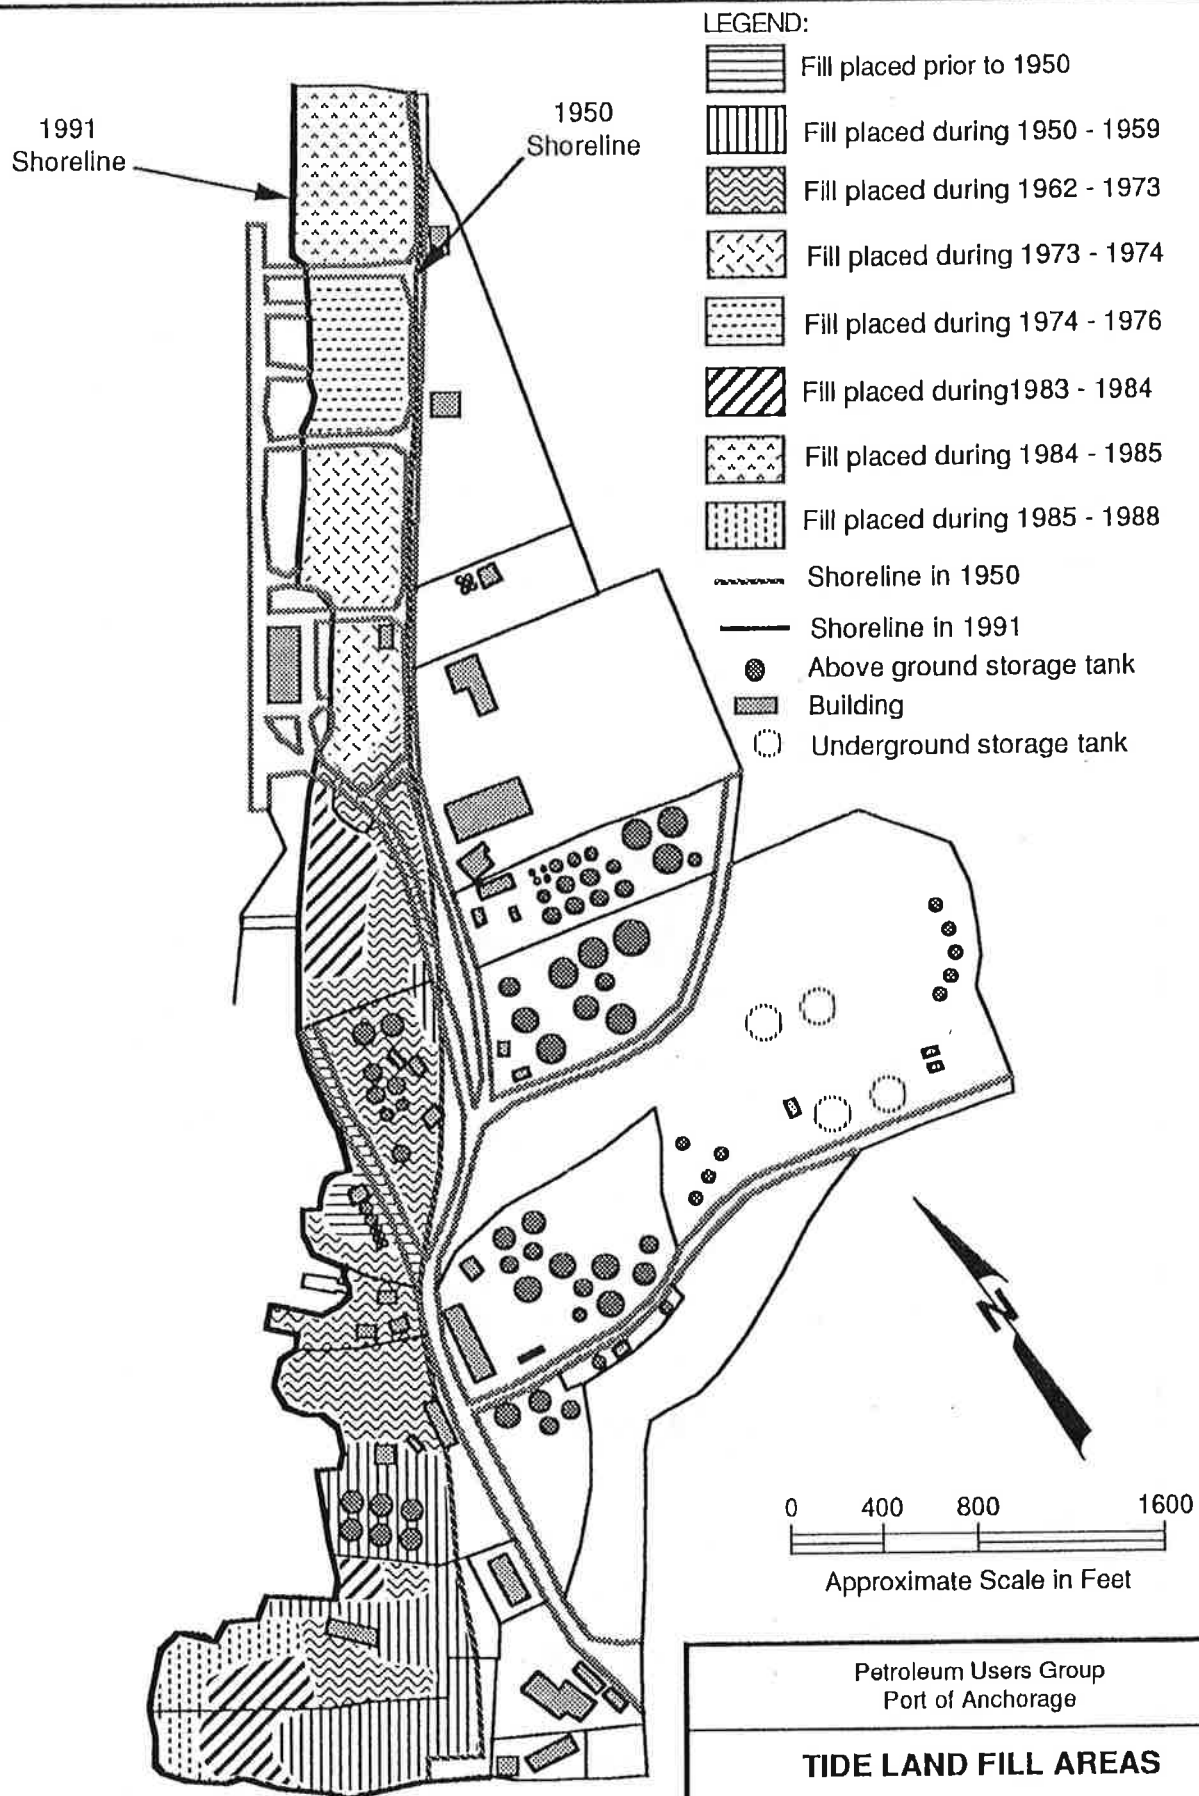
Figure 2

and gravels, landslide debris and soils dredged from the bottom of the inlet. A historical depiction of the fill placement within the former tideland areas is included in Figure 2. This information was taken from the series of aerial photographs from 1950 to 1991. As seen in Figure 2, the shoreline has been extended to the west into the inlet by an average of about 60 feet since 1950. Along the south portion of the POA-PUG area adjacent to Ship Creek, the shoreline has been extended over 140 feet. Although not shown on Figure 2, substantial amounts of fill have also been placed within the parcels located east of the 1950 shoreline.

TIDE LAND FILL AREAS

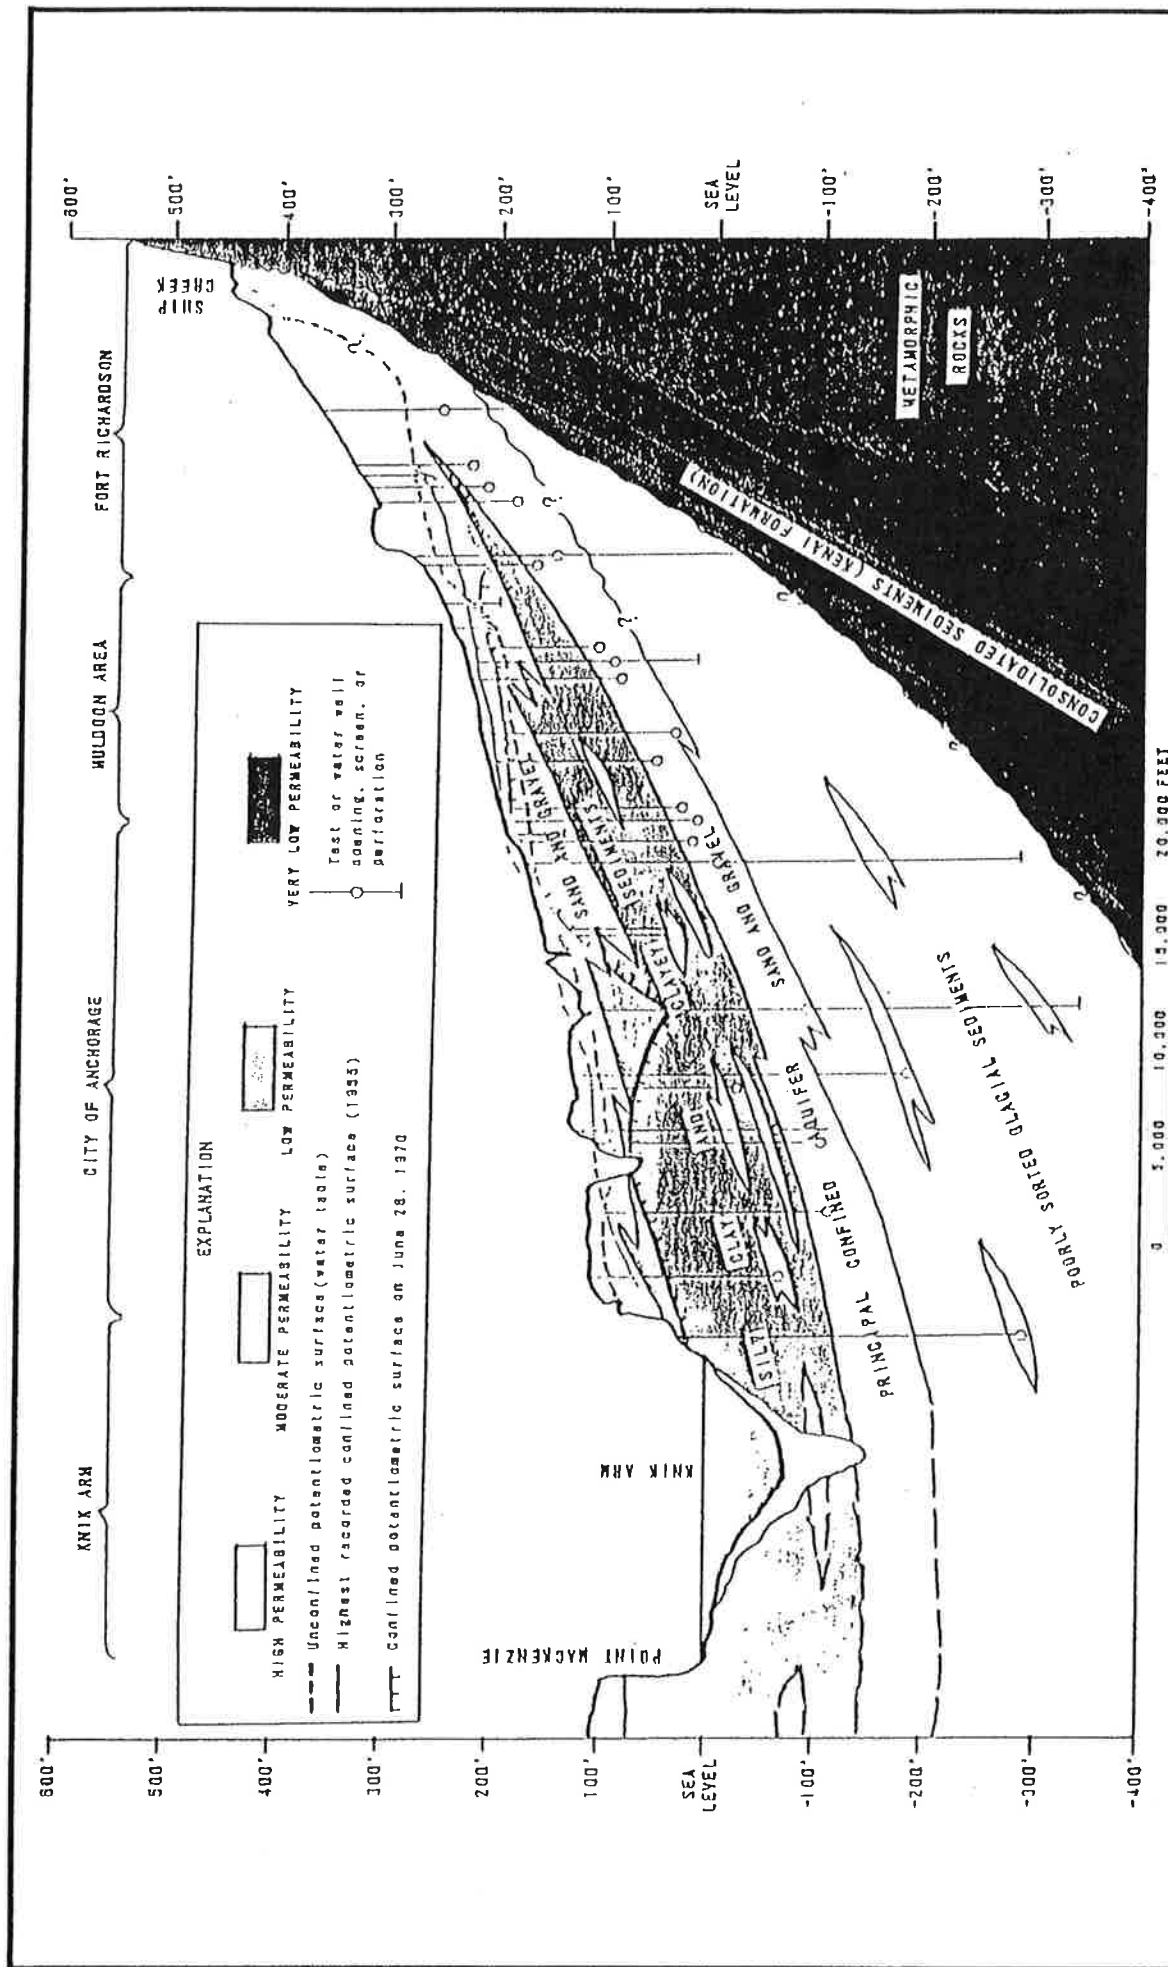
Petroleum Users Group Port of Anchorage	
REGIONAL GEOLOGY AND HYDROLOGY CROSS SECTION	
July, 1992	Y-5108
SHANNON & WILSON, INC. Geotechnical Consultants	Figure 3

The regional geology and hydrology is relatively consistent throughout the entire POA-PUG area. The existing geologic regime is a result of several glaciation episodes and more recent events including tidal flat deposition, landslide deposition and man-made filling. A cross section depicting the general regional geology and hydrology features within the Anchorage area is shown on Figure 3.
