December 12, 2023

**Subject: Final 2023 Initial Vapor Intrusion Investigation Survey Report, AFSC Off-Airport Fuel Facility, Port of Alaska**

2023 Initial VI Investigation  
 AFSC Off-Airport Fuel Facility  
 Anchorage, AK

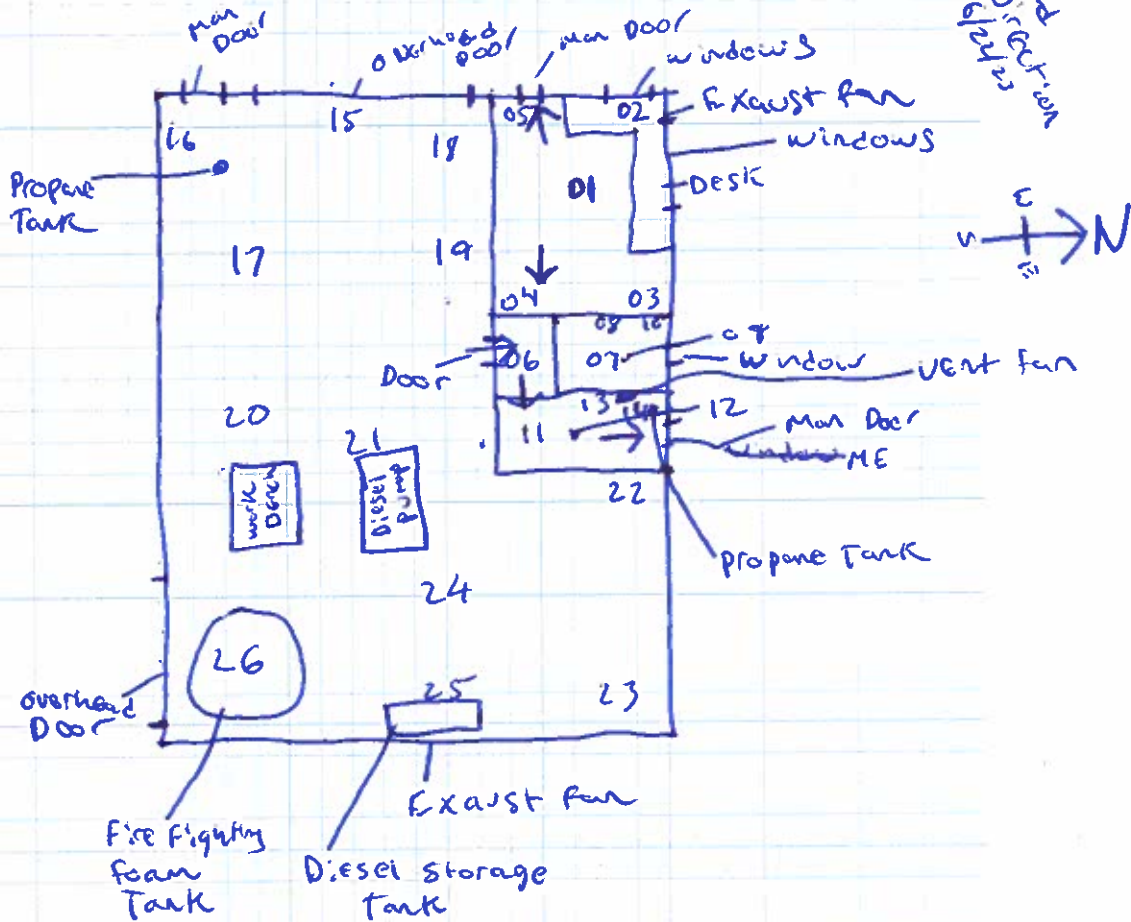
Outside Dimensions = 32 ft x 41

Arrows Represent Air flow

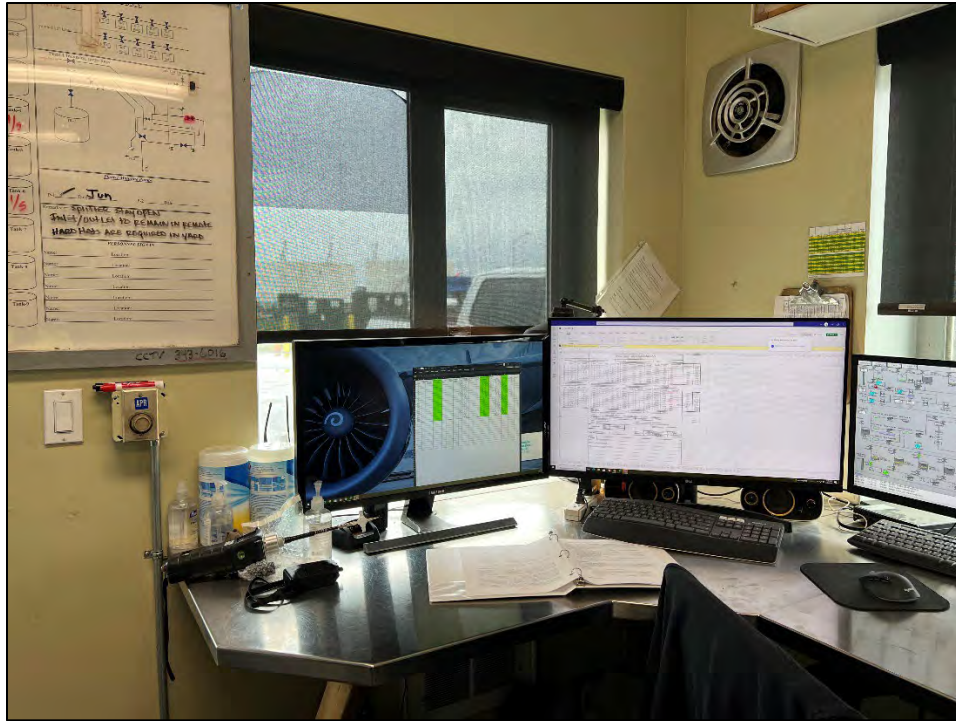
Photograph 3: View looking northeast. Facility monitoring station and desk in the office area. Note windows and the in-wall exhaust fan.

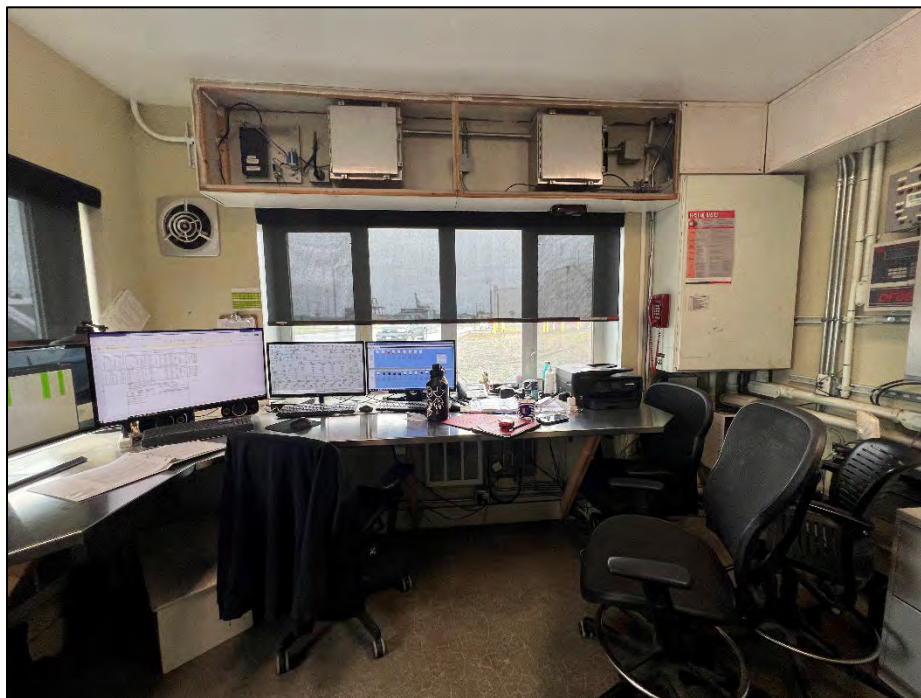
Photograph 4: View looking north. Facility monitoring station and desk in the office area. Note windows, exhaust fan, and radiant heater under the desk.

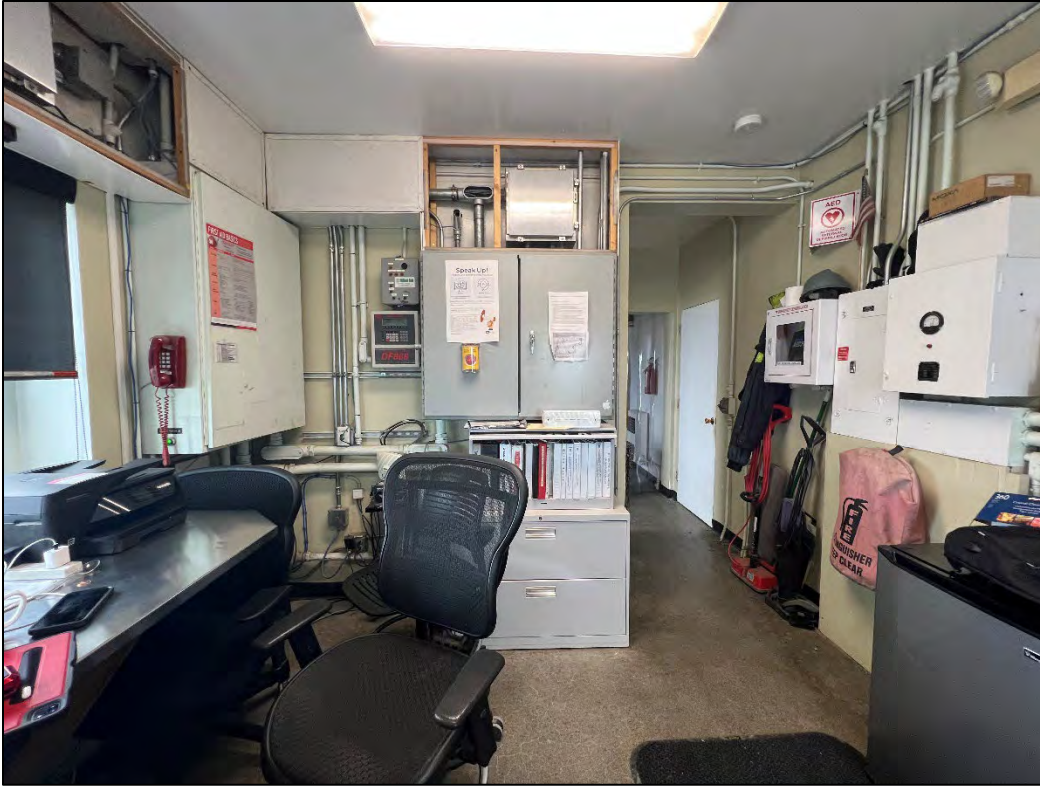
Photograph 5: View looking east. East side of the Office. Note hallway to back room, door to the garage area along the wall on the right side of the hall.

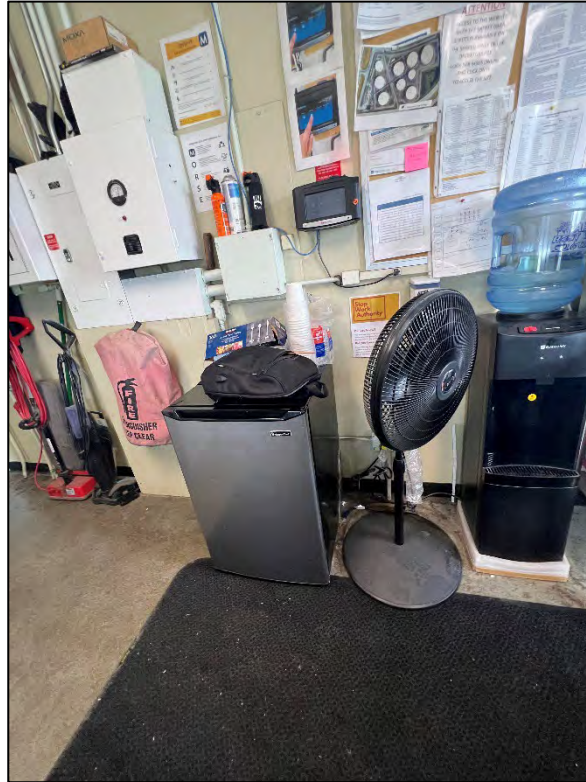
Photograph 8: View looking south. Office south wall. Fan supplements ventilation in the office area.

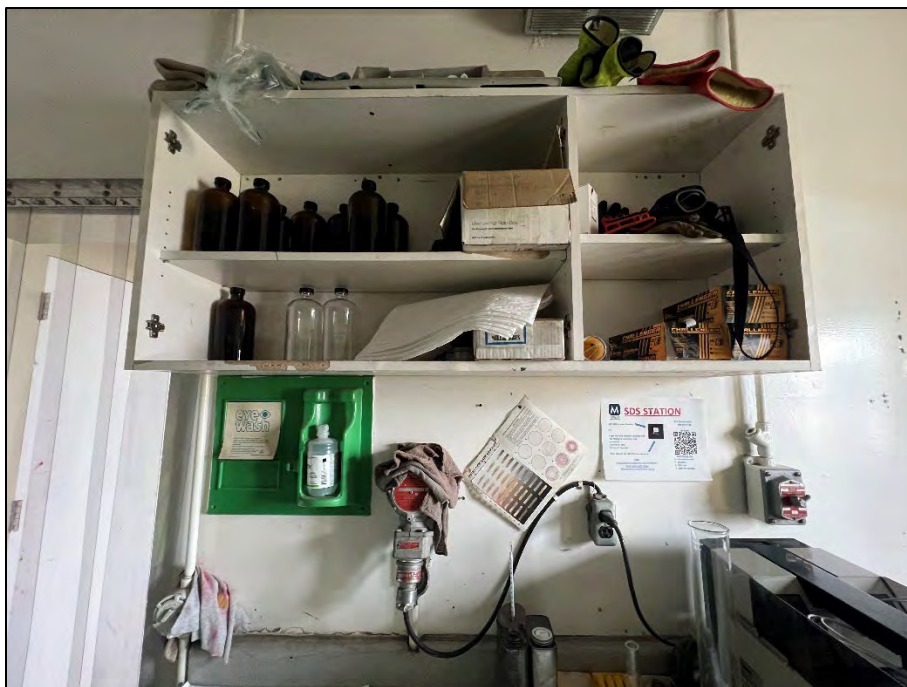
Photograph 13: View looking west. Shelving above the flash point testing area in the back room. Amber glass bottles have fuel in them for testing.

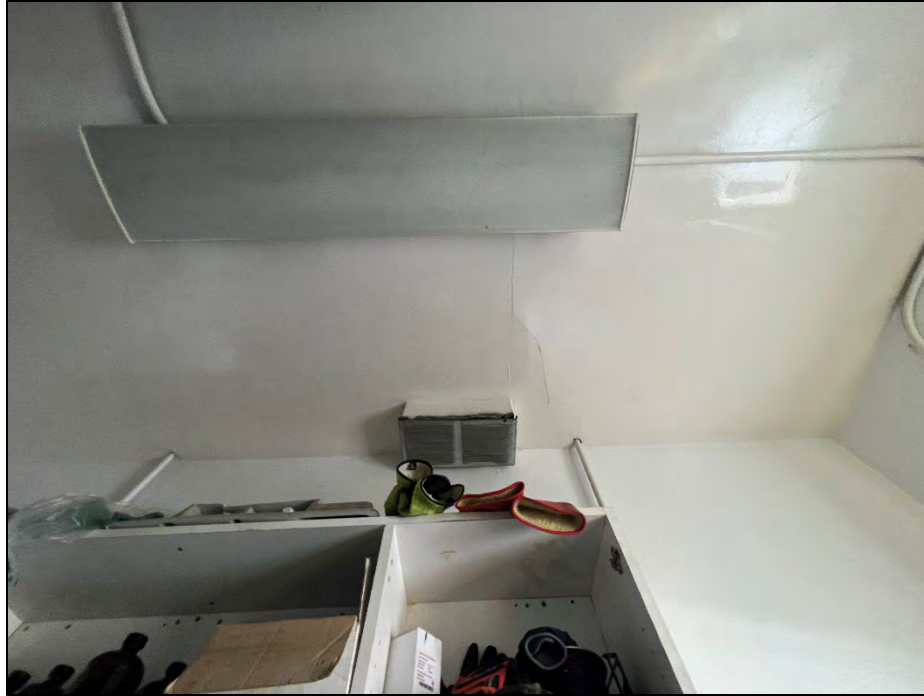
Photograph 16: View looking up. Exhaust fan above the flash point testing area in the back room.

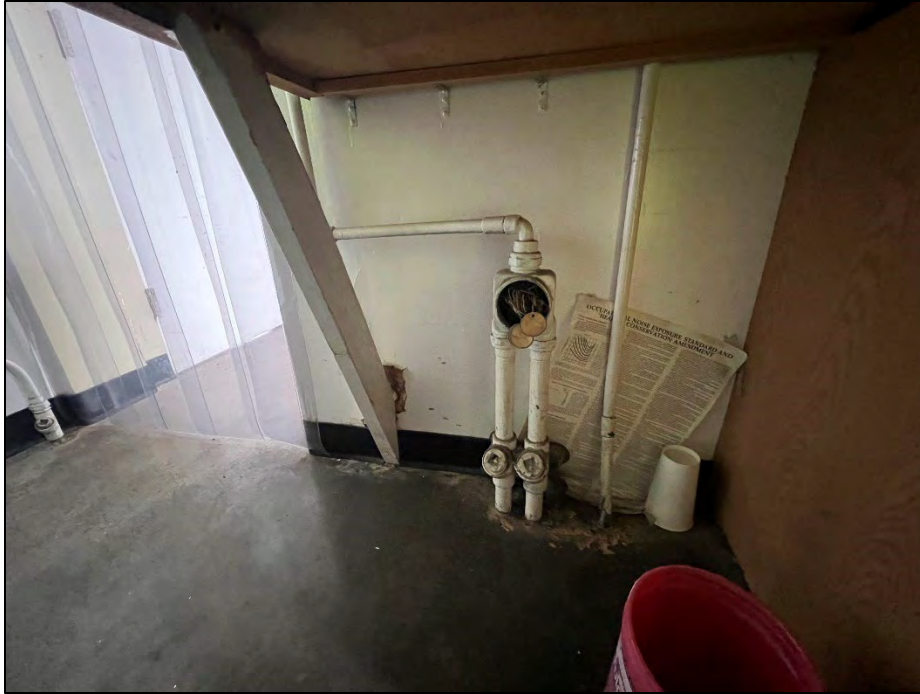
Photograph 18: View looking west. Utility access under flash point testing counter in the garage area of the control building.

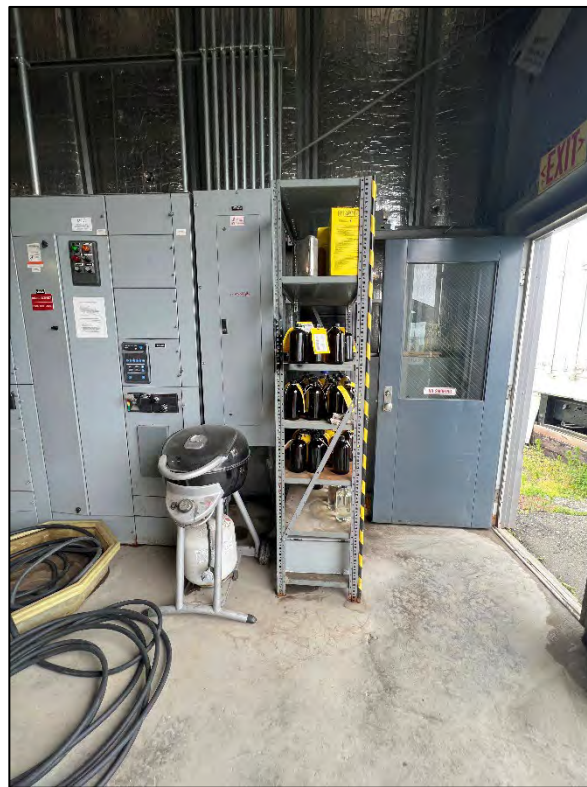
Photograph 19: View looking south. Fuel sample storage rack and the propane grill in the garage. Garage personnel door on right side of photo.

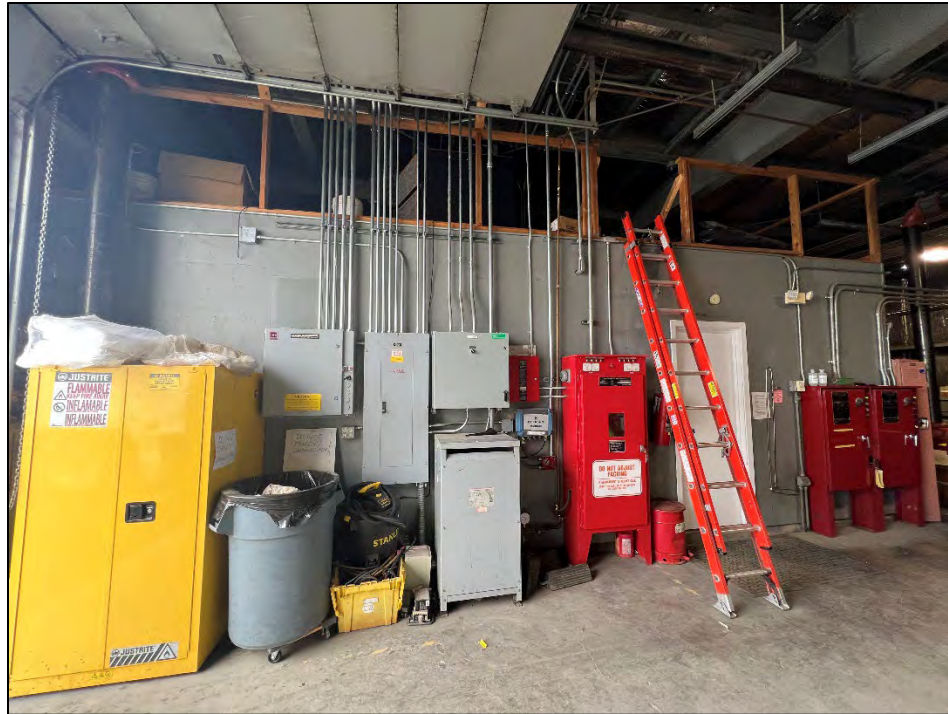
Photograph 22: View looking north. North side of garage area. Walled off area is the office/restroom/backroom areas. Note open storage on top of office rooms. Door leads to hallway between office and back room.

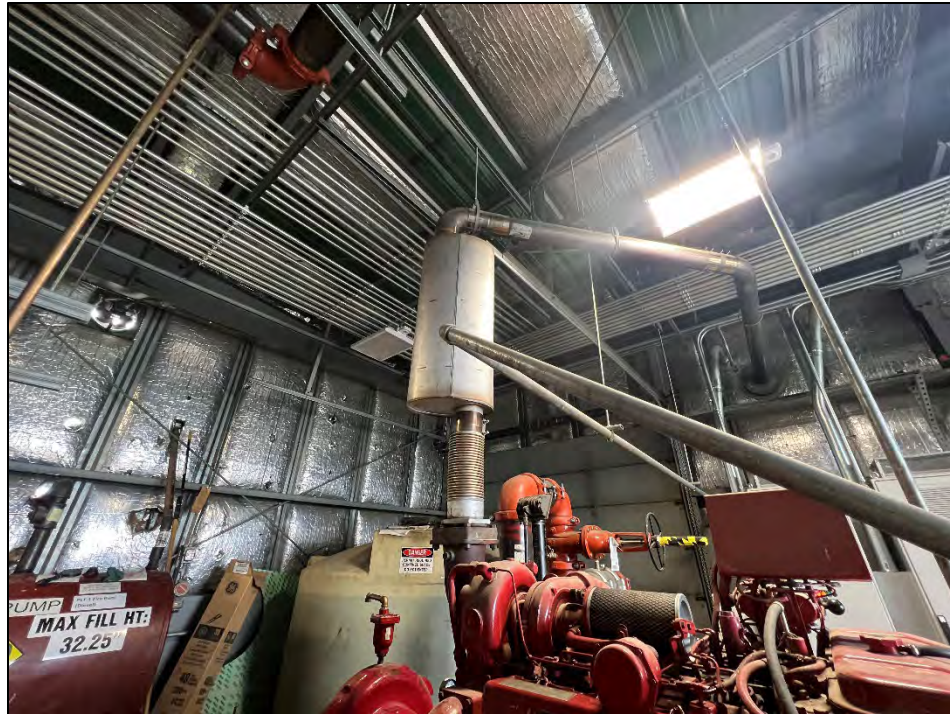
Photograph 24: View looking southeast. Exhaust system for the diesel pump. Exhaust goes out through ducts to the south wall of building.

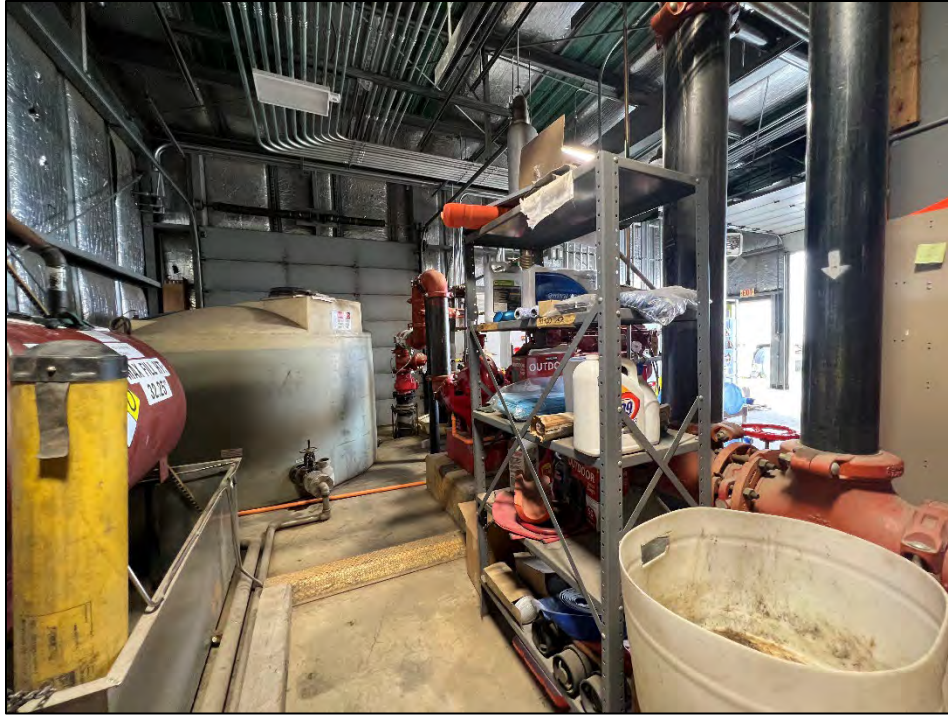
Photograph 32: View looking south. Central area of the garage. Used for storage. Note protected diesel lines running on floor from diesel AST to the pump (behind the shelf)

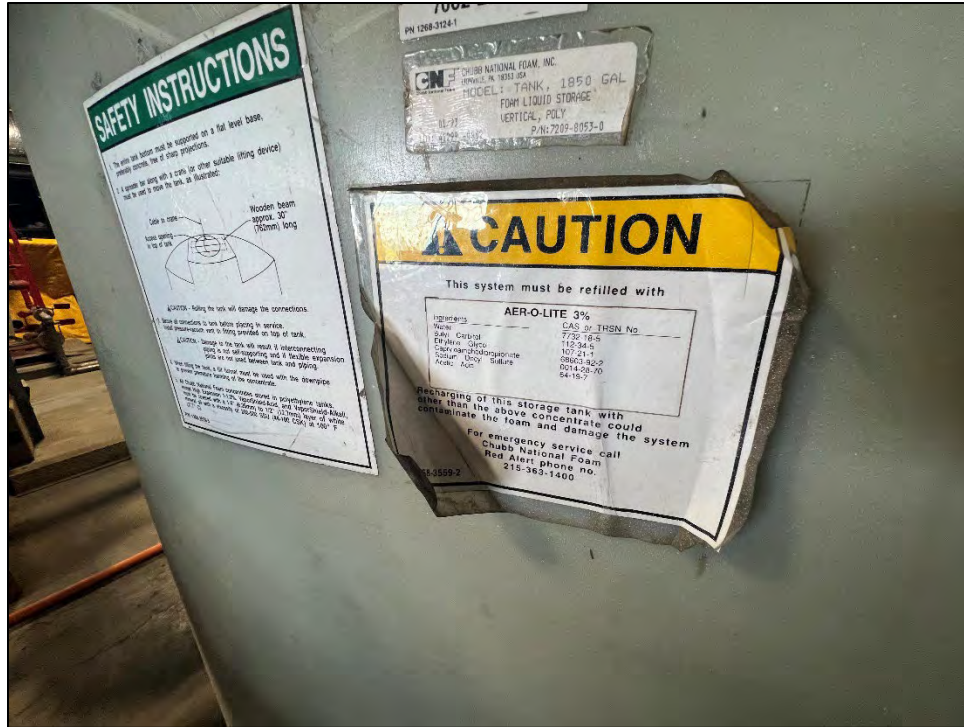
Photograph 34: View close up. Contents of the fire fighting foam AST and warning labels.
