**TUNTUTULIAK SITE RECONNAISSANCE
AND RECOMMENDATION REPORT
TUNTUTULIAK, ALASKA
DRAFT**

**ADEC Aboveground Storage Tank Program
410 Willoughby Avenue, Suite 105
Juneau, Alaska 99801-5207**

**Bristol Environmental & Engineering Services Corporation
2000 W. International Airport Road, #C-1
Anchorage, Alaska 99502
(907) 563-0013**

January 2001

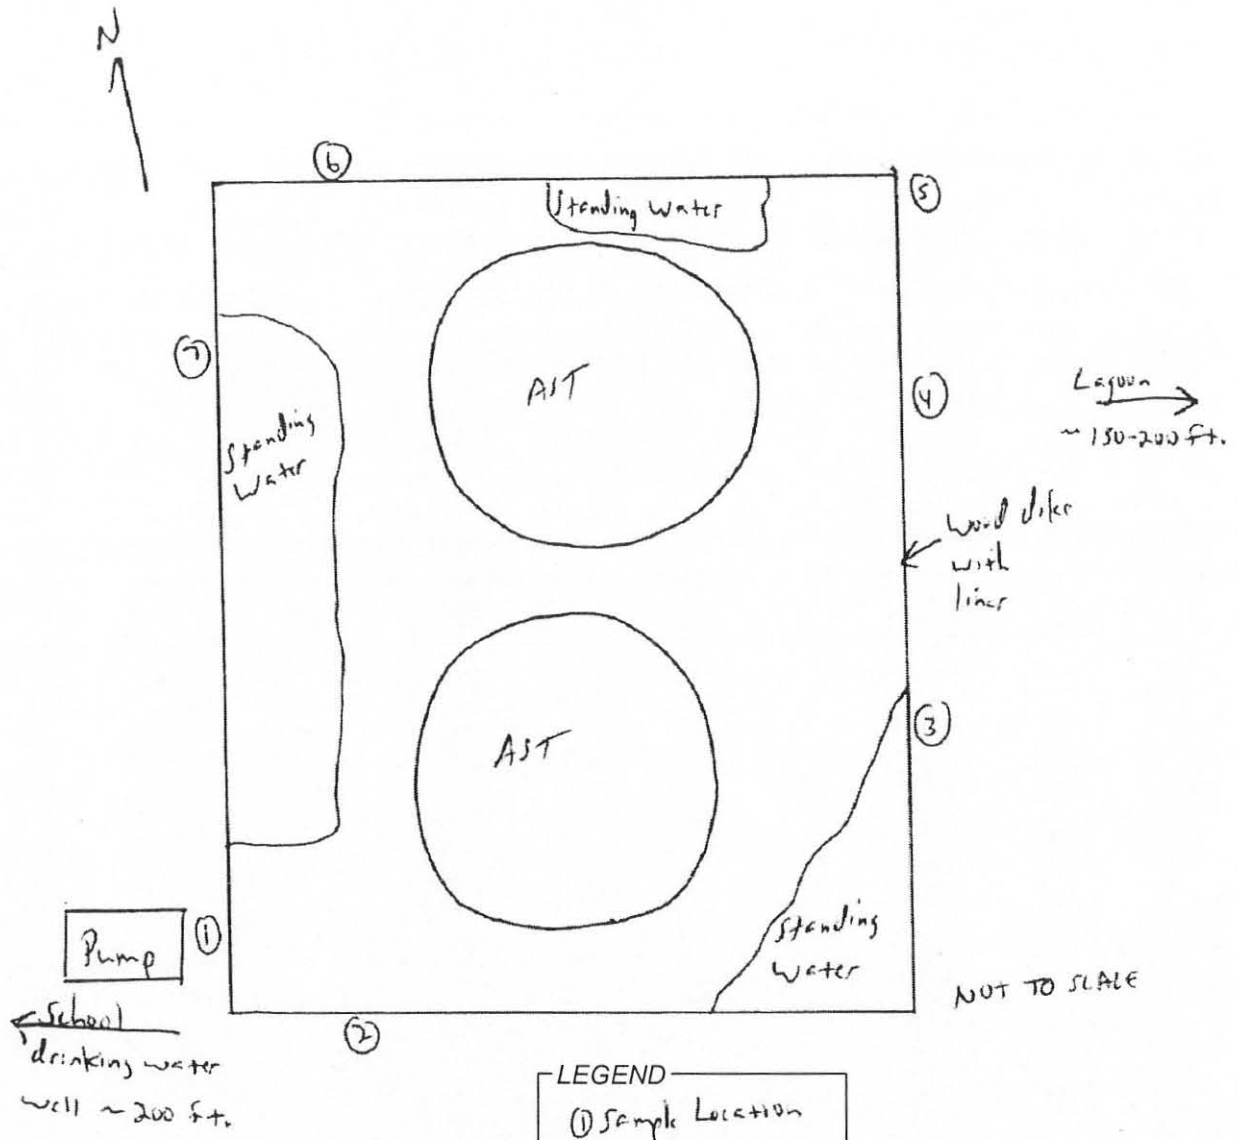
BRISTOL Environmental & Engineering Services Corporation Contract No: 18-5001-10	Site 4 - Lewis Angapak Memorial School, LKSD - Field Drawing Tuntutuliak, Alaska	Date: January 2001	Figure 5
		Drawn By: CJL Checked By: JSR	Project No: 21071

Two ASTs are located at this site (photograph 8). Seven soil samples were collected using a hand auger for PID screening and potential submittal for laboratory analysis for DRO, GRO, and BTEX. All samples were collected from 0-6 inches below ground surface. The location of the soil samples, as well as the PID results and depths of the samples are shown on Figure 5.

- *Soil staining observed:* None.
- *Sheen on water observed:* None.
- *Soil description:* Peat to 6 inches, underlain by gray silt.
- *Depth to water table observed in soil borings:* Approximately 6 to 12 inches below ground surface.
- *Estimated direction of surface water and groundwater flow:* East, toward a lagoon located approximately 150-200 feet from the tank farm. Although the surface water and groundwater would generally be expected to flow eastward, this direction may change because of the relatively flat topography and influence of seasonal flooding or rainfall.
- The nearest drinking water well is located approximately 200 feet west of the school tank farm. This well provides drinking water to the school, and the depth of the well is not known. According to Mr. Robert Enoch, the school well and the Washeteria wells are the only drinking water wells in the village.

Location	PI	Depth (in.)
①	Ø	0-6
②	Ø	0-6
③	Ø	0-6
④	Ø	0-6
⑤	Ø	0-6
⑥	Ø	0-6
⑦	Ø	0-6

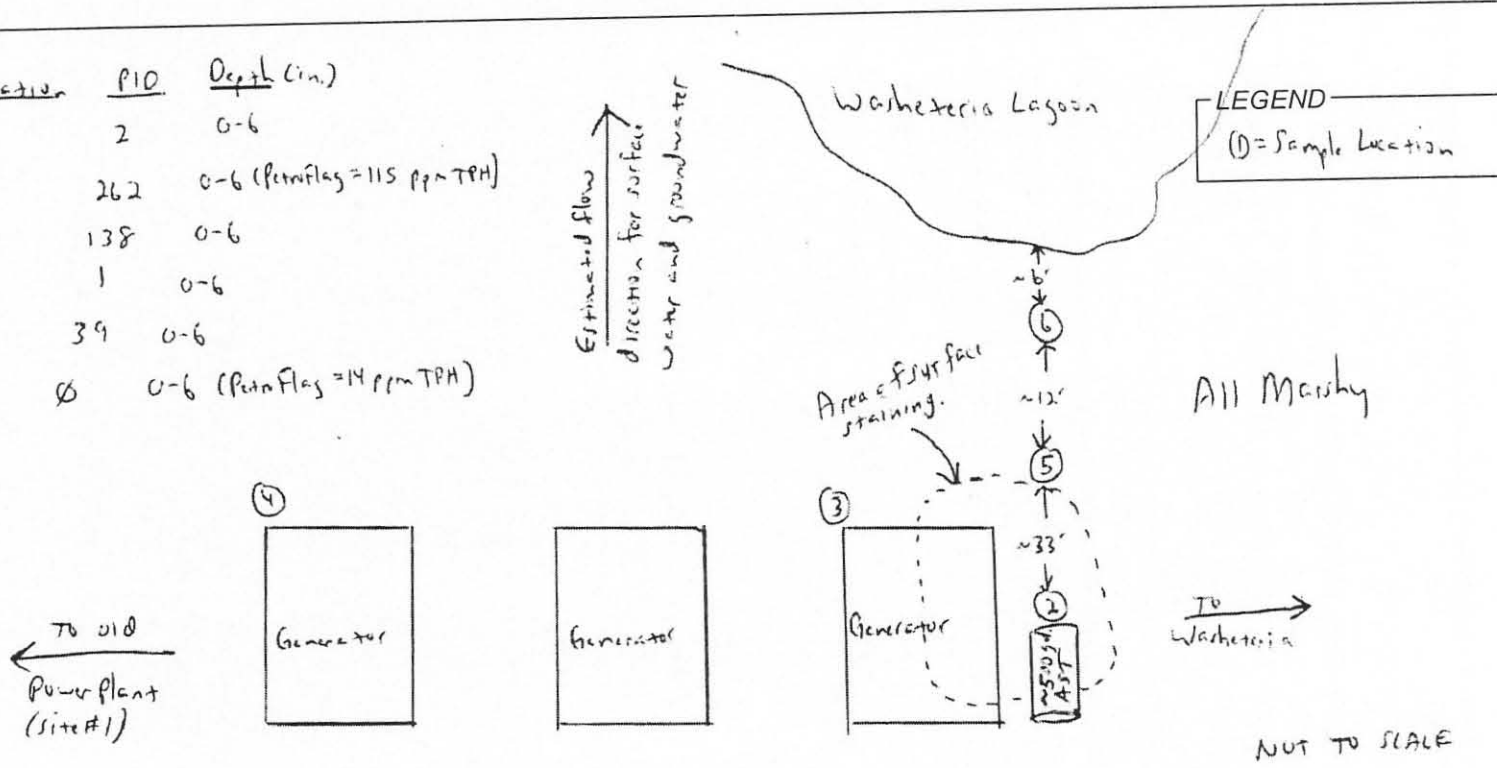
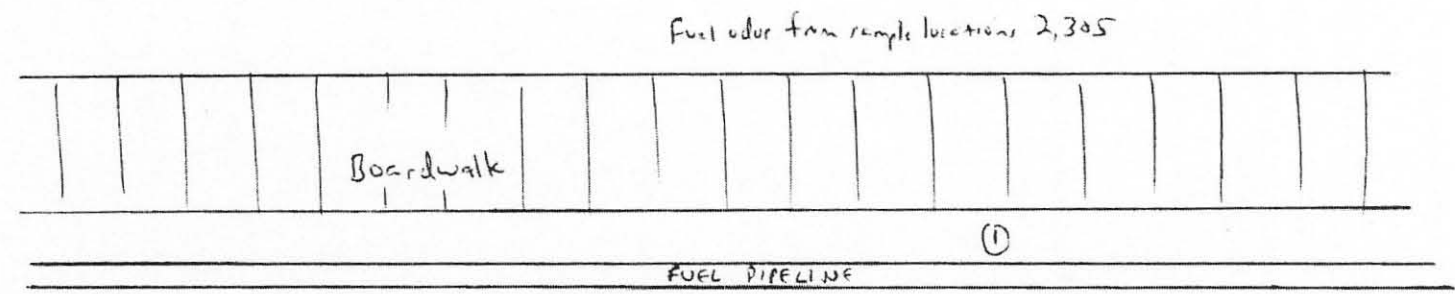
BRISTOL Environmental & Engineering Services Corporation Contract No: 18-5001-10	Additional Reconnaissance Area (Electric Plant) - Field Drawing Tuntutuliak, Alaska	Date: January 2001	Figure 7
		Drawn By: CJL Checked By: JSR	Project No: 21071

Using a hand auger, six soil samples were collected for PID screening and potential submittal for laboratory analysis for DRO, GRO, and BTEX. The location of the soil samples, as well as the PID results and depths of the samples are shown on Figure 7.

Location	PID	Depth (in.)
①	2	0-6
②	262	0-6 (PetaFlag = 115 ppm TPH)
③	138	0-6
④	1	0-6
⑤	39	0-6
⑥	8	0-6 (PetaFlag = 14 ppm TPH)

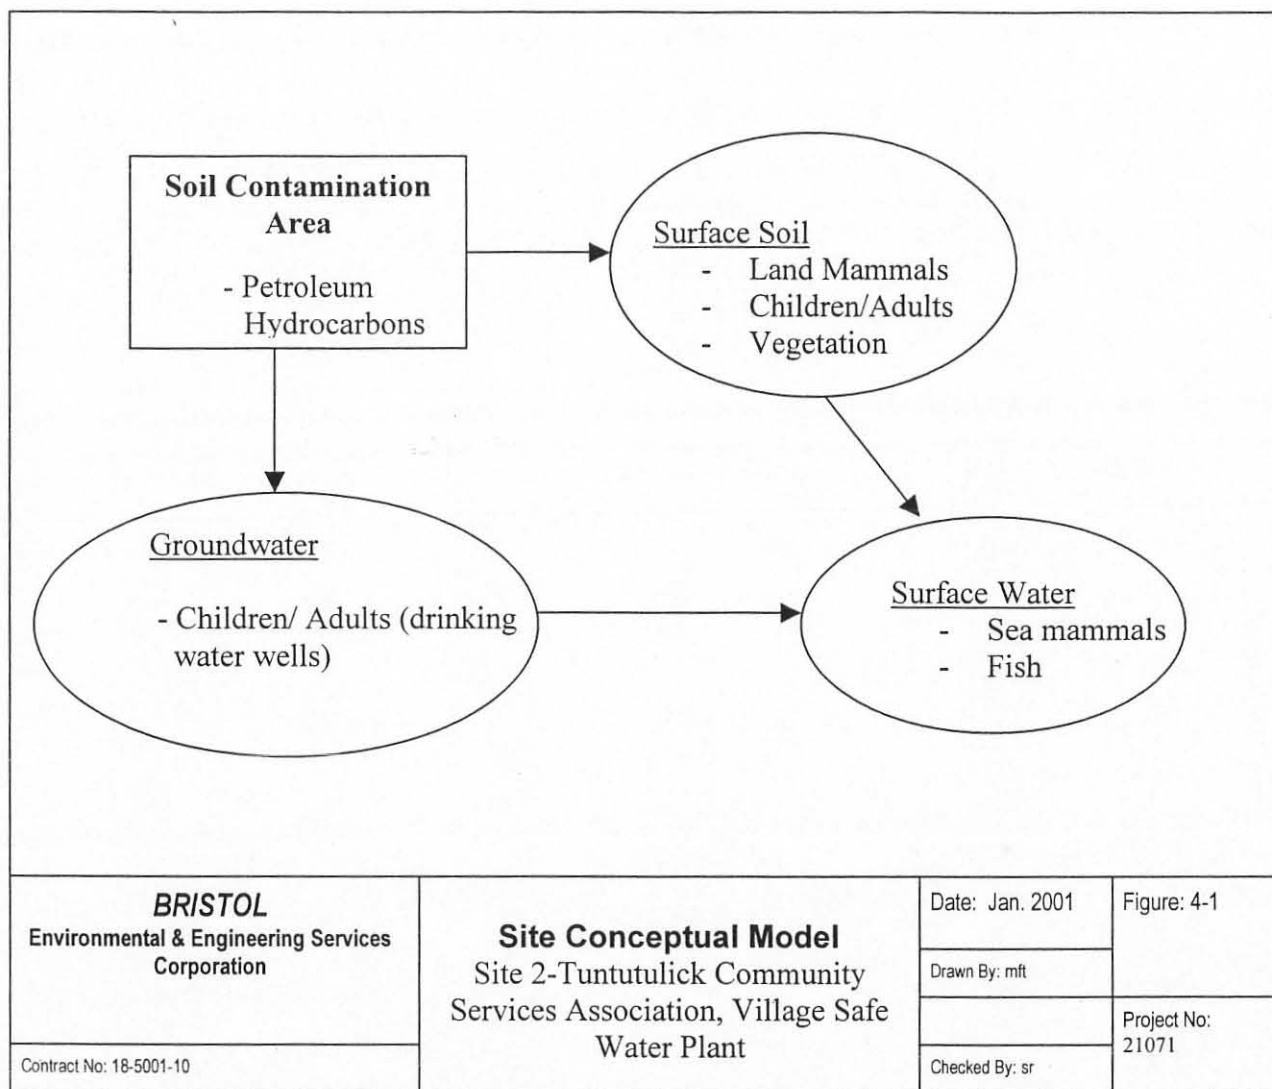
Based on data collected during the site reconnaissance, the conceptual model (Figure 4-1) showing potential contaminant sources and receptors has been developed.

Based on the site conceptual model shown above, the following types of samples, general sample locations and rationale, are presented:
