**Remediation Equipment
Operation Completion Report
Bentley Mall
Fairbanks, Alaska**

REMEDIATION EQUIPMENT OPERATION COMPLETION REPORT

**Bentley Mall
Fairbanks, Alaska**

January 2011

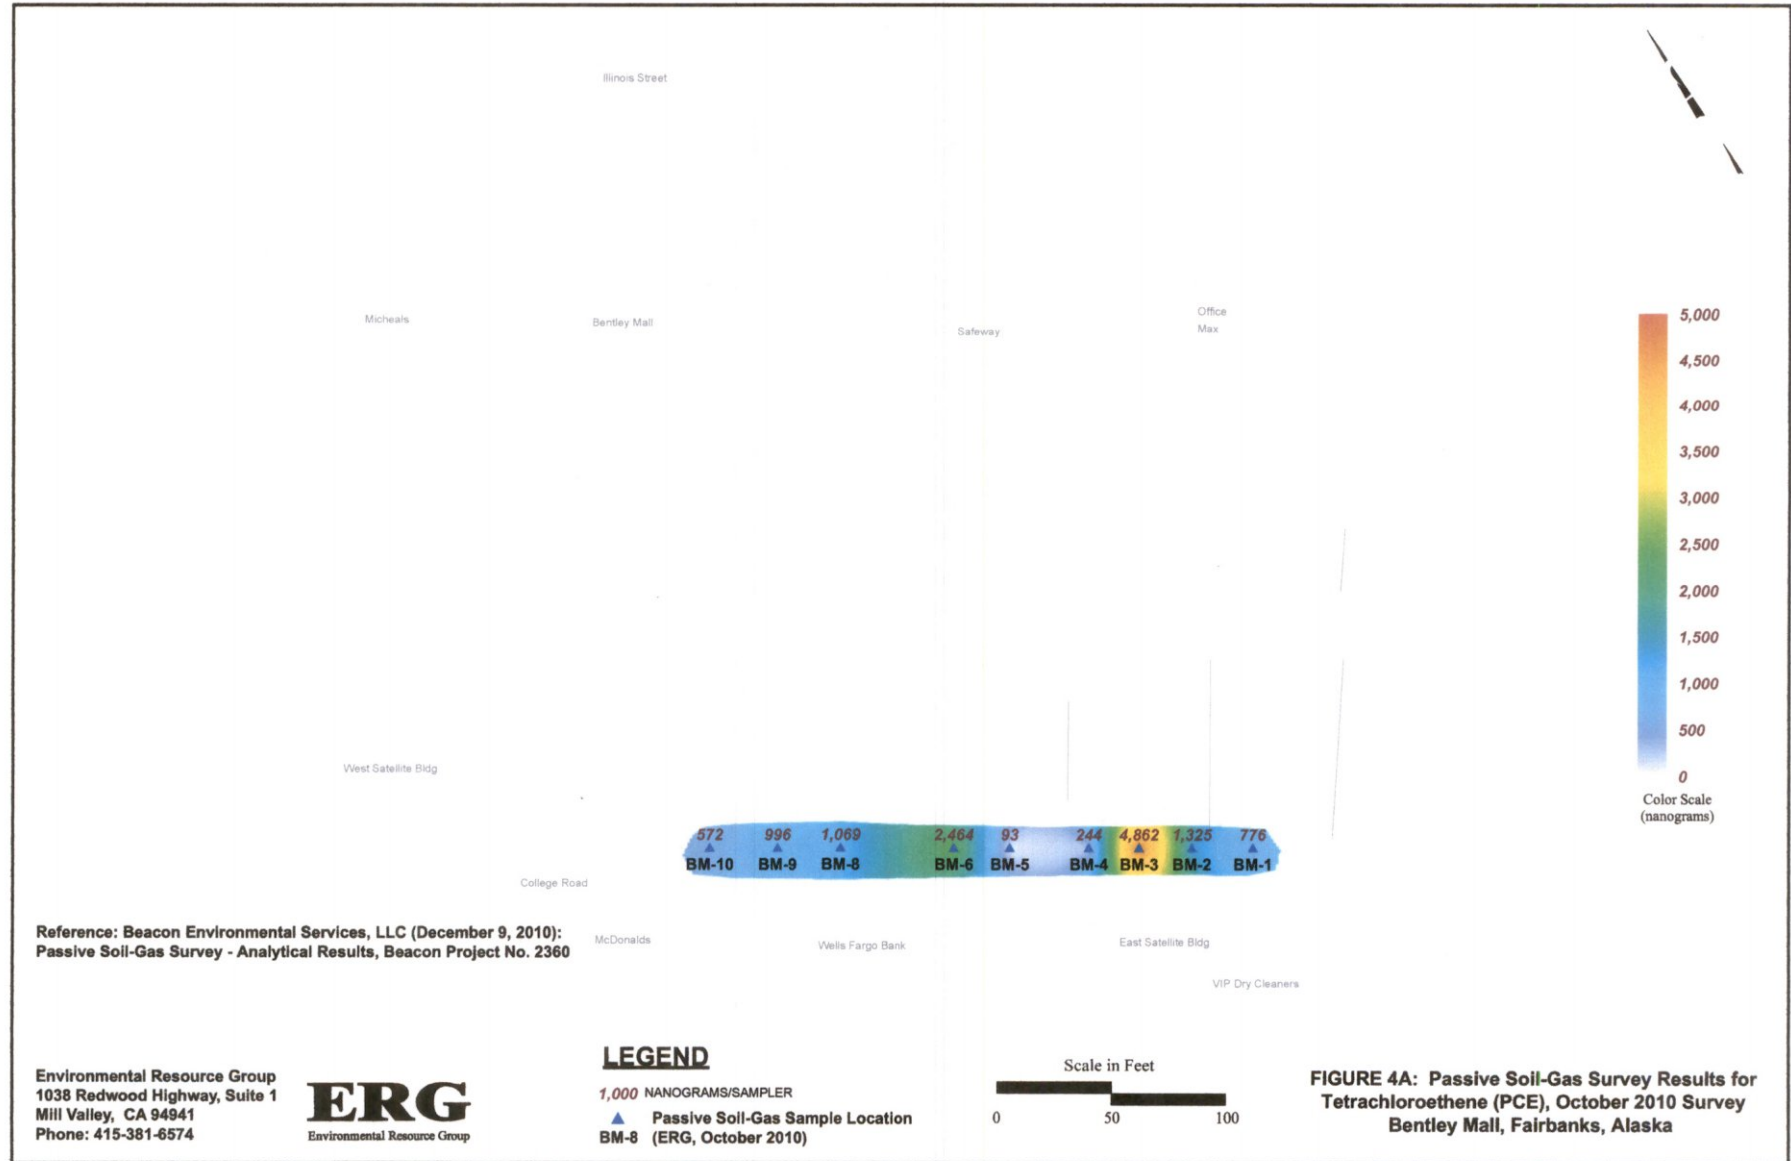
The investigation results indicate an approximately 84% decrease in PCE and TCE when the PSG sampling results for October 2010 are compared to the baseline PGS sampling results for August 2003-June 2004. The PSG survey results provide evidence of source removal by remediation efforts with reduced PCE and TCE levels in subsurface soil in the southern portion of the Bentley Mall. PSG maps showing results for October 2010 (**Figure 4A and 4B**) and August 2003-June 2004 (**Figure 3A and 3B**) are attached for comparison.
