TECHNICAL MEMORANDUM

Landfill Assessments at LF024 and LF026

Eareckson Air Station

June 2025

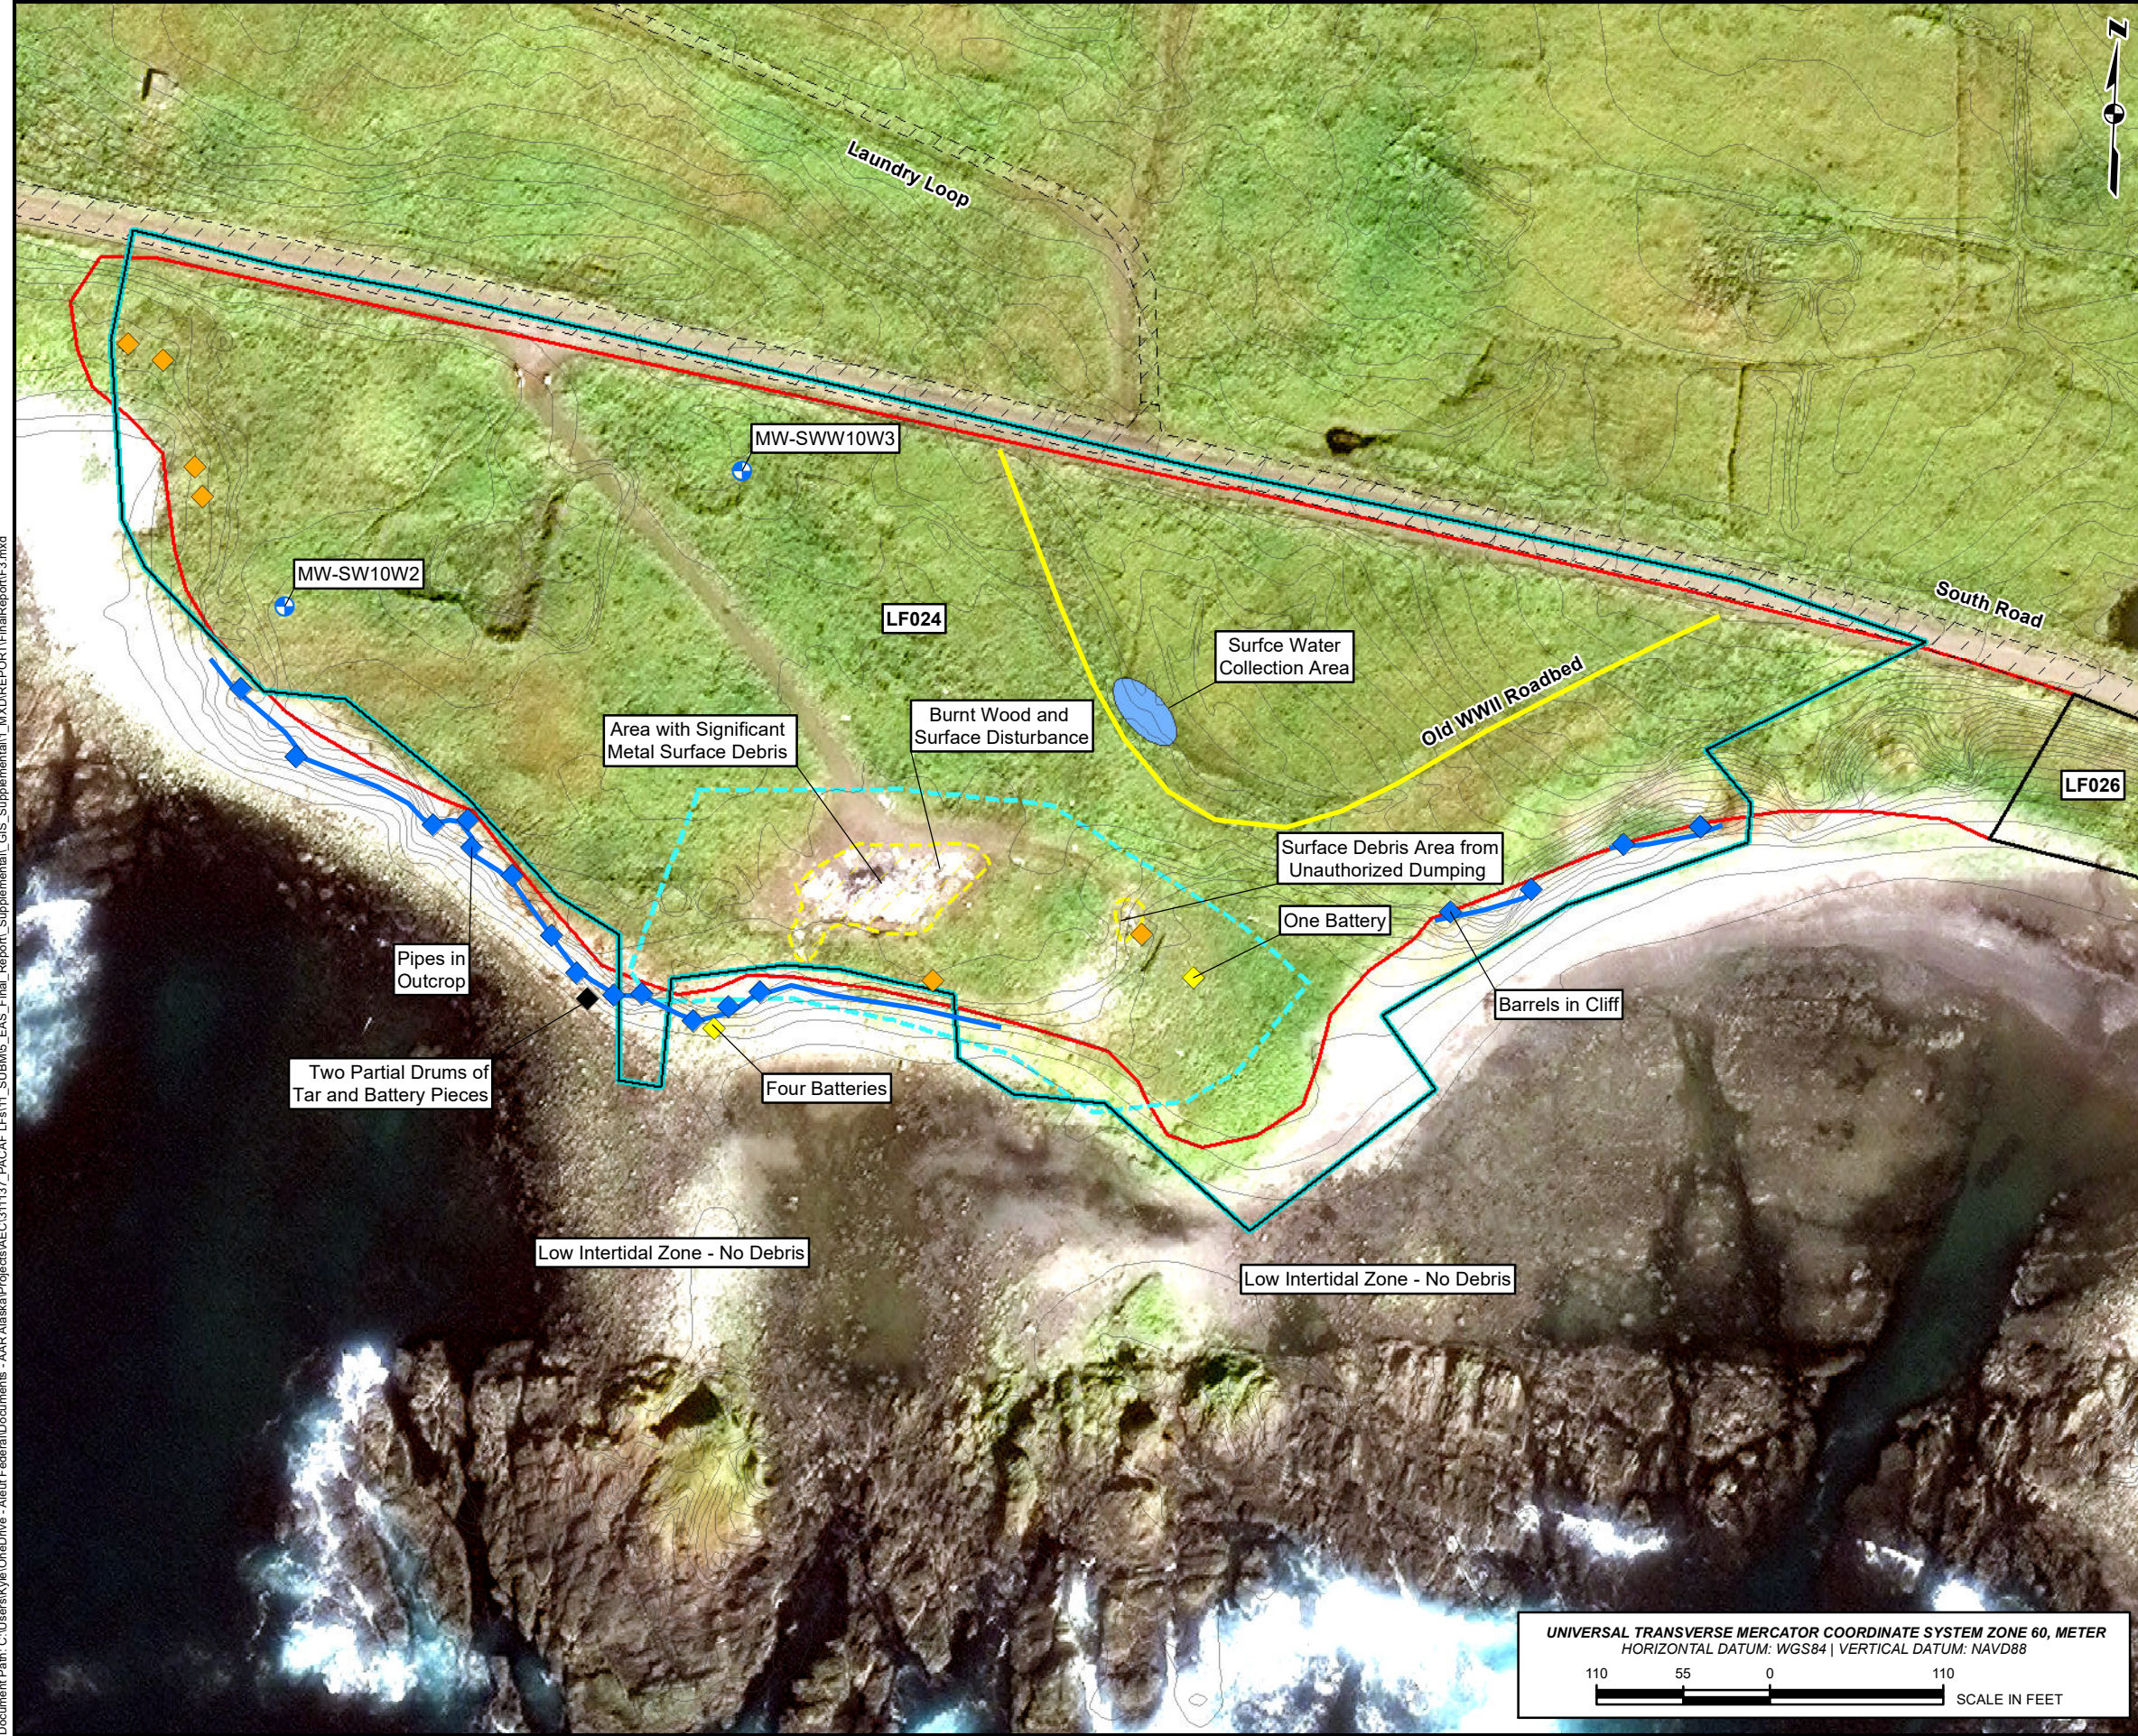
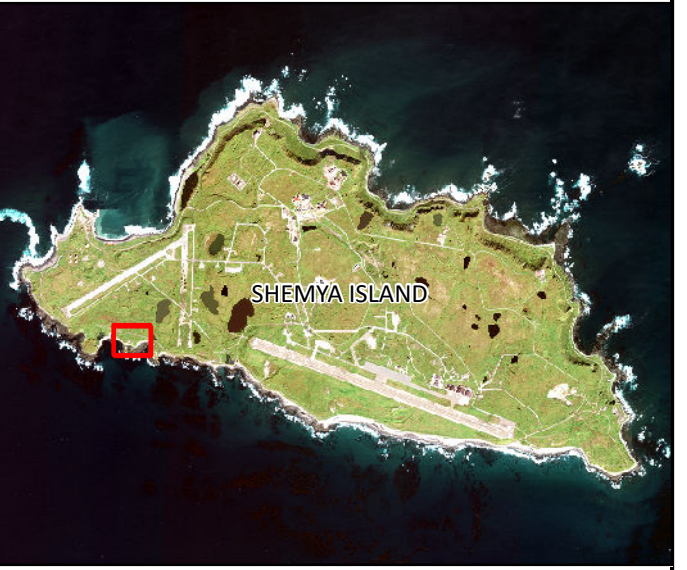
PROJECT No.: 311137	DATE: 6/3/2025	FIGURE: 3
P.M.: S.B.	DRAWN: K.T.

Observations noted during the LF024 inspection included (Attachment A, Figure 3):

The LF024 landfill cap was well vegetated across nearly 90% of the site with the exception being where the cover was disturbed around the burnt wood area and along the ocean bluff where the cover is actively being eroded. Exposed debris was observed along the southern and southwestern boundary eroding into the ocean was mostly metal, however several lead acid batteries and partial drums of tar were noted. In addition, a volume of metal debris was observed on the ground surface and partially buried along the southern beach bluff and to the north around the remnant burnt wood area. The hatched area shown in Attachment A, Figure 3, displays the general location of this surface debris. Additional metal debris was observed in the beach bluff, along the beach middle and high intertidal zones and scattered on the ground

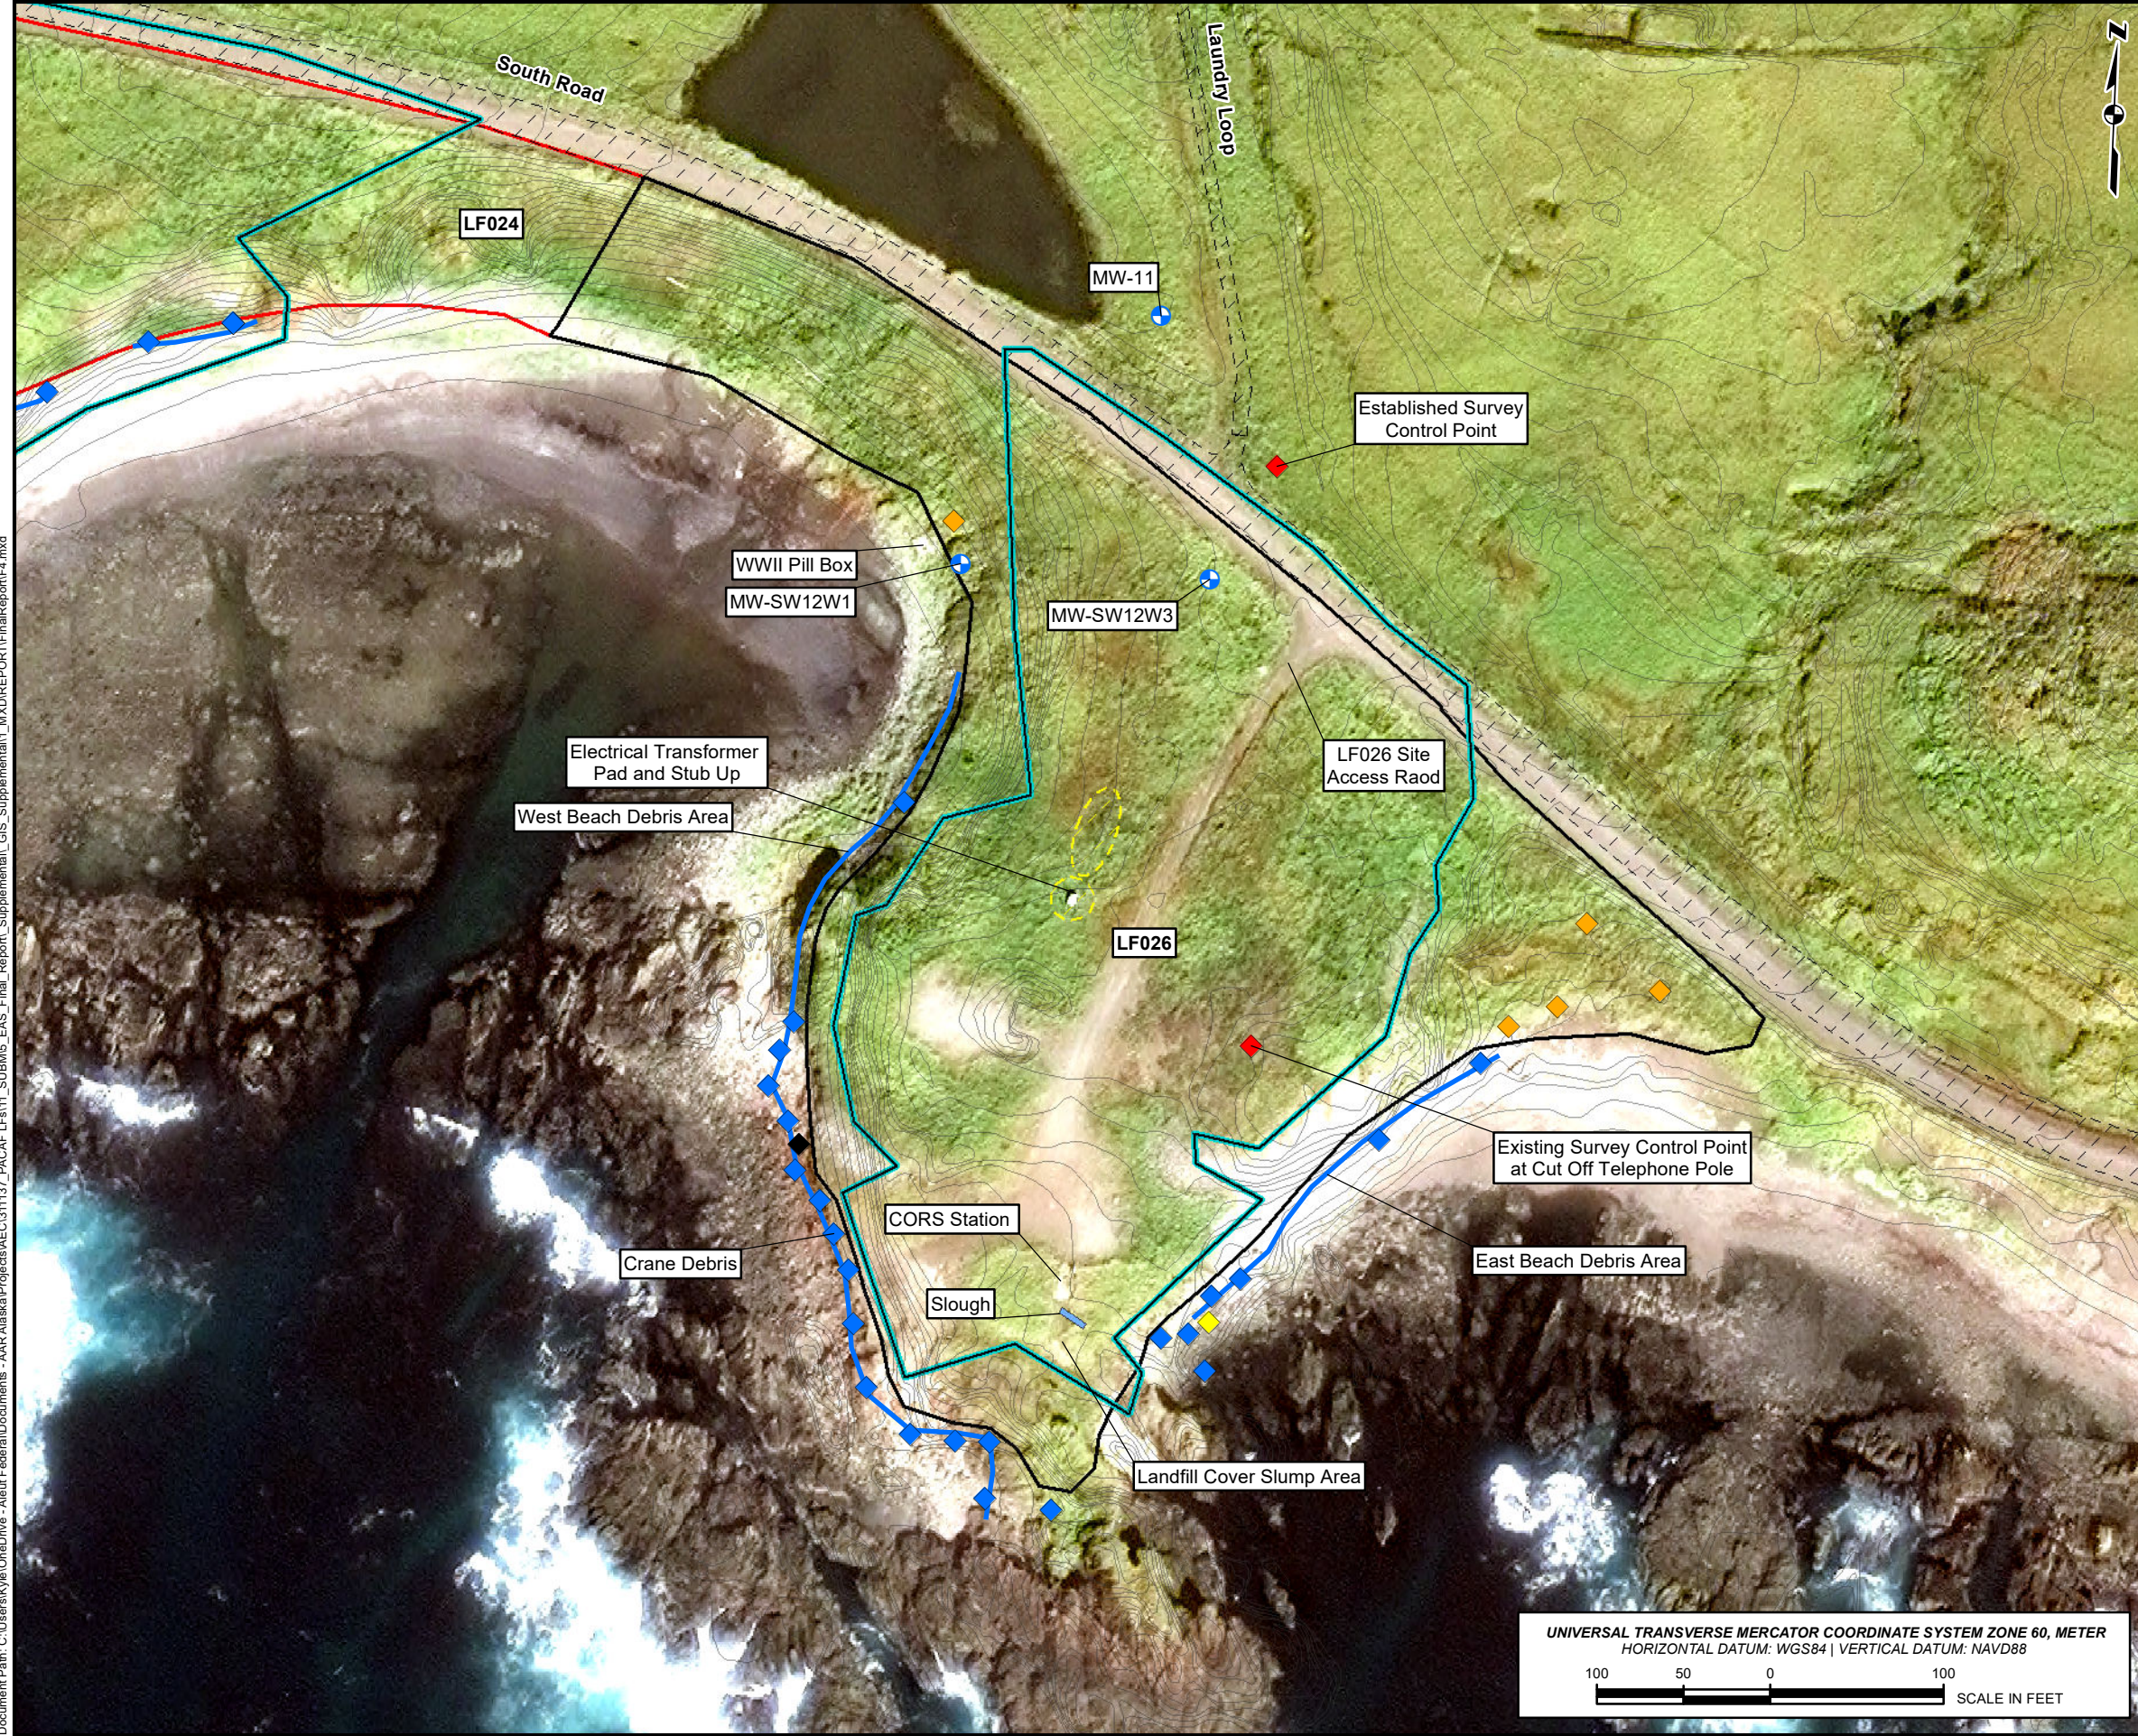
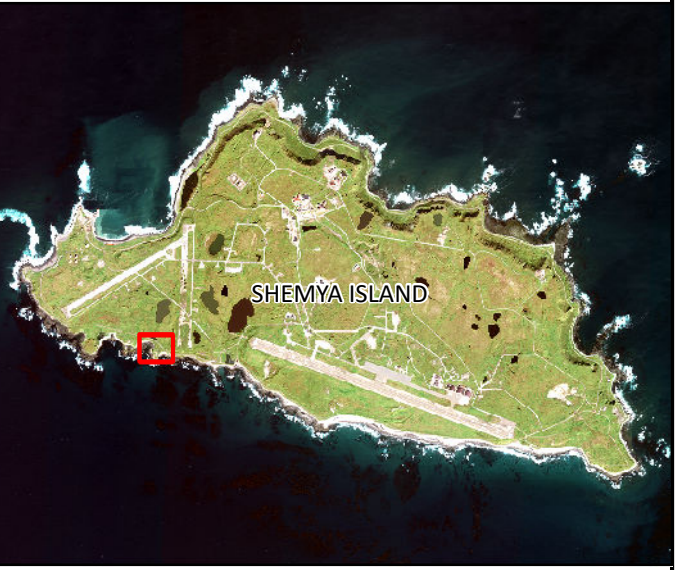
PROJECT No.: 311137	DATE: 6/3/2025	FIGURE: 4
P.M.: S.B.	DRAWN: K.T.

Observations during the LF026 inspection included (Attachment A, Figure 4):

- LF026 boundaries extend further south and east from Figure 2 landfill boundaries based on observed beach bluff and surface debris. Observed landfill extents are presented in Figure 4.

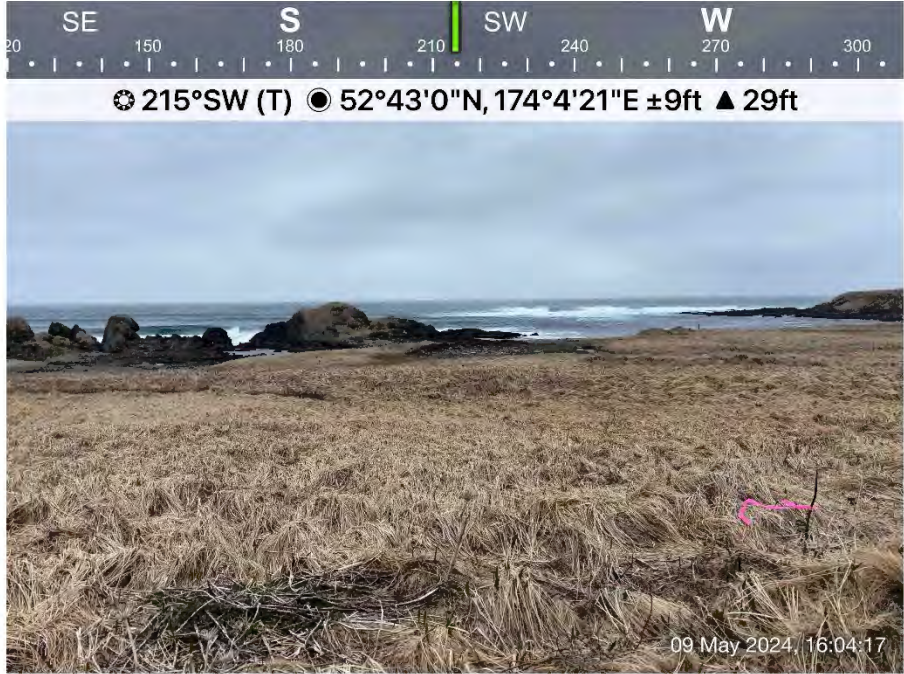
- The landfill cap was well-vegetated across approximately 90% of the site, with no areas of stressed vegetation noted. However, in the south-central area of the site, where historical wood burning has occurred, surface metal debris has been exposed (Attachment B, Photograph 13). The ocean bluff is actively eroding, exposing additional landfill debris into the intertidal zones along the southwestern and southern boundaries (Attachment B, Photographs 04–08). Based on observations of landfill cover thickness along the bluff and the presence of less surface metal, the landfill cover appears to range from just a few inches to 12 inches thick in the south-central area along the beach bluff and the central remnant burnt wood debris area. In contrast, cover material along the beach bluff to the west of the south-central area was 2 to 3 feet thick. LF024 cover conditions are also visible in Photos 01–03.

Photograph 01: Overview of the LF024 area.

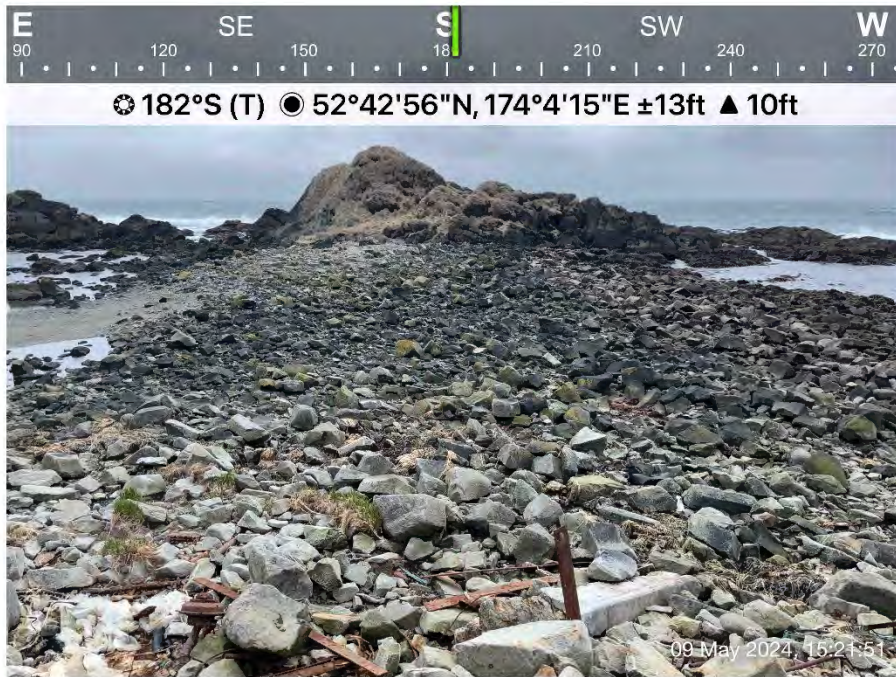
Photograph 10: LF024 southwestern peninsula area overview of middle intertidal zone.

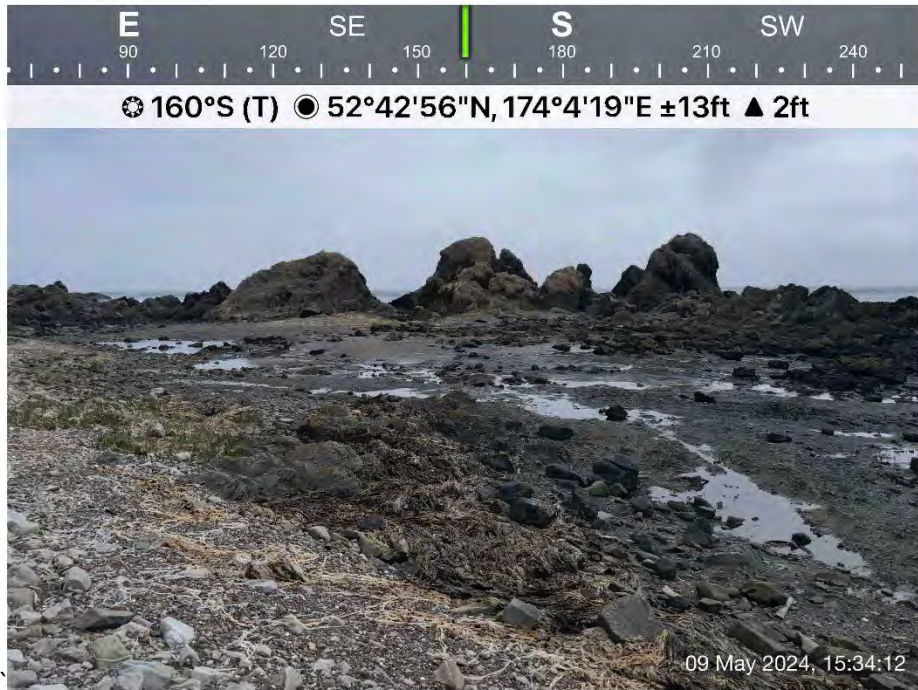
Photograph 12: LF024 southeastern peninsula low and middle intertidal zone overview.

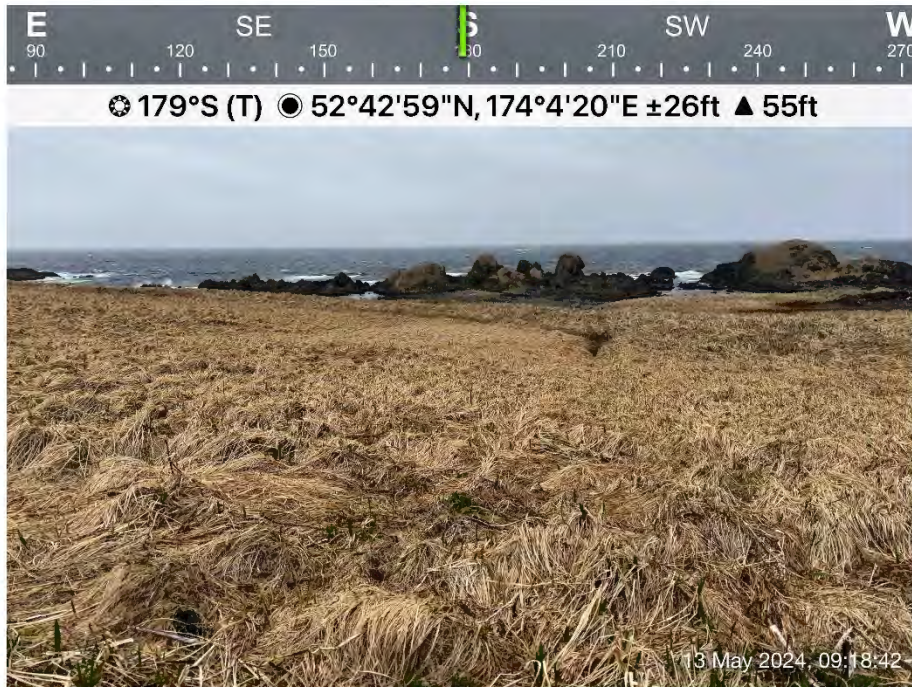
- The old WWII roadbed that curves through the northeastern portion of the site collects some surface water runoff although likely seasonal (Attachment B, Photograph 17).

Photograph 17: LF024 old WWII roadbed and surface water ponding.

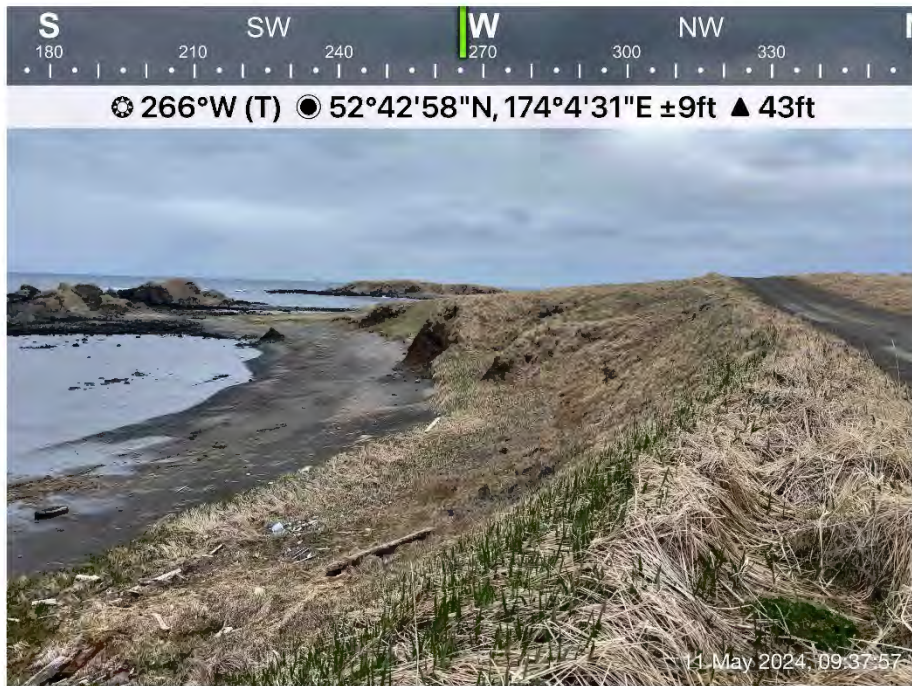
Photograph 18: LF024 view west from the eastern boundary.

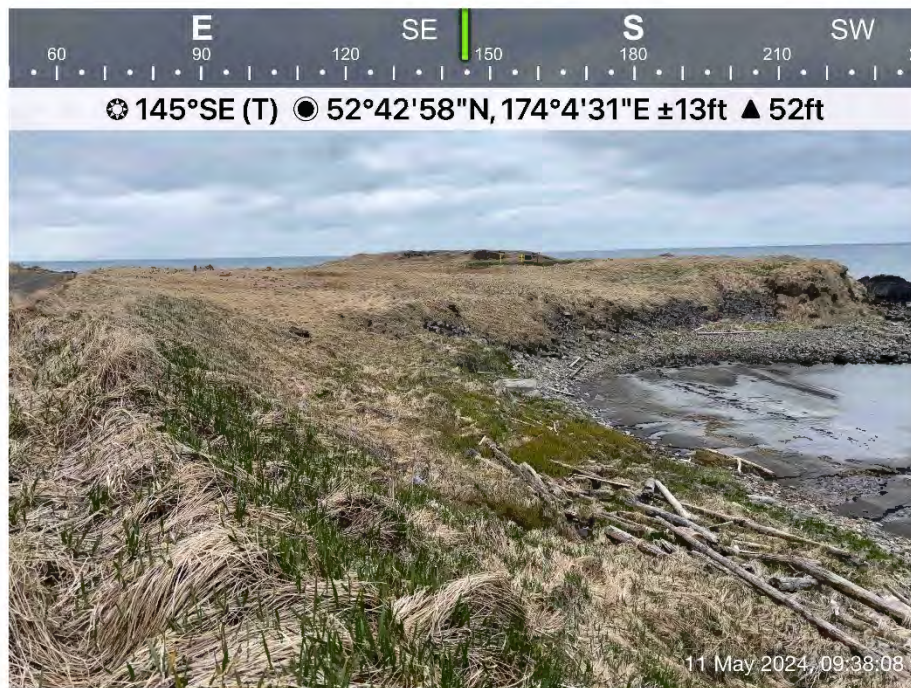
Photograph 26: View of LF026 western boundary from LF024 boundary with WWII pill box in the center of picture.

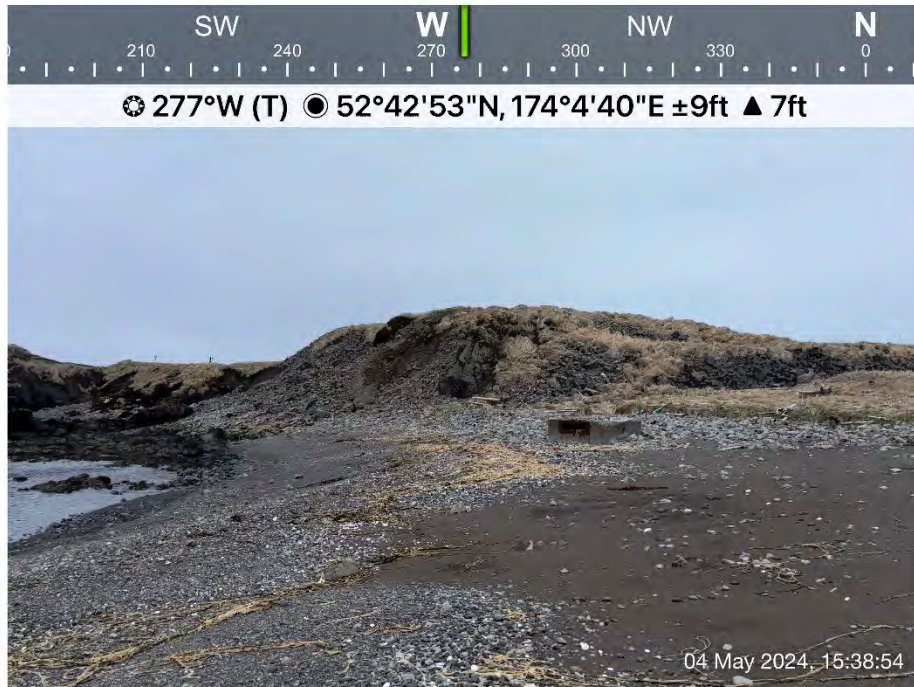
Photograph 31: LF026 eastern boundary.

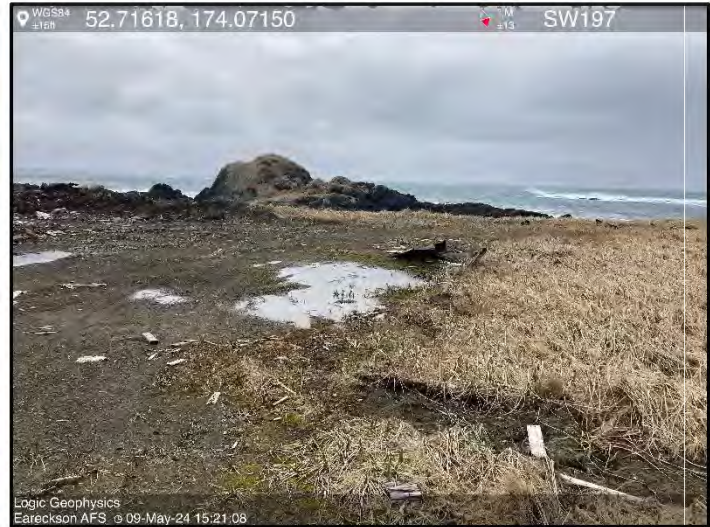
The Eareckson landfill was located on Shemya Island to the southwest of the runway. The surface within the planned survey area was variable, including gravel, rock, debris, hummocks, tussocks, and terrain features (Photo 4). Surface debris was prevalent within the project area and precluded data collection in some locations. Due to safety considerations and time limitations, the steepest areas were not collected with the GPR. Direction and length of lines depended on the site features, both natural and manmade. For example, the easiest way to collect lines with the sled is up and down slopes, not traversing across them.

Photo 4: An example of surface conditions at Eareckson AFS landfills.

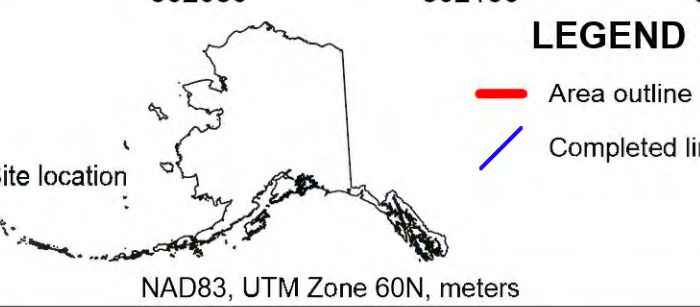
Figure 2
Interpreted Depth of Cover

The initial processing and interpretation of geophysical data provided estimates of the cover depth and lateral extents of the debris locations. The maximum depth of penetration with the GPR was approximately 12 feet. Figure 2 of the geophysical report (Attachment D) shows the lateral and vertical extent of the debris and Figure 3 of the geophysical report (Attachment D) shows the gridded surface elevations. The estimated depth below surface for the top of the debris ranged from 0 to 3 feet. Test pitting is recommended to ground truth the estimated depths.

Figure 2 shows the results from the GPR interpretation at Eareckson over the surveyed area for the lateral and vertical extent of the debris. Estimated depth below surface for the top of the debris ranged from 0 to 3 feet. A hatched area on Figure 2 provides an outline of the section of the landfill which had prevalent surface debris. Figure 3 shows the gridded surface elevations, ranging from ~1 to 17 m in NAVD88, Geoid12B.
