Brownfield Assessment

Property Assessment and Cleanup Plan
Larsen Bay Old School
Larsen Bay, Alaska

By:
Shannon & Wilson, Inc.
5430 Fairbanks Street, Suite 3
Anchorage, Alaska 99518

April 2011

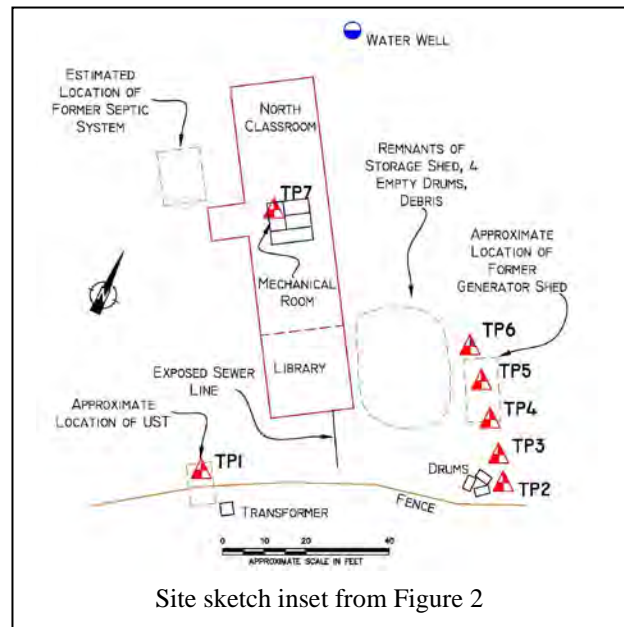
4.3.2 Soil Screening Locations

Test pit locations are shown above and on the Site Plan depicted in Figure 2. Table 1 contains a summary of visual soil classifications and screening results for each test pit.

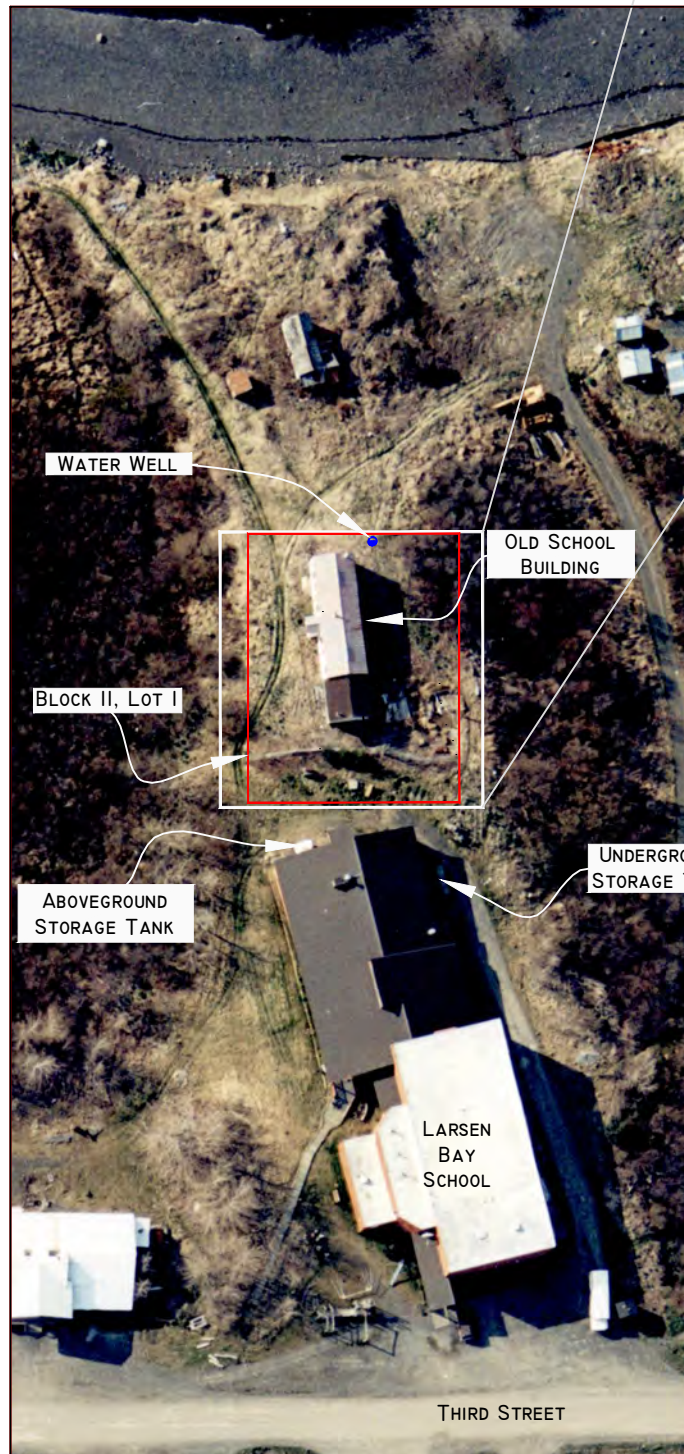
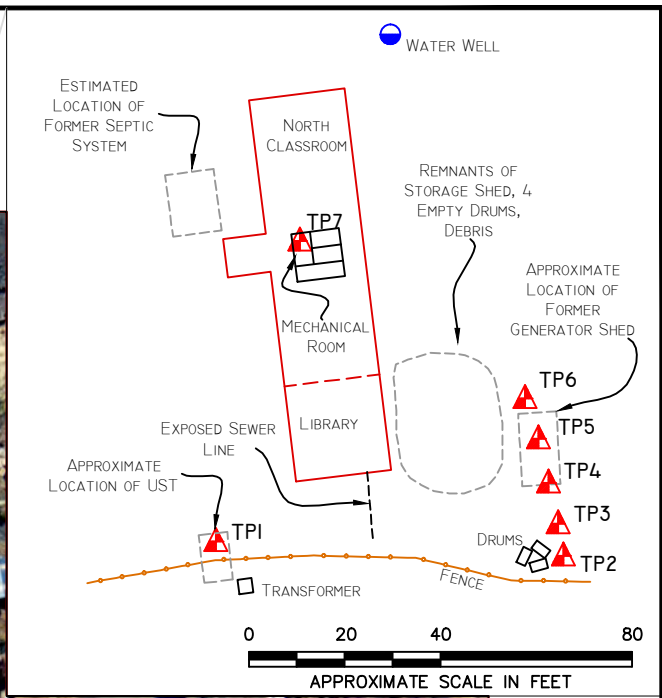
LARSEN BAY OLD SCHOOL PACP LARSEN BAY, ALASKA	
SITE PLAN	
APRIL 2011	32-I-17376
SHANNON & WILSON, INC. <small>Geotechnical & Environmental Consultants</small>	FIG. 2

Records of reported spills, cleanup activities, or corrective actions at the Old School property were not found in our research. The DEC UST database has a record that one 2,000 gallon UST was closed in place. This UST is thought to be on the adjacent school property to the south (See Figure 2). The above-ground fittings of a UST were observed at the northeast corner of the new school addition during our site visit. The fittings did not suggest that the UST had been closed.

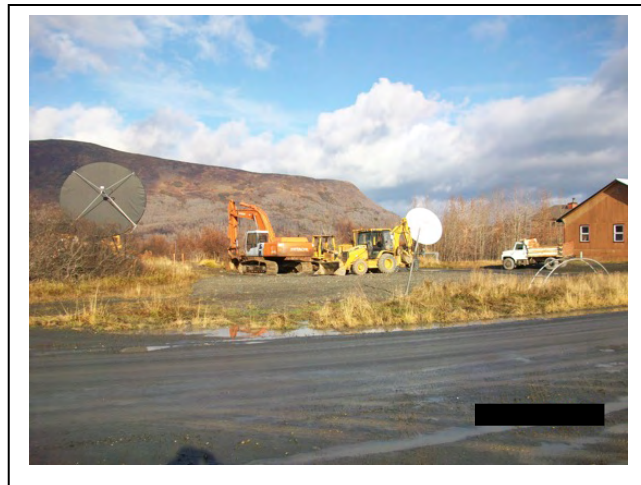
Photo 12: City of Larsen Bay heavy equipment and northwestern corner of City building, Old School is behind trees between the satellite dish and the City building, looking north-northeast 10/25/2010.

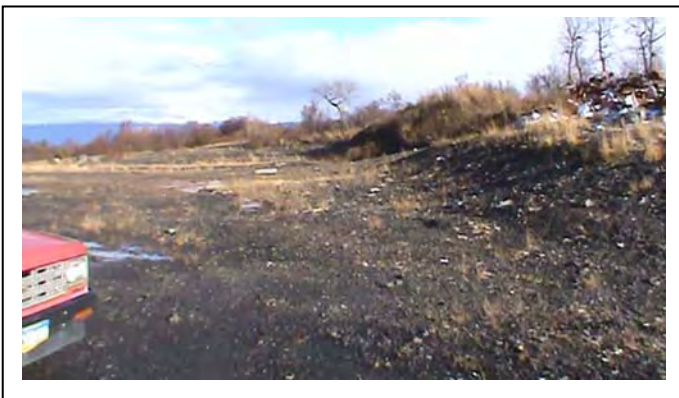
Photo 13: One of several disturbed open areas west of the village and east of the landfill that have potential for setting up soil treatment cells, looking east-northeast 10/25/2010.
